Bridge Inspection Report

02202 SH 367 White Co. over LITTLE RED RIVER

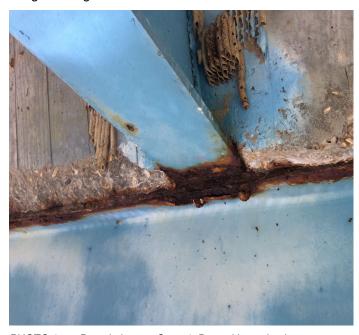
Maintenance Comments:

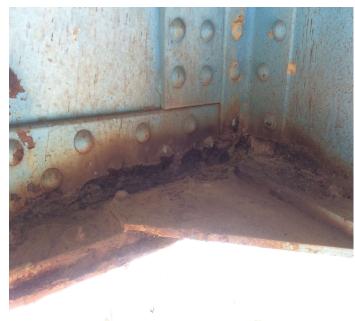
Maintenance Comments:

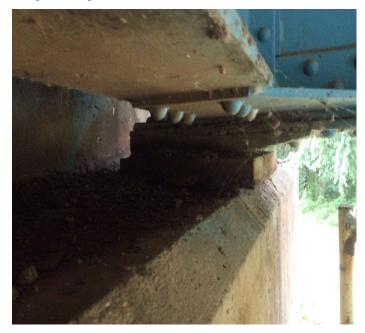
Maintenance Comments:

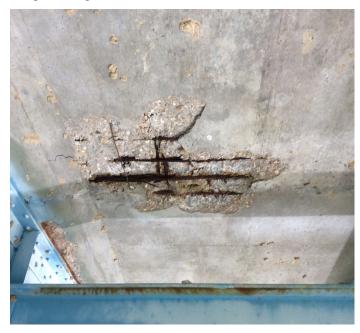
Maintenance Comments:

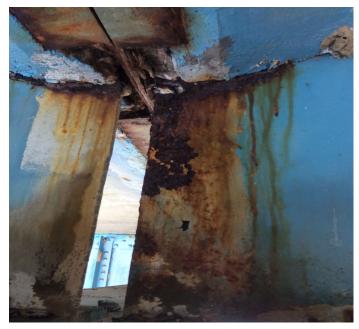
Maintenance Comments:

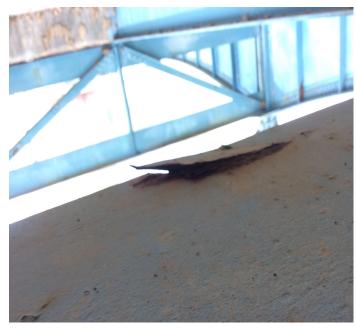
Floor beam 1 has a crack in top Flange at Span 5.

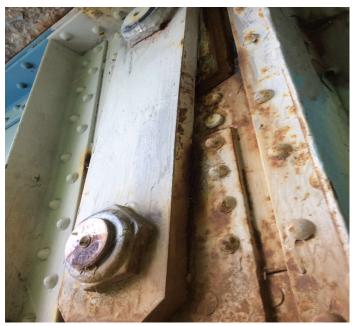
Maintenance Comments:

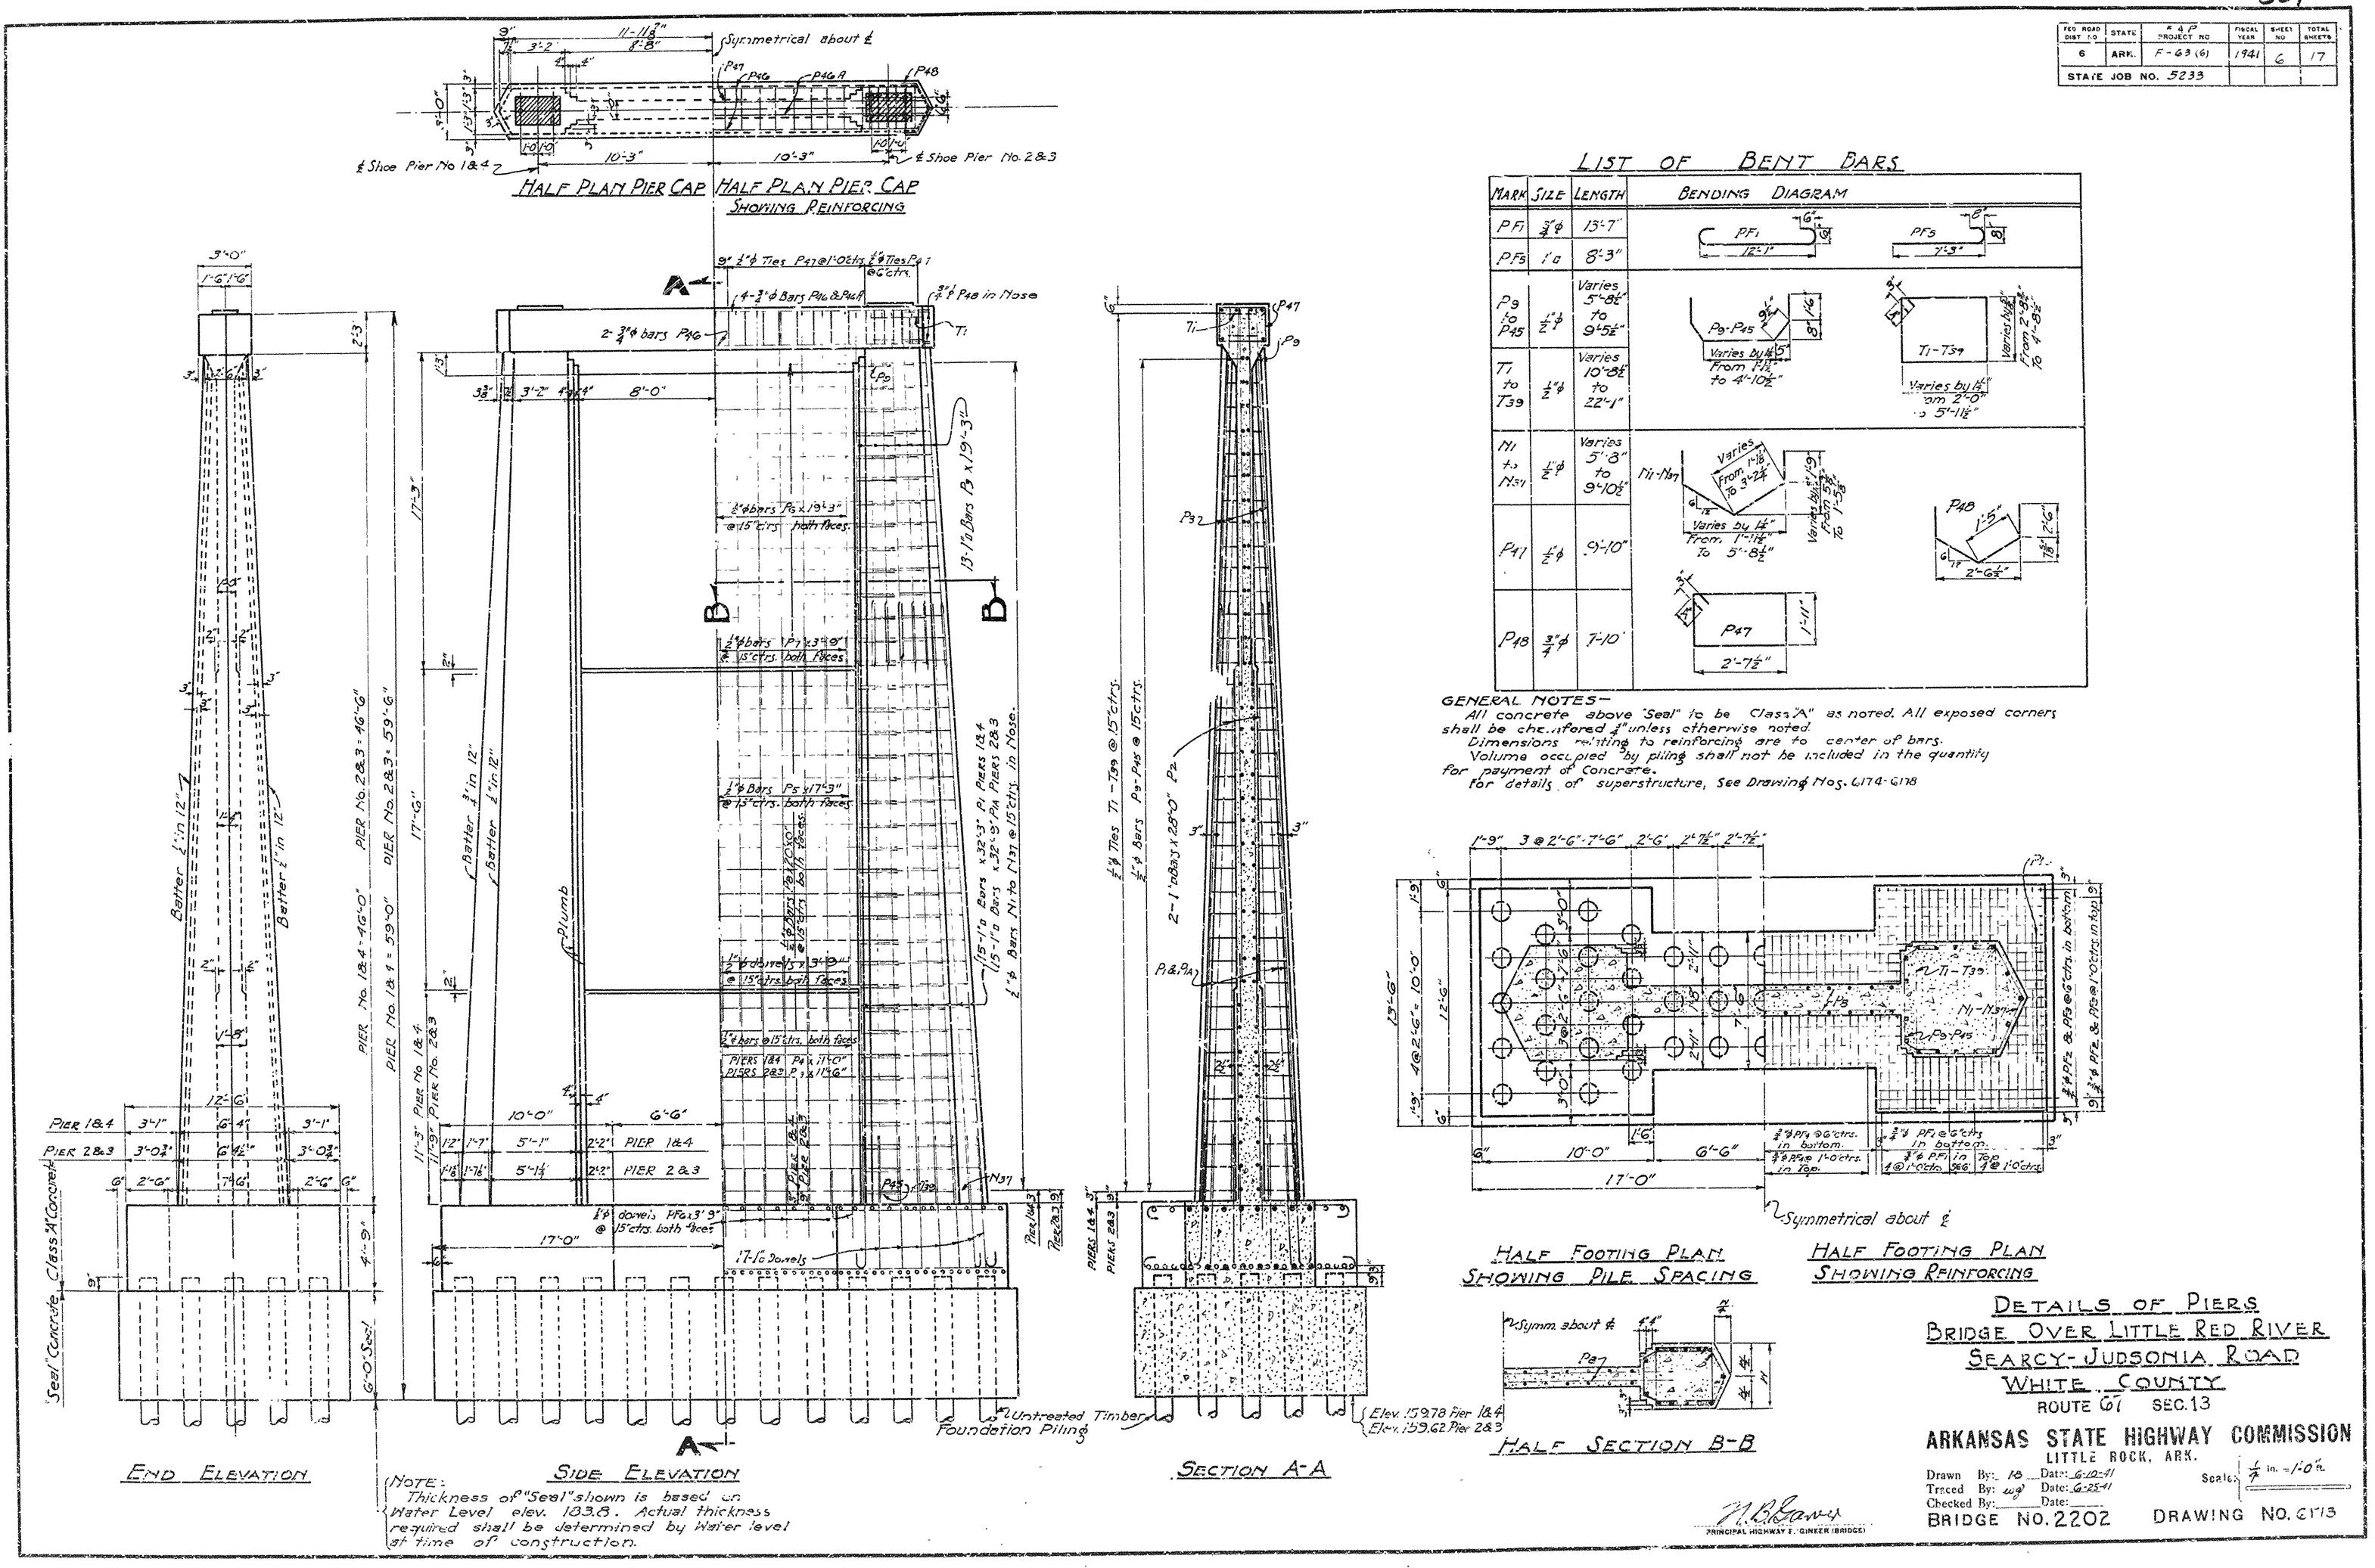
Checked By: Date:
BRIDGE NO. 2202 DRAWING NC. 6172

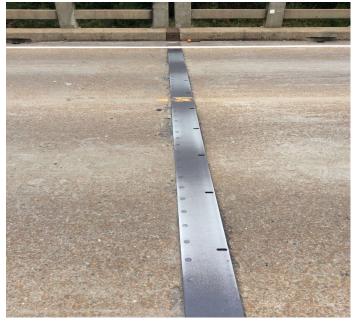
Maintenance Comments:

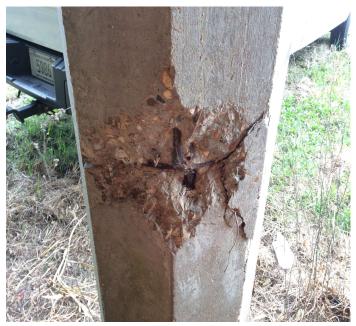
Maintenance Comments:

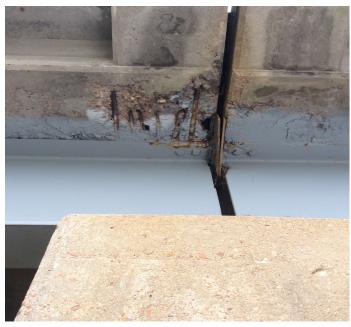
Maintenance Comments:

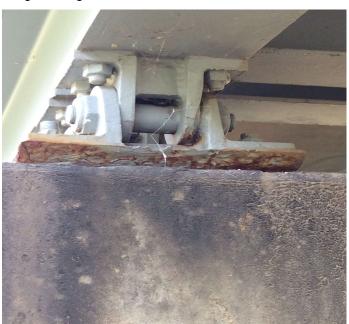
Heavy section loss to all moveable bearings
Section loss to several anchor bolts and nuts with some bent or missing.
