ARKANSAS STATE HIGHWAY AND TRANSPORTATION DEPARTMENT

INTEROFFICE MEMORANDUM

SUBJECT: Pavement Condition and Needs Study - Revised
Highway 150 from I-55 to Highway 137
Mississippi County

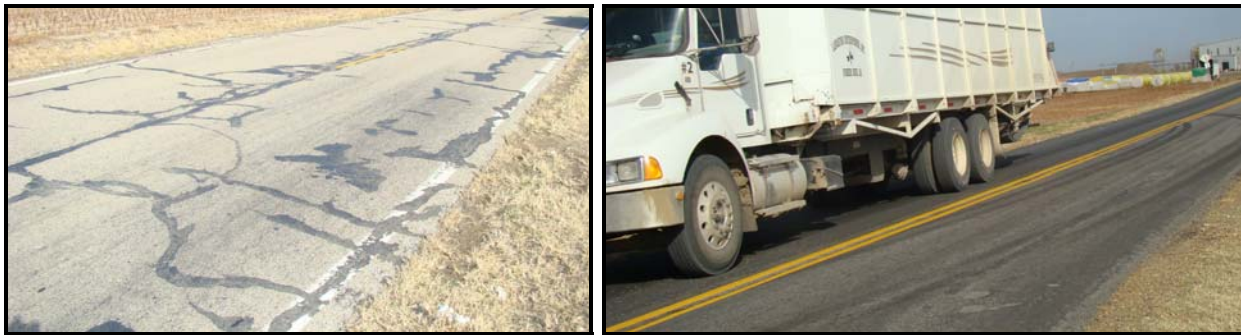
FIGURE 4. Cracking and Minor Rehabilitation

As with most low volume highways added to the state highway system from the county, the roadway sections are highly variable. A visual review of the route verifies this assumption. The field survey conducted in November 2010 found that there are many identifiable areas of minor rehabilitation. Approximately 58% of this route was found to have some type of minor rehabilitation (seal, patch or thin overlay). There were segments that exhibited longitudinal and block cracking, as well as significant rutting in others. This can be seen in Figures 4 and 5. Further details regarding the pavement conditions along this route are included in Appendix B.

Therefore, it is recommended that overlaying and restriping the existing roadway pavement from I-55 to Highway 137 and minor widening with Safety Edge is needed to improve the ride quality and safety. It is expected that the remaining life of the pavement can be extended significantly with a 2-inch overlay. It should be noted that a significantly thicker overlay would be required to provide a 20-year service life. The total estimated construction cost is \$2.2 million.

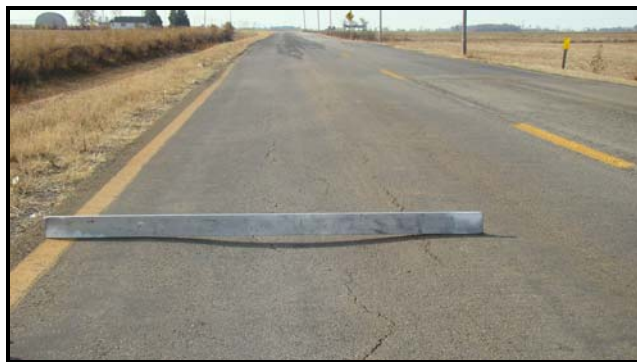
FIGURE 5. Typical Rutting Found Within Log Mile 8.4-10.46

analysis determined that most of the pavement on this segment has an average remaining life of over nine years. In order to extend the pavement life of the entire study segment 20 years, an asphalt overlay of approximately 3.5 inches on the existing pavement would be required. A closer inspection of the FWD analysis shows that the pavement is weaker from around log mile 8.4 to the end of the route at log mile 10.46. The FWD analysis results can be found in Appendix B.

Pavement condition data was collected in November 2010. The average International Roughness Index (IRI) for the segment is 128 inches per mile (in/mi), which is considered fair. The average rut depth of segment is 0.12 inches, which is considered good. There is an increase in the IRI and rutting within the last two miles of the segment (Log Mile 8.4 – Log Mile 10.46) where average IRI increases to 157 in/mi (fair) and the average rut depth increases to 0.20 inch (good). Selected sections show the rut depth significantly exceeding 0.25 inches in depth, which is considered fair.

the ride quality and safety for the entire route and structurally improve the weakest section of the route. Based on the FWD analysis and pavement condition assessment, improvements to the section from log mile 8.4 to log mile 10.46 may be considered a higher priority.

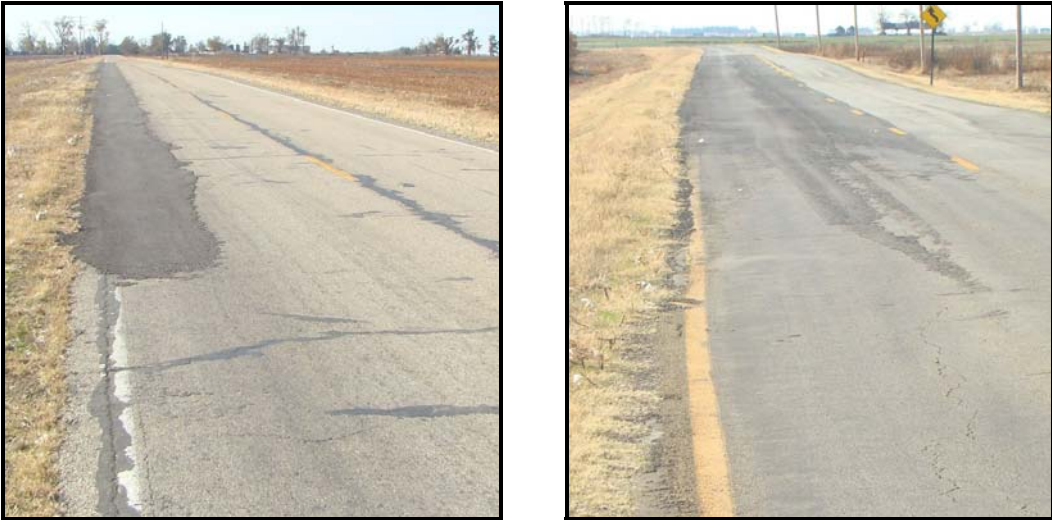
FIGURE 6. Pavement Edge Deterioration

The unpaved shoulder width of this segment is approximately four feet. Selected sections of the study segment exhibit significant pavement edge deterioration due to the large trucks encroaching on the shoulders (see Figure 6). The pavement edge deterioration is a potential safety concern since heavy trucks and other vehicles may be forced to travel closer to the centerline to avoid the shoulder deterioration.

Safety Edge, an asphalt paving technique, has been used in the recently years around the country to protect motorists from run-off-the-road crashes, particularly on two-lane roads with unpaved shoulders. During the normal paving process, pavement edges are formed vertical or near vertical. Recent research has shown that almost all drivers and vehicles can recover if the edge is tapered to 30 degrees from the horizontal. Safety Edge provides the tapered edge and is easy to include in the paving process thus provides a safer roadway edge and a stronger interface between the pavement and the graded material.
