TRC1002

**Evaluation of High Performance Curing  
Compounds on Freshly Poured Bridge  
Decks**

Final Report

Arkansas State Highway & Transportation Department

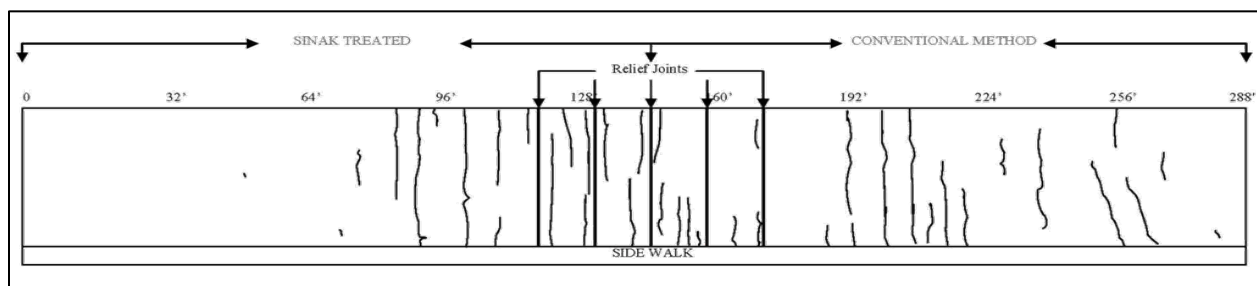
Figure 5 First Distress Survey of Job Number 030350

The bridge deck in Hope was completed on September 2, 2009. The first of the three distress surveys was conducted on October 28, 2009. At the time of the first distress survey, the last 20 feet on the control section was covered with equipment. Therefore, the last 20 feet of the control section was not evaluated in the distress survey. The total length of cracking on the HPCC half of the bridge deck was 277 feet. The total length of cracking measured on the control section was 300 feet. Due to the equipment on the bridge deck, a comparison of the cracking between the two sections was not completed.

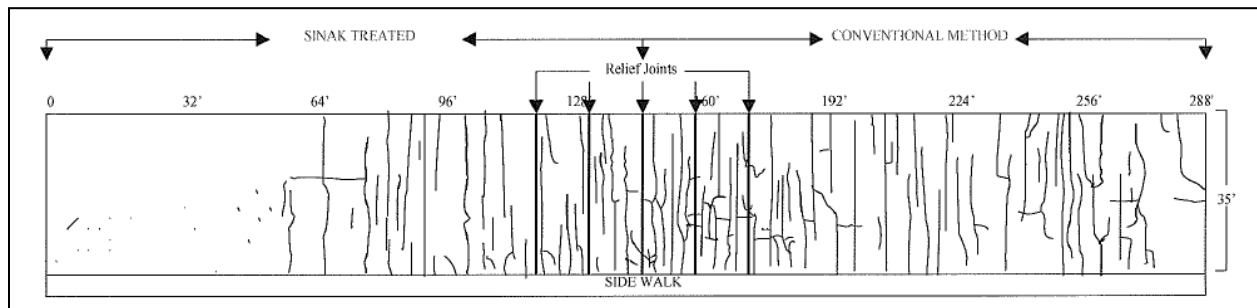
Figure 6 Second Distress Survey of Job Number 030350

The second distress survey for job number 030350 was completed on January 14, 2010. The HPCC total crack length measured 672 feet and the total crack length for the control section was 1,190 feet. At the time of this distress survey there was approximately a 44% reduction in cracking with the HPCC when compared to the control section. The third and final distress survey was completed in two parts the first part, the westbound lanes, was surveyed on February 16, 2012 and the second part of the distress survey was completed on March 7, 2012. The HPCC section had 1,750 linear feet of cracking where the control section had 2,654 feet of linear cracking. The

reduction in cracking was approximately 34 percent when comparing the HPCC section to the control section.

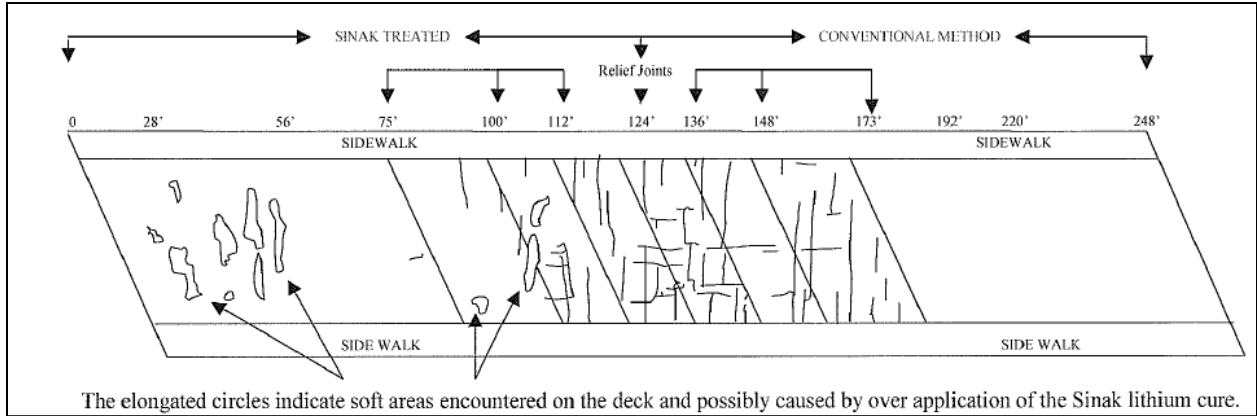
Figure 7 First Distress Survey of Job Number 030341

The bridge deck in Texarkana was completed on September 2, 2009. The first distress survey was completed on November 12, 2009. In the areas where ponding had occurred during the application of the HPCC, the surface of the concrete became soft and is indicated by the elongated circles in the distress survey. With the final application of the HPCC several months later, the softer areas did seem to harden. At the time of the first distress survey, there was a total crack length of 173 feet on the HPCC half of the deck and 301 feet of total crack length on the control sections. There was approximately a 43% reduction in the HPCC section when compared with the control section. Due to time constraints the distress survey was not completed a year after placement of the bridge deck. The second survey was completed in two parts. The first part was completed on February 21, 2012 and the second part was completed on March 22, 2012. The total linear feet of cracking for the HPCC half was 1,402 linear feet and the control section had 1,608 linear feet of cracking. There was a 13% reduction in cracking when comparing the HPCC to the control section.

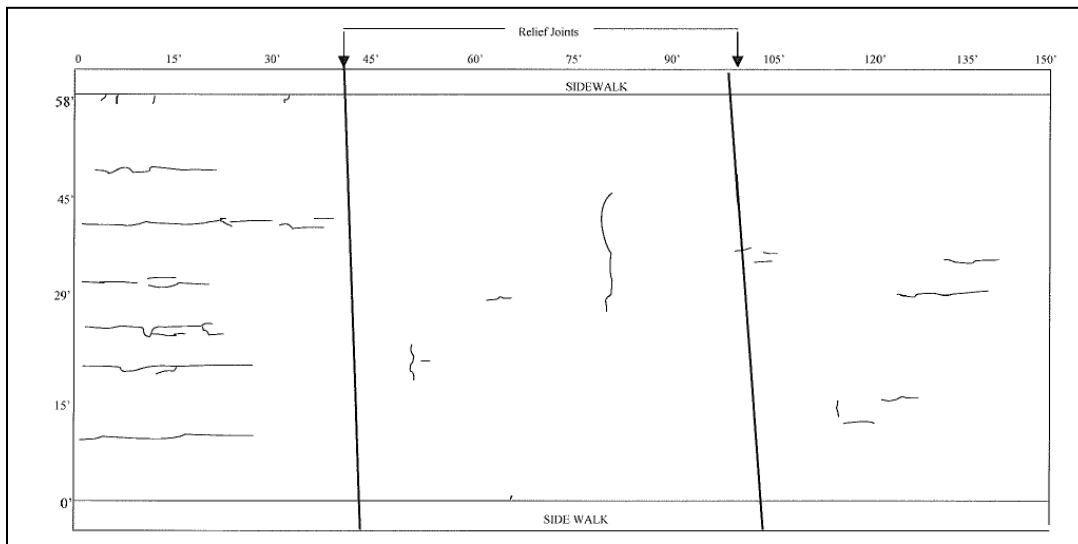
Figure 8 First Distress Survey of Job Number 100608

The bridge deck in Pocahontas was placed on March 31, 2010. Since the entire bridge deck was treated with the HPCC, there is no comparison for this bridge. The first distress survey was completed on June 16, 2010 with a total crack length of 236 linear feet. The second distress survey was completed on August 25, 2010 with a total crack length of 1,208 linear feet. The third and final distress survey was completed on February 27, 2012 at which time the bridge deck had a total crack length of 2,485 linear feet.

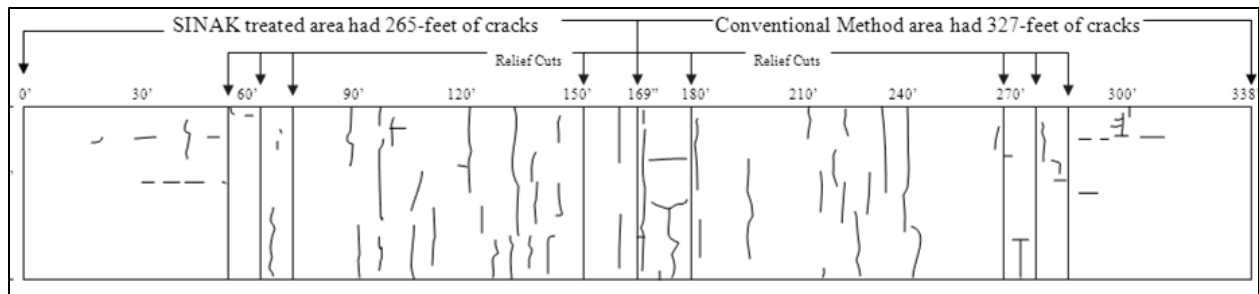
Figure 10 First Distress Survey of Job Number 030322

The final bridge in the project was Job Number 030322 near Prescott, Arkansas. The bridge deck was placed on August 19, 2010 and the first distress survey was completed on October 20, 2010. There were 265 linear feet of cracking on the HPCC section of the deck and 327 linear feet of cracking on the control section. The HPCC section had a reduction in cracking of approximately 19% when compared to the control section at the time of the survey. The second distress survey was completed on March 24, 2011. The total crack length on the HPCC section was 906 linear feet and was 1,137 linear feet on the control section. This showed a reduction in cracking on the HPCC section of approximately 20% when compared to the control section. The third and final distress survey was completed on March 6, 2012. The control section had 1,978 linear feet of cracking where the HPCC section had 1,709 linear feet of cracking. The amount of cracking on the HPCC section of the bridge deck was reduced by approximately 14% when compared with the control half of the bridge deck.
