Guidelines for Selections of Pipe Culverts

**DURABILITY STUDY OF
VARIOUS CULVERT MATERIALS**

April 1999

1. Report No. FHWA/AR-98-007		2. Government Accession No.		3. Recipient's Catalog No.	
4. Title and Subtitle GUIDELINES FOR SELECTION OF PIPE CULVERTS				5. Report Date April 1999

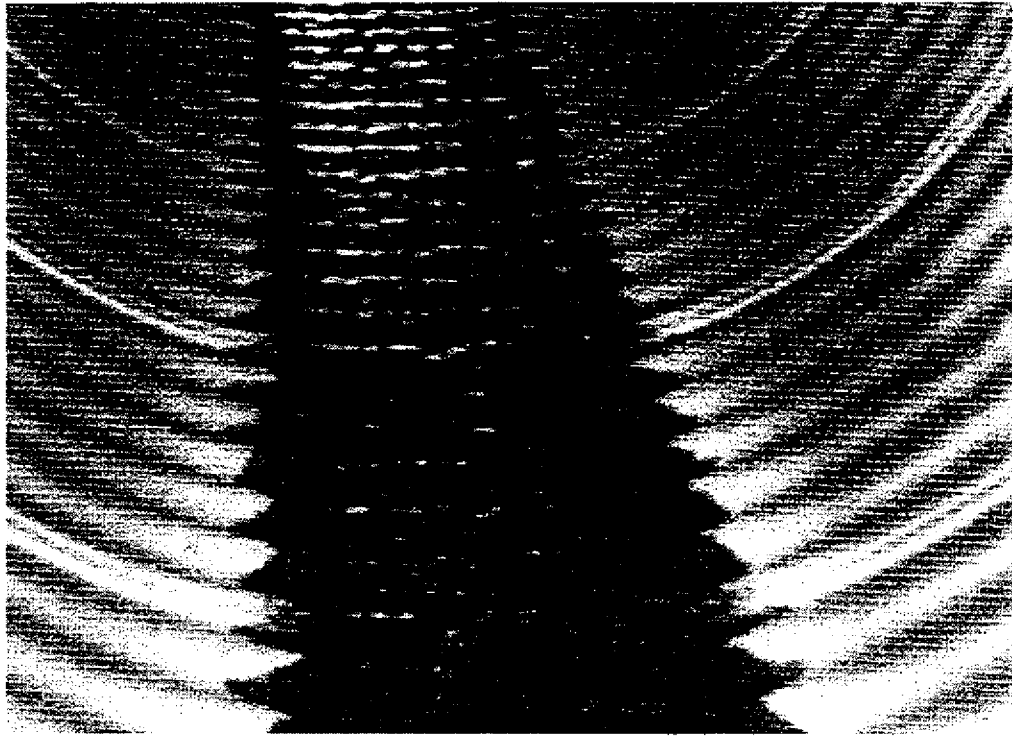
Figure 8. Inside of an uncoated CMP in Waldron, AR. This culvert had a 2 rating. The water line is consistent with corrosion.

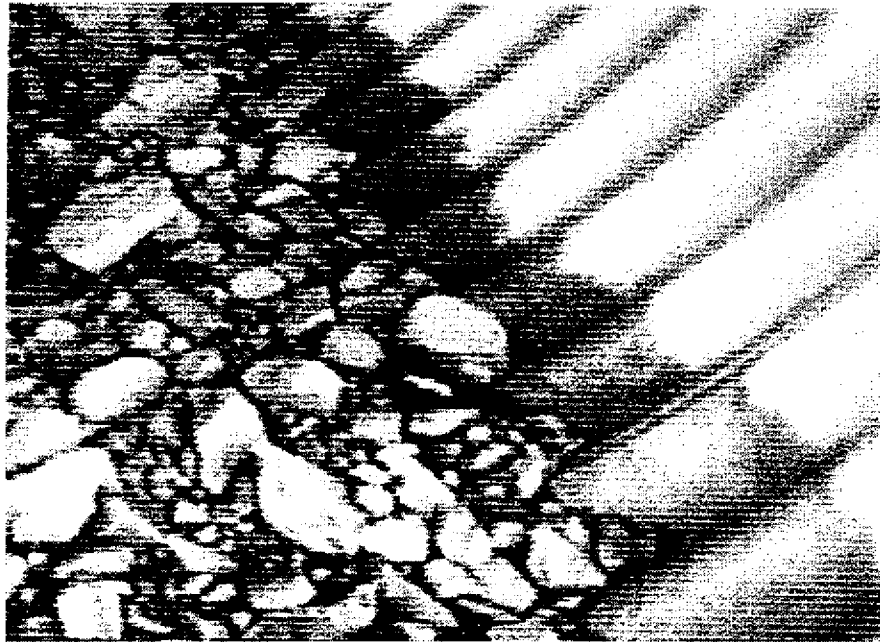
Figure 11. A close-up of the corrosion inside the same uncoated CMP. The rating was a 3.

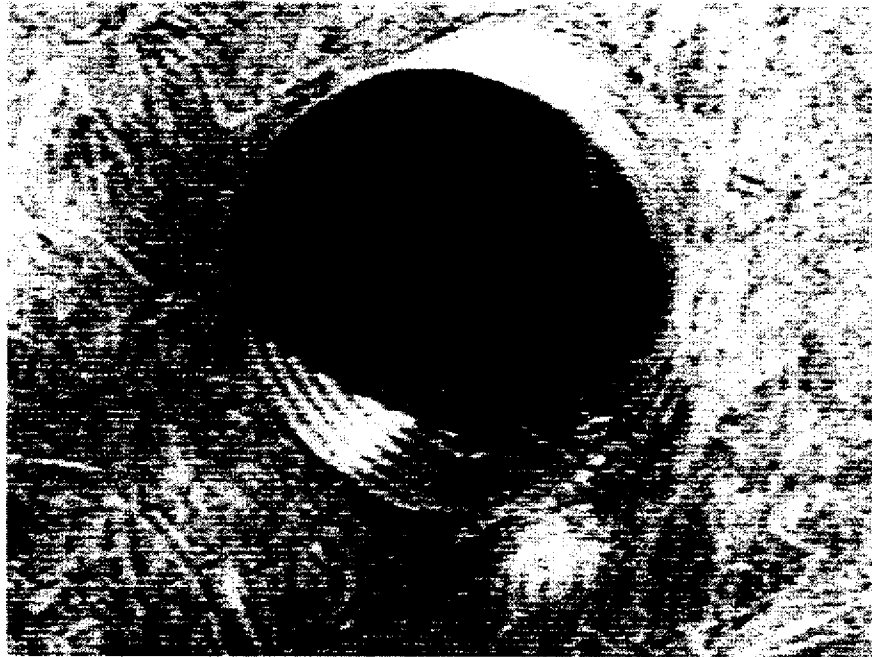
Figure 12. An uncoated CMP culvert with corrosion at the end section. This culvert was rated a 4.

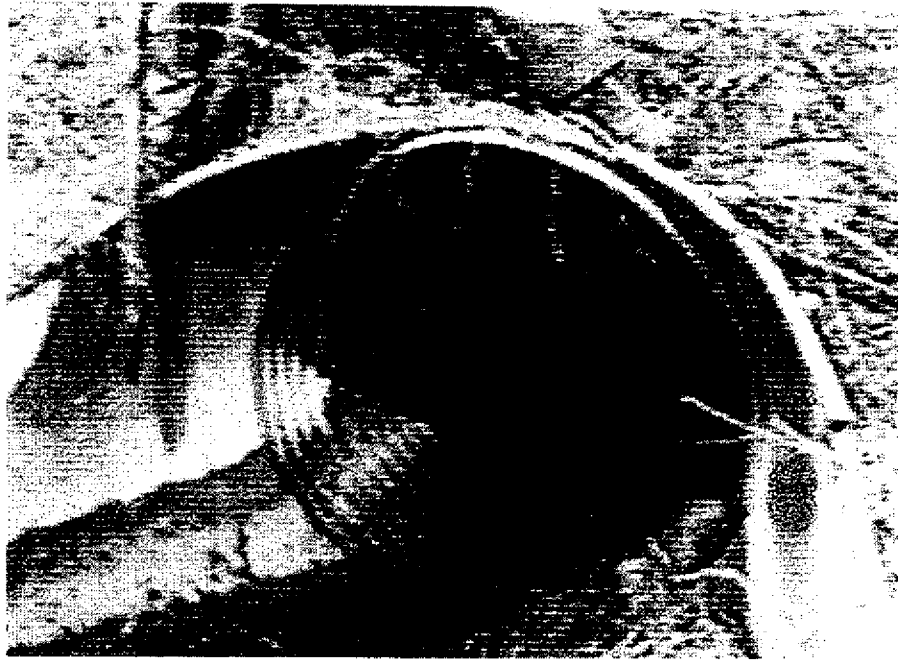
Figure 14. An uncoated CMP located in Sevier County.
This culvert received a rating of 4.

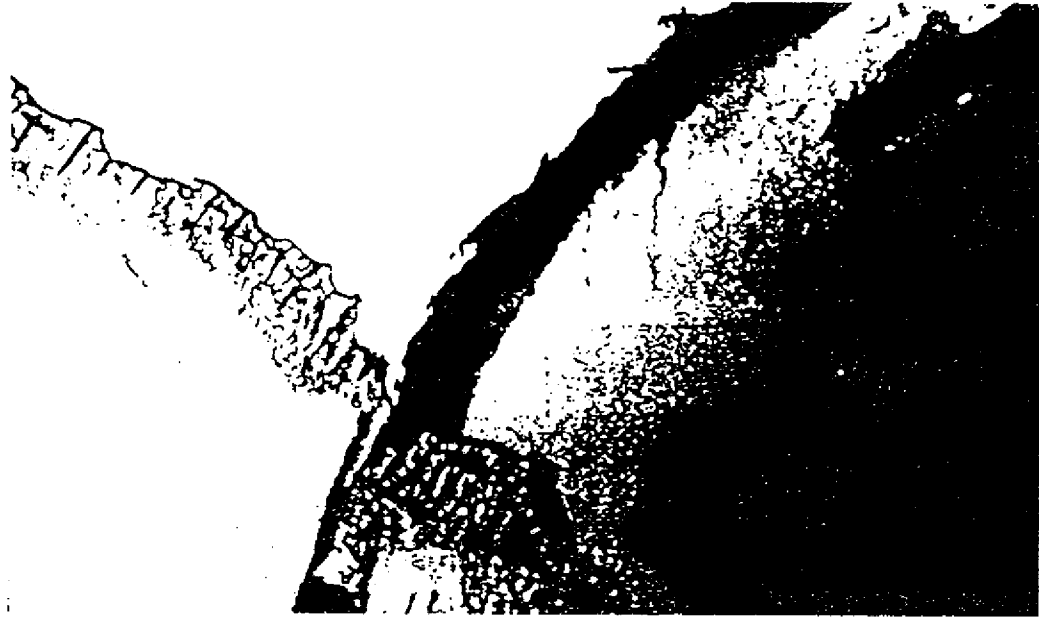
Figure 23. Spalling exposing reinforcing steel.

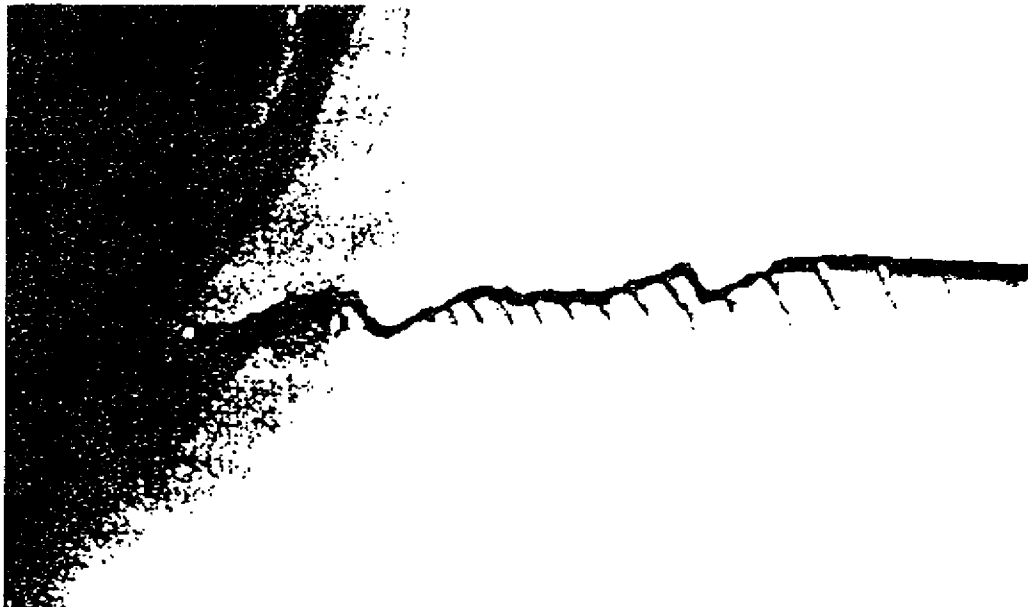
Figure 24. Shear slabbing.
