Causes Of Bridge Pier Staining

Sam I. Thornton
Charles Springer
1974

FINAL REPORT HIGHWAY RESEARCH PROJECT 33

conducted for
The Arkansas State Highway Department
in cooperation with
The U.S. Department of Transportation
Federal Highway Administration

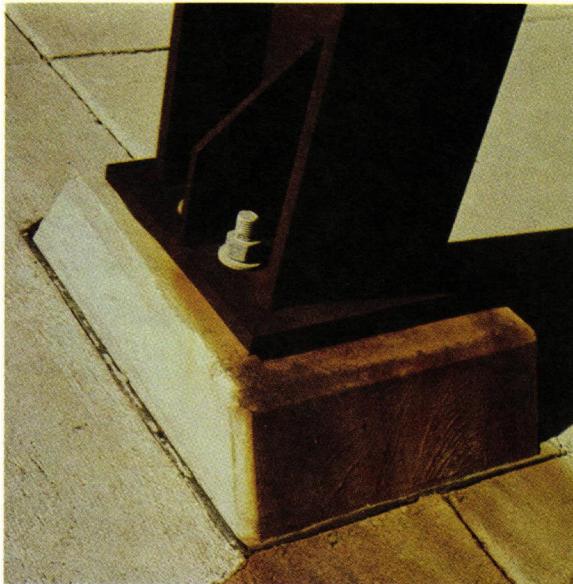
Rust stains are those stains which are directly traceable to metal rust. For example, the stains which are found under the columns of Corten steel or below exposed reinforcing steel. As expected, rust stains contained iron compounds and were the familiar burned red or rust color.

Rust stains, by the way they were identified, are a result of rusting from steel in the bridge structure. Rust stains occurred at the anchor bolts, bridge expansion joints, bridge piers, and on the apron at the end of bridges. Several examples of rust stains which occurred before the bridge deck was placed were found on concrete aprons. Almost all of the rust stains on bridges were below places on the bridge which are difficult if not impossible to paint.

Graffiti and rust stains were very difficult to remove. Sandblasting is an effective method of stain removal but has the disadvantage of removing part of the concrete. When repeated often, sandblasting removes the concrete matrix. Derrington, Stowe and Miller in the Corps of Engineers paper C-68-8, "Investigation of Methods for Removing Stains from Mortar and Concrete" recommend using sodium citrate—sodium hydrosulfite for removing iron stains. Details of this method are included in Appendix C. The method, however, is expensive and time consuming.

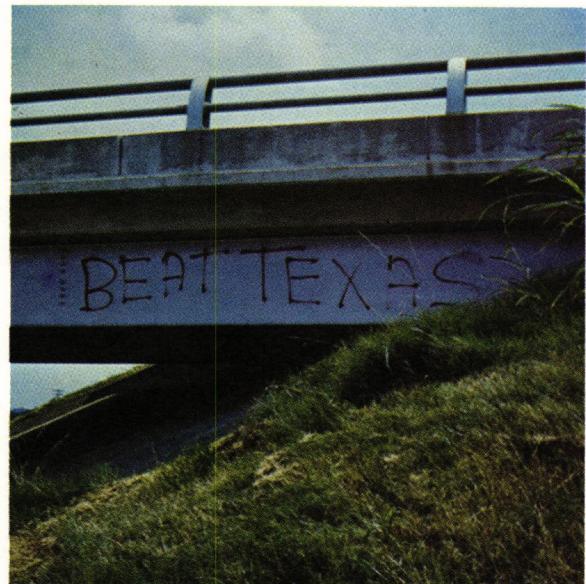
Graffiti stains are mostly paint stains from pressurized cans.

Graffiti is the result of vandalism. Graffiti's origin, therefore, is people. Graffiti stain, therefore, can best be controlled by a sense of public responsibility.

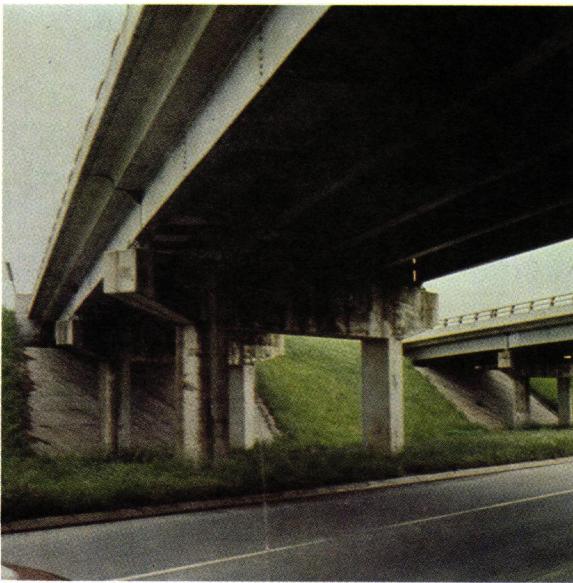
Gray

Red and gray stains are the result of weathering and surface runoff. The stains occur in areas where runoff from the bridges wets the concrete surfaces. In addition, the composition of the stains, i.e. iron, silica, aluminum, sulfur, indicate that soil and road grime are the origin. The presence of sulfur is not surprising because it is used in the manufacture of tires (1 to 1½% by weight) and occurs naturally in asphalt (usually less than 1% by weight). Inspection trips during and just after showers confirmed that areas of red and gray stains are wet by surface runoff.

Red and gray stains were relatively easy to remove in the initial test sections. Application of commercial alkaline detergents and moderate mechanical action removed almost all of the stain in the one square foot test area. Dry brushing and rinsing also removed most of the deposit.

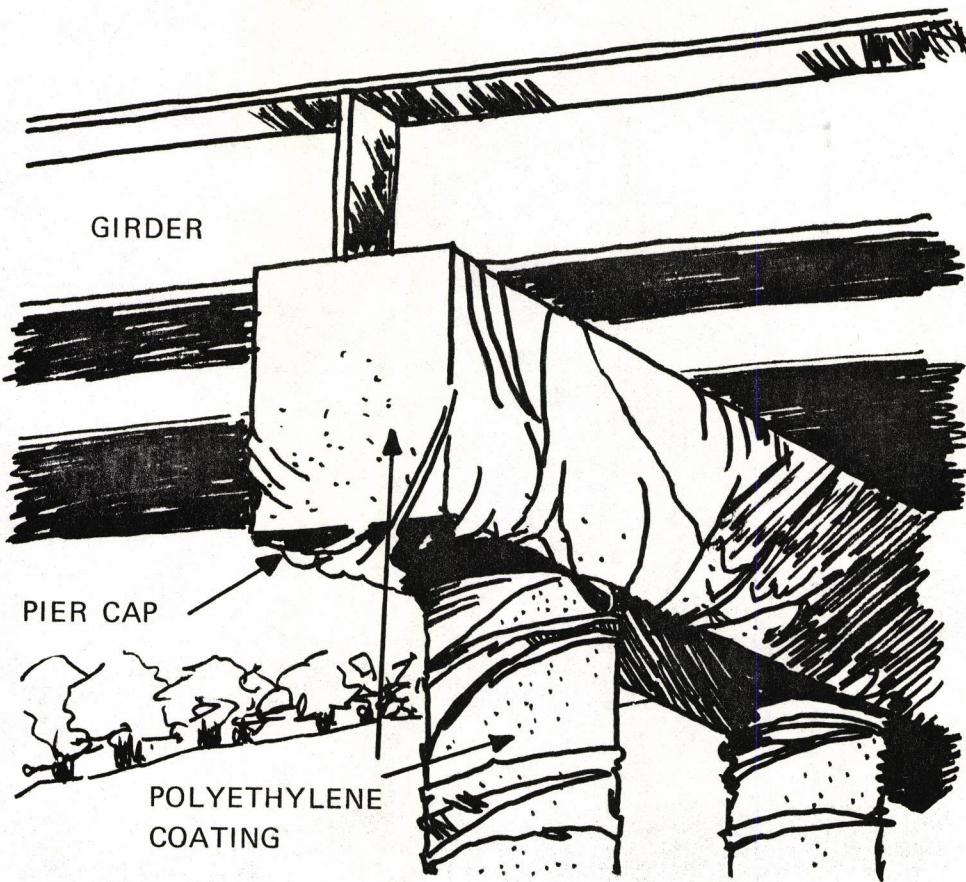
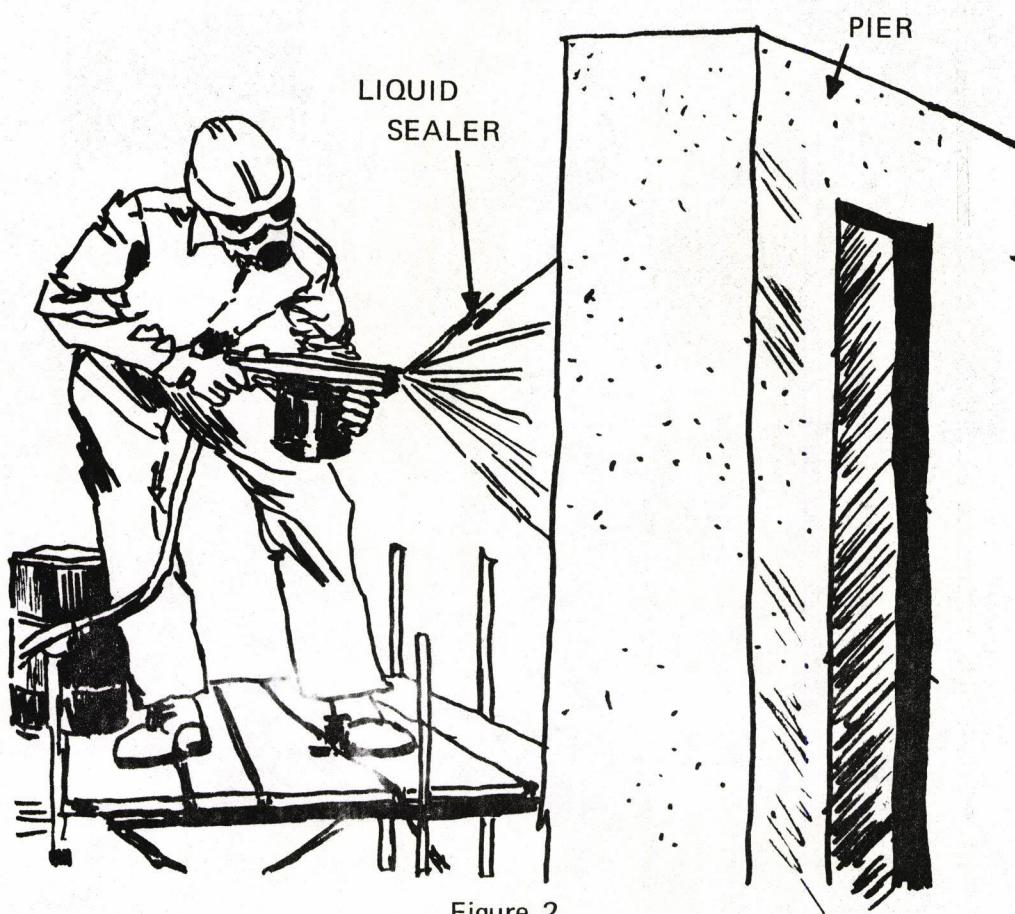
Figure 2

Coatings and sealers are effective in prevention of stains over short periods of time (Figure 2). Polyethylene and vinyl can effectively prevent stains during the construction period before the bridge deck is poured. With time, coatings and sealers break down and expose the concrete to stains.

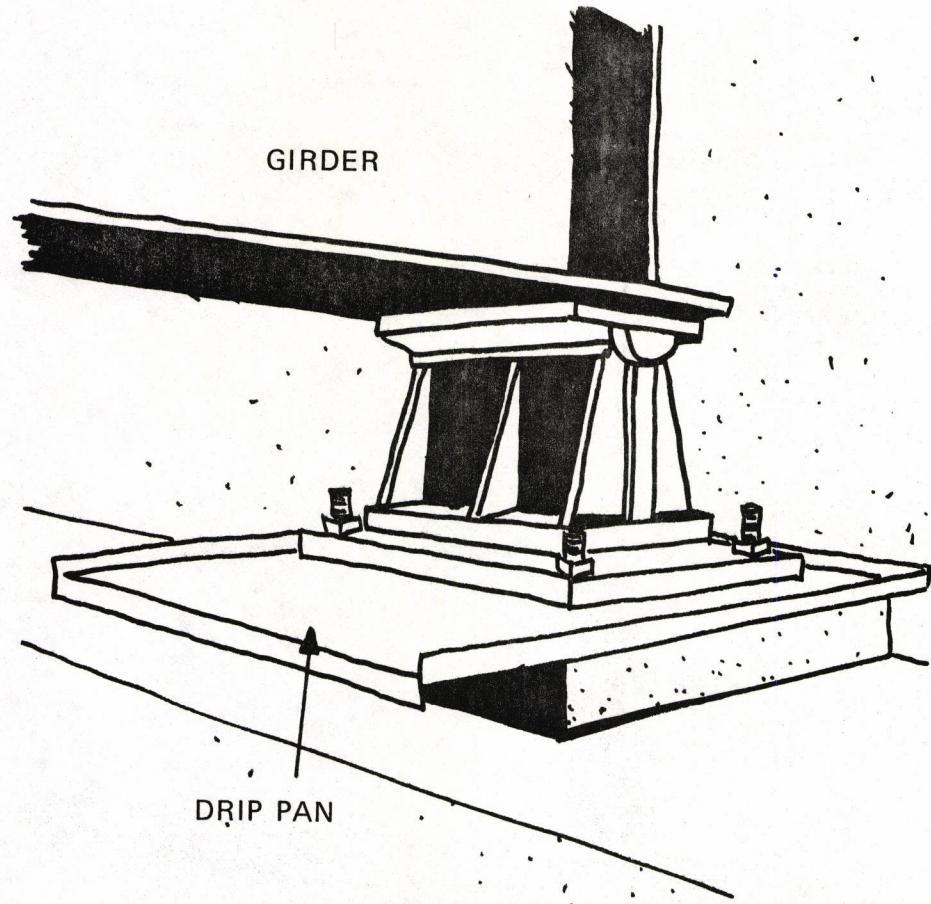
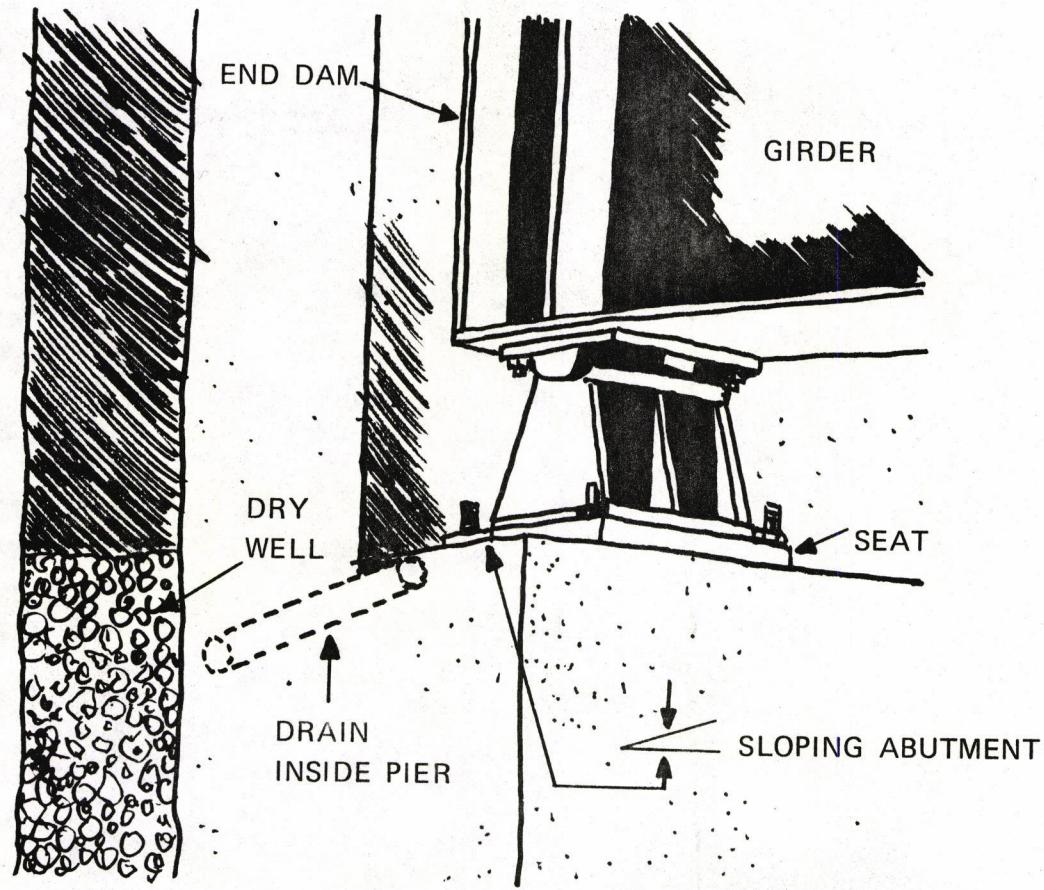
Figure 3

A sloping abutment with drain (Figure 3) is effective for eliminating stains from the bridge ends. Drip pans, also shown in Figure 3, are only moderately successful because wind which accompanies the storms will blow water on the bridge piers.

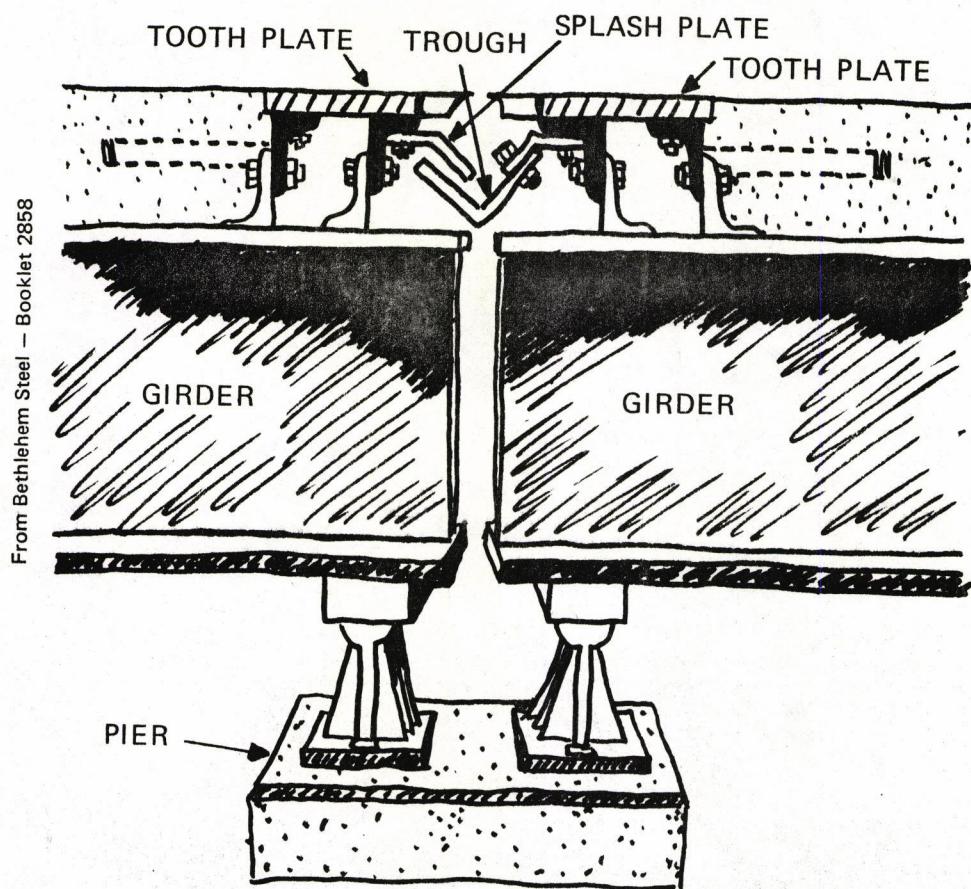
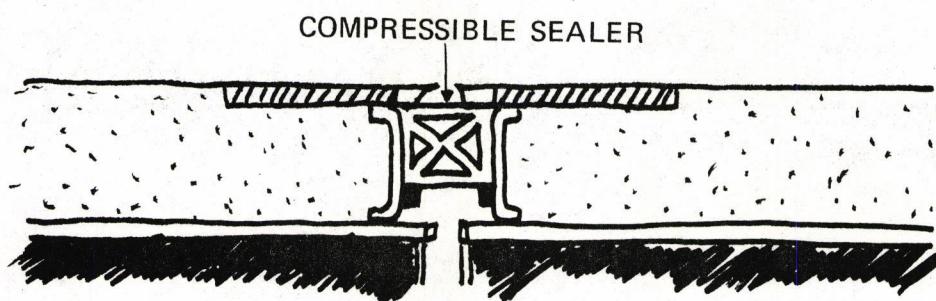
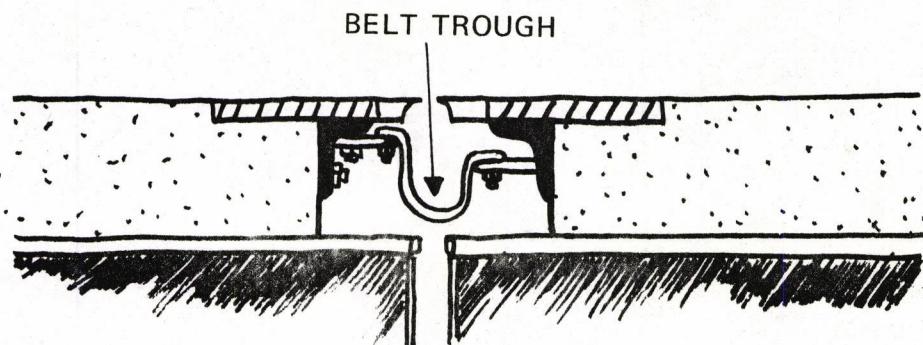
Figure 4

Expansion joints between sections of bridges can effectively be sealed in one of three ways (Figure 4). Where expansions are large, as in the finger type joints, the

neoprene or conveyor belt type trough is effective. Care must be taken, however, that the belt type trough has sufficient room to flex so it will not become clogged. Intermediate movements can be absorbed with the angle troughs and still remove water which passes the joint. Small expansions can be absorbed with the compressible block type joint sealers. Compressible joint sealers must be installed with care or leaks will develop.

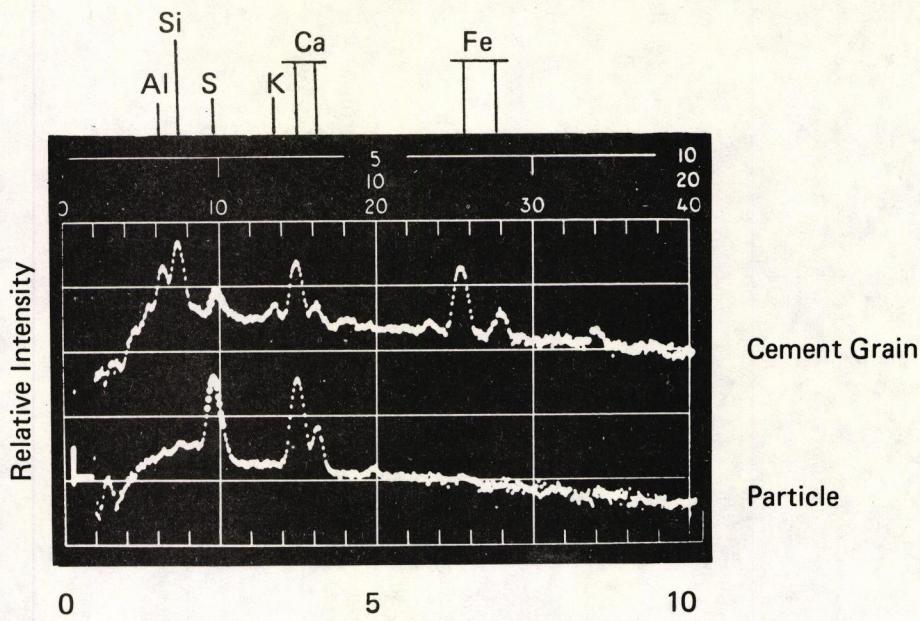
Figure A-3 (a)

Iron, Sulfur and Potassium are the elements found which might be stain related. Aluminum, Silica, and Calcium were also found but are common in concrete.

Comparison of the X-rays gathered from a "cement grain" and a small particle on the surface of the same grain.

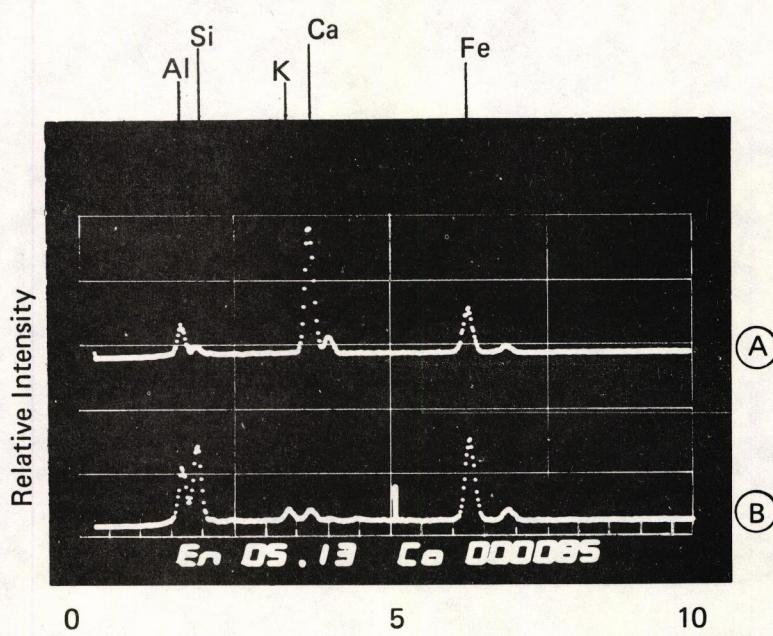
Figure A-3 (b)

Analysis from areas A and B shown in Figure A-2 (b).
