INVESTIGATION OF THE EFFECTIVENESS
OF BRIDGE BEARING ANCHOR DEVICES
AND BRIDGE JOINT COMPRESSION SEALS

FINAL REPORT

HIGHWAY RESEARCH PROJECT 56

AUGUST, 1979

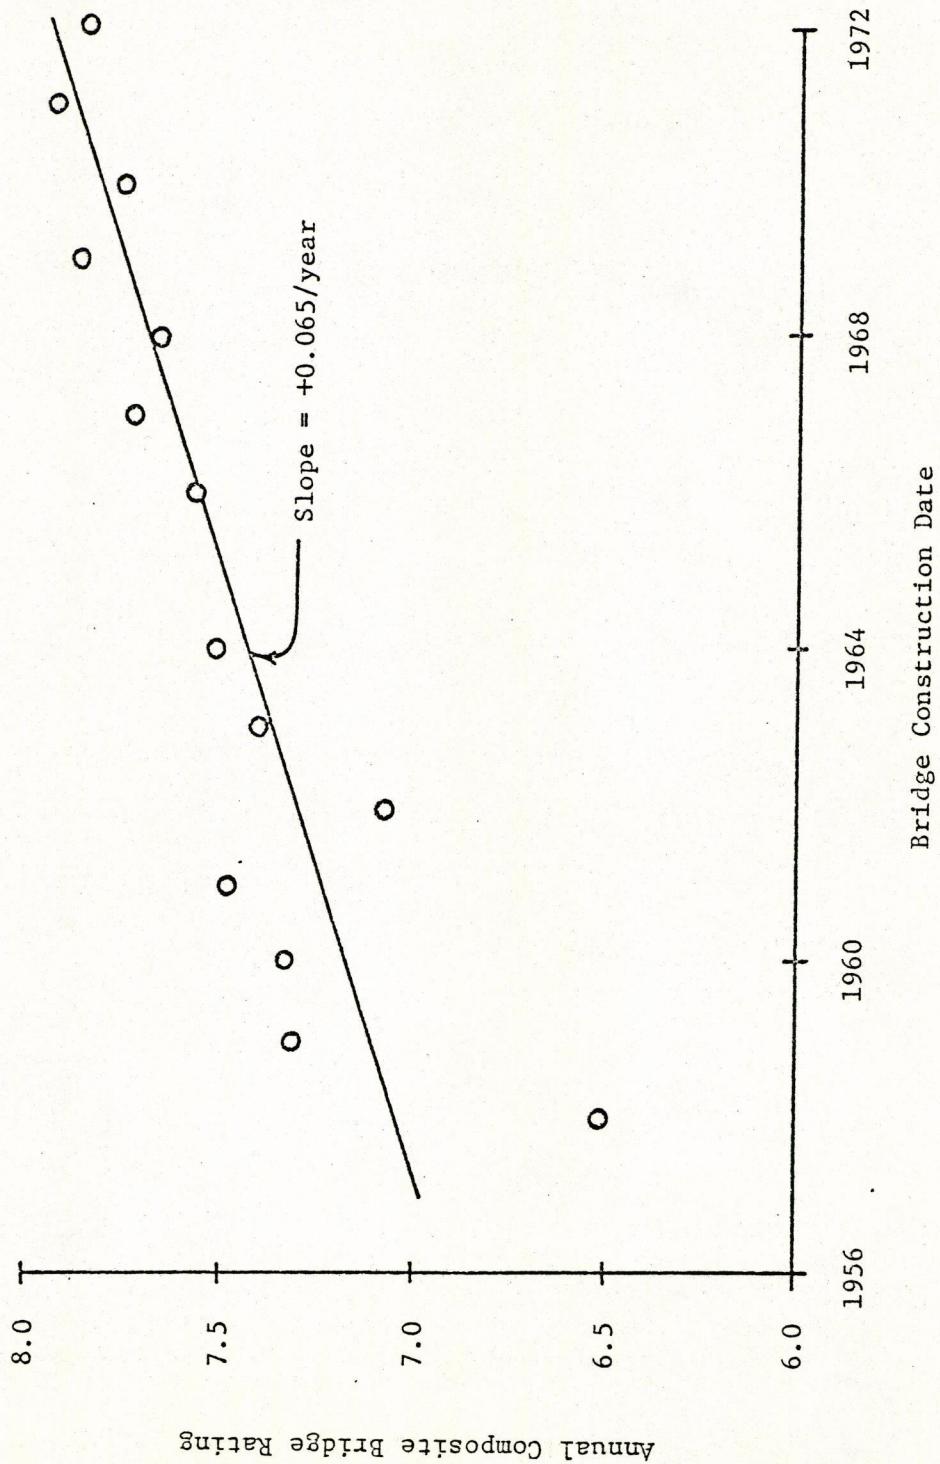
Figure 1. Effect of Age on Overall Bridge Condition

A linear relationship between the overall bridge rating and the year constructed was determined to be appropriate. The graph had a positive slope of 0.065. This factor was used to adjust data samples of unequal age.

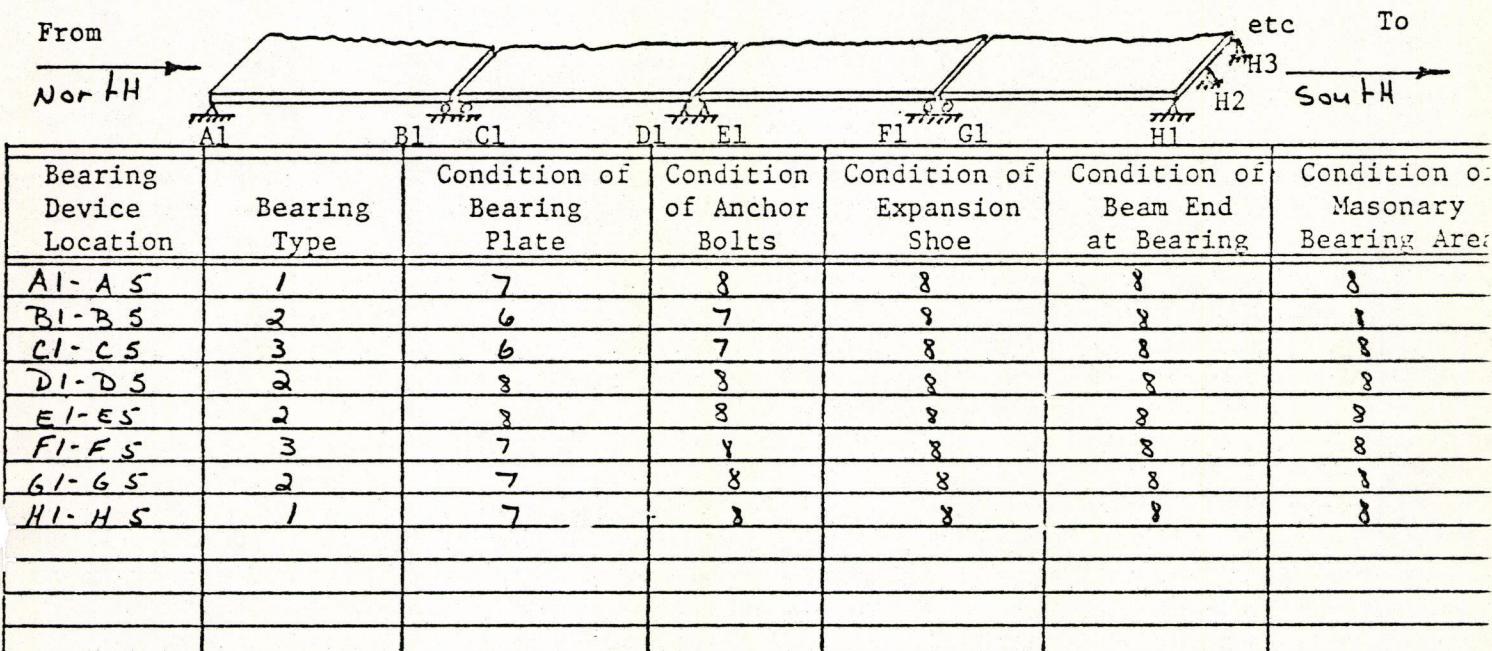
Comments 7 nuts TAKEN off A & H LINE. NAME PLATE MISSING
PHOTO OF NUT STOLEN & PHOTO OF A H... PT ← (?)

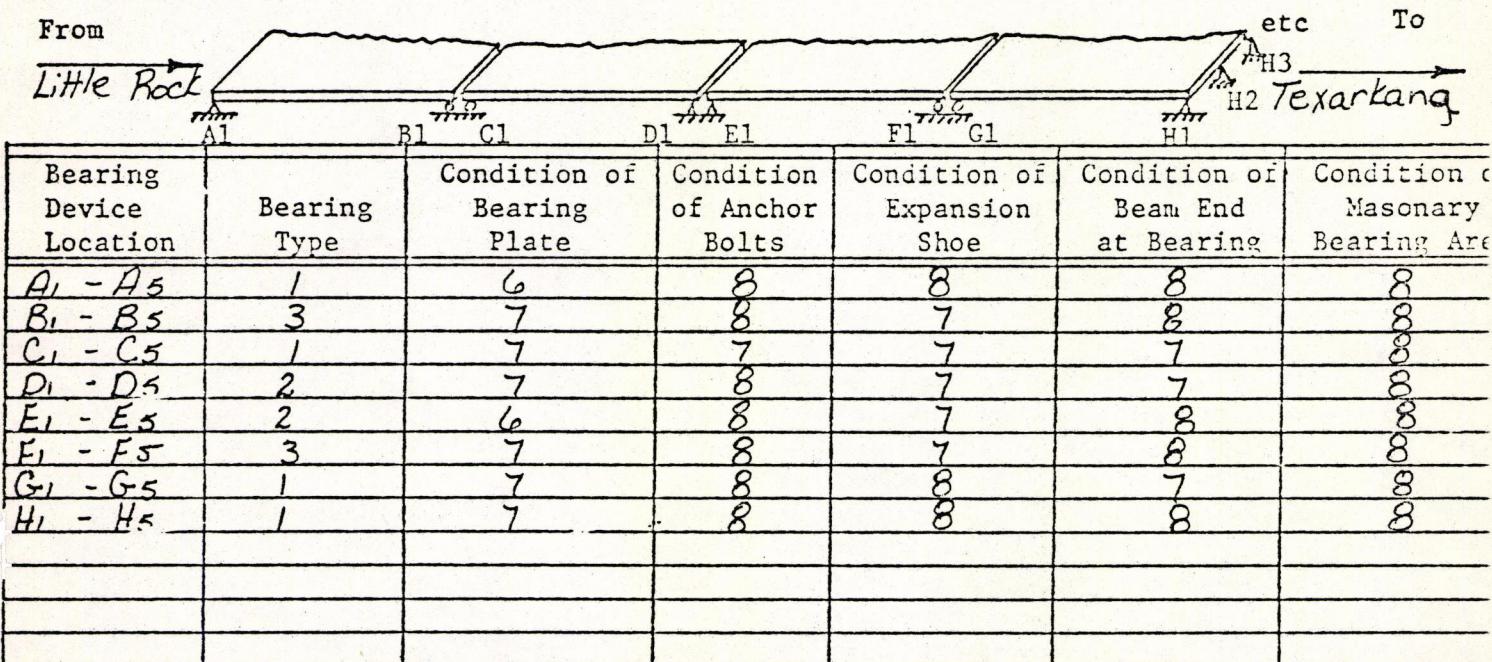
Comments Bridge drains on the end spans the upper flange is rusting at the drain. Nuts are missing off the bolts at C1 & C2. (Inside - 1 Bolt of 2)

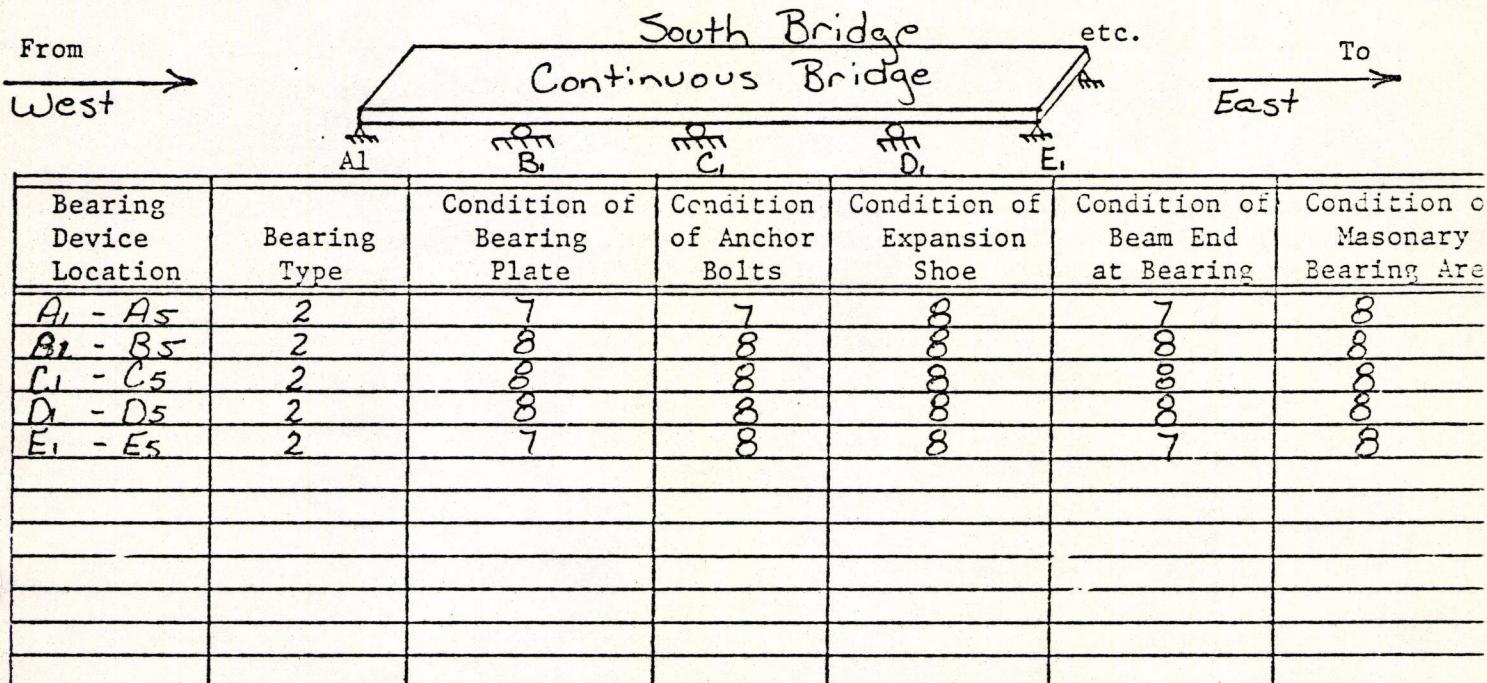
Comments Headwalls cracked - light rust on outside beams on the exterior top flange at the concrete line. There is a dirt build up from 3 to 6 inches on both abutments. No bridge number.

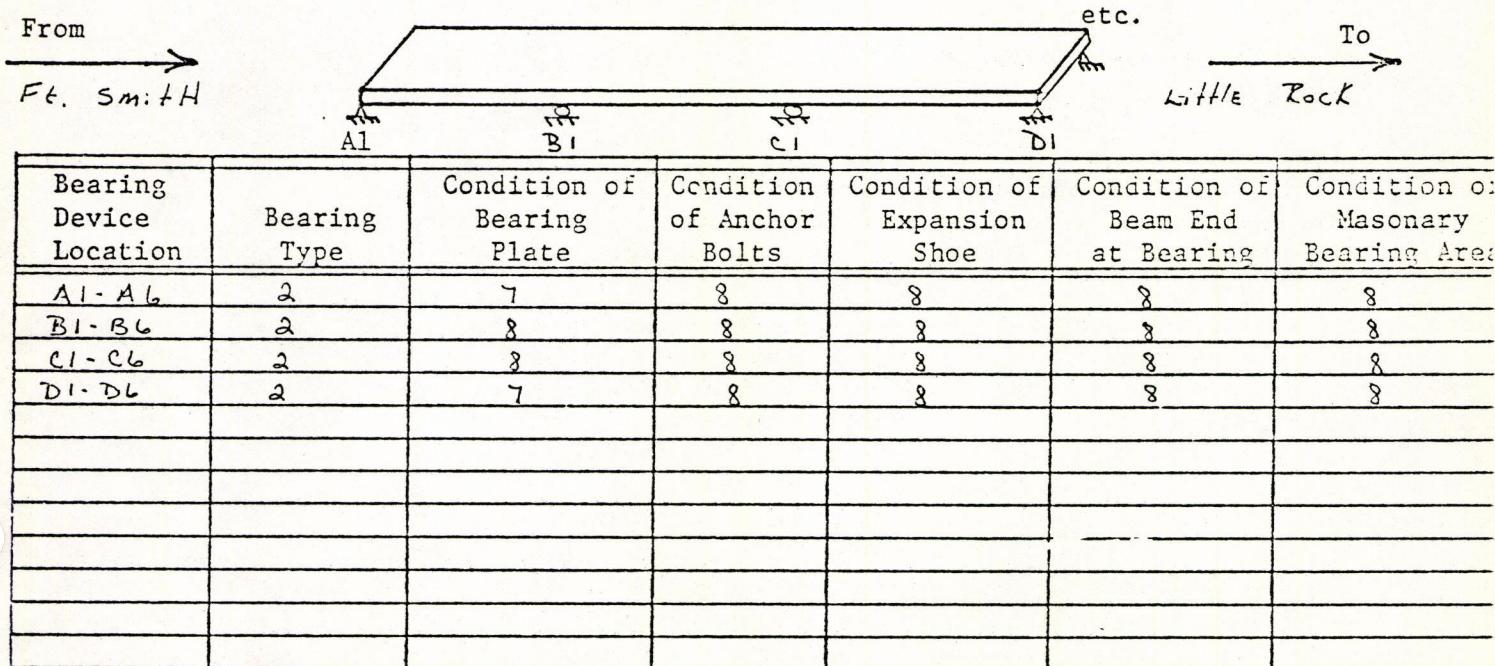
Comments Joint Neoprene Aid CHEWED UP ON TOP

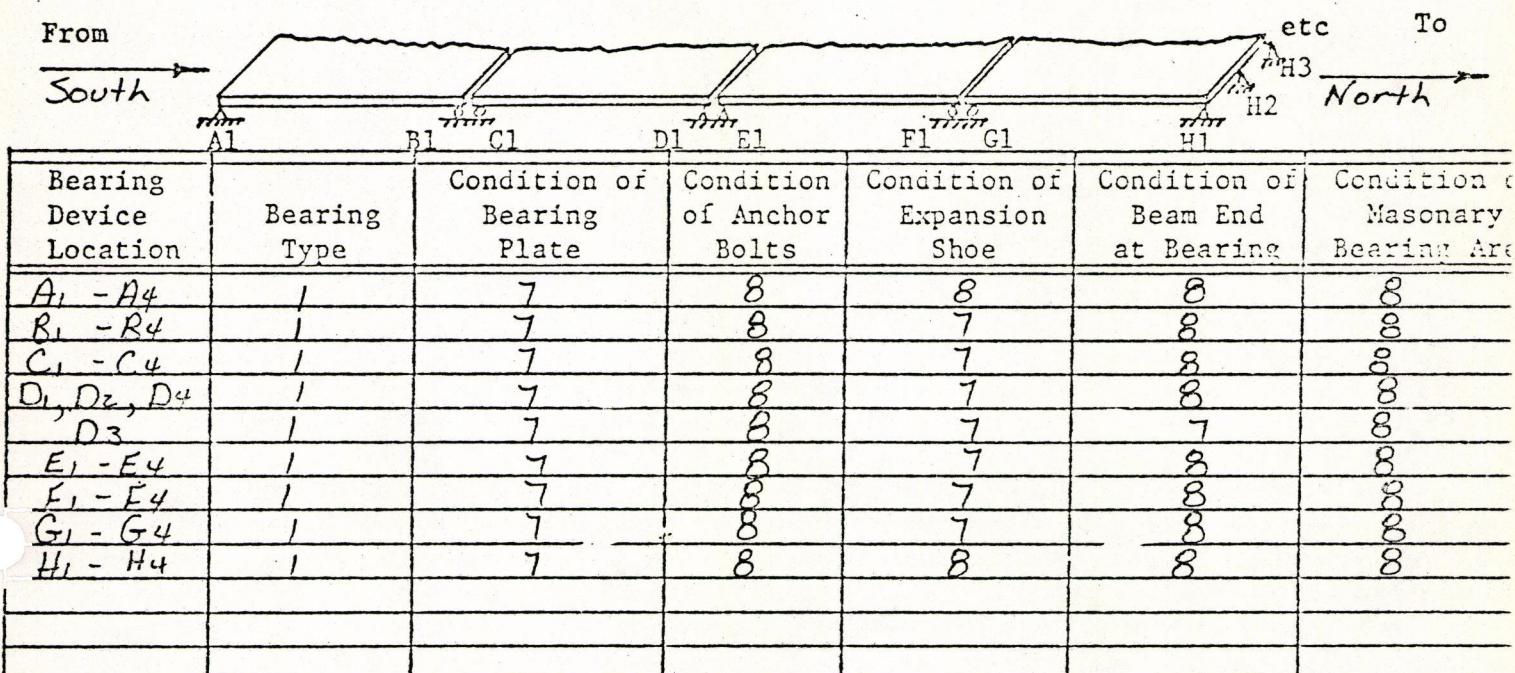
Comments Joints at Bridge ends are closed. First support at A has very little expansion capability - Center joint is O.K.
