### **TRC-0003 CORROSION PROTECTION STRATEGIES**

**ARKANSAS STATE HIGHWAY AND TRANSPORTATION DEPARTMENT  
PLANNING AND RESEARCH DIVISION**

**November 2005**

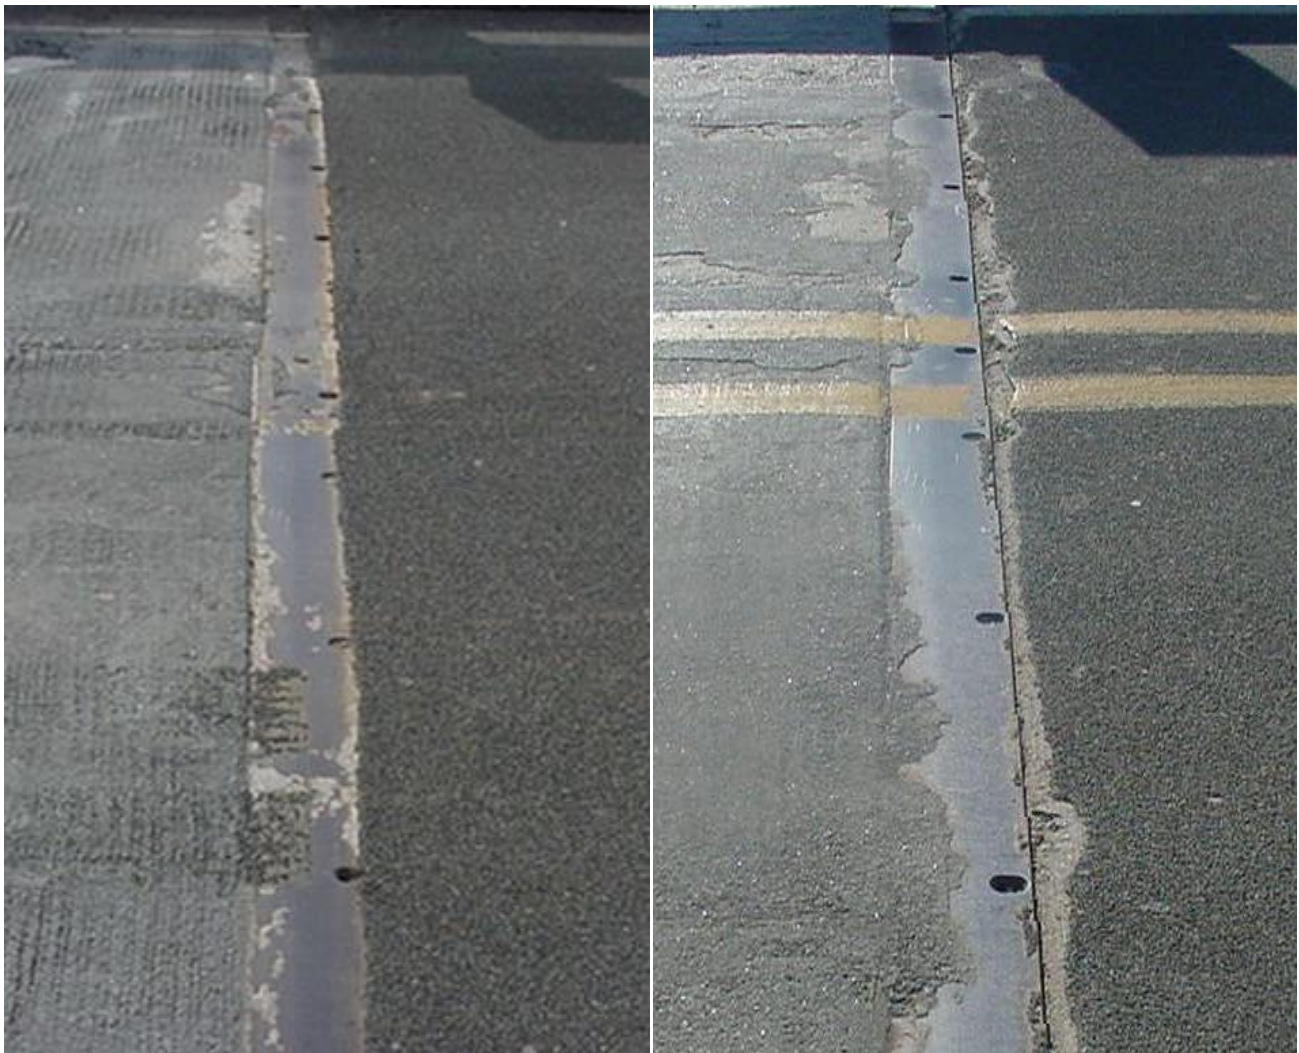
**Figure 1 - Polycon (Left) and Sikadur (Right)**  
**May 2000** **October 2005**

The deteriorated bridge deck received two bridge deck sealants/thin-overlays installations that were completed during late November 1999. It became apparent at installation that the Polycon product was not applied evenly nor finished properly. Claims of cold weather at the time of installation were stated as the reason for the adhesion problem and general unacceptable appearance of the Polycon product. Efforts to rectify the problem by the installer did not meet with any success. As it was, the results were not adequate enough to conduct a proper comparison between the two overlay products. Installation and performance of the Sikadur 22 product appeared to be satisfactory.

No records were available to ascertain the exact locations of the original test holes. With 95% of the traveled bridge deck having been patched, there was little hope of actually finding a section of original bridge deck to test without removing the overlay or drilling in the gutter sections. In order to be relevant, corrosion protection comparisons between each overlay requires comparative sampling be taken in close proximity to the previous test holes. Shown below in Figure 1 for easy comparison is a photo taken after the initial installation and one taken recently.

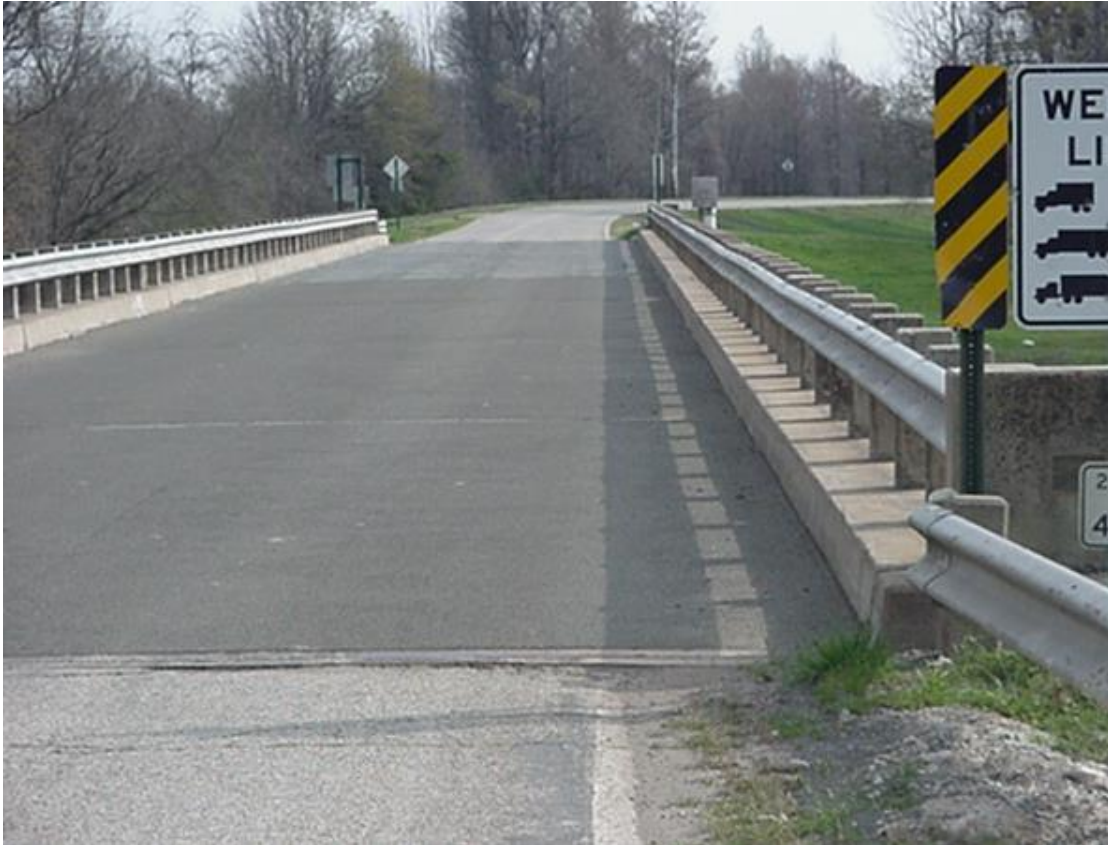
**Figure 2**

The photo in Figure 2 was taken in May 2000 and shows the completed bridge deck. A corresponding photo in Figure 3 was taken in October 2005.

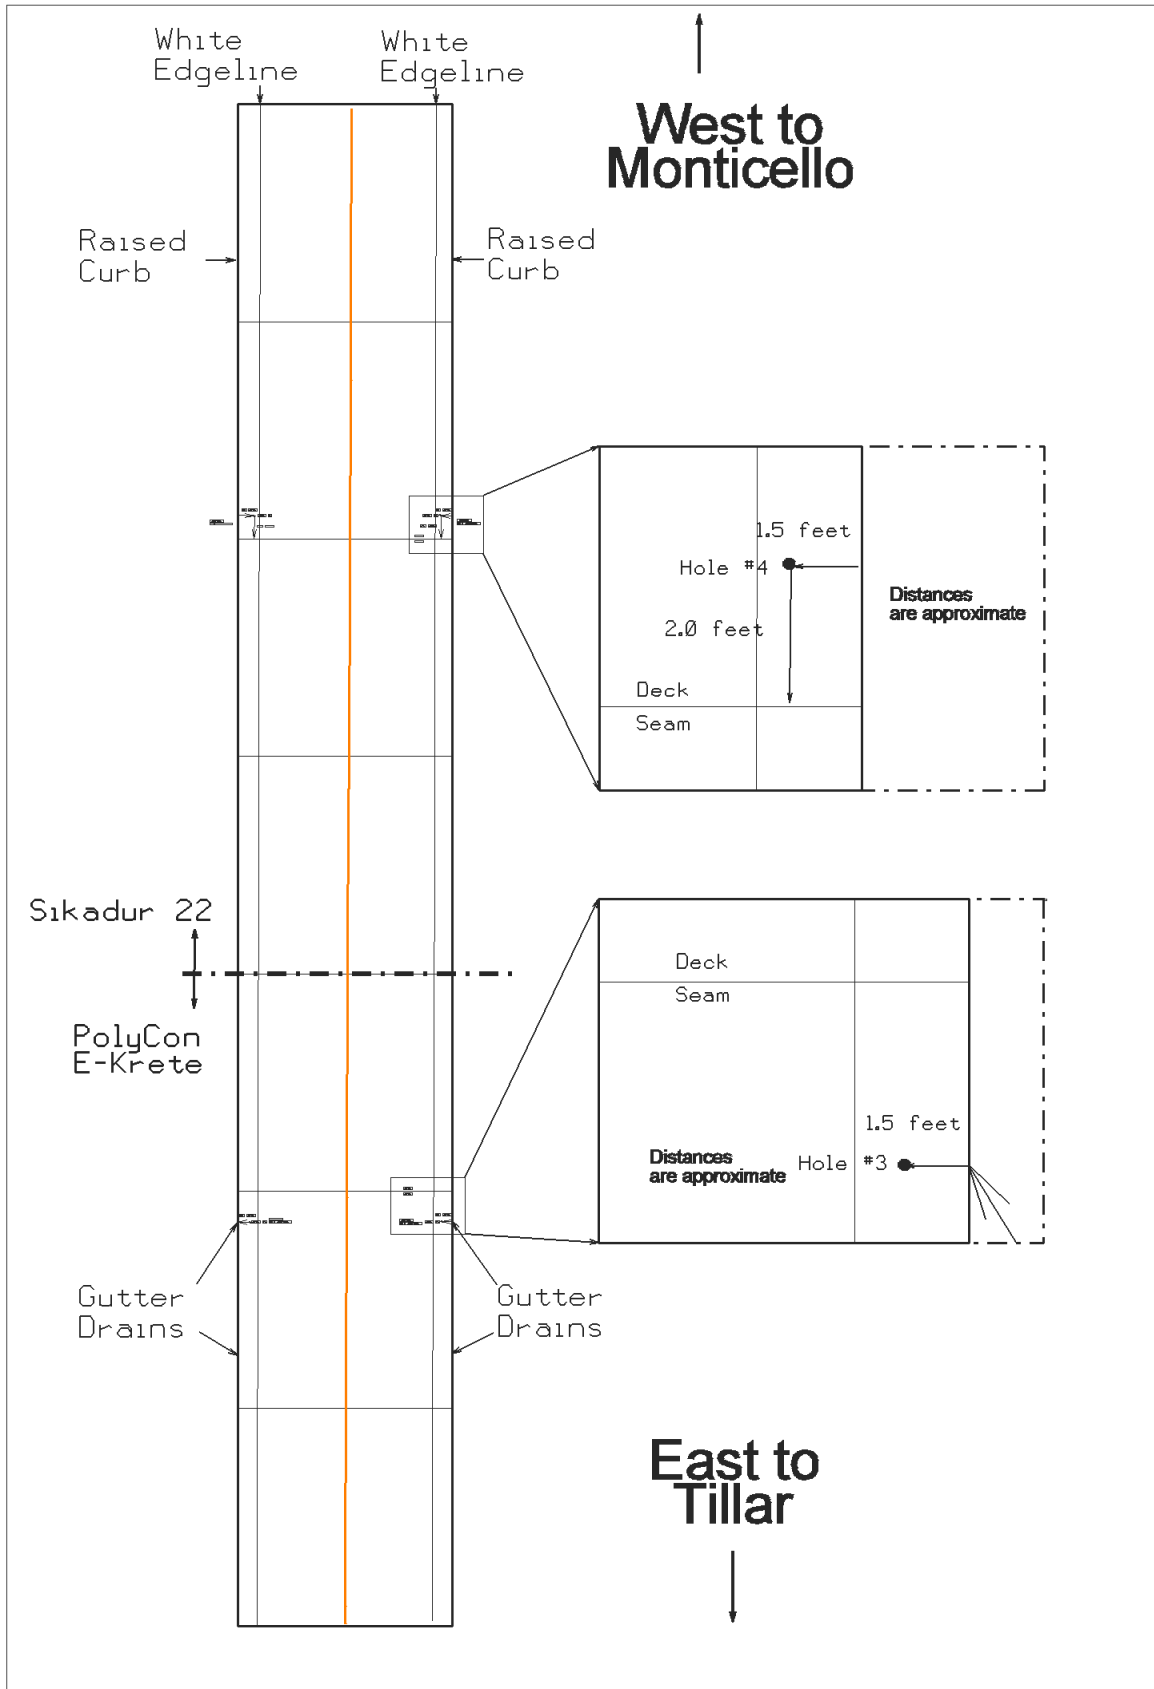
**Figure 1A - Tillar Bridge Deck**

Chloride ion samples from four test holes were taken from the gutters of the Tillar Bridge surface in October 2004. Initial project work identified the travel lanes as the locations of the highest areas of patching while the gutters were relatively devoid of patches. Without proper documentation, once the overlays were applied, there was no way to determine original deck concrete from patch material inside the travel lanes. As a result, no correlations can be drawn between samplings, however, any future gutter testing and saturation rates can be collected and monitored at points typically accumulating the highest percentages of chloride concentrations. Holes 1 and 4 were located under the Sikadur material and Holes 2 and 3 were located under the Polycon material. The latest test results are shown in Table 3. Refer to Appendix A and Figure 1A for bridge deck test locations and deck section layout.
