TRC9207

Performance of Pavement Drainage Systems

Final Report

**Planning & Research Division
Arkansas State Highway and Transportation Department**

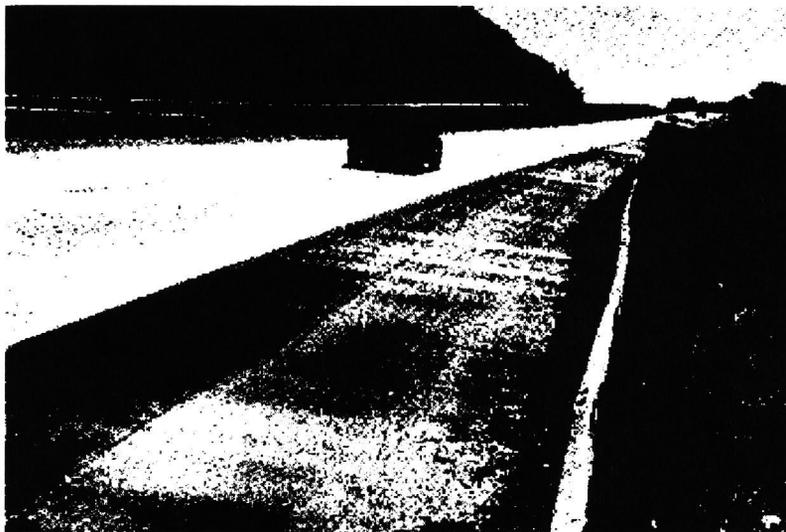
Picture 12. Pumping Evidence on I-40

In spite of the installation of these pavement edge drains on I-40, pumping continued and resulted in the multiple slab replacements during the following years (see Picture 12 in Appendix A). During this same time period in

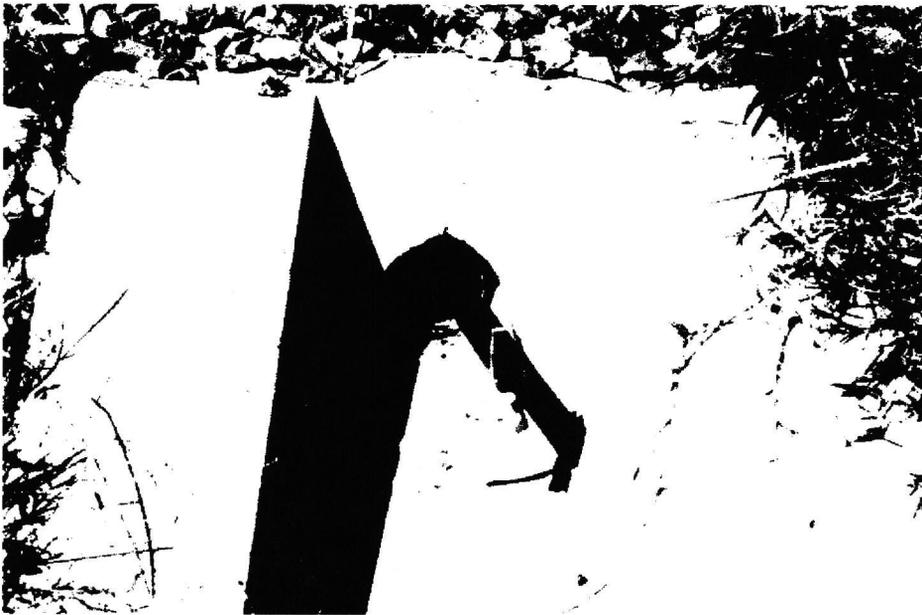
On the second day of the demonstration project, edge drain inspections were performed along I-540 in Crawford County. These edge drains were installed along this highway between one and two years of the inspection date under Job R40036. Only one of the outlet pipes checked with these edge drains allowed full access to its' end cap. See Picture 17 in Appendix A. The other drains checked either had outlet pipes partially crushed, (see Picture 18 in Appendix A), or were crushed and filled with debris. See Picture 19 in Appendix A.

Picture 18. Crushed Edge Drain Outlet Pipe on I-540 in Crawford County
