ARKANSAS STATE HIGHWAY AND TRANSPORTATION DEPARTMENT

MEMORANDUM

TO: Mr. Veral Pinkerton, Bridge Engineer
FROM: W. E. Tyler, District Engineer, District No. 3
SUBJECT: BRIDGE CAP CONSTRUCTION

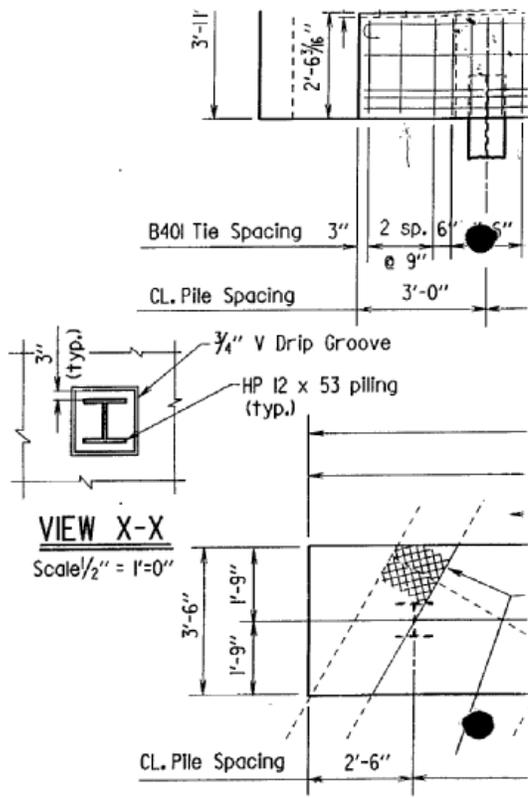
We have found in many of our bridge inspections that steel pilings are showing deterioration where they are connected to the cap. It appears that water is draining down the cap, under the cap, and collecting at the junction of the cap and steel piling.

It is suggested that a drip groove be constructed on the bottom of the cap between the edge of the cap and the piling.

This could possibly reduce the deterioration.

2 Layers of 45 # Roofing Felt 8" x 7"
 under ends of all of the Units (Above
 an addn'l. layer covering full width of Cap)
