**ARKANSAS STATE HIGHWAY AND TRANSPORTATION DEPARTMENT
EQUIPMENT AND PROCUREMENT DIVISION
BID INVITATION**

Bid Number: M-14-019P

1. Asbestos Abatement and Demolition located at Hwy. 394-CR 80 (Antioch) (U.S. Hwy. 167) Route 167 Section 18, Independence County; as per attached work list for Tracts 7XED, 10X, 11XED, 13XED, 18XED, 64X & 109X - Job 050213.

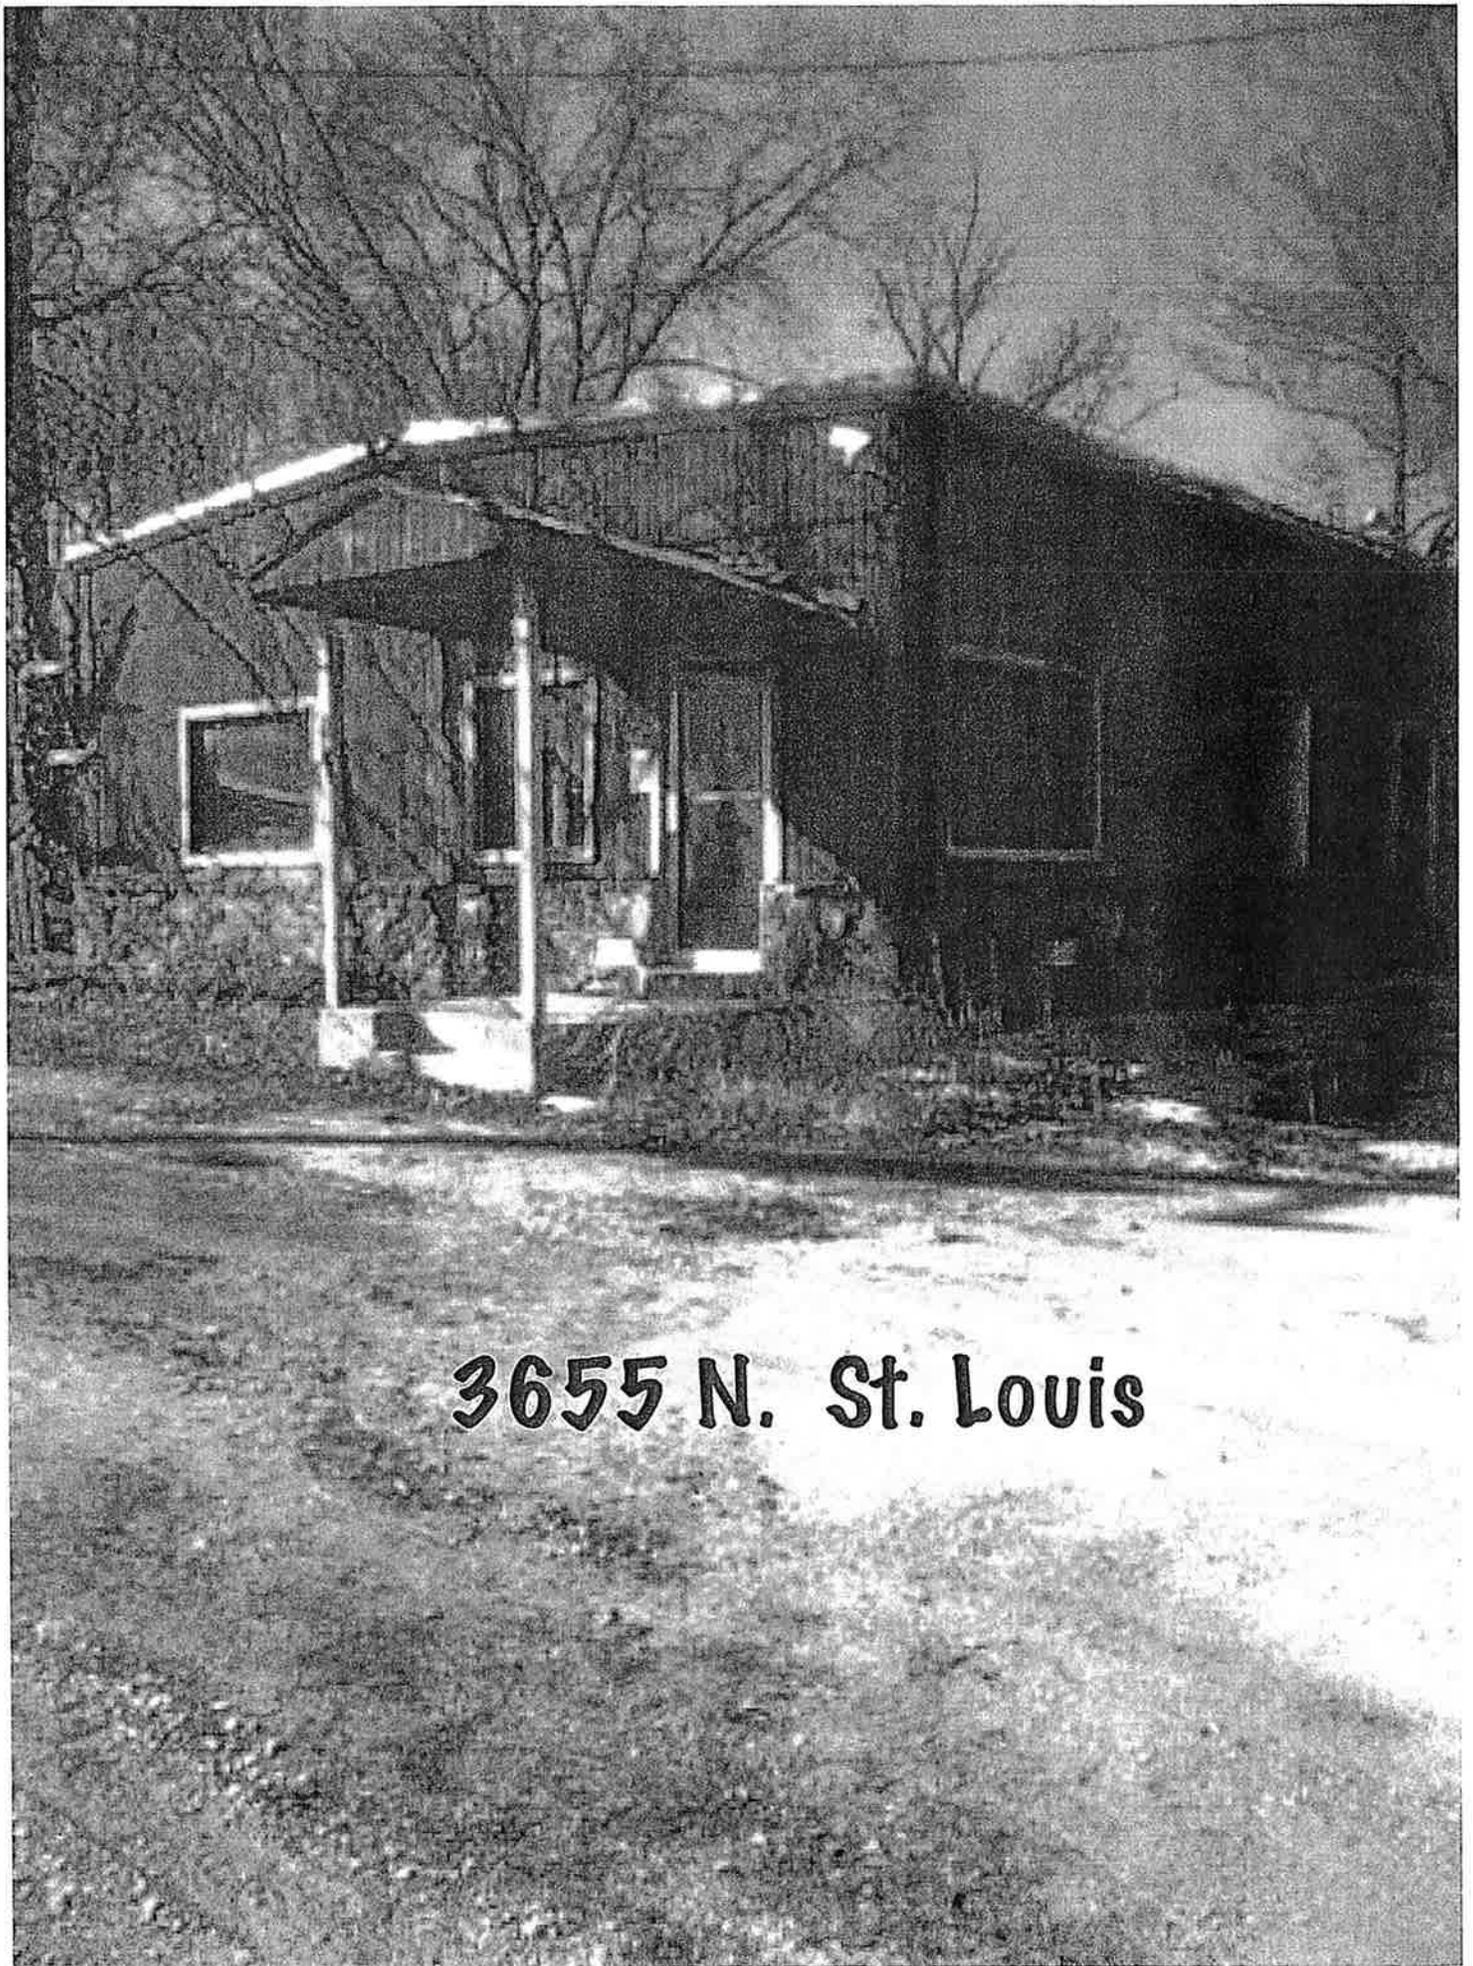
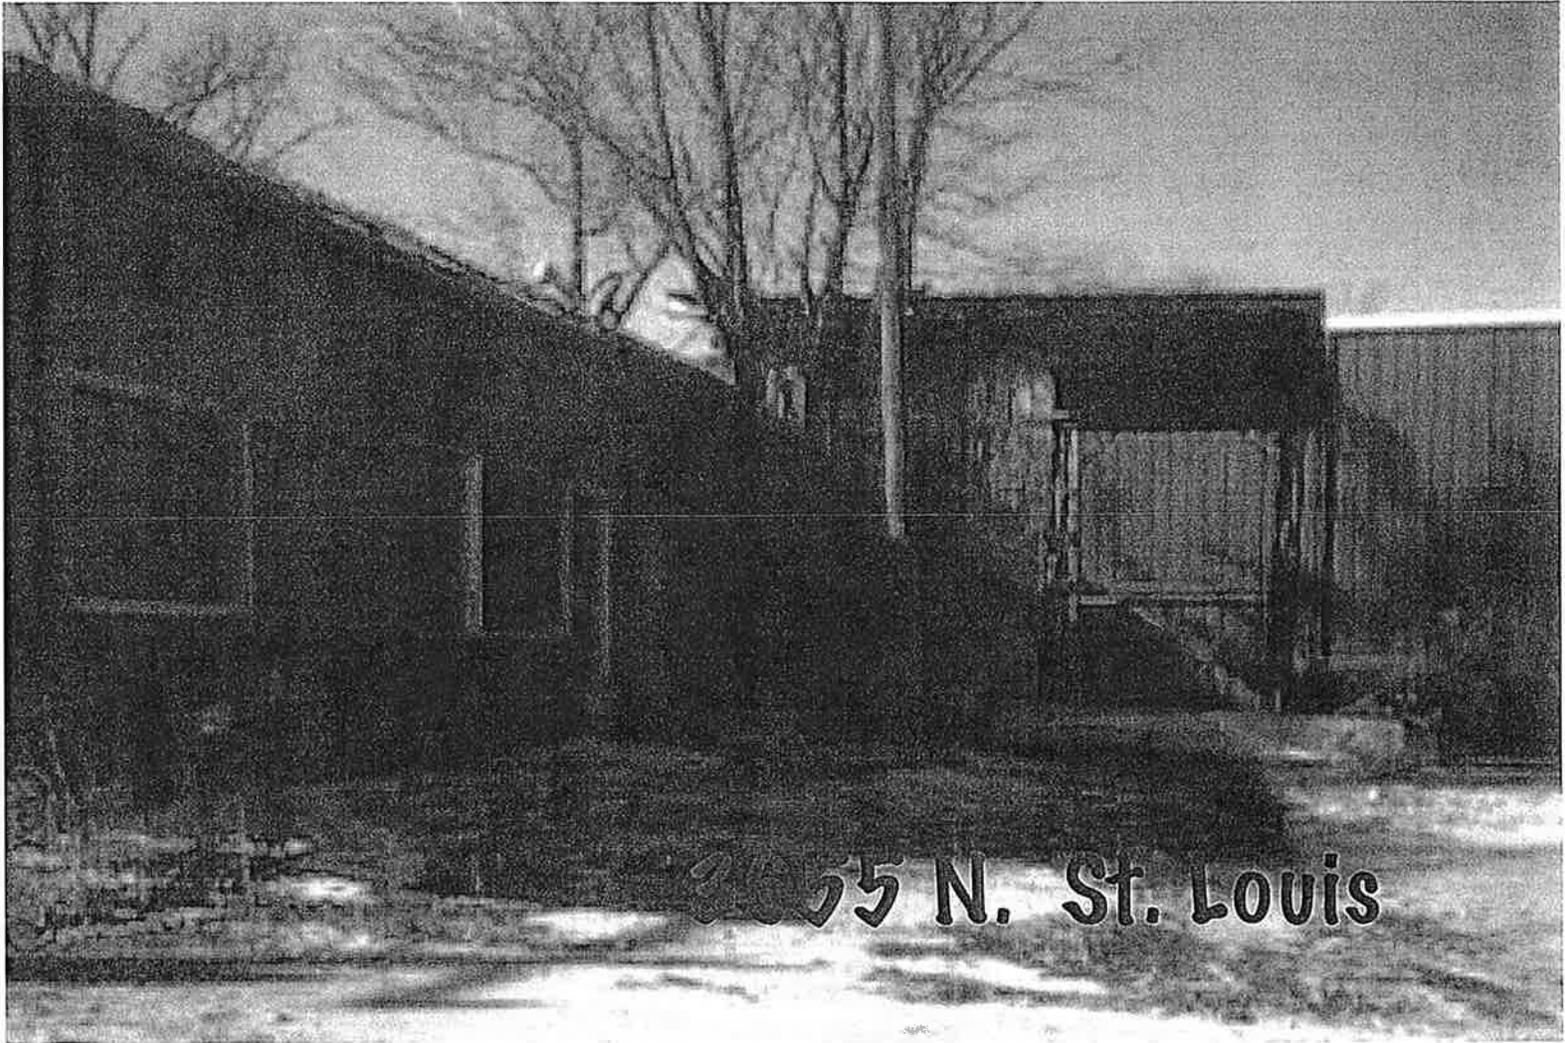
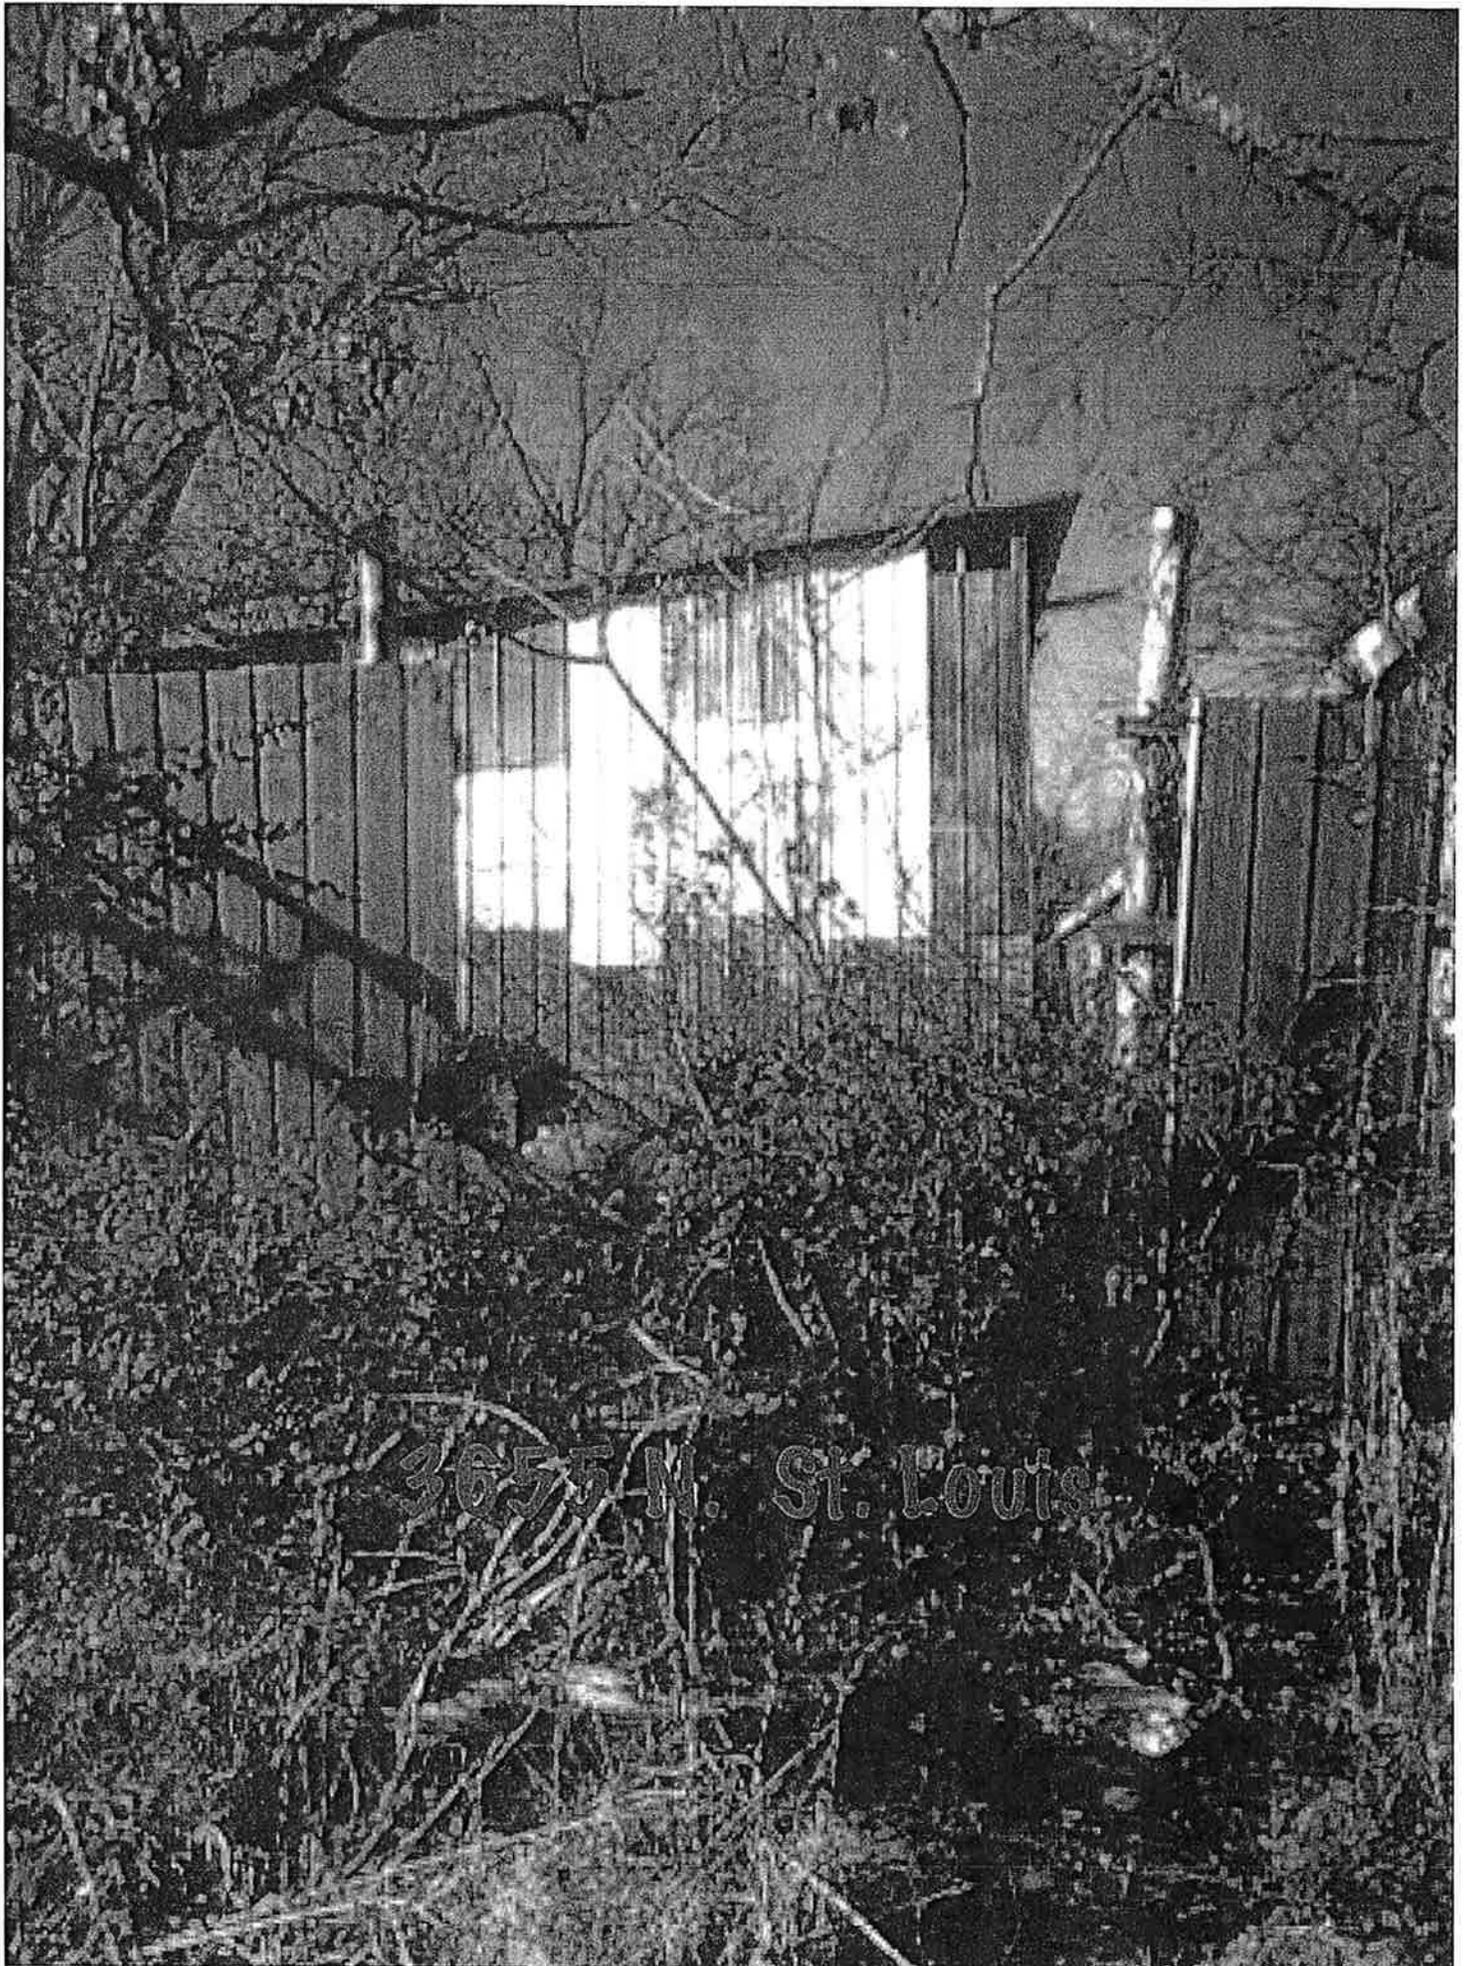
3655 N. St. Louis

Sample #	Layer #	Sample Location	Layer Name / Sample Description	Asbestos Detected	Asbestos Type	% ACM	Condition	Friable	Quantity
#1	#1	FRONT OFFICE	Ceiling Tile, White/ Brown	No	NAD	NAD	N/A	N/A	N/A
#2	#1	FRONT OFFICE	Floor Tile, Beige	No	NAD	NAD	N/A	N/A	N/A
#2	#2	FRONT OFFICE	Mastic, Tan	No	NAD	NAD	N/A	N/A	N/A
#3	#1	FRONT OFFICE	Lino/urn, Brown	No	NAD	NAD	N/A	N/A	N/A
#4	#1	BACK RM	Ceiling Sheetrock, White/ Beige	No	NAD	NAD	N/A	N/A	N/A

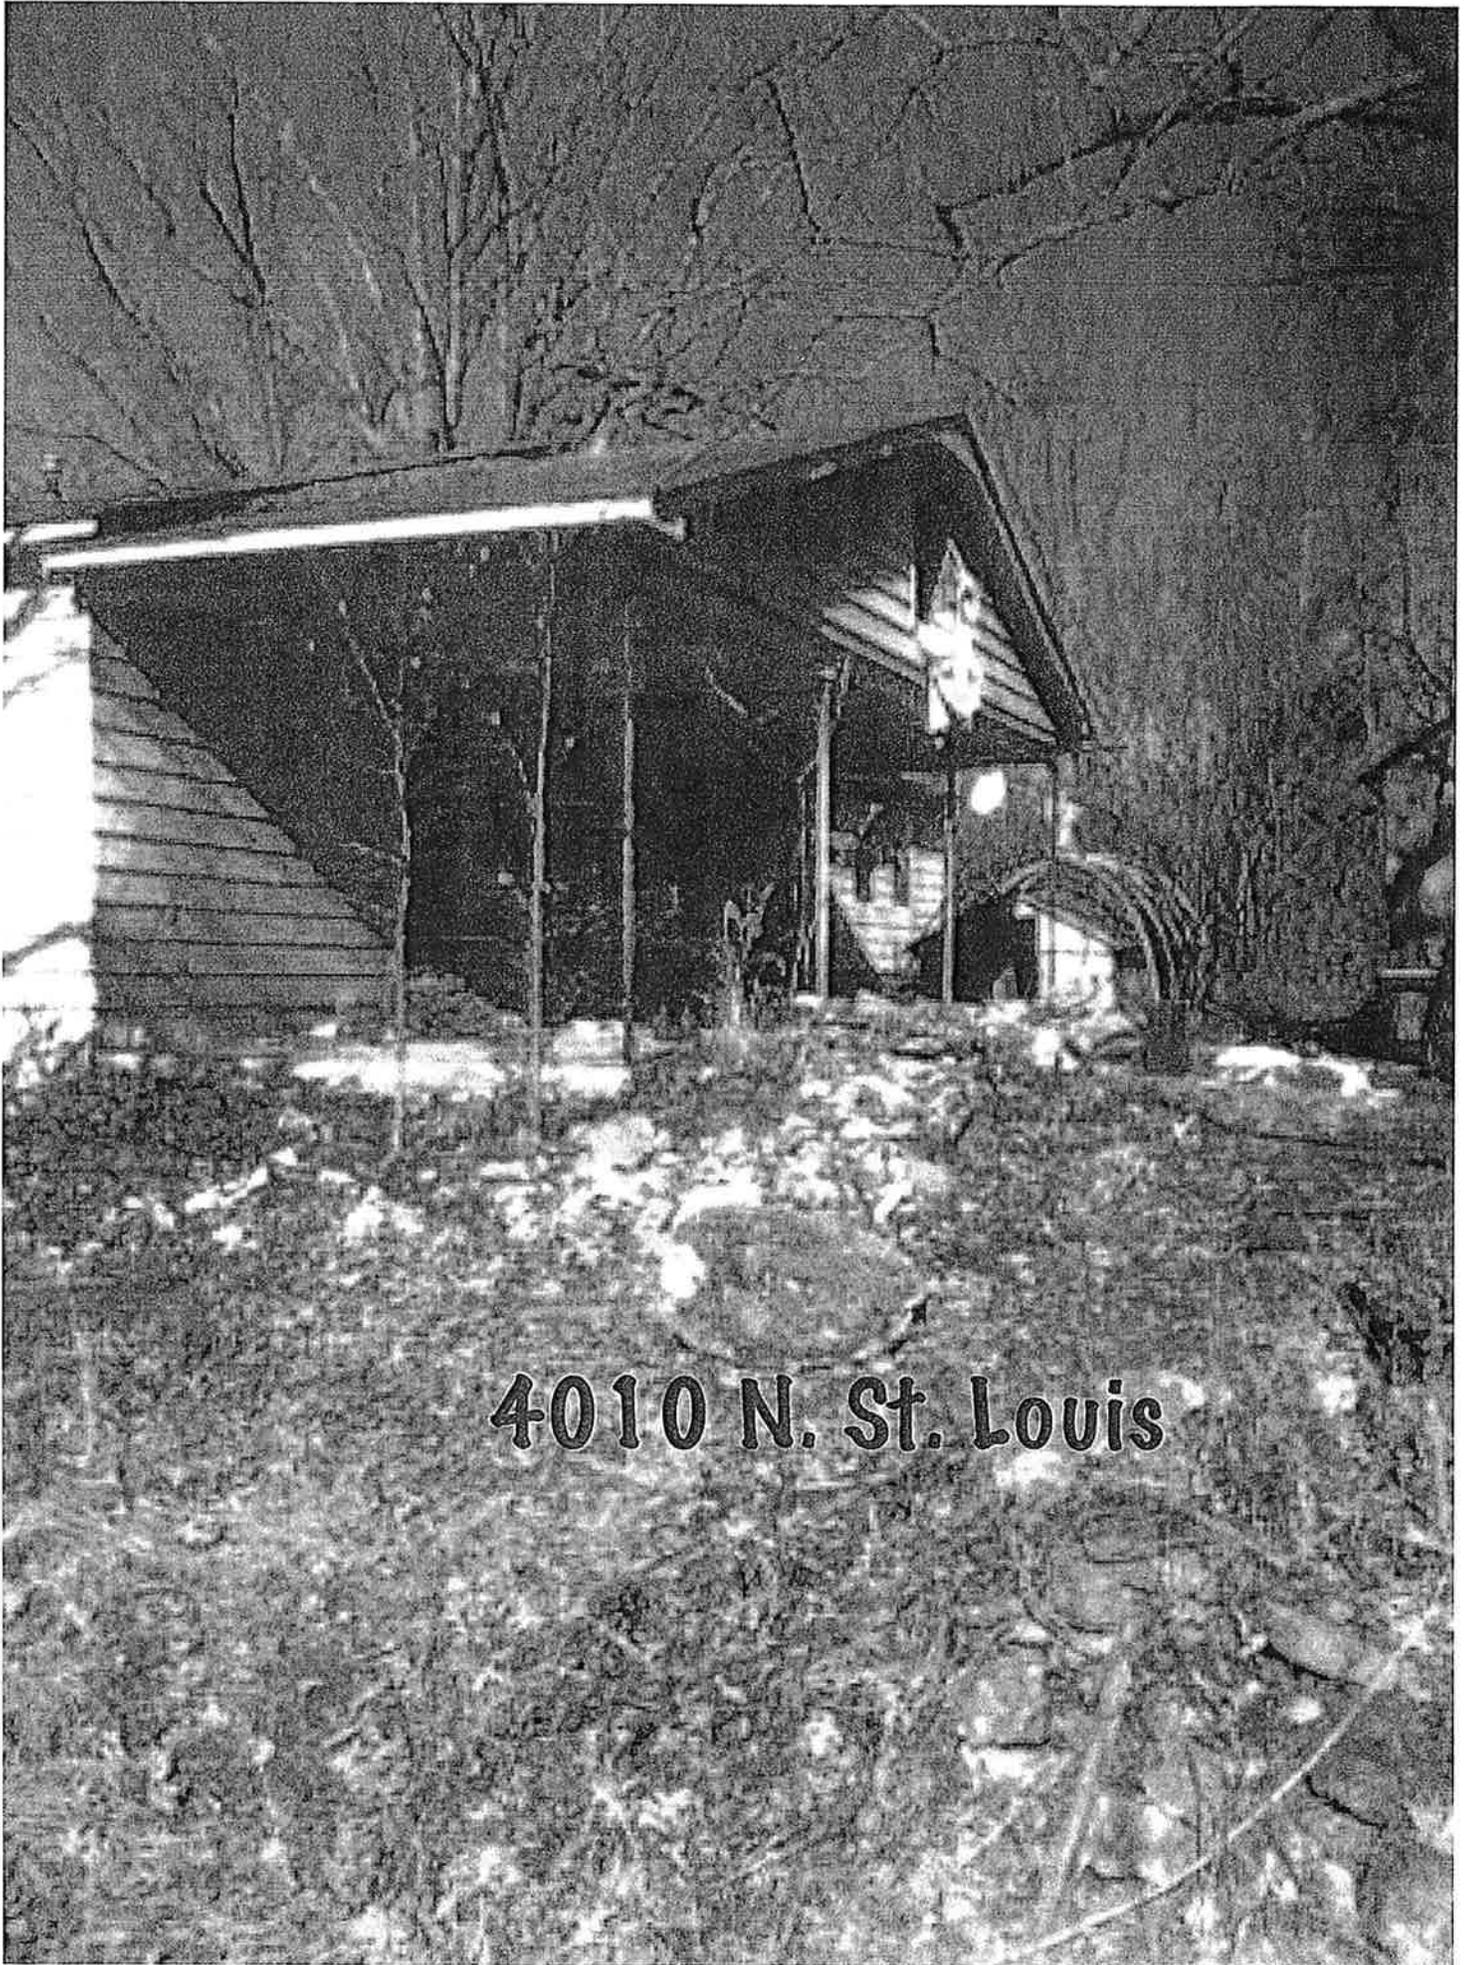
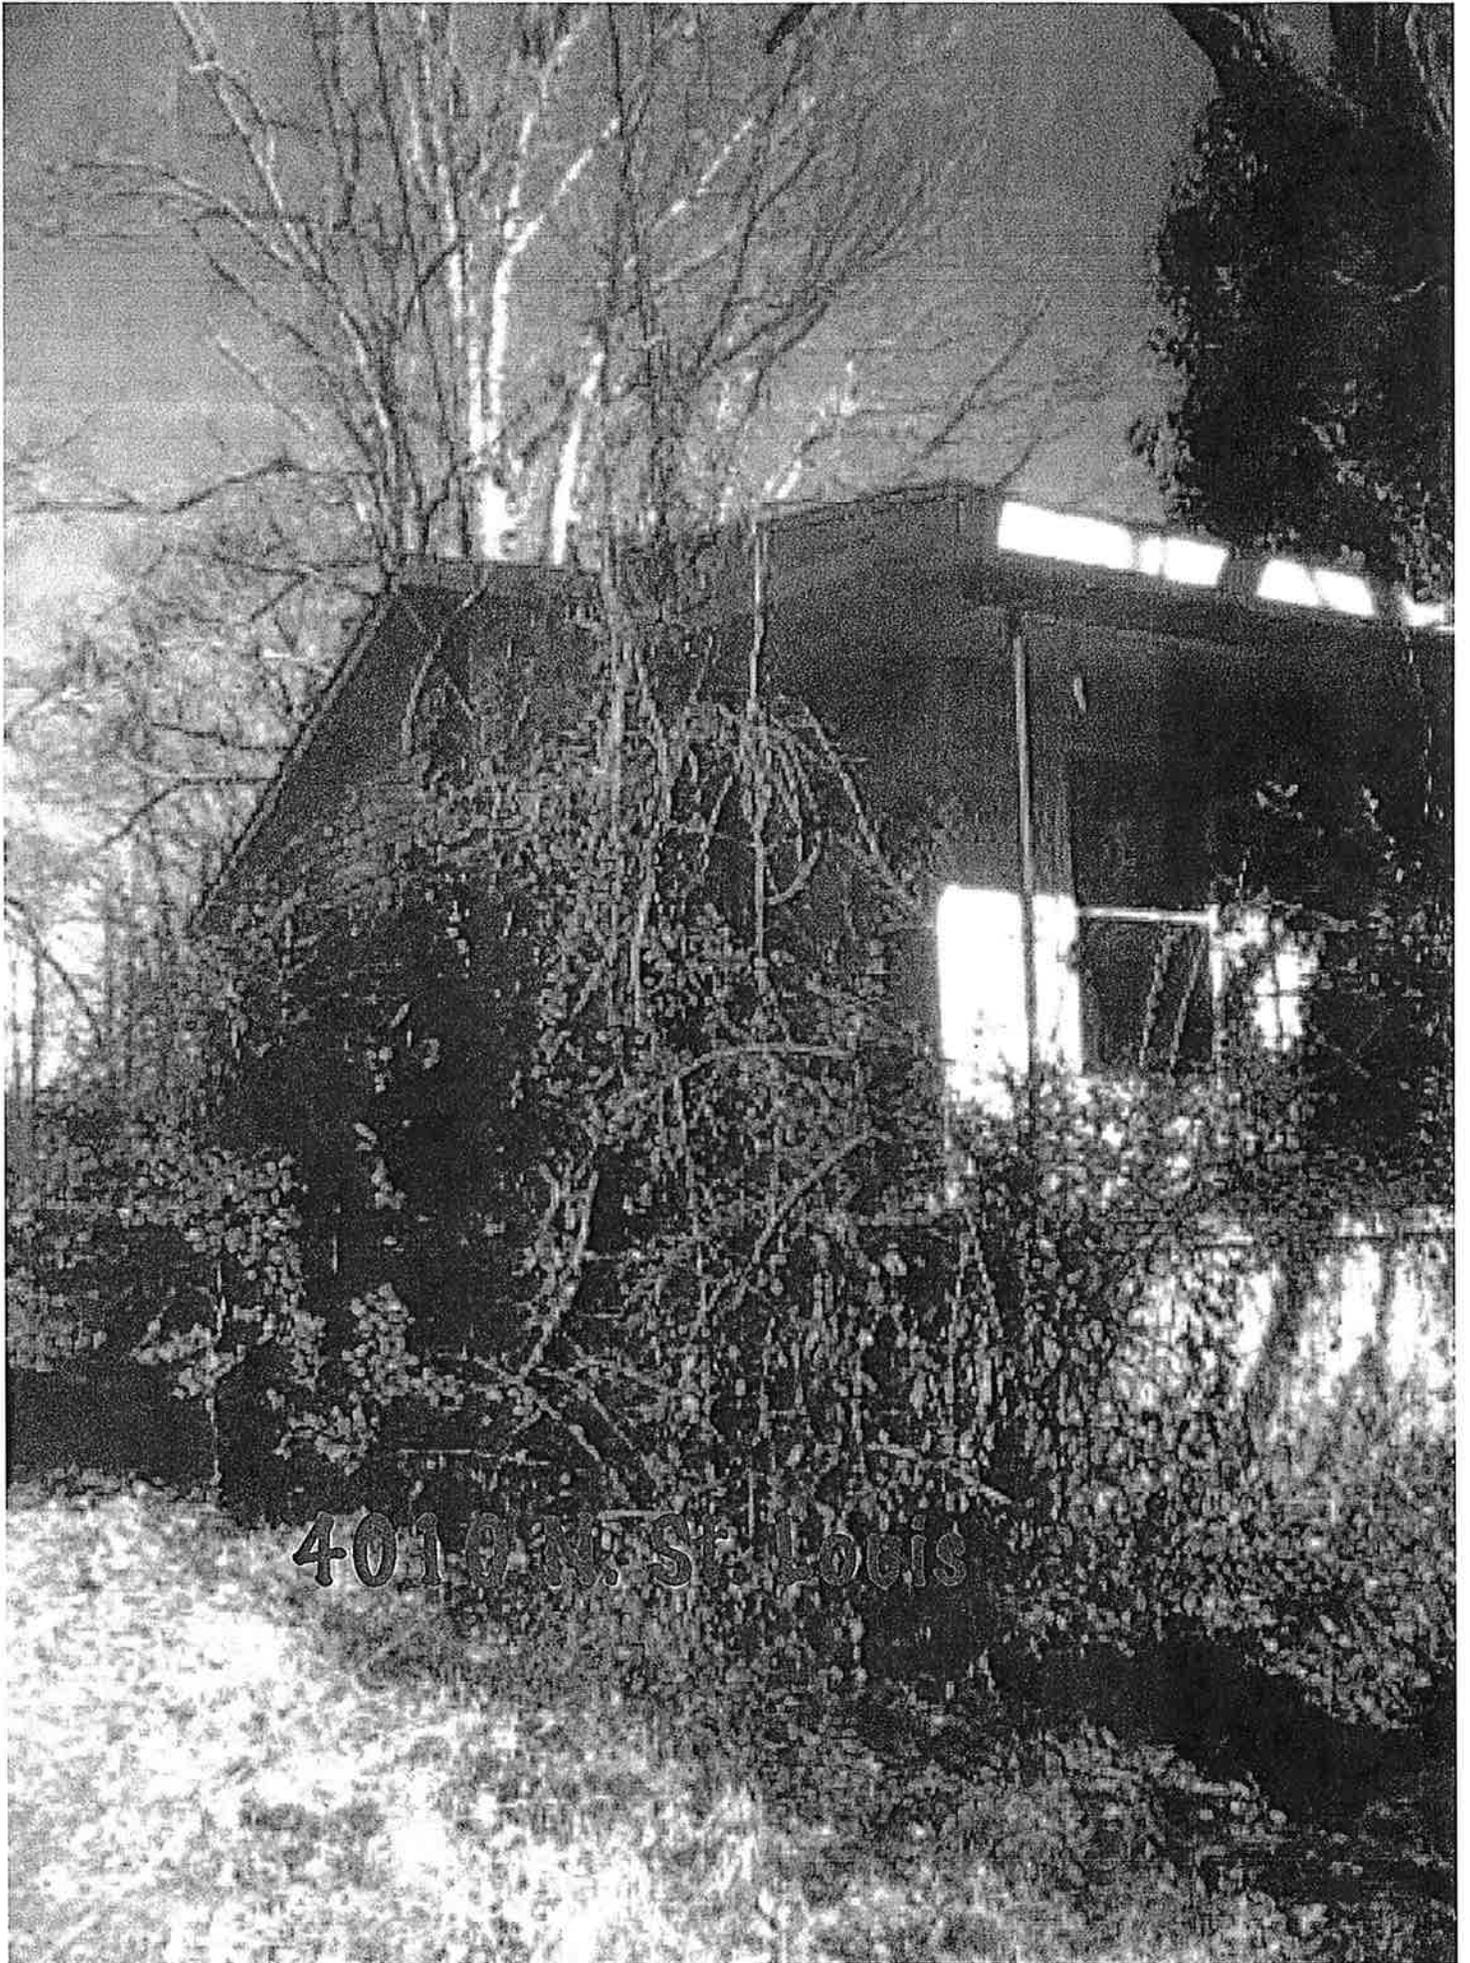
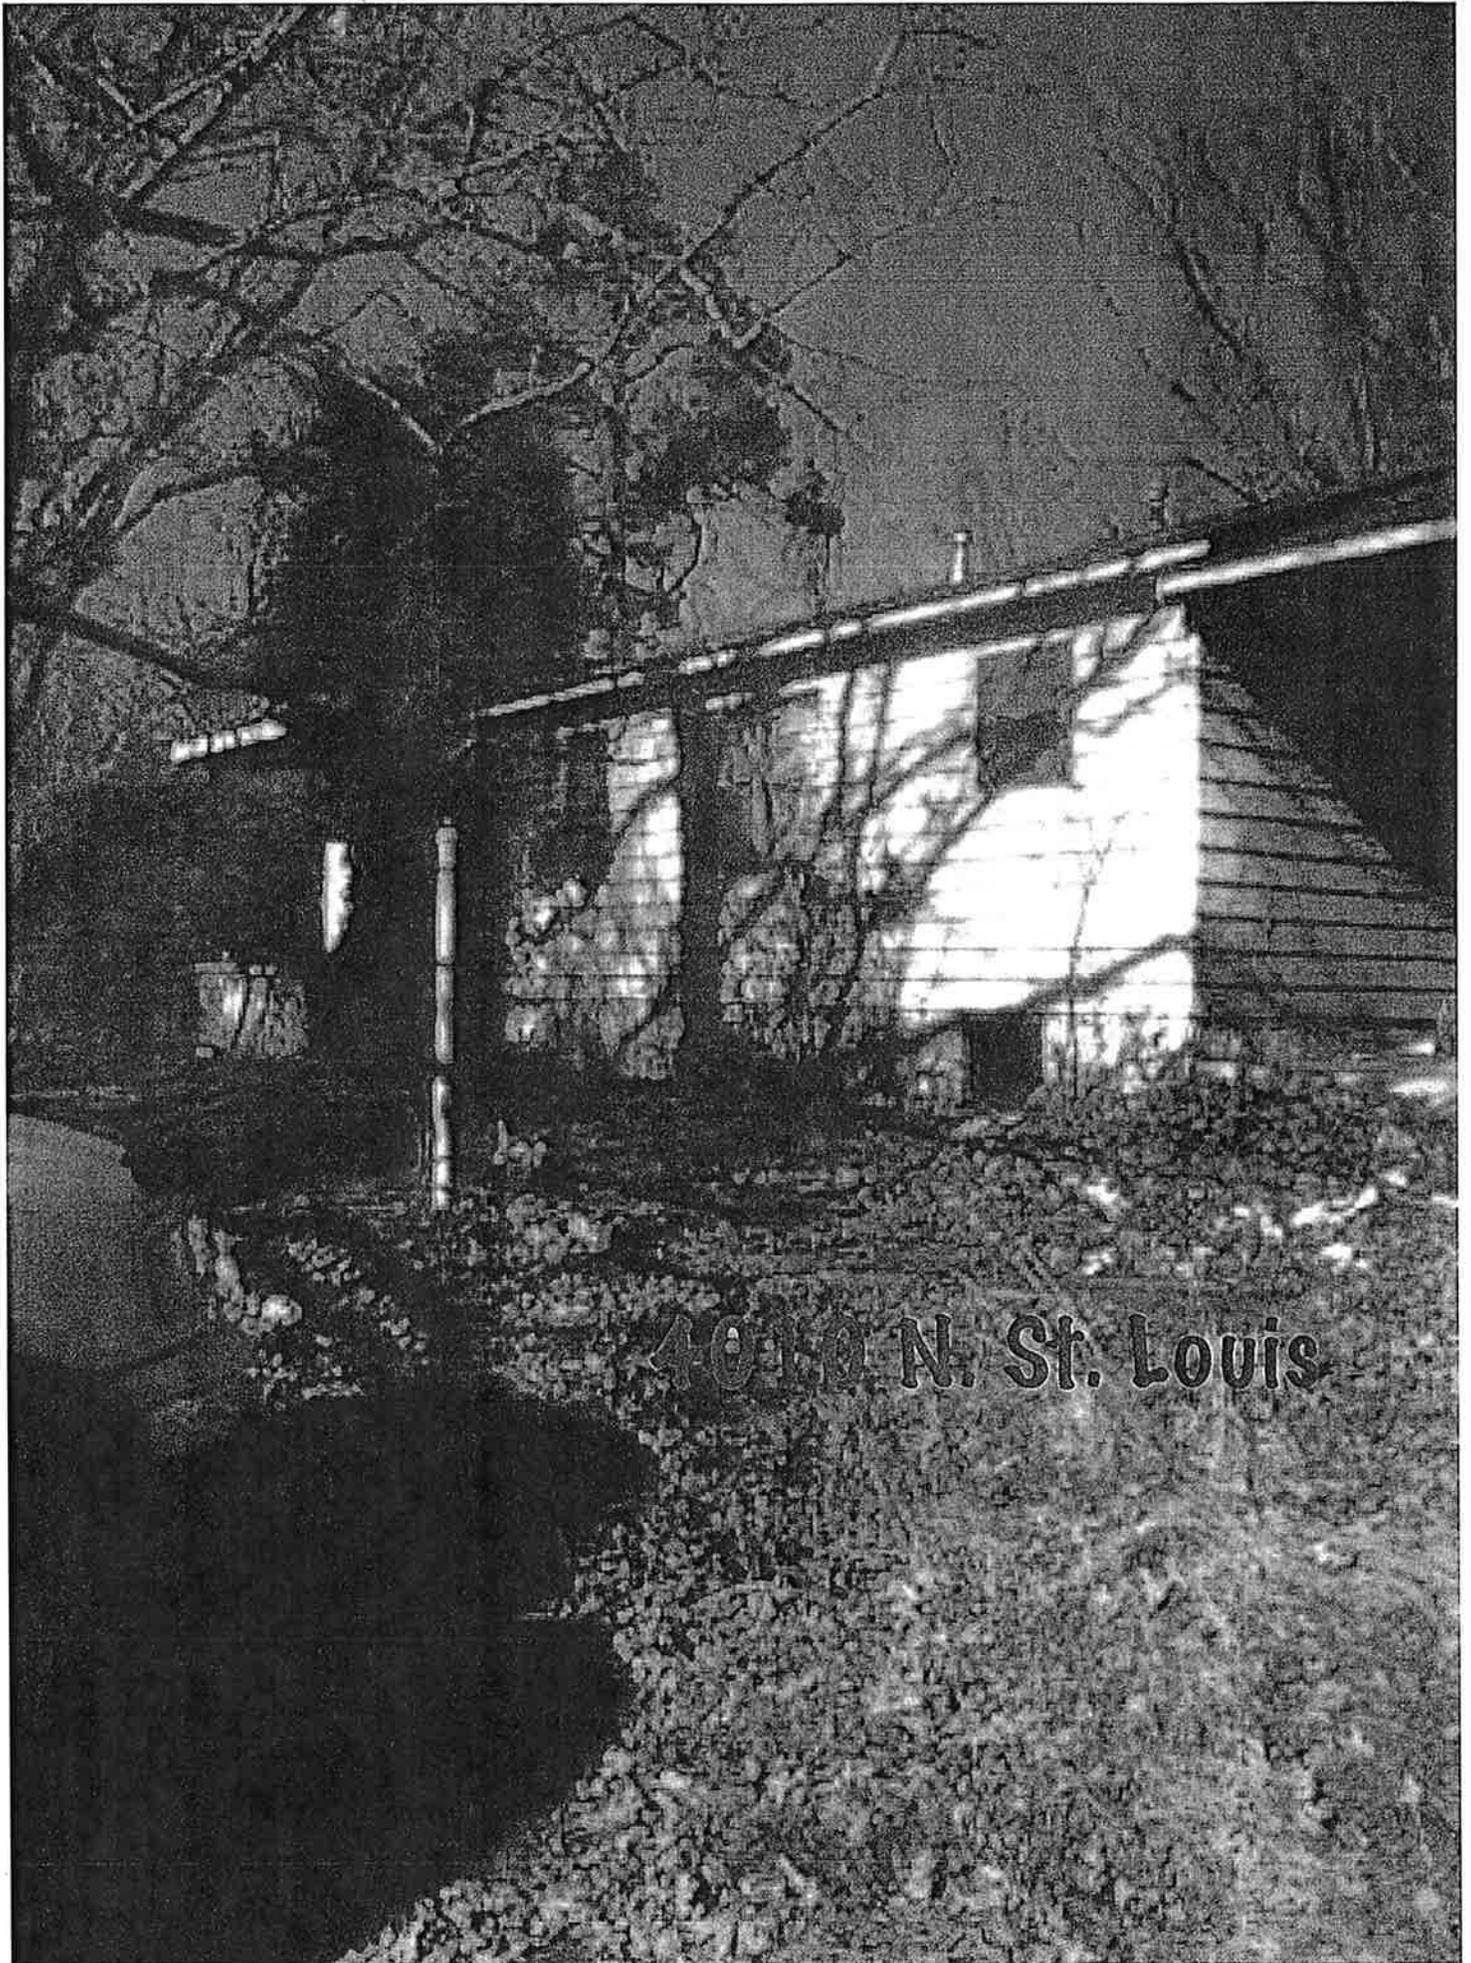
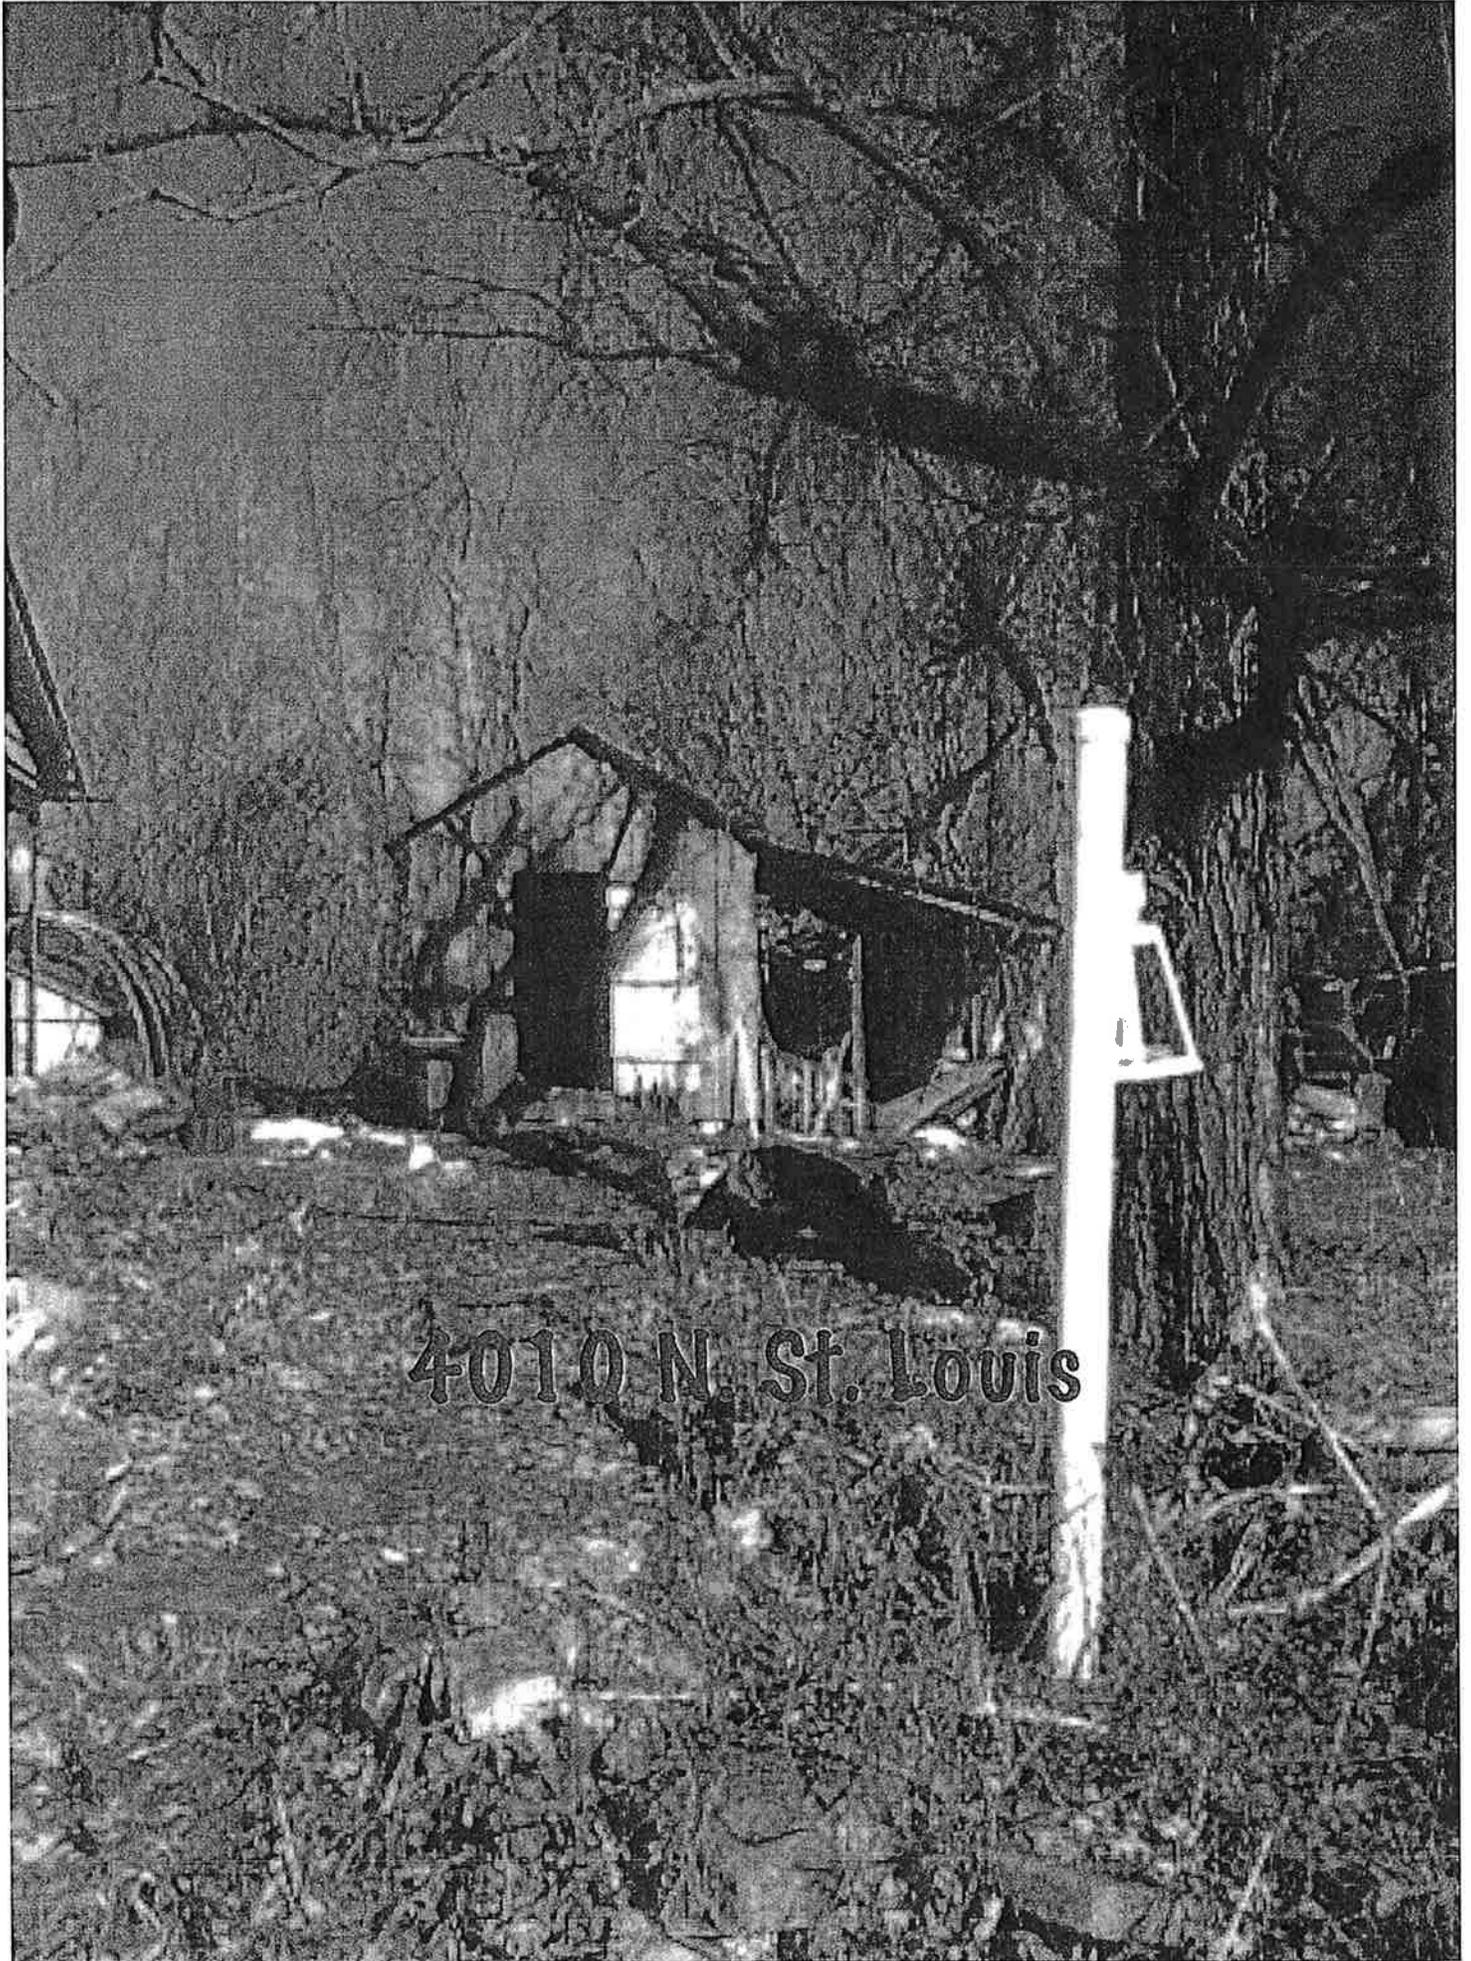
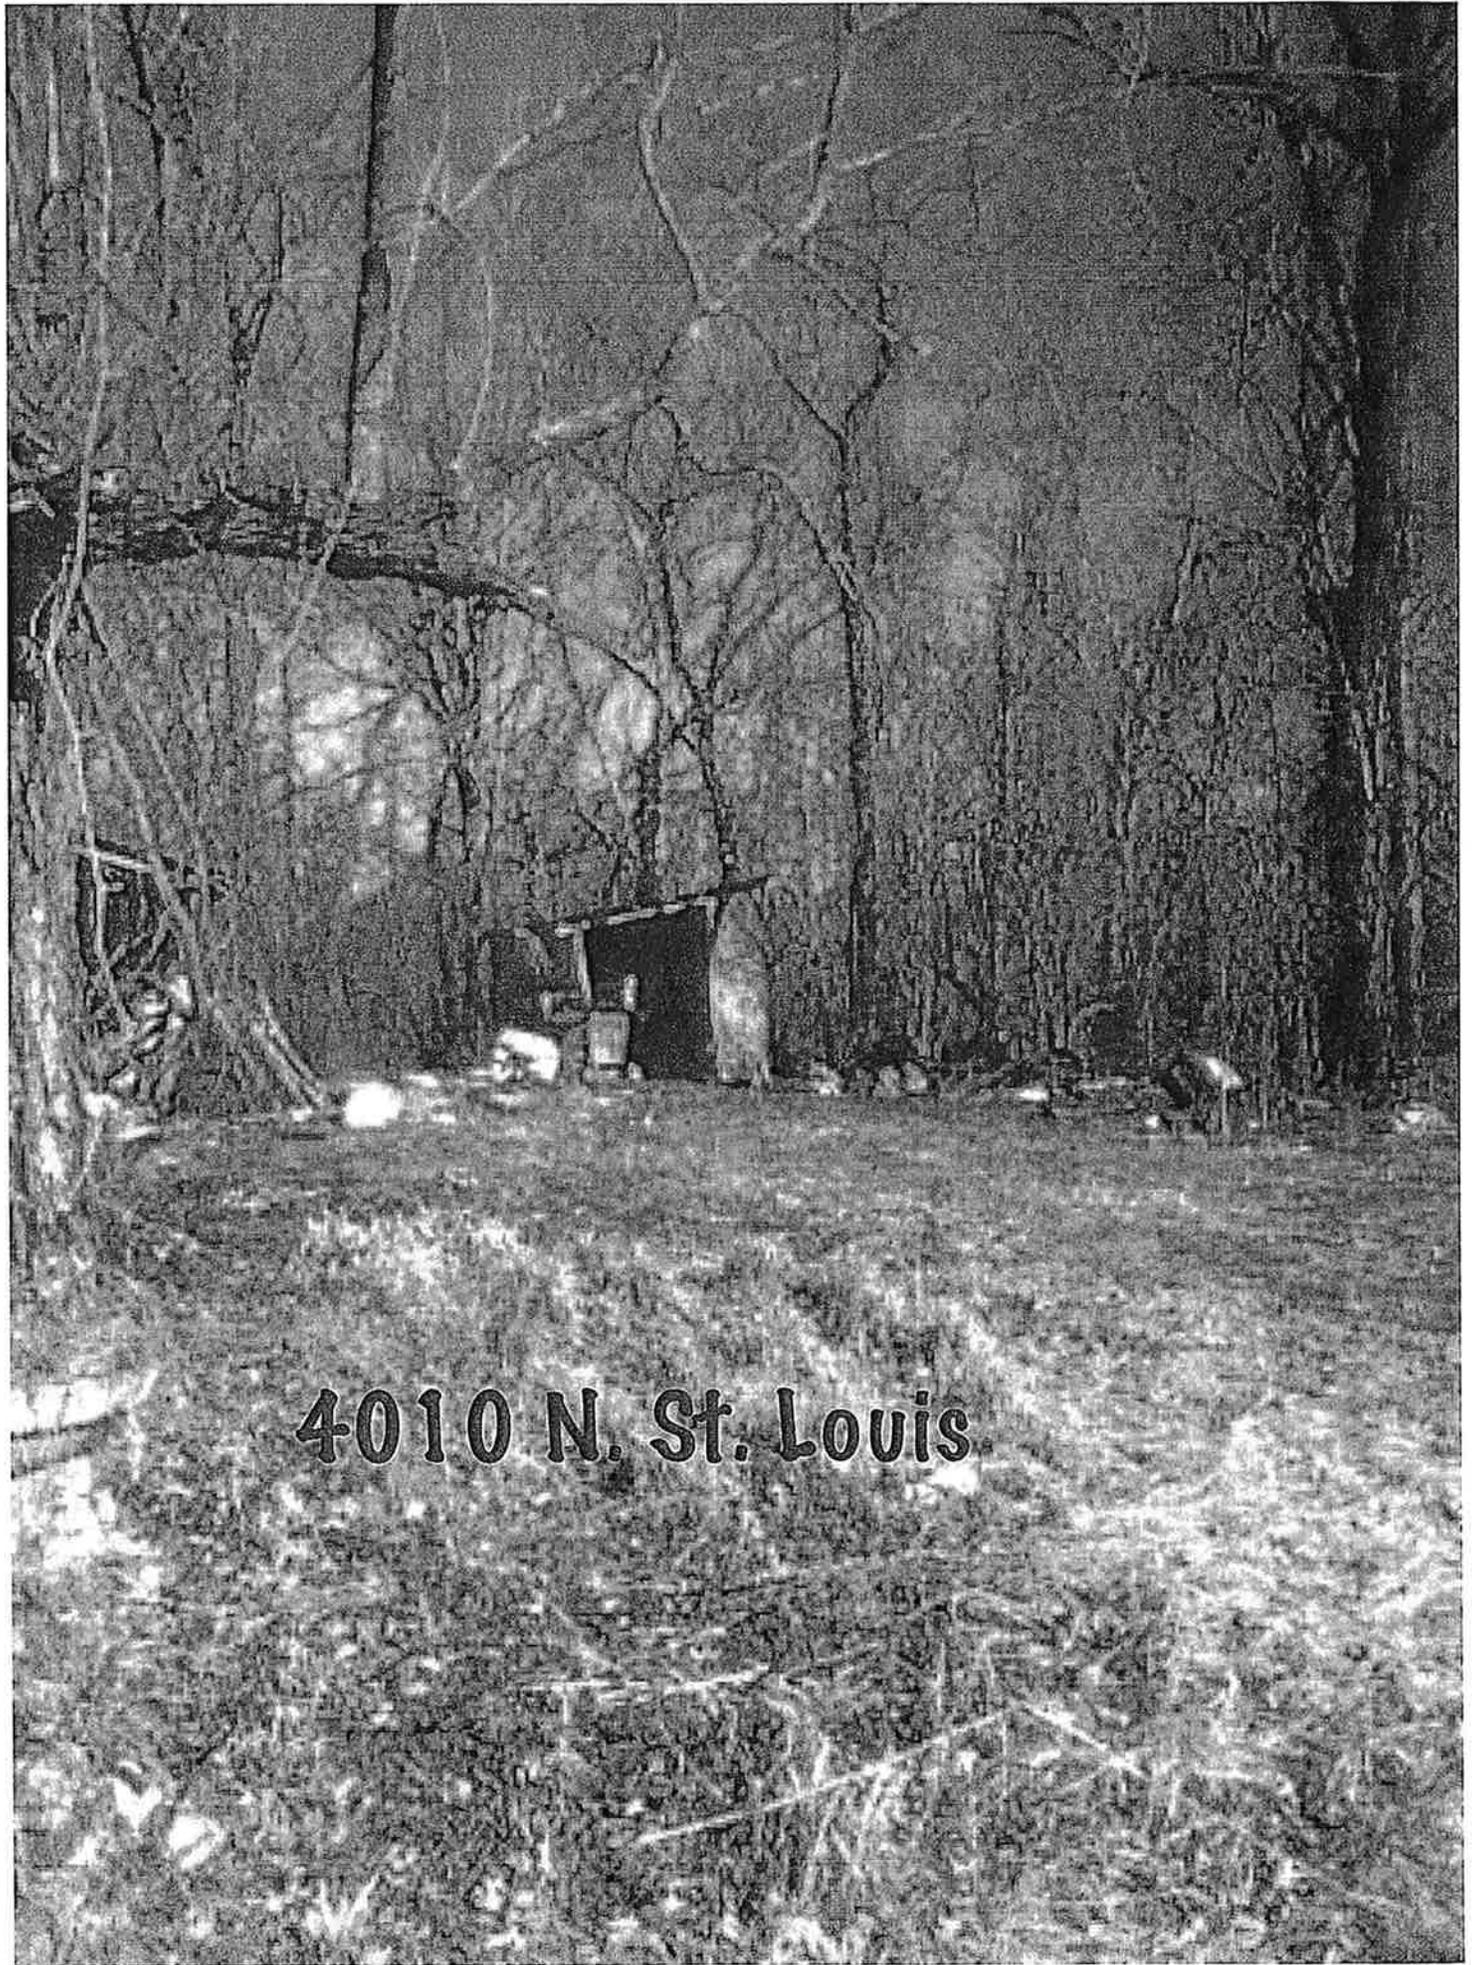
4010 N. St. Louis

Sample #	Layer #	Sample Location	Layer Name / Sample Description	Asbestos Detected	Asbestos Type	% ACM	Condition	Friable	Quantity
#1	#1	KITCHEN	Ceiling Drywall, White/ Beige	No	NAD	NAD	N/A	N/A	N/A
