**ARKANSAS STATE HIGHWAY AND TRANSPORTATION DEPARTMENT
EQUIPMENT AND PROCUREMENT DIVISION
BID INVITATION**

Bid Number: M-14-019P

1. Asbestos Abatement and Demolition located at Hwy. 394-CR 80 (Antioch) (U.S. Hwy. 167) Route 167 Section 18, Independence County; as per attached work list for Tracts 7XED, 10X, 11XED, 13XED, 18XED, 64X & 109X - Job 050213.

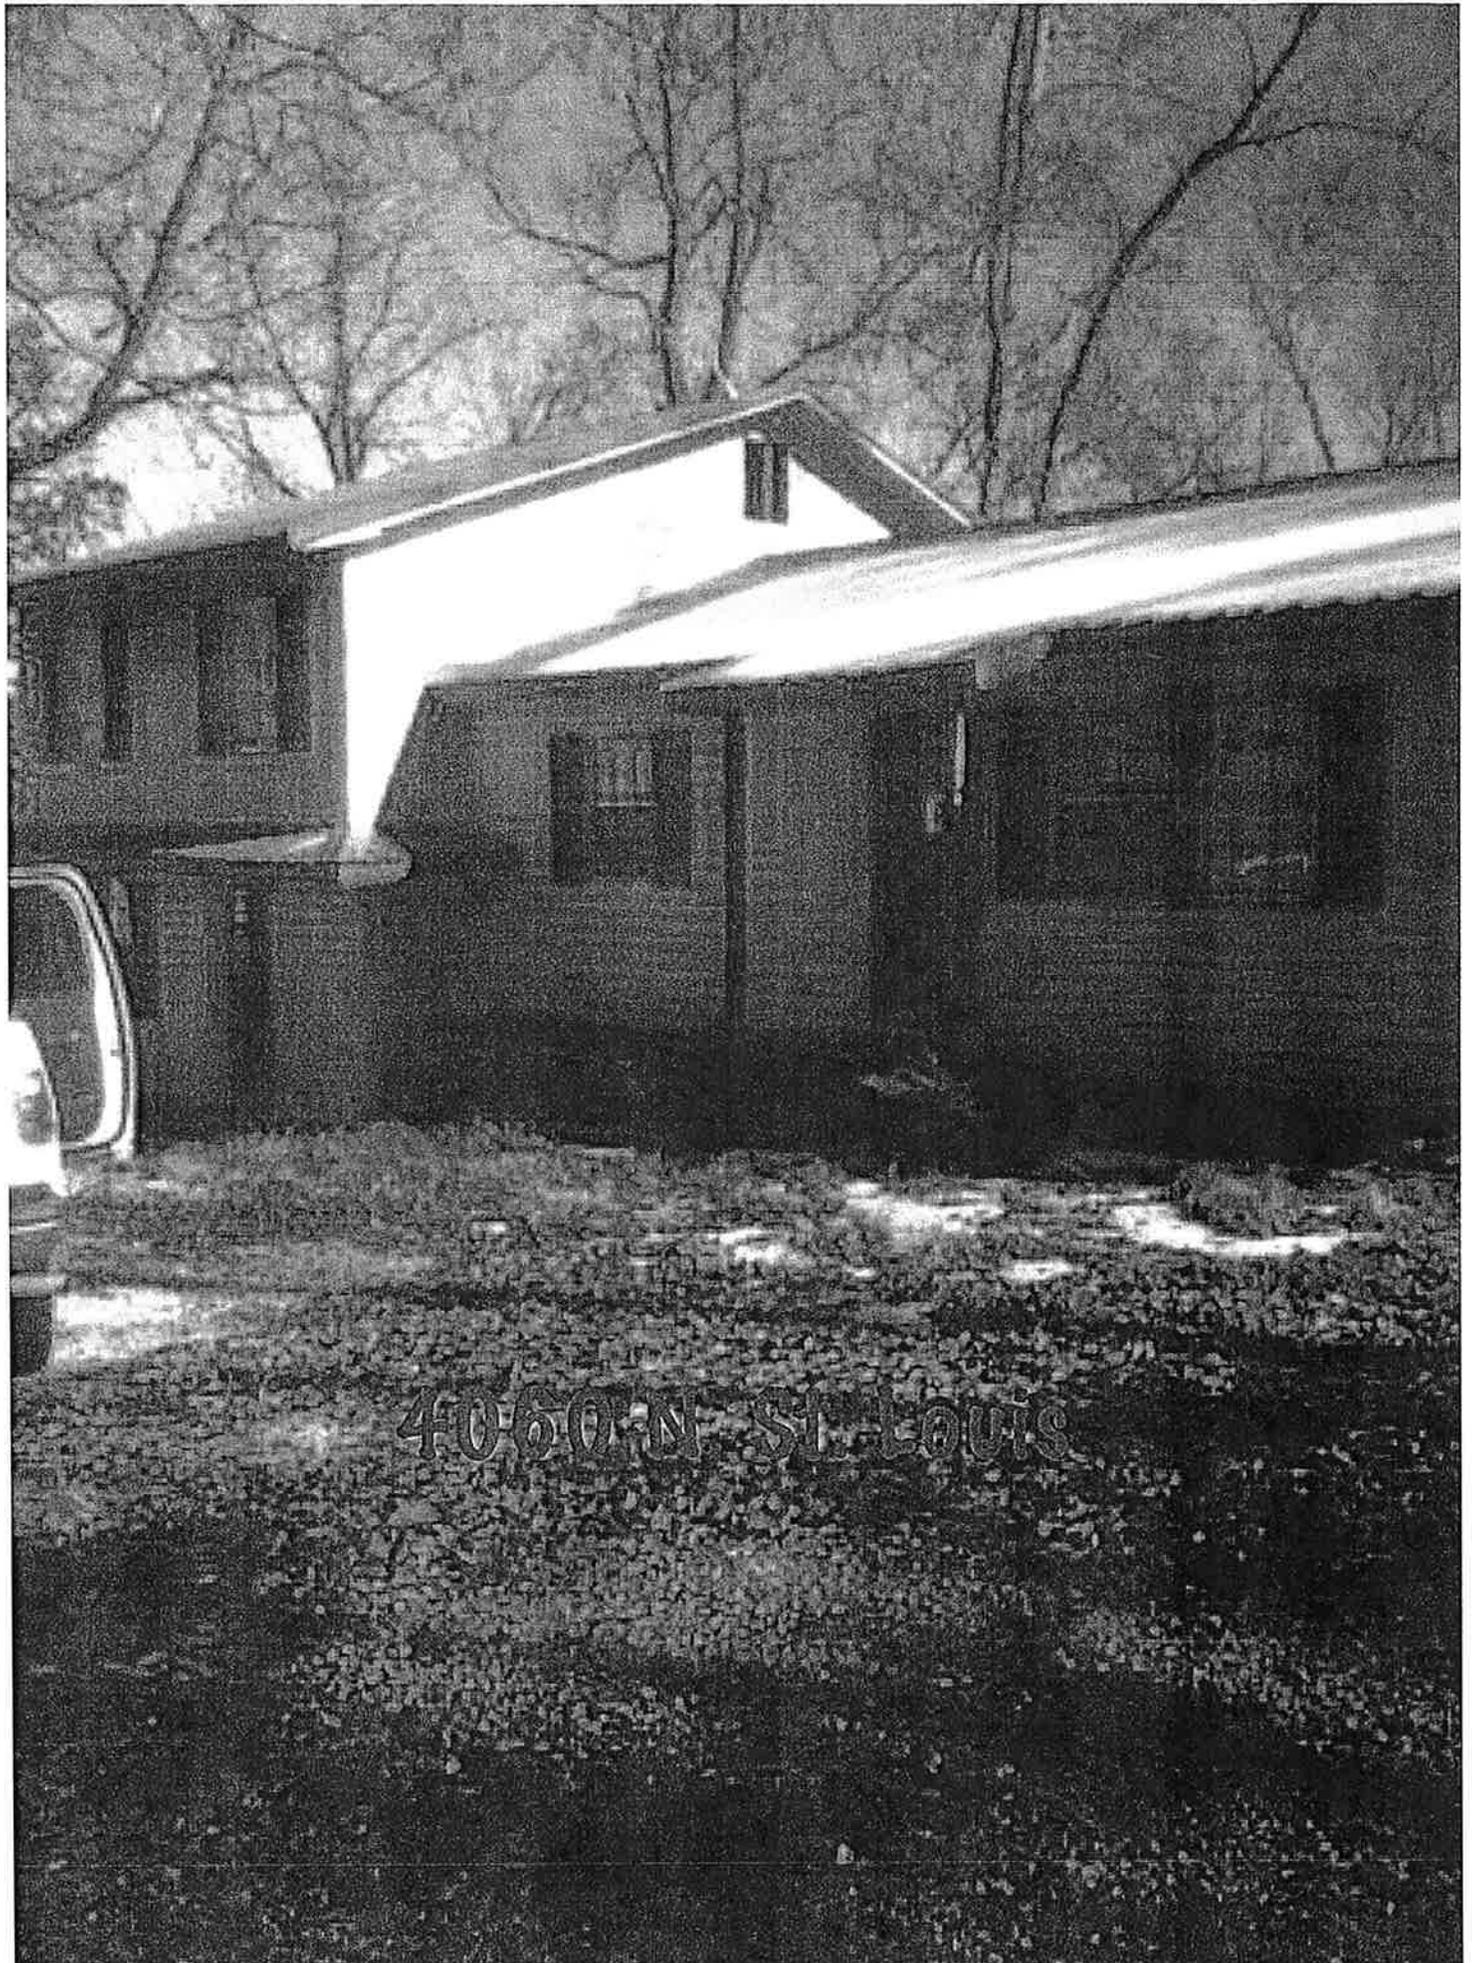
4060 N. ST. LOUIS

Sample #	Layer #	Sample Location	Layer Name / Sample Description	Asbestos Detected	Asbestos Type	% ACM	Condition	Friable	Quantity
#1	#1	KITCHEN	Linoleum, Off White	No	NAD	NAD	N/A	N/A	N/A

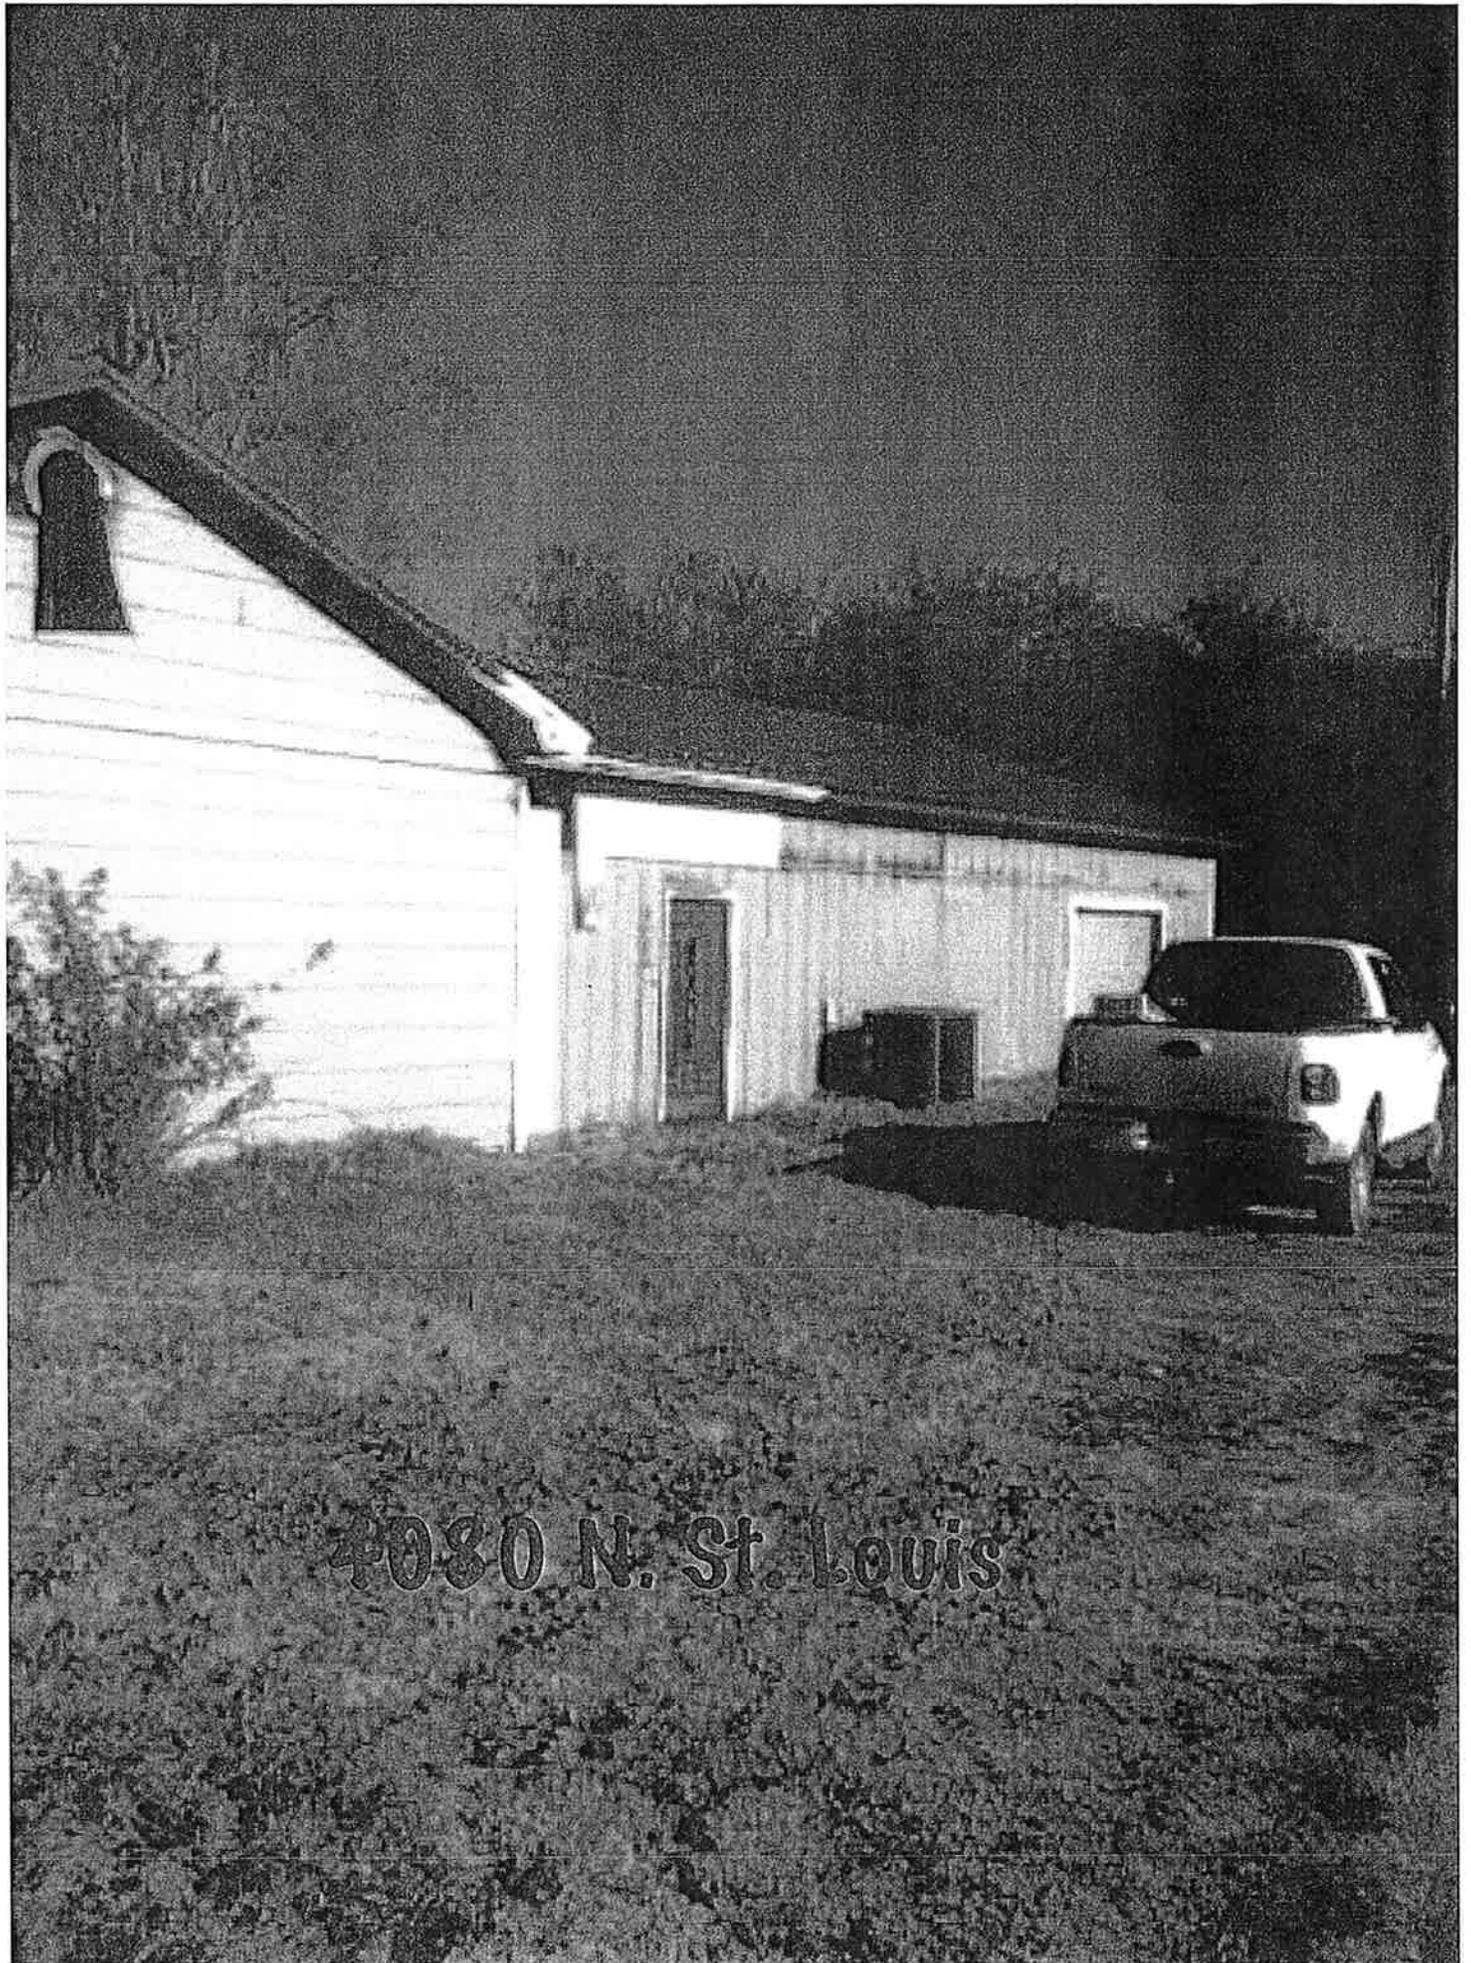
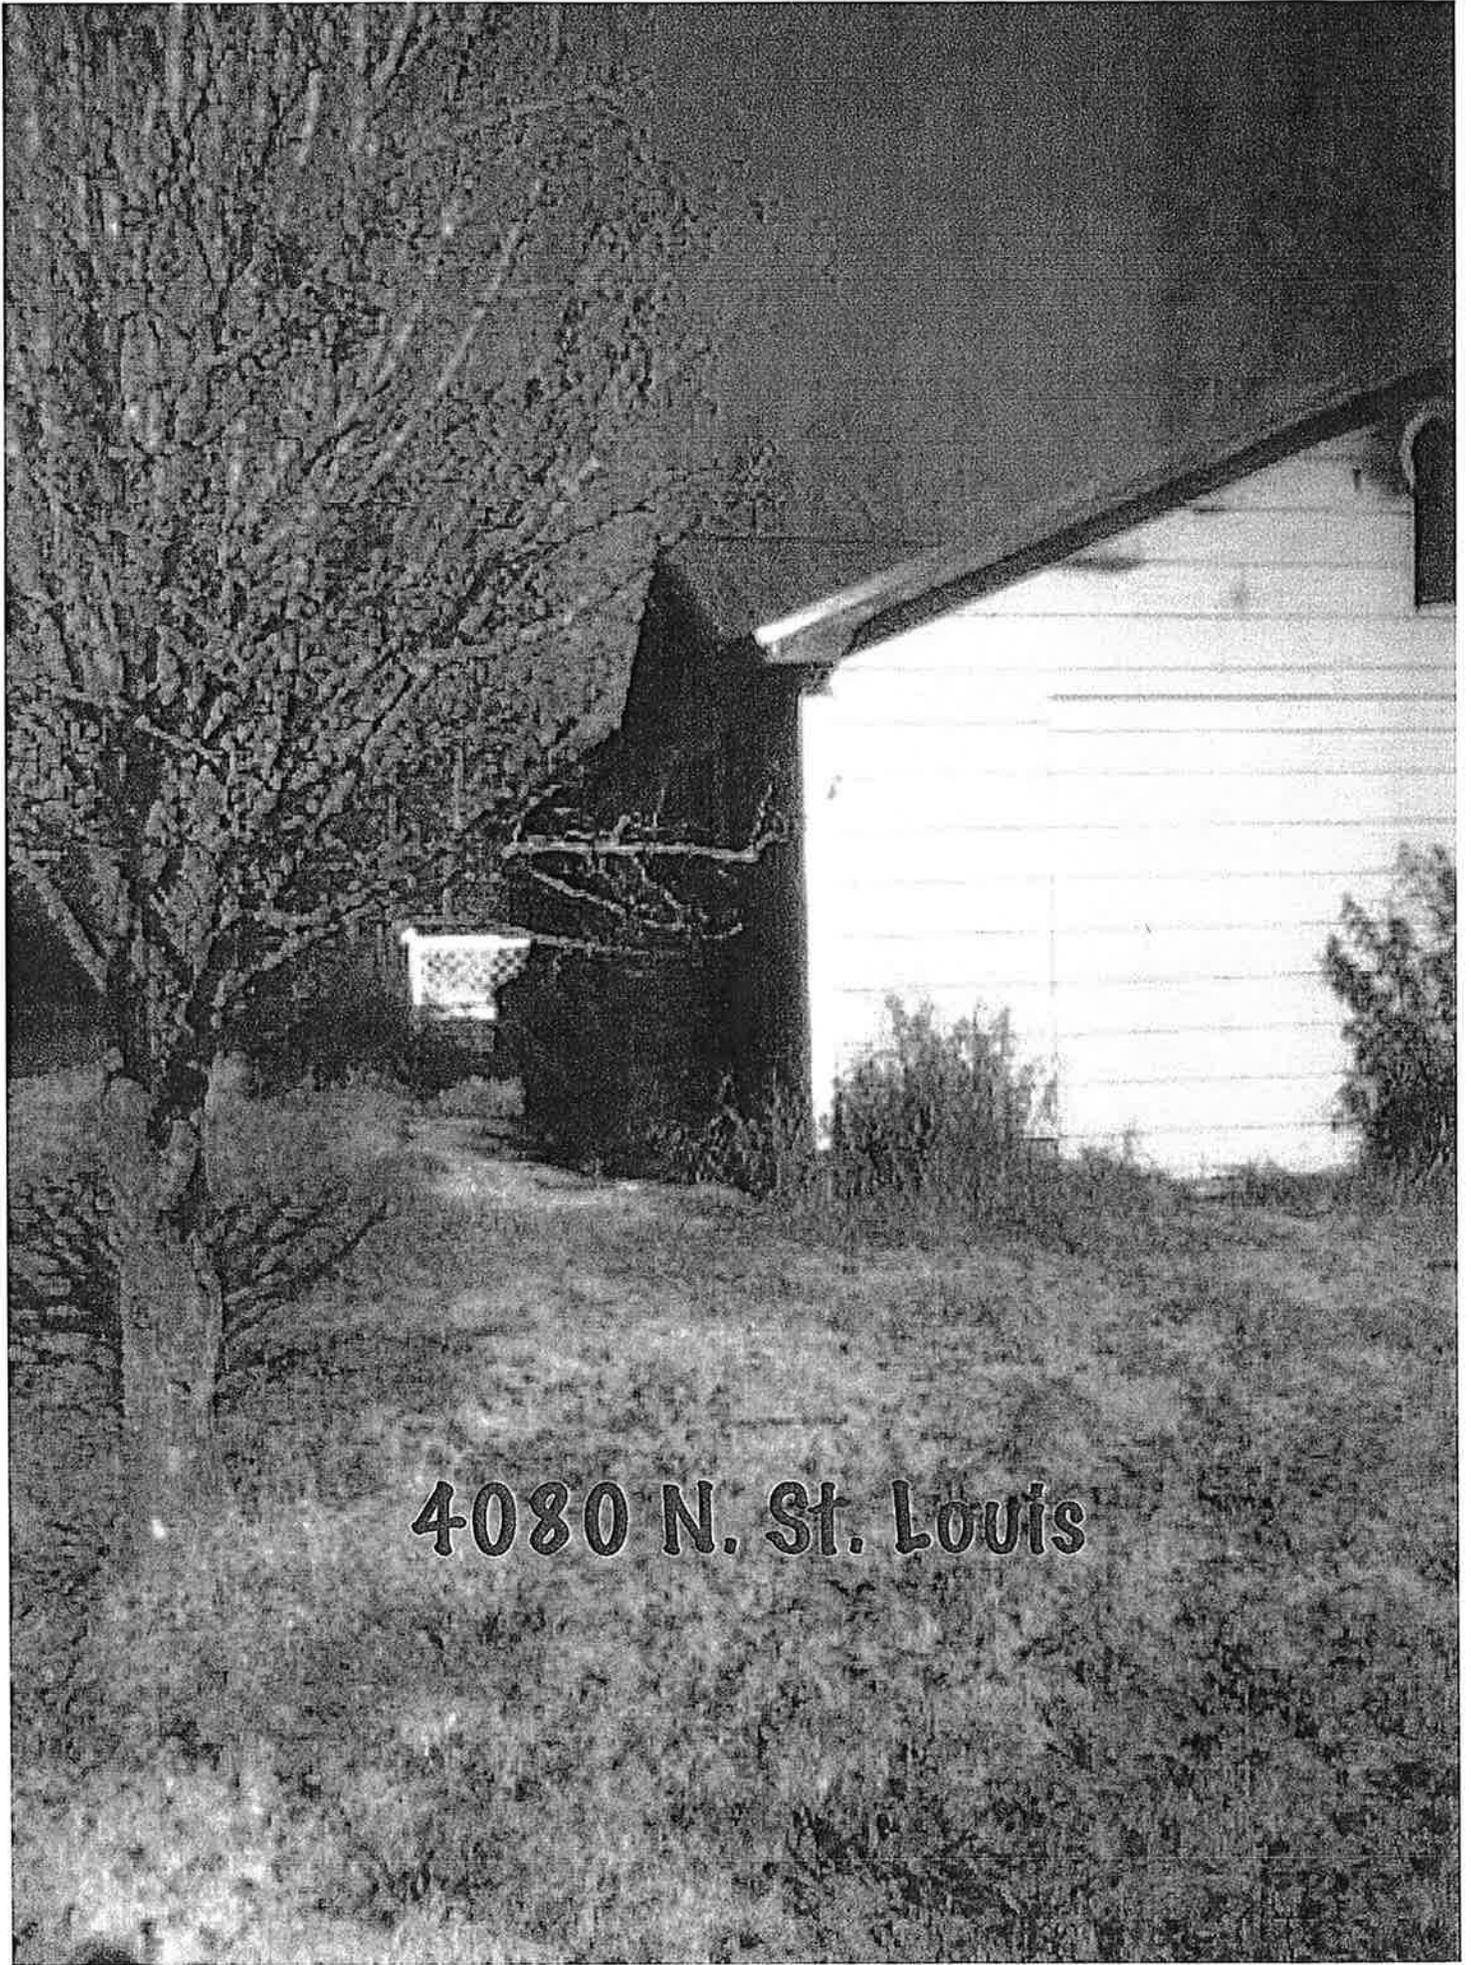
4080 N. St. Louis

Sample #	Layer #	Sample Location	Layer Name / Sample Description	Asbestos Detected	Asbestos Type	% ACM	Condition	Friable	Quantity
#1	#1	SOUTH ENTRY	Linoleum, Lt. Green	No	NAD	NAD	N/A	N/A	N/A

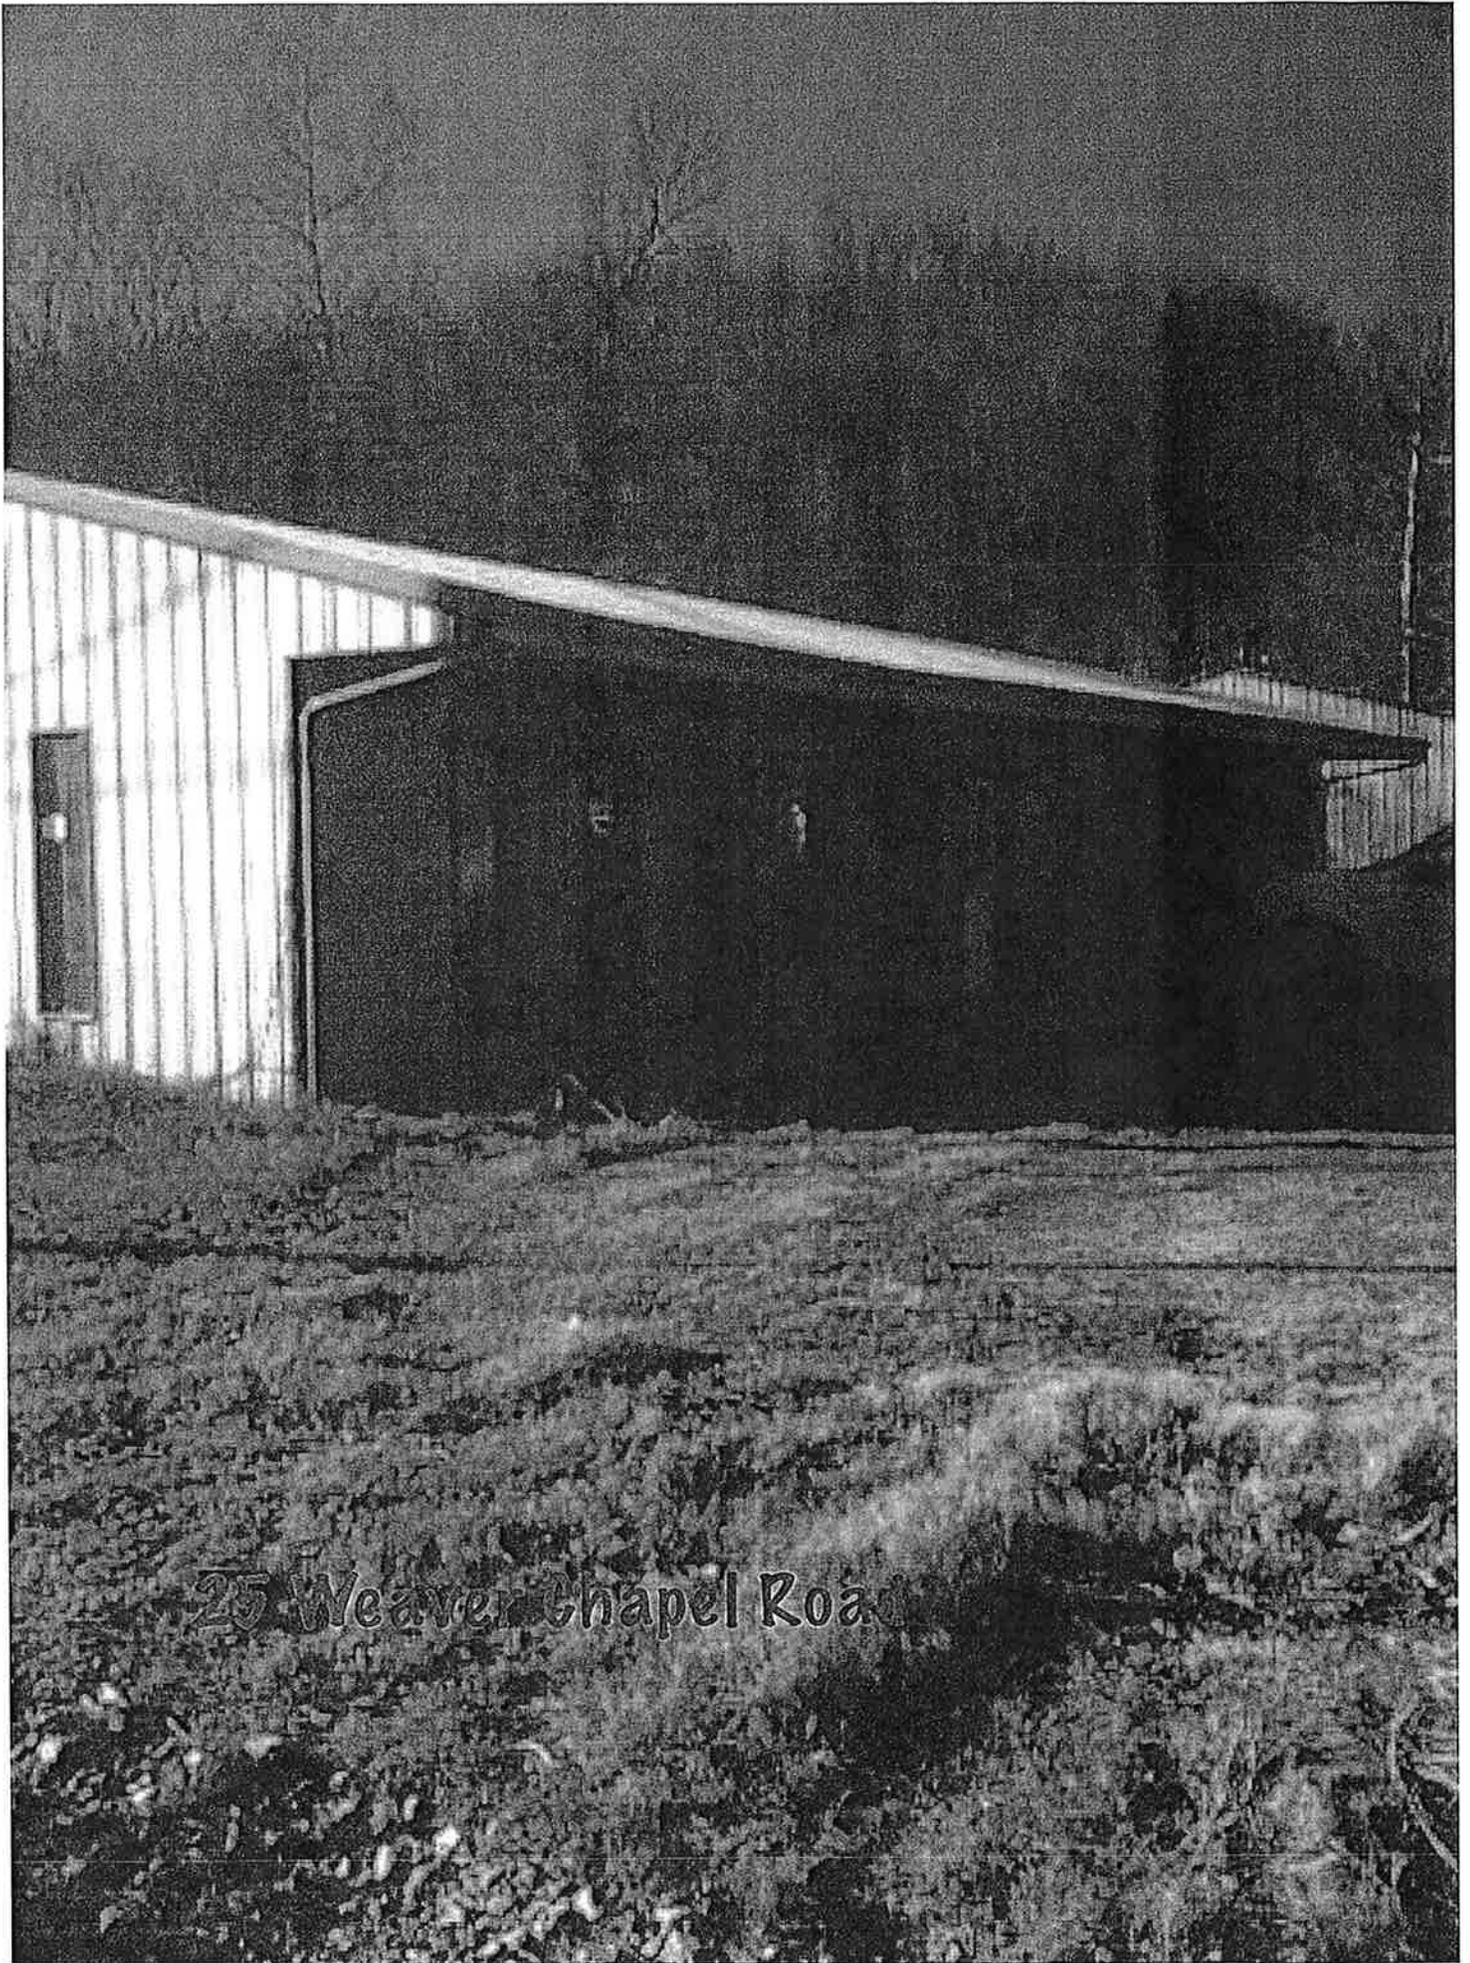
25 Weaver Chapel Road

Sample #	Layer #	Sample Location	Layer Name / Sample Description	Asbestos Detected	Asbestos Type	% ACM	Condition	Friable	Quantity
#1	#1	LEFT RM	Linoelum, White/ Off White	No	NAD	NAD	N/A	N/A	N/A
#1	#2	LEFT RM	Mastic, Yellow	No	NAD	NAD	N/A	N/A	N/A
#2	#1	LEFT RM	Ceiling Tile, Beige/ Off White	No	NAD	NAD	N/A	N/A	N/A
#3	#1	LEFT RM	Sheetrock, Off White/ Brown	No	NAD	NAD	N/A	N/A	N/A
#4	#1	MIDDLE RM	Ceiling Ttle, Beige/ Off White	No	NAD	NAD	N/A	N/A	N/A
#5	#1	MIDDLE RM	Sheetrock, Off White/ Brown	No	NAD	NAD	N/A	N/A	N/A
#5	#2	MIDDLE RM	Mud, White/ Off White	No	NAD	NAD	N/A	N/A	N/A
#6	#1	RIGHT RM	Ceiling Tile, Beige/ Off White	No	NAD	NAD	N/A	N/A	N/A

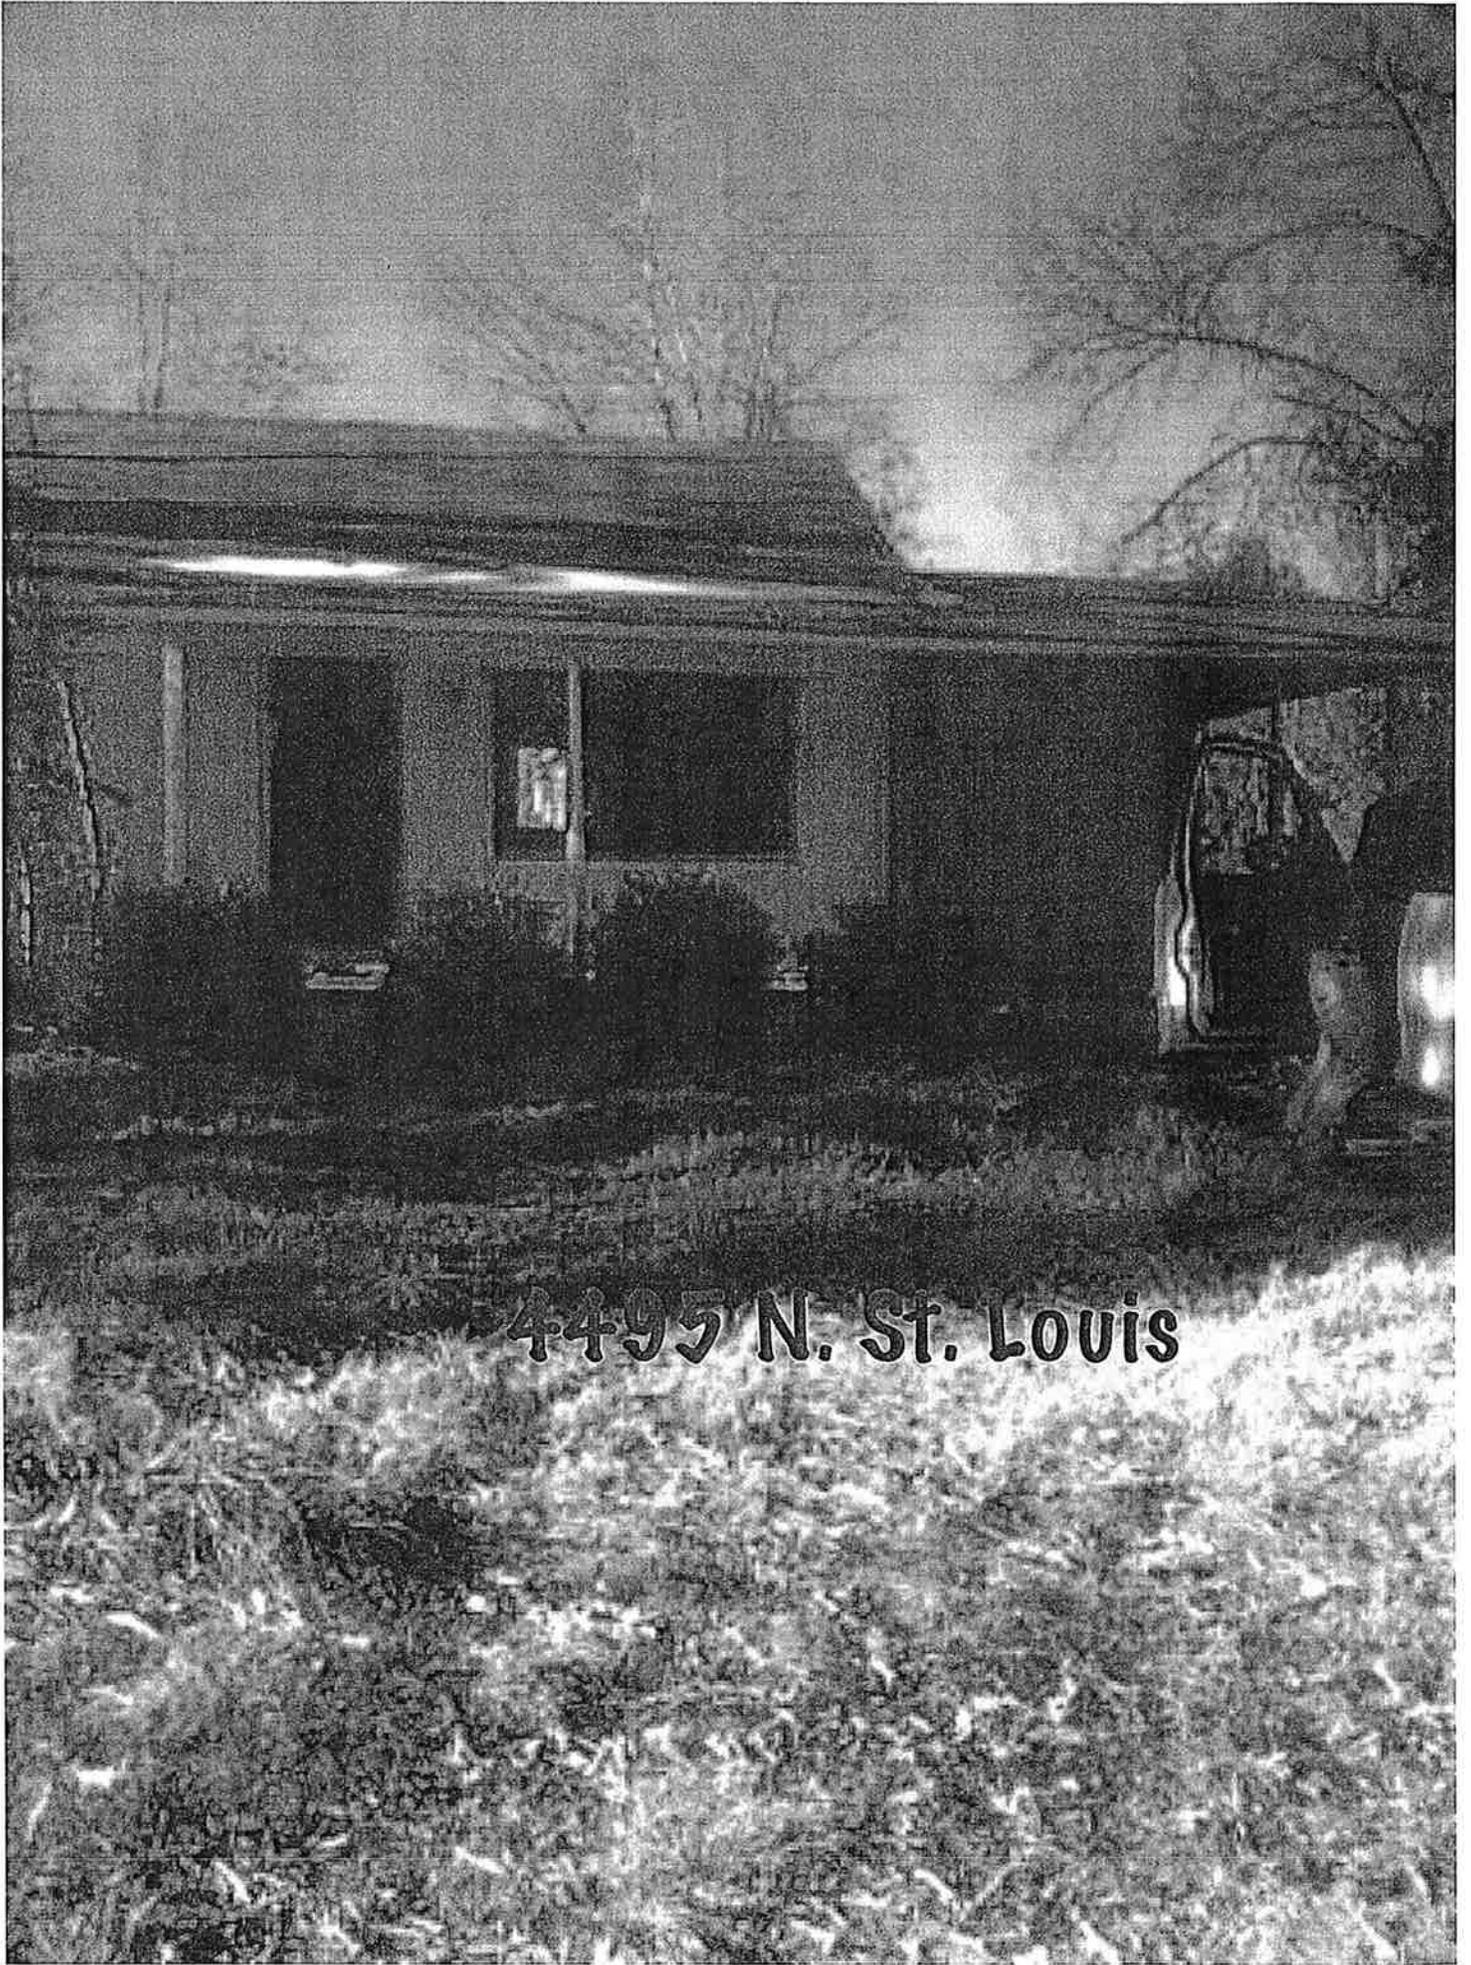
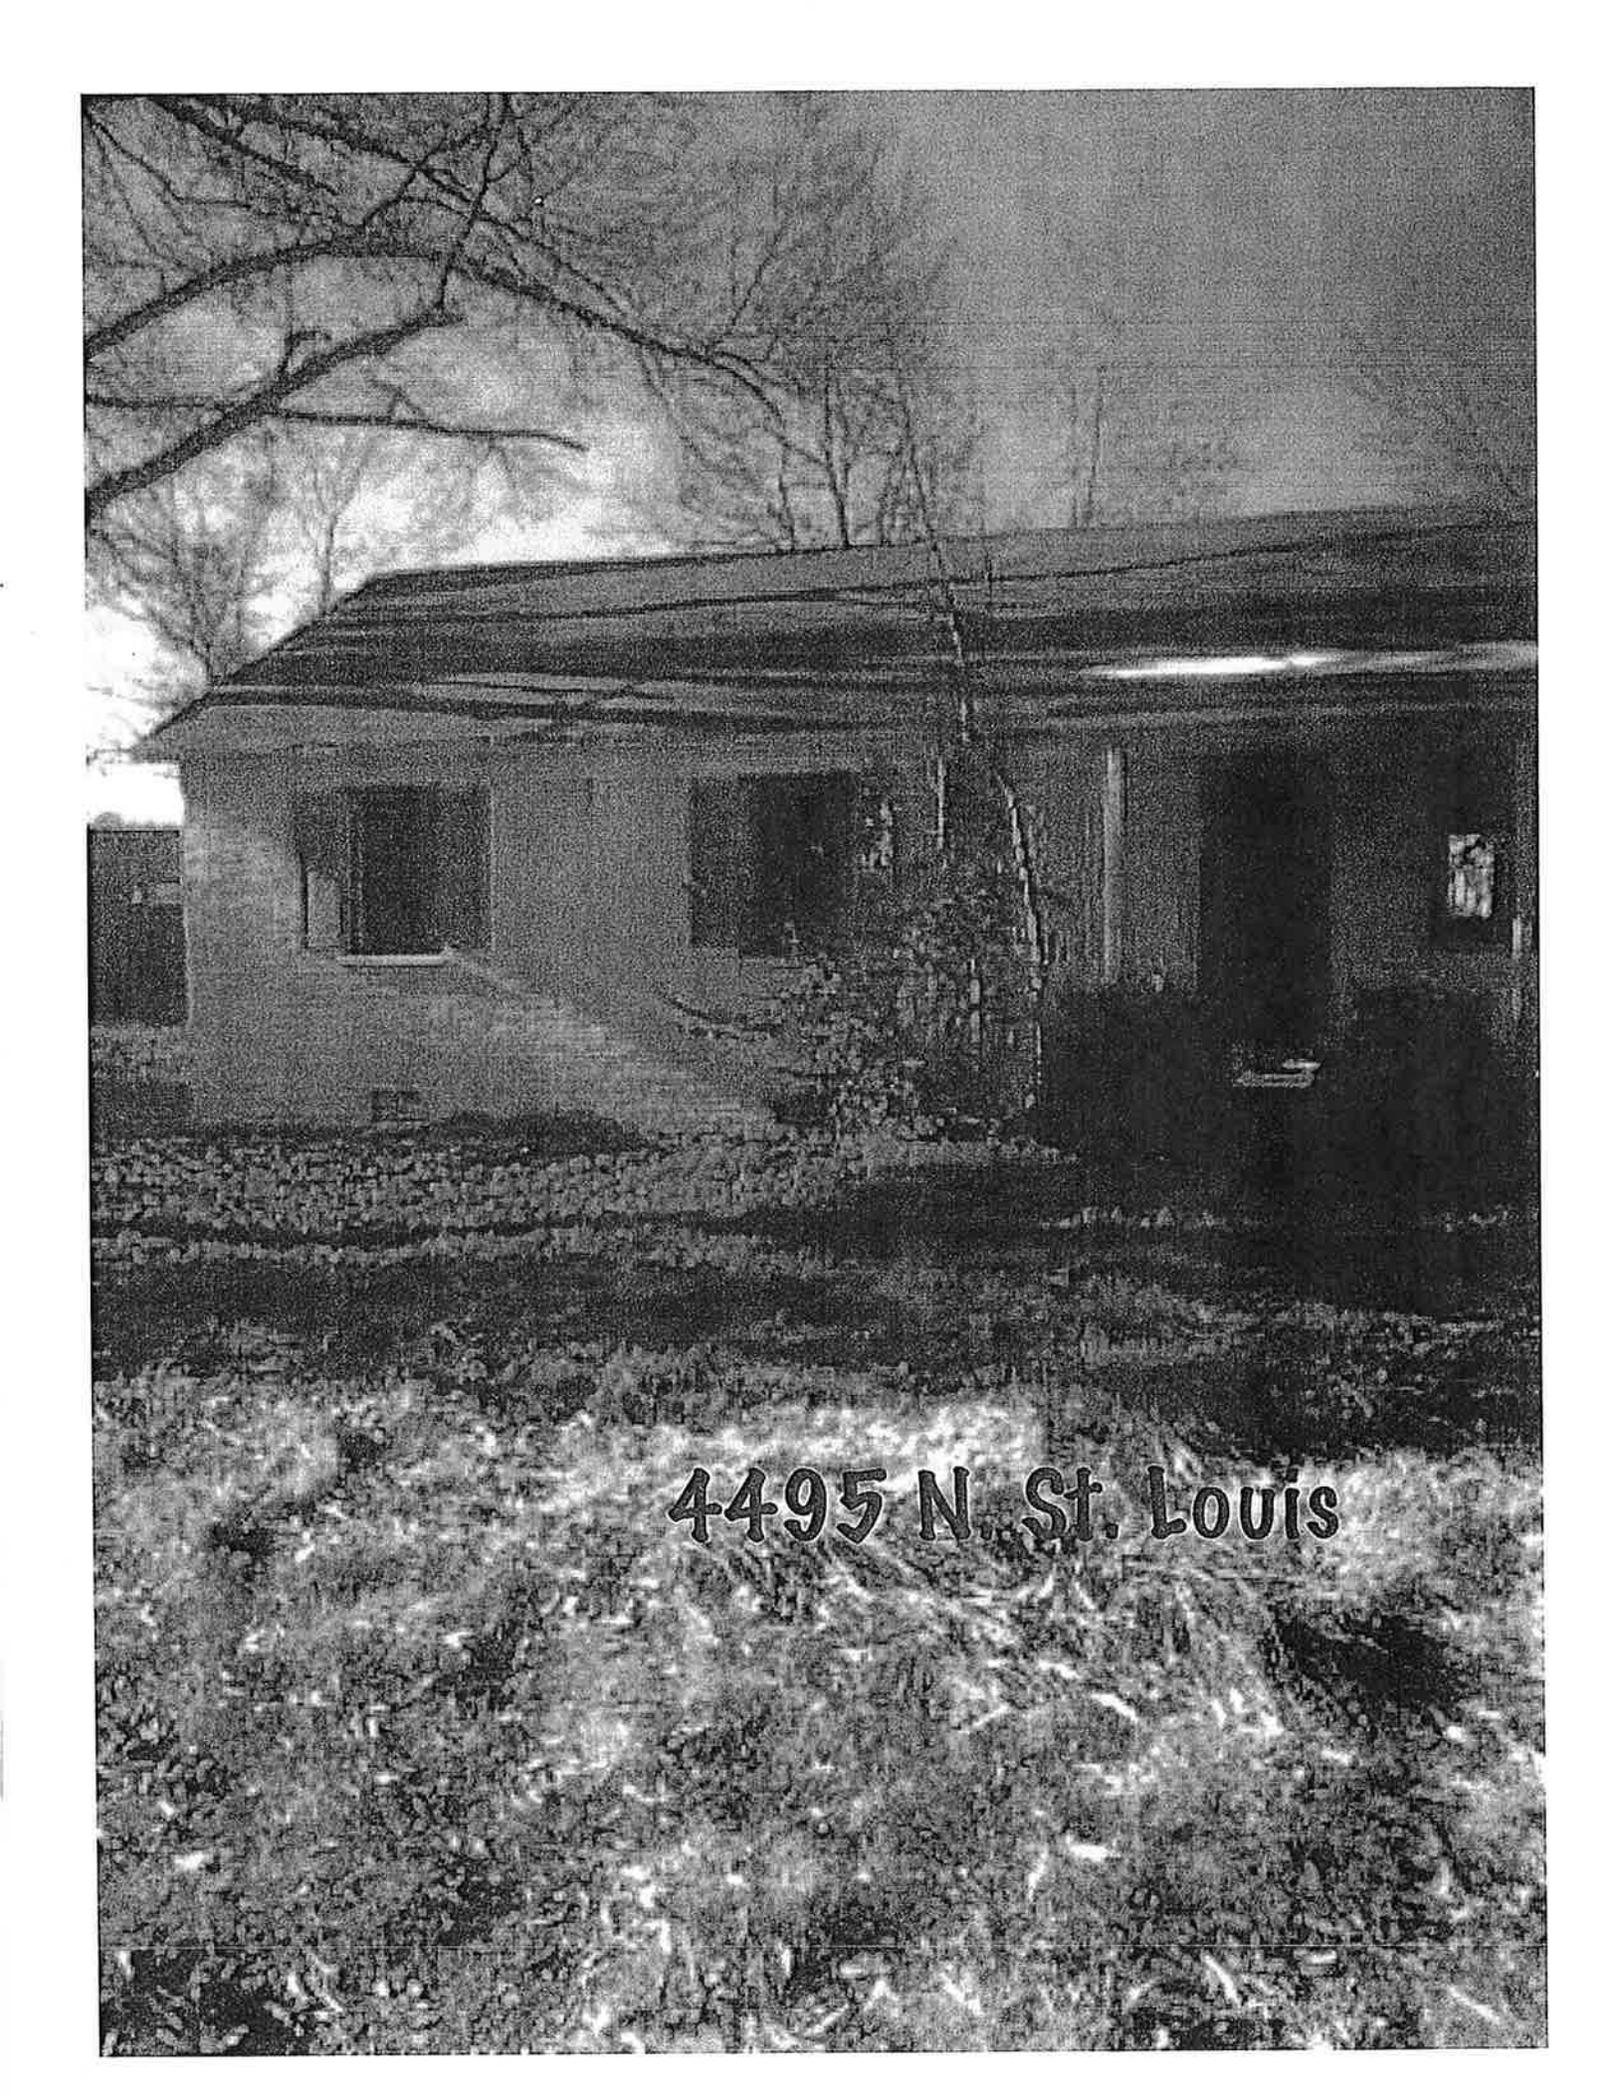
4495 N. St. Louis

Sample #	Layer #	Sample Location	Layer Name / Sample Description	Asbestos Detected	Asbestos Type	% ACM	Condition	Friable	Quantity
#1	#1	BATHRM	Ceiling Drywall, Brown/ Tan Ceiling Texture/ Paint, White Note: Sample is mainly Paint - no Texture present	No	NAD	NAD	N/A	N/A	N/A
#1	#2	BATHRM		No	NAD	NAD	N/A	N/A	N/A
#2	#1	BATHRM	Drywall, Brown/ Tan	No	NAD	NAD	N/A	N/A	N/A
#3	#1	LIVING RM	Ceiling Drywall, Brown/ Tan	No	NAD	NAD	N/A	N/A	N/A
#3	#2	LIVING RM	Ceiling Texture, White/ Off White	No	NAD	NAD	N/A	N/A	N/A
#4	#1	LIVING RM	Drywall, Brown/ Tan	No	NAD	NAD	N/A	N/A	N/A
#4	#2	LIVING RM	Wall Texture, White/ Beige	No	NAD	NAD	N/A	N/A	N/A
#5	#1	ROOF	Roof Shingle, Black/ Gray	No	NAD	NAD	N/A	N/A	N/A
#6	#1	EXTERIOR	Exterior Asphalt Siding, Green/White/Black	No	NAD	NAD	N/A	N/A	N/A
