**ARKANSAS STATE HIGHWAY AND TRANSPORTATION DEPARTMENT
EQUIPMENT AND PROCUREMENT DIVISION
BID INVITATION**

Bid Number: M-14-019P

1. Asbestos Abatement and Demolition located at Hwy. 394-CR 80 (Antioch) (U.S. Hwy. 167) Route 167 Section 18, Independence County; as per attached work list for Tracts 7XED, 10X, 11XED, 13XED, 18XED, 64X & 109X - Job 050213.

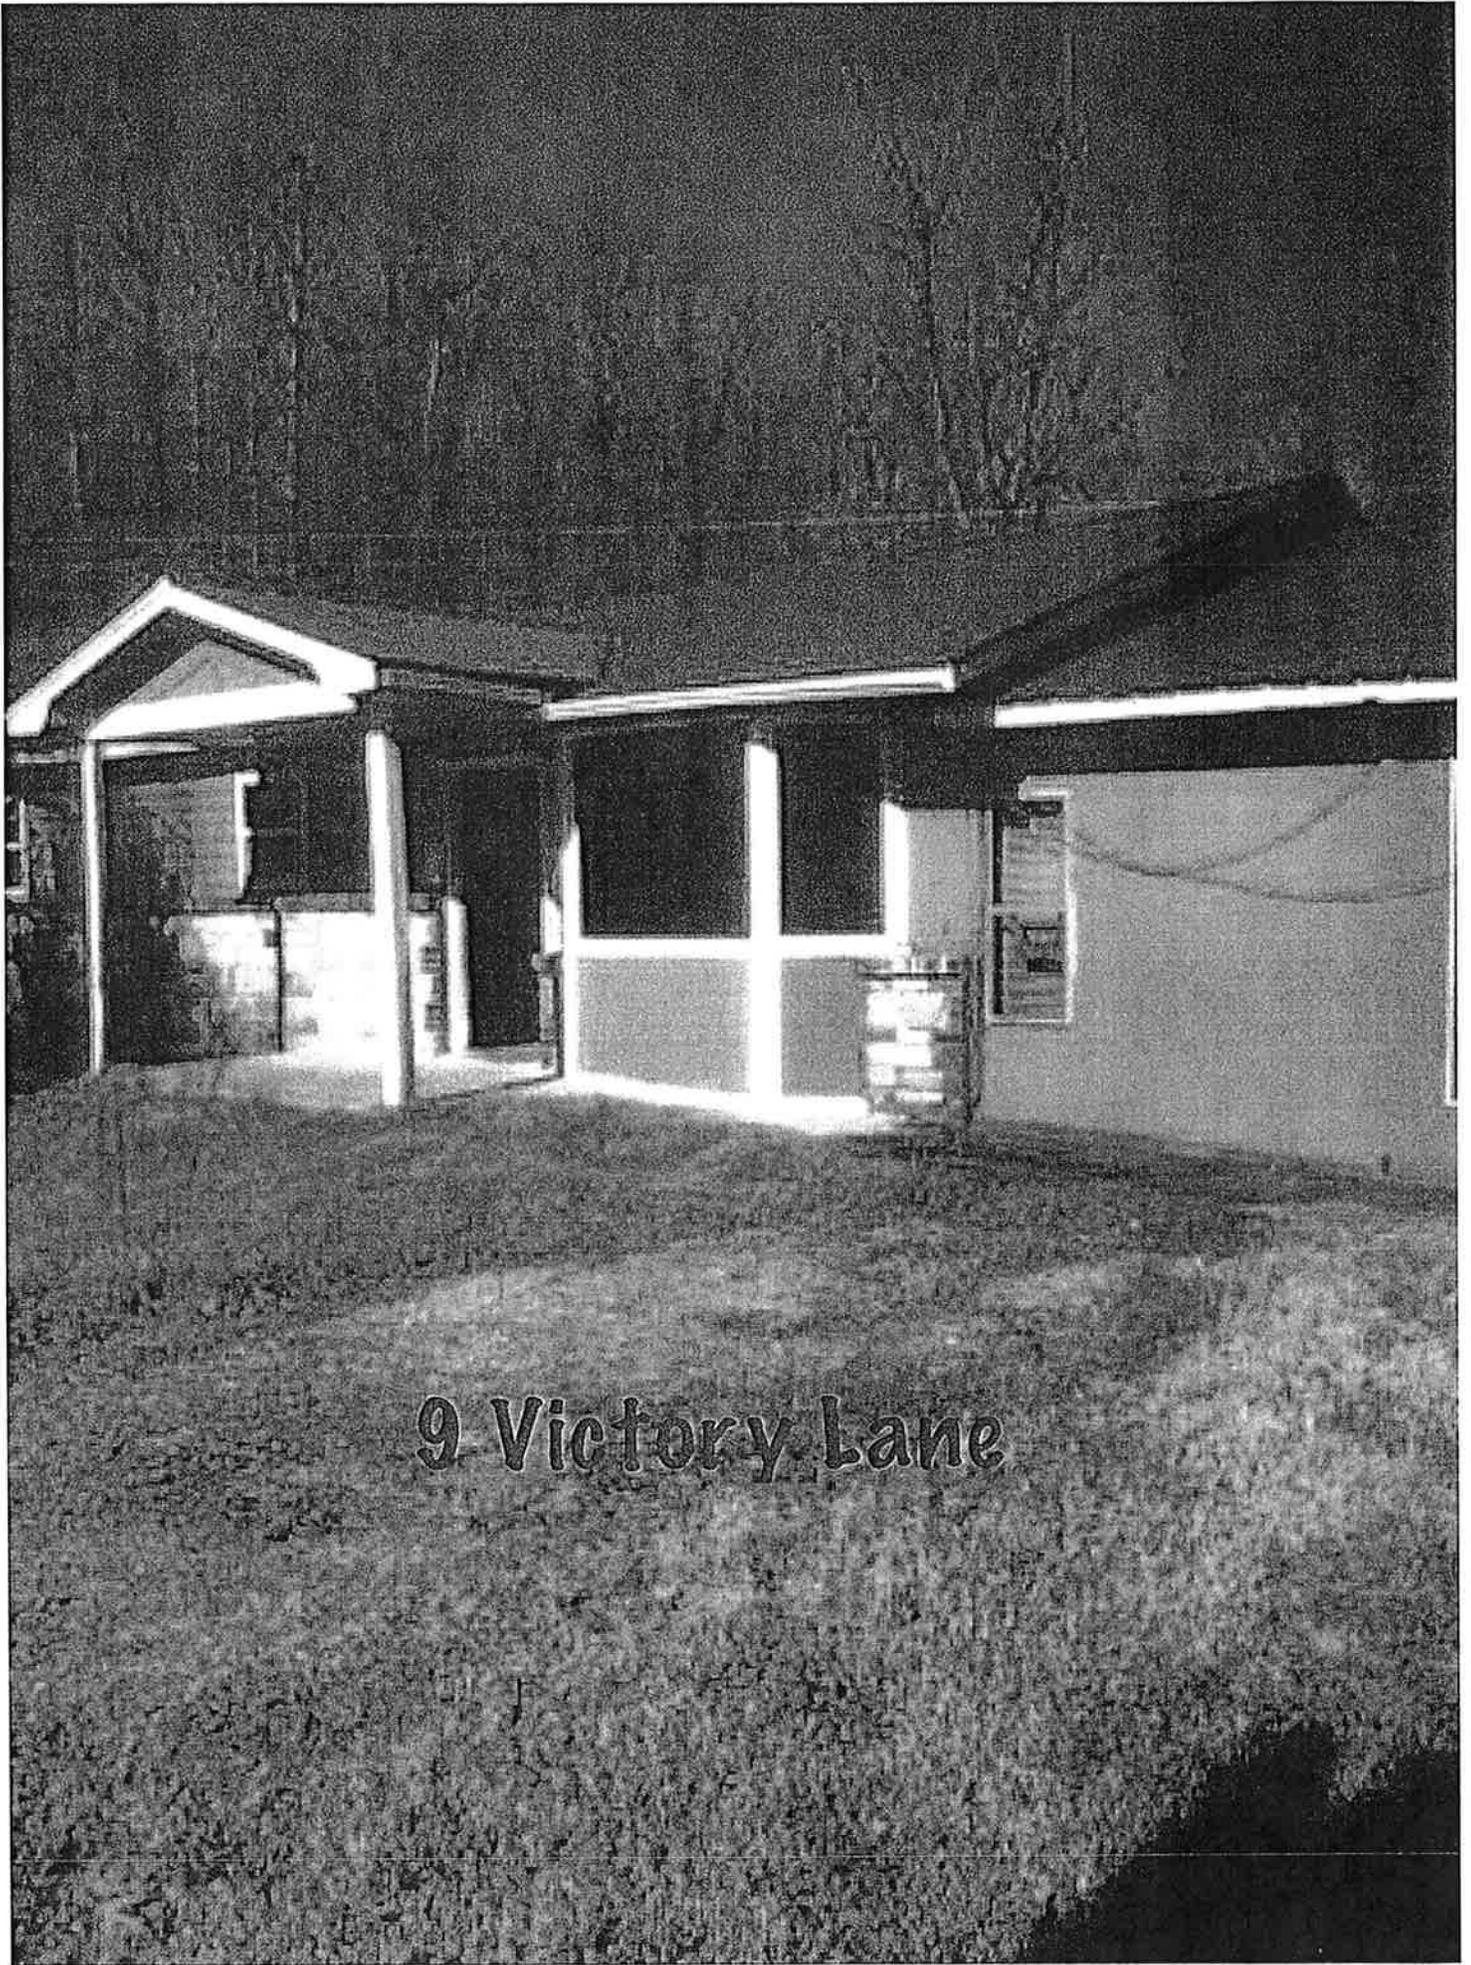
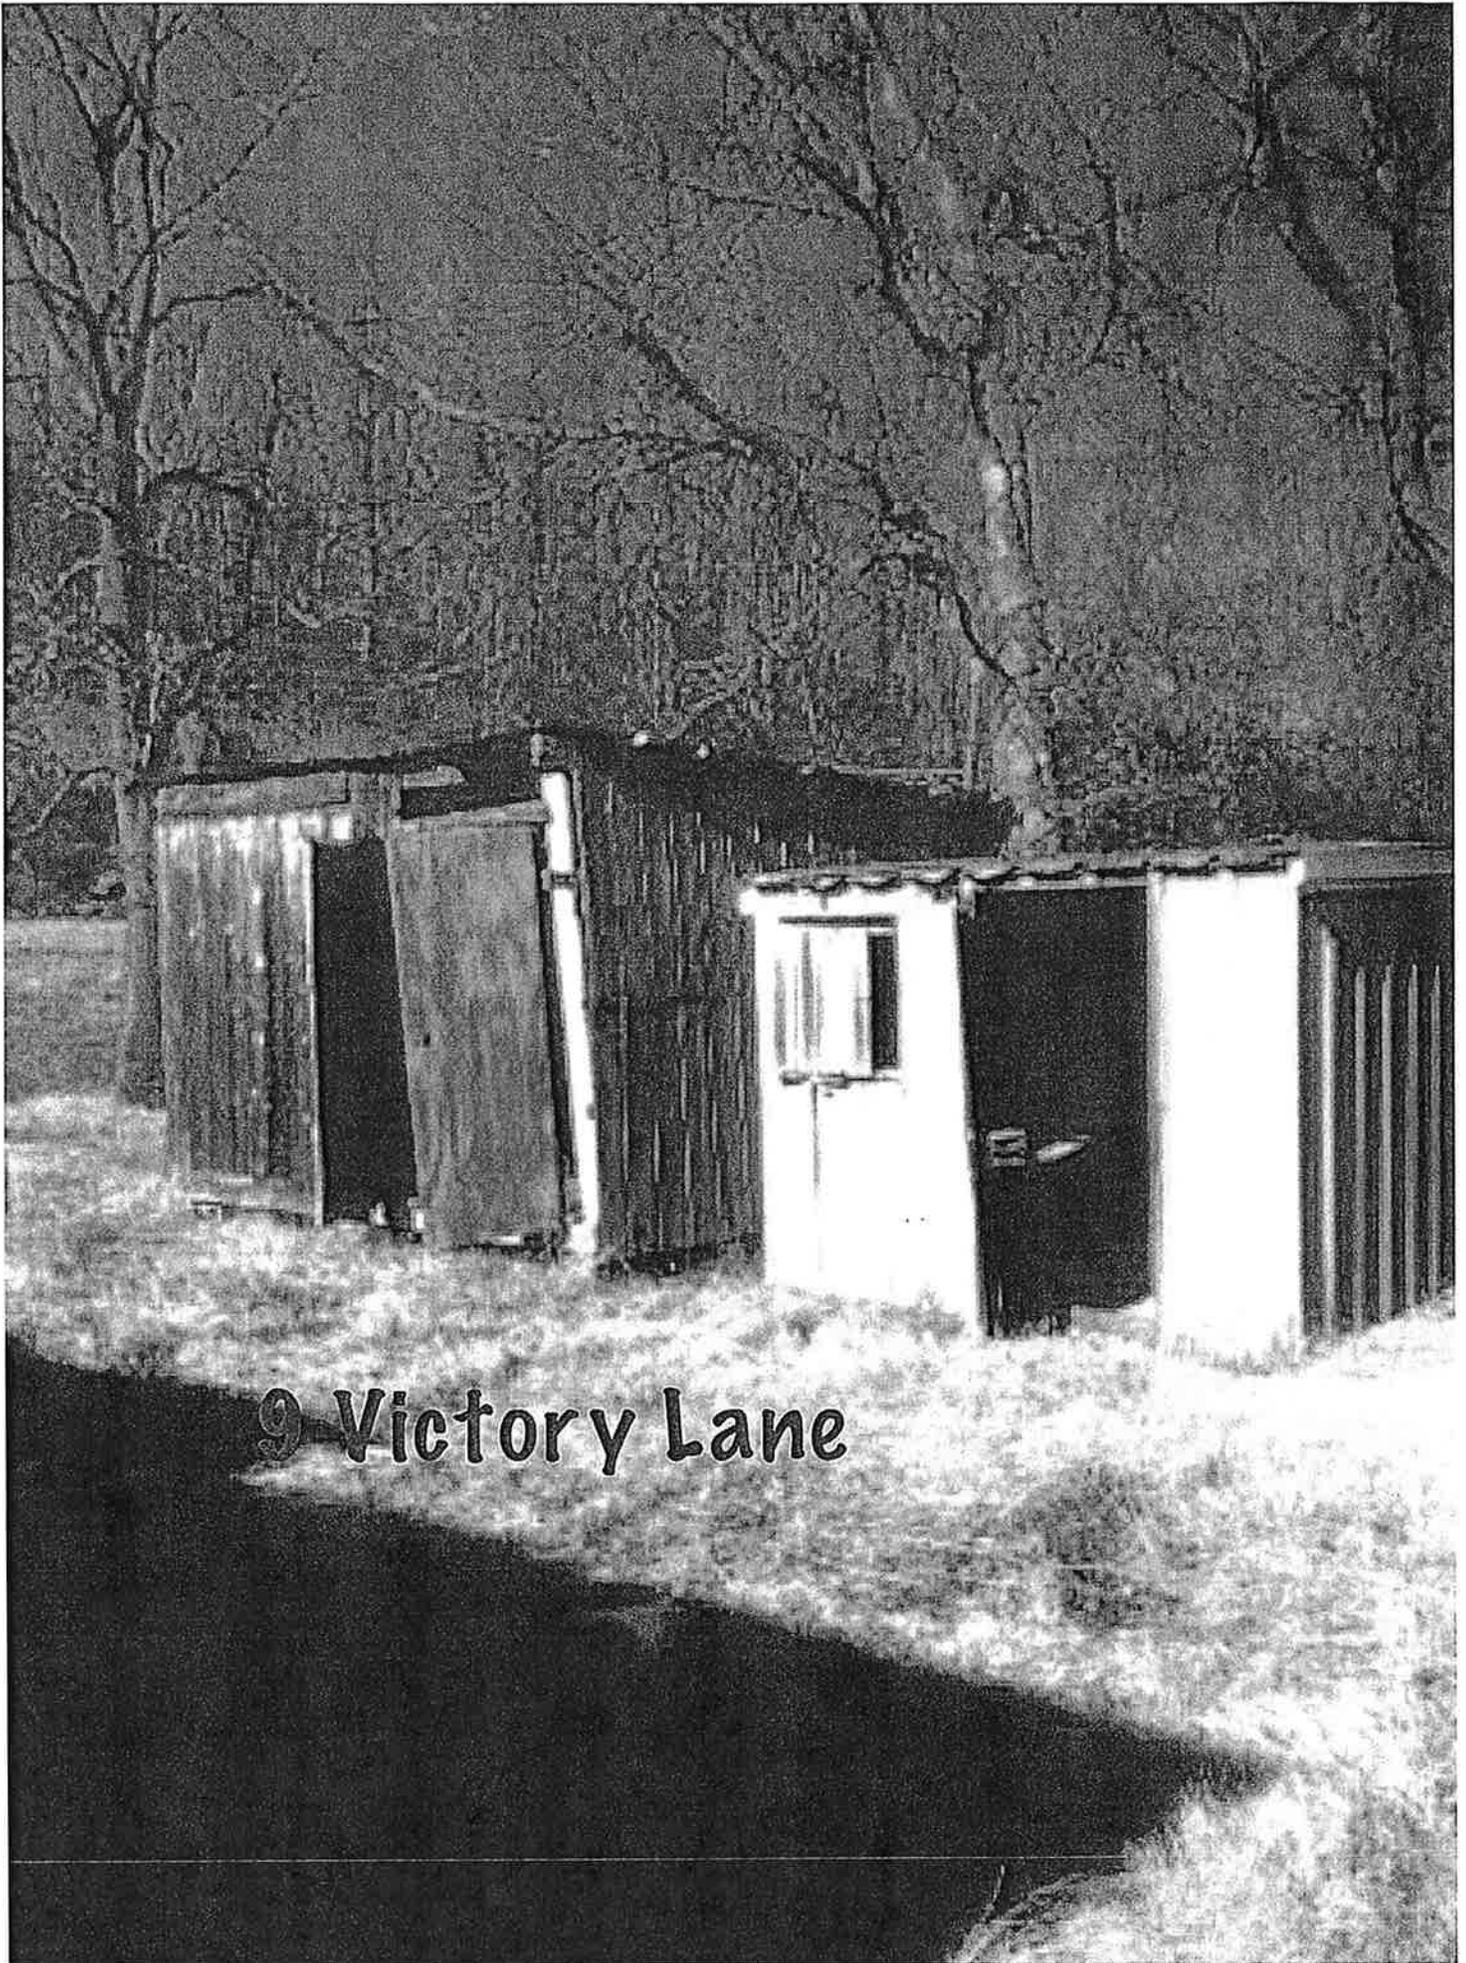
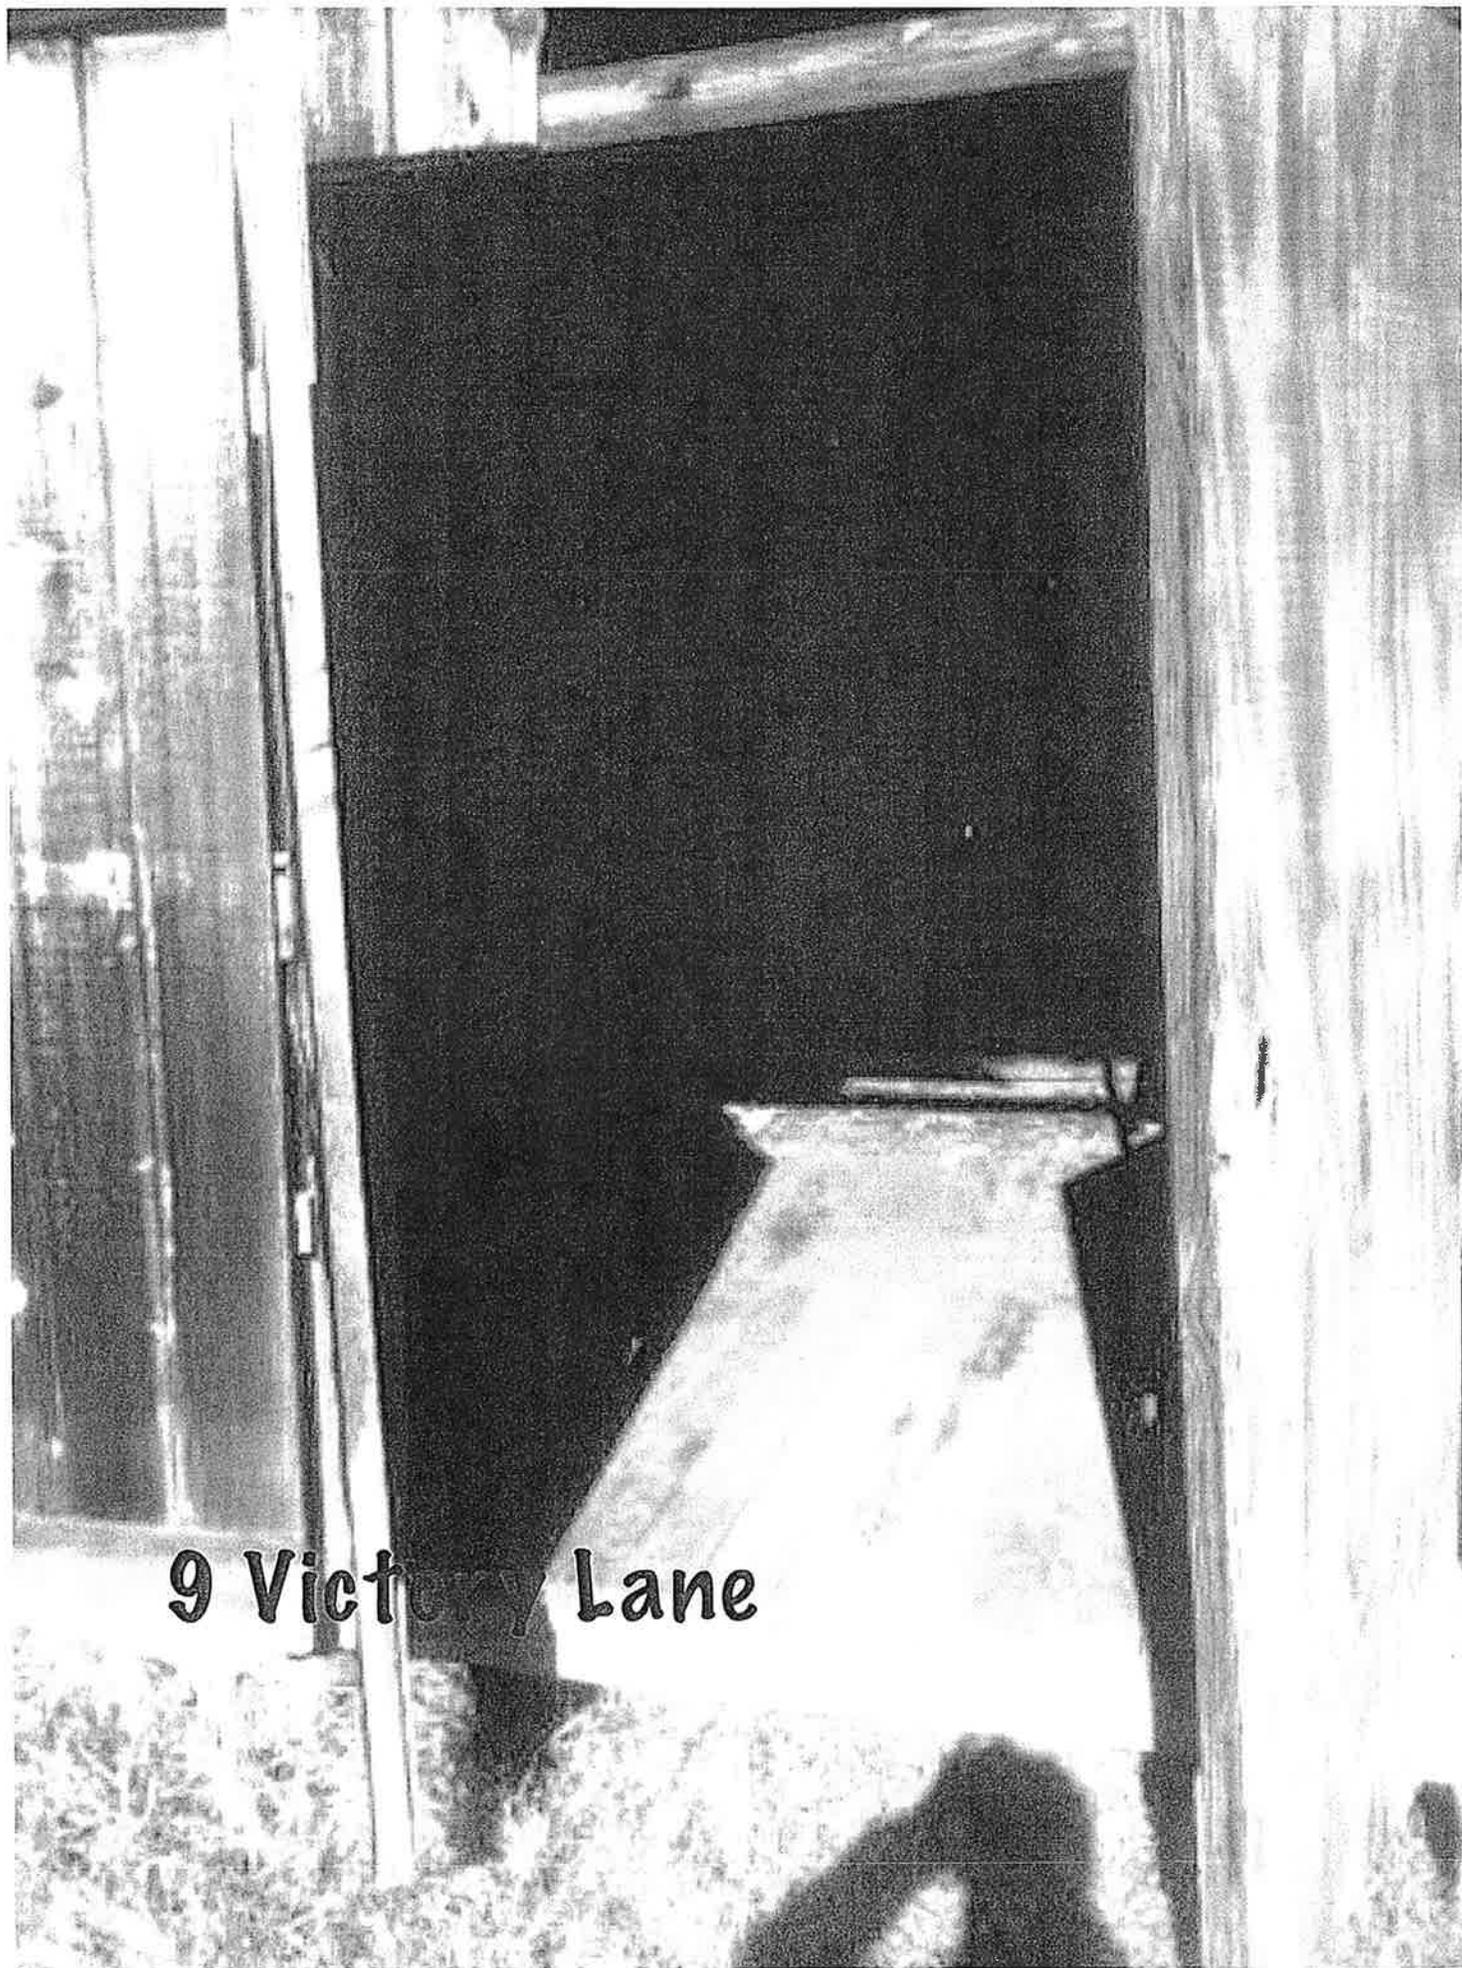
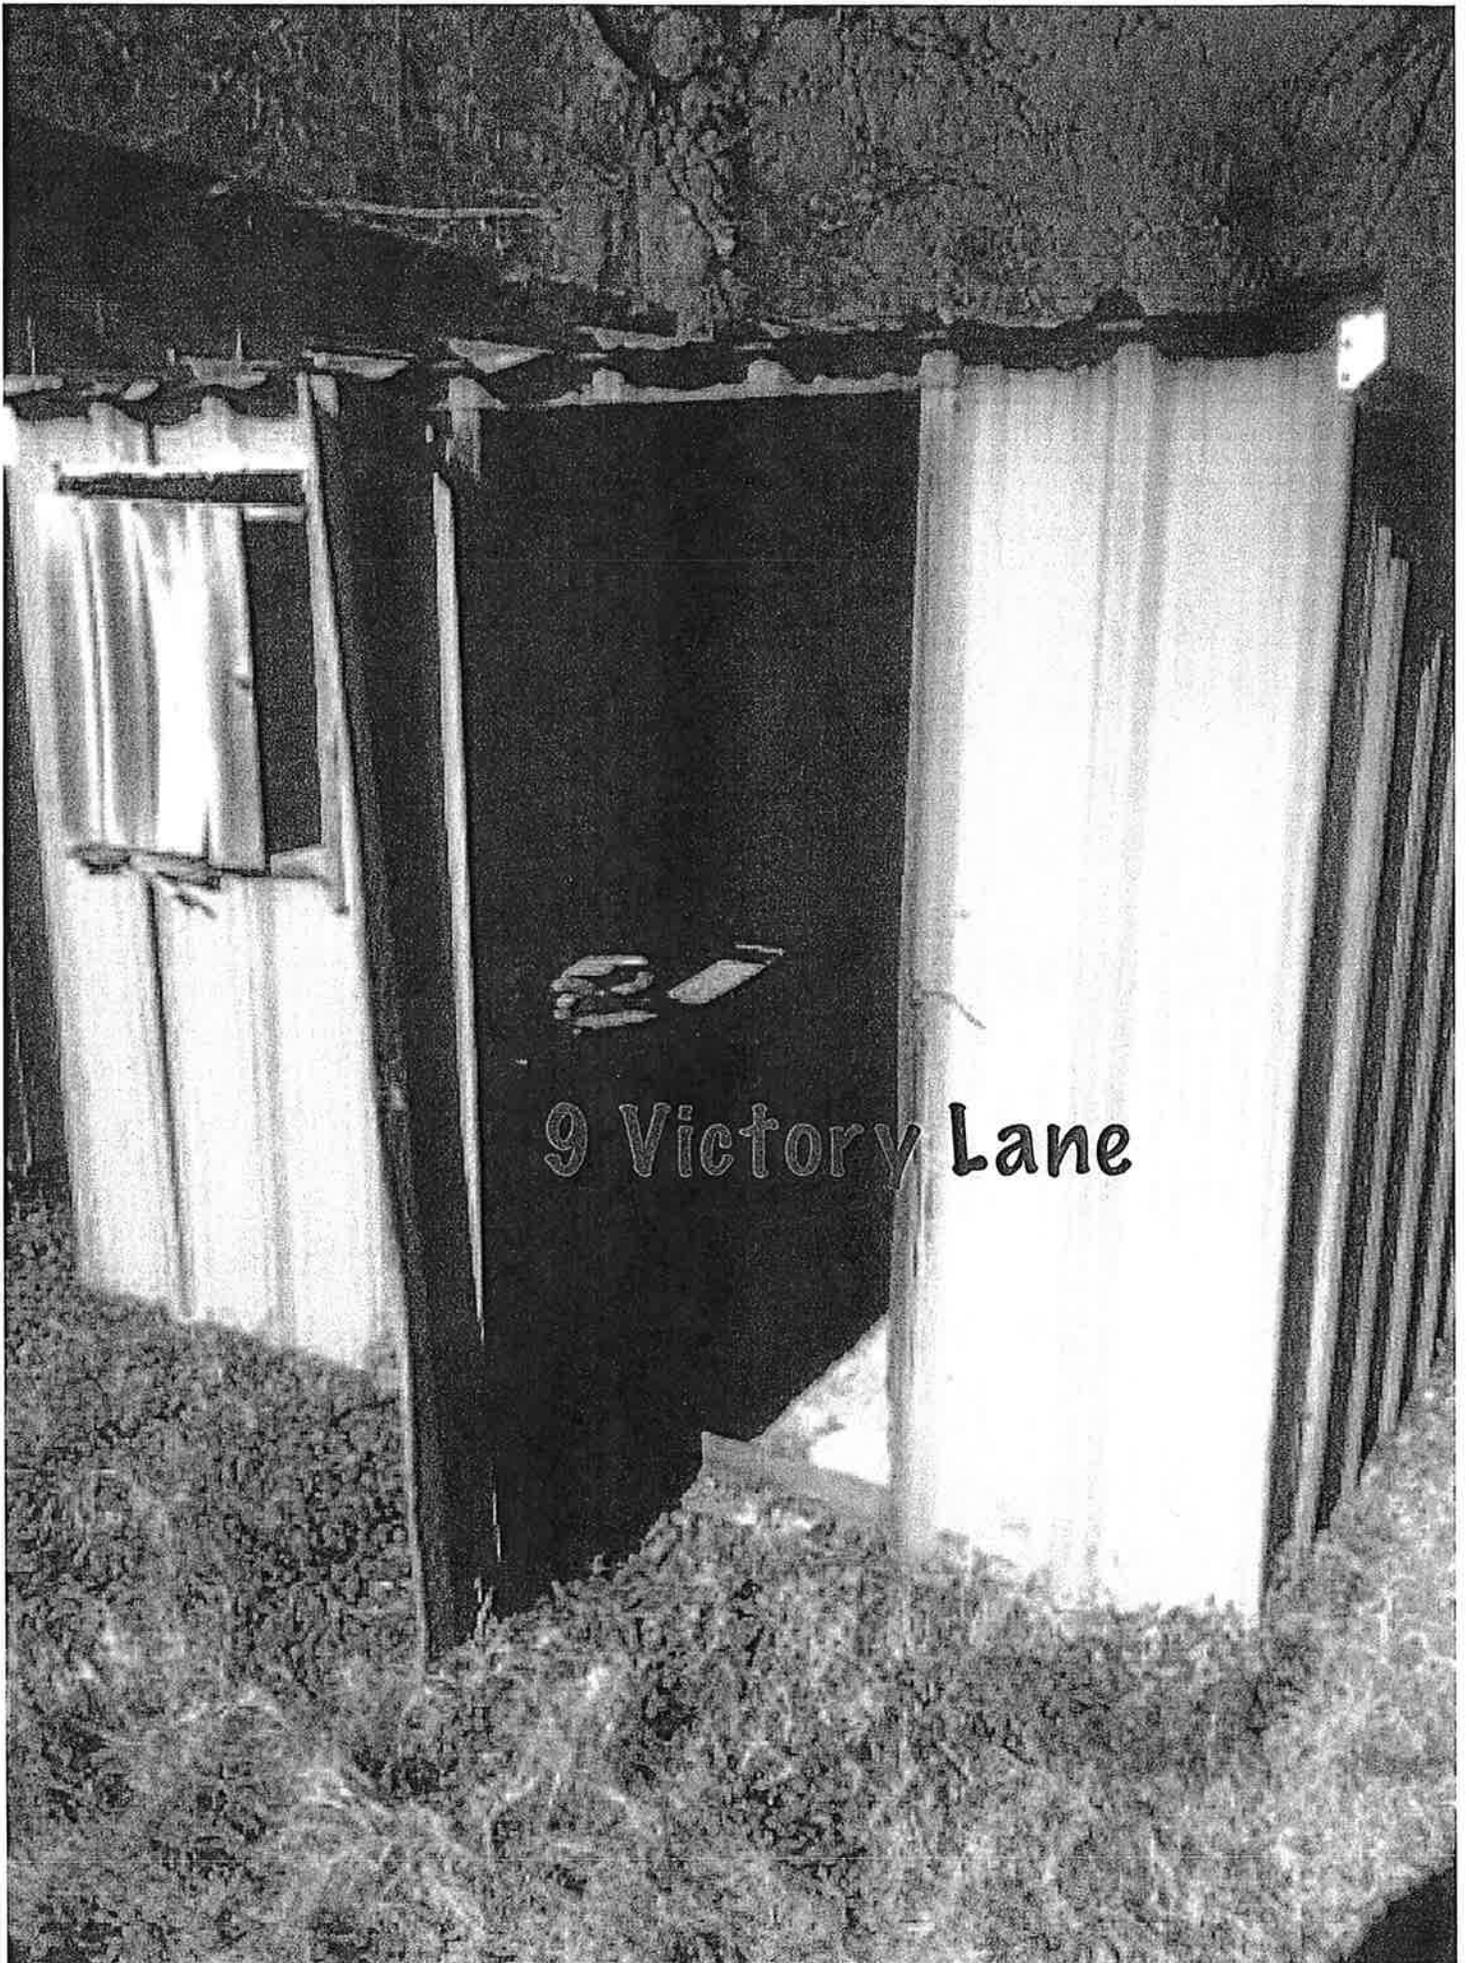
9 Victory Lane

Sample #	Layer #	Sample Location	Layer Name / Sample Description	Asbestos Detected	Asbestos Type	% ACM	Condition	Friable	Quantity
#1	#1	LIVING RM	Ceiling Texture, White/ Off White	Yes	Chrysotile	2%	Good	Yes	1125 sq ft
