ARKANSAS STATE HIGHWAY AND TRANSPORTATION DEPARTMENT

SUBSURFACE INVESTIGATION

STATE JOB NO.		CA0610	
FEDERAL AID PROJEC	CT NO	NHPP-2662(7)	
	HOT SPR	INGS – I-30 (WIDENING) (S)
STATE HIGHWAY	70	SECTION	9 & 10
IN	G	ARLAND & SALINE	COUNTY
LETTING OF	DECEMBER 7, 2016

GEOTECHNICAL INVESTIGATION AHTD 061377 HOT SPRINGS – I-30 (WIDENING) (S) FEDERAL AID PROJECT ("FAP") NO. 9991 GARLAND COUNTY AND SALINE COUNTY, ARKANSAS

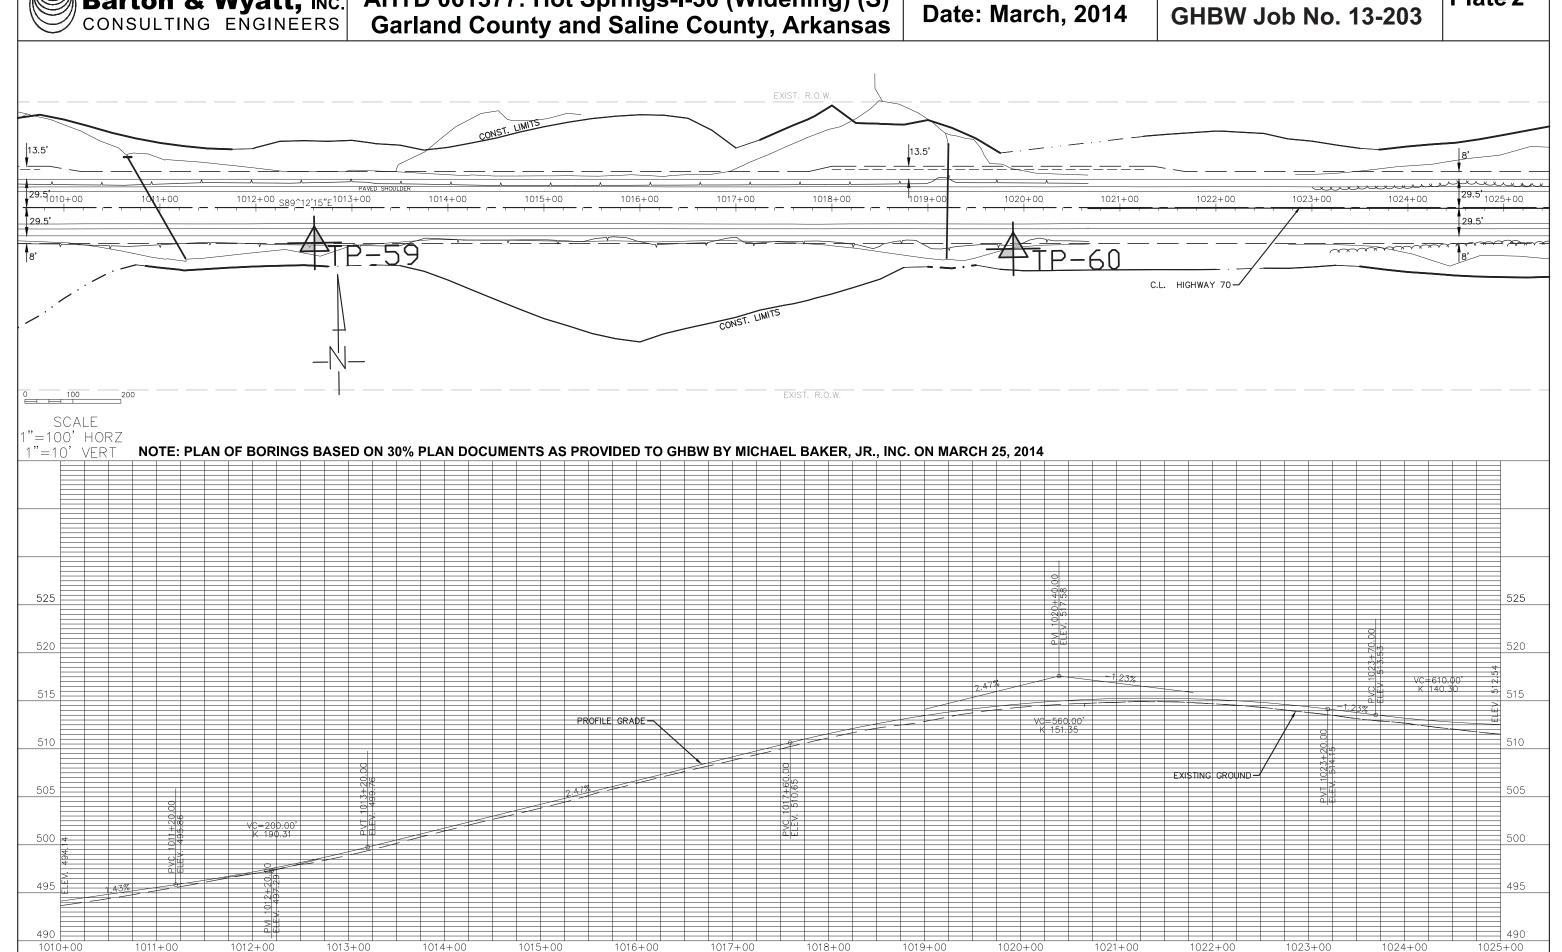
PLAN OF BORINGS AND TEST PITS AHTD 061377: Hot Springs-I-30 (Widening) (S)

Grubbs, Hoskyn, Barton & Wyatt, INC. CONSULTING ENGINEERS C.L. HWY. 70 STA. 1028+63.91= C.L. LONSDALE CUTOFF RD. STA. 10+00.00= C.L. HWY. 128 STA. 10+00.00 1027+00 1028+00 1026+00

Subsurface conditions in the roadway alignments, structure locations, and embankments were explored by performing a total of 84 sample borings and test pits. The alignment vicinity is shown in Attachment 1. The approximate sample locations are shown on the Plan of Borings and Test Pits provided in Attachment 2.

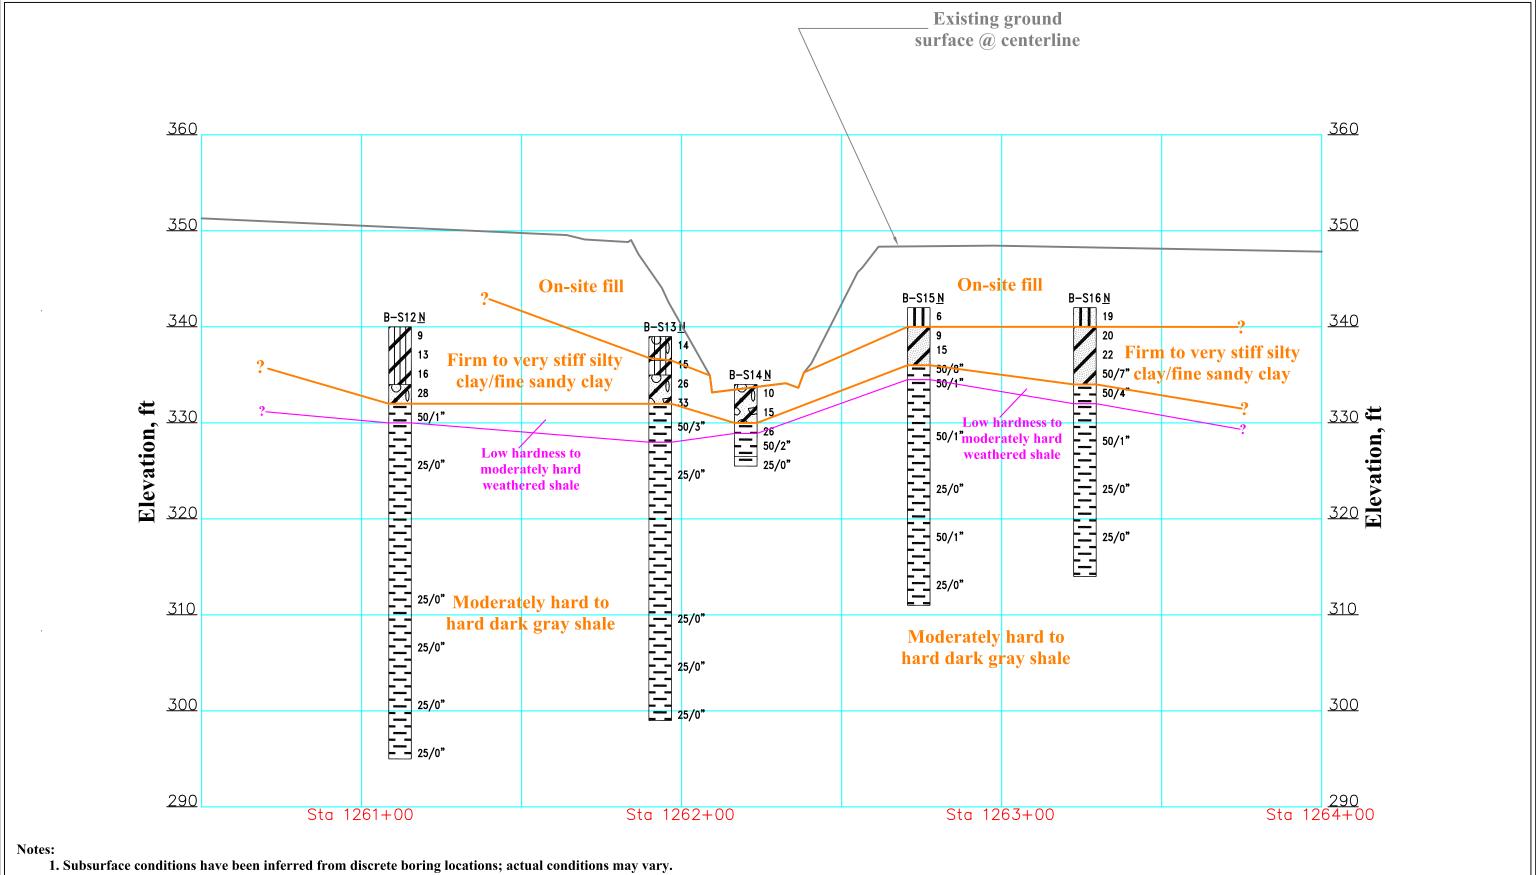
Generalized Subsurface Profile A-A'
AHTD JOB 061377: US 70 over Ten Mile Creek (East)
Saline County, Arkansas

- 1. Subsurface conditions have been inferred from discrete boring locations; actual conditions may vary.
- 2. Ground surface approximate.

To aid in visualizing subsurface conditions, Generalized Subsurface Profiles for the two (2) bridge structures are presented in Attachment 6. It should be recognized that the stratigraphy illustrated by the profiles has been inferred between discrete boring locations. In view of the natural variations in stratigraphy and conditions, variations from the stratigraphy illustrated by the profiles should be anticipated. Additionally, the natural transition between strata is generally gradual, and the stratigraphy described in the sections above may vary.

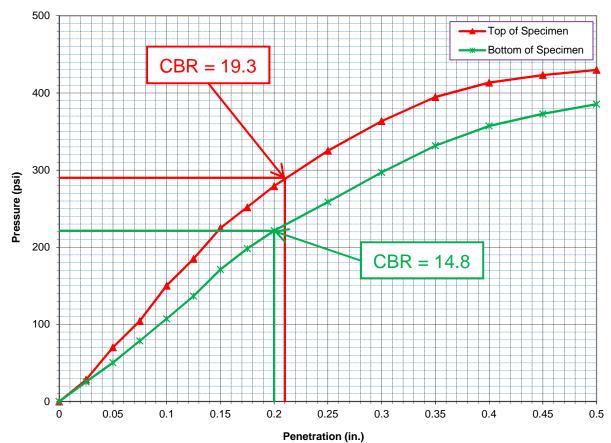
Laboratory CBR Test Report (AASHTO T-193)

Test Pit/Depth, ft		sification	Natural Moisture	Assumed Specific	Liquid Limit, %	Plastic Limit, %	% Passing	% Passing		
	USCS	AASHTO	Content, %	Gravity	Elititi, 70	Entrit, 70	No.4	No.200		
TP-11/1-3	GP-GC	A-2-6	NA	2.67	37	24	23	8		
PROCTOR TE	ST RESU	JLTS (AASH	ITO T-99)	MATERIAL DESCRIPTION						
Optimum	Moisture	Content = 1	4.8%	Reddish tan and tan weathered SHALE w/silty clay						
Maximur	m Dry Dei	nsity = 114.7	pcf	seams and lavers

Moisture-Density Relationship (Proctor) tests were performed on three (3) representative samples of potential subgrade soils in accordance with AASHTO T-99 or T-180 methods,

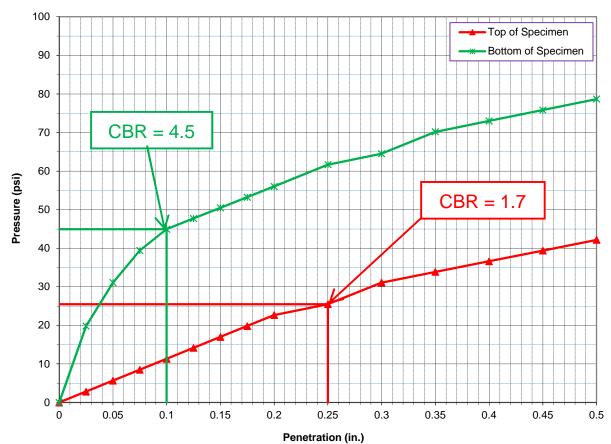
Laboratory CBR Test Report (AASHTO T-193)

Test Pit/Depth, ft	Clas	sification	Natural Moisture	Assumed Specific	Liquid Limit, %	Plastic Limit, %	% Passing	% Passing		
	USCS	AASHTO	Content, %	Gravity	LIIIIII, 70	LIIIIII, 76	No.4	No.200		
TP-12/1-3	CL	A-7-6	NA	2.7	46	23	90	55		
PROCTOR TE	ST RES	JLTS (AASH	ITO T-99)	MATERIAL DESCRIPTION						
Optimum	Moisture	Content = 1	7.1%	Reddish tan and gray silty clay w/shale fragments						
Maximur	n Dry De	nsity = 105.7	pcf	and clayey silt pockets

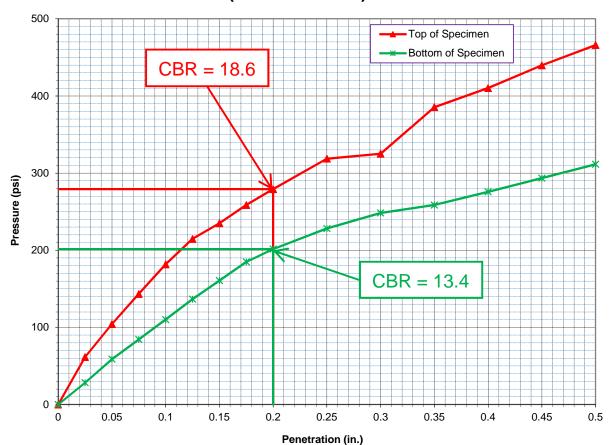
Laboratory CBR Test Report (AASHTO T-193)

Test Pit/Depth, ft	Clas	sification	Natural Moisture	Assumed Specific	Liquid Limit, %	Plastic Limit, %	% Passing	% Passing		
	USCS	AASHTO	Content, %	Gravity	LIIIIII, 76	LIIIIII, 70	No.4	No.200		
TP-16/1-3	GC A-2-6		NA	2.68	37	21	58	18		
PROCTOR TE	ST RESU	LTS (AASH	TO T-180)	MATERIAL DESCRIPTION						
Optimum	Moisture	Content = 13	3.0%	Reddish tan and tan silty clay w/shale and						
Maximur	n Dry De	nsity – 120 3	ncf	sandstone fragments

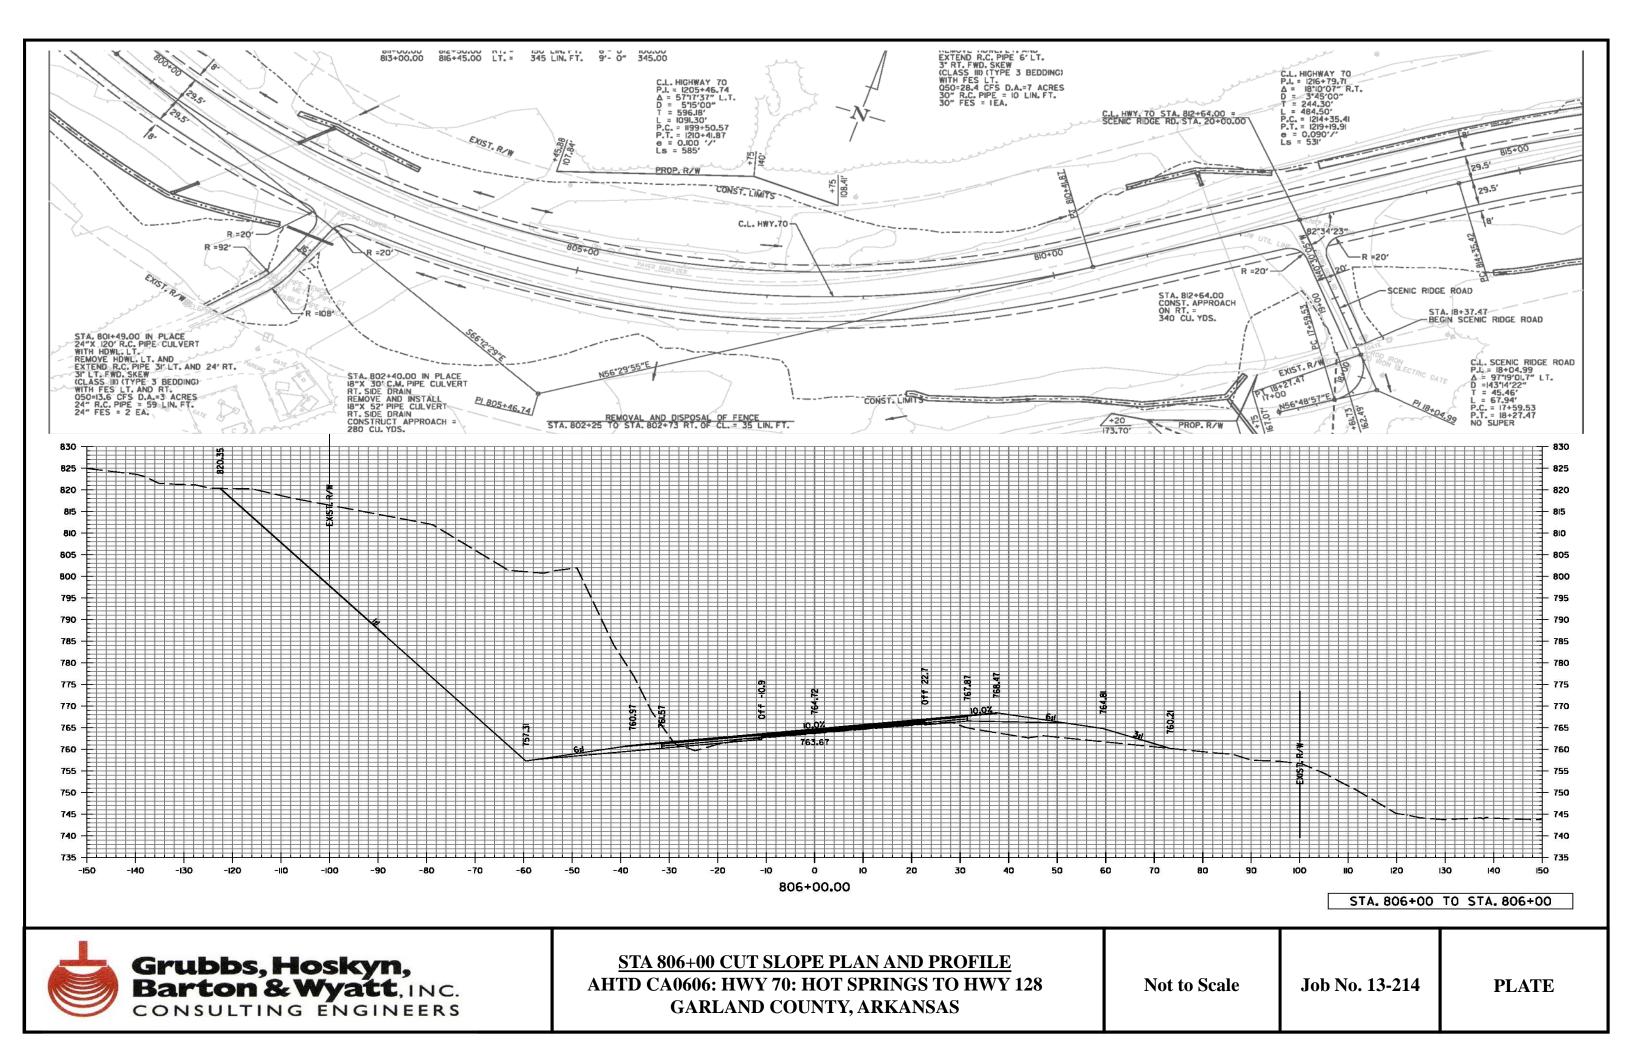
AHTD CA0606: Hwy70-Hot Springs-Hwy128 - Sta 806+00-Left - End Const & Long Term z

The stability analyses were performed for three (3) loading conditions:

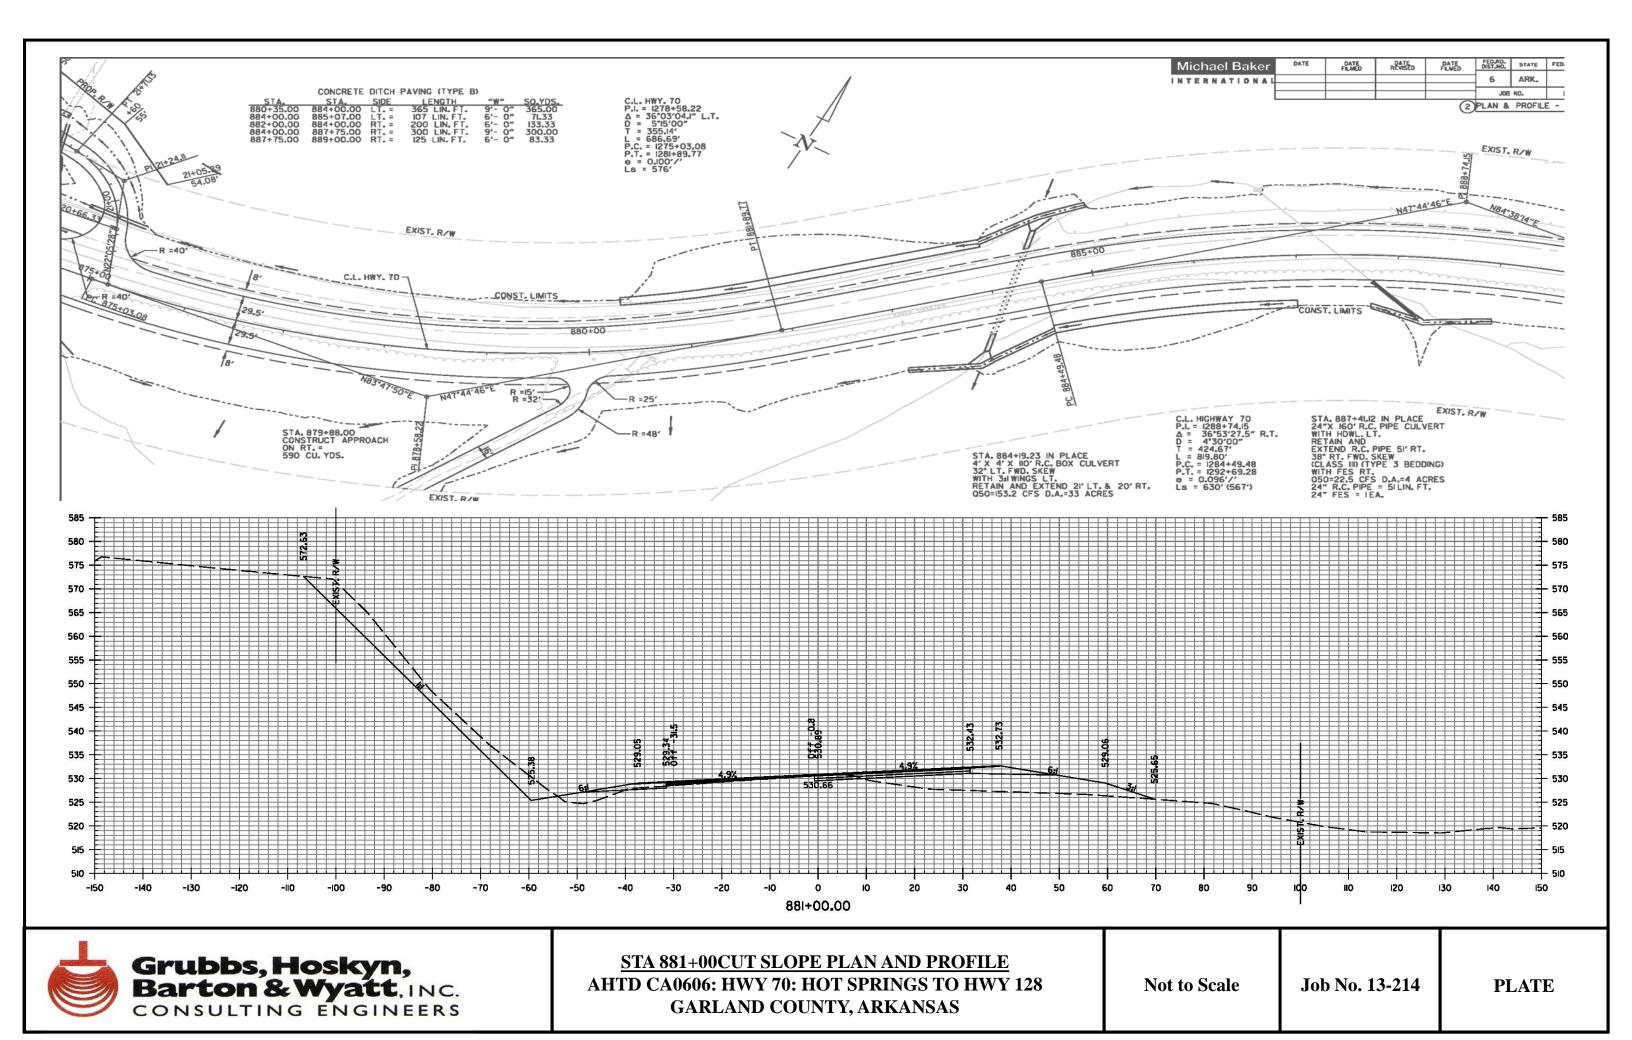
AHTD CA0606: Hwy 70-Hot Springs-Hwy 128-Sta 881+00 - Lt Side - End of Construct z:
