ARKANSAS STATE HIGHWAY  
AND  
TRANSPORTATION DEPARTMENT

RE: AHTD Job Number CA0702  
Hwy. 274 – Hampton (Widening)(S)  
Calhoun Counties

Job CA0702  
Hampton - Hwy. 274  
(Widening) (Hwy. 167)  
Calhoun County

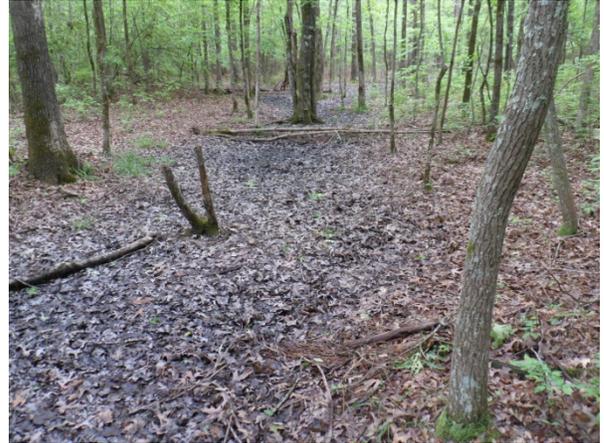
Water-stained leaves in drainage swale portion of Wetland 1.

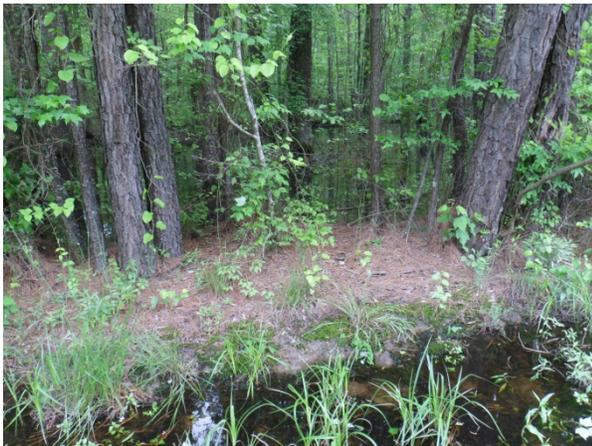
Western edge of Wetland 1, facing east.

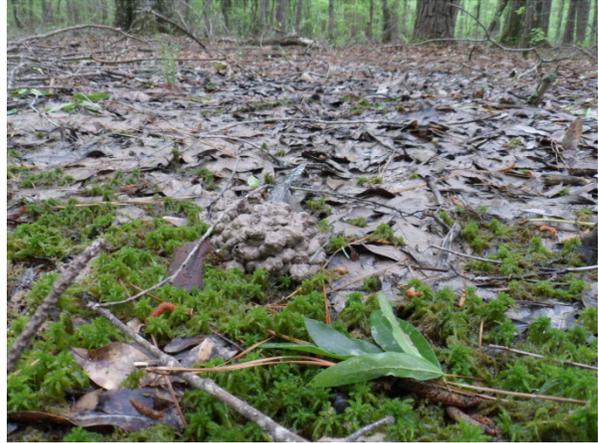
Crayfish borrows and water-stained leaves in Wetland 2.

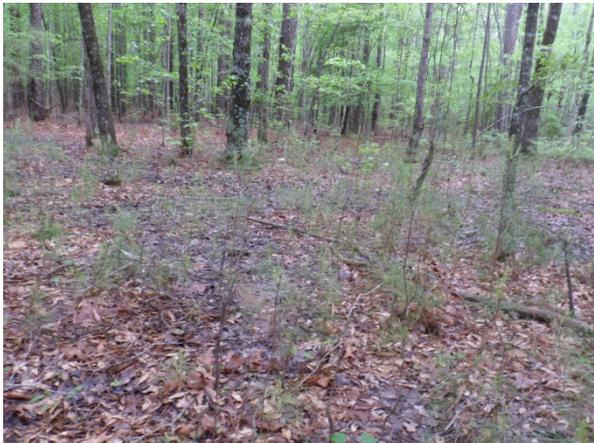
Saturated areas in Wetland 2 with relatively sparse vegetation and pine seedlings.

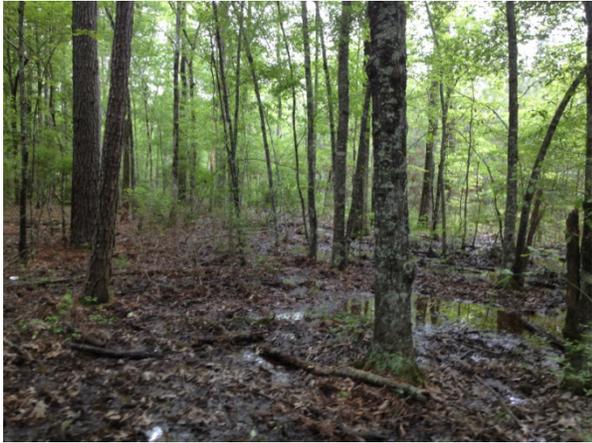
Water-stained leaves in Wetland 3 bottomland hardwoods.

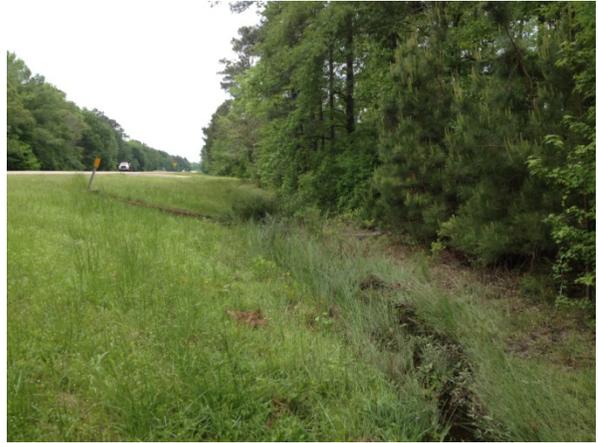
Emergent herbaceous portion of Wetland 3 facing north near culvert for S1.

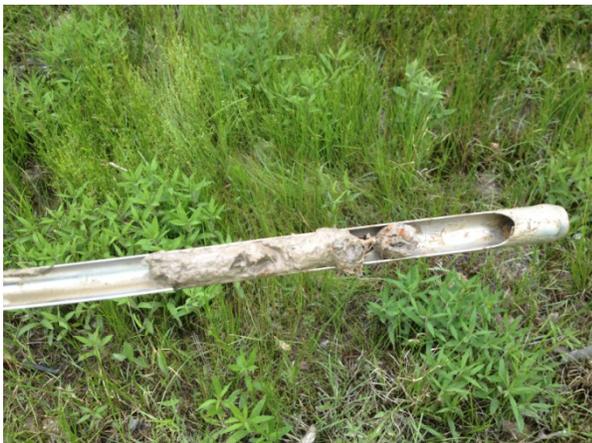
Soils in Wetland 5 showing reduced conditions.

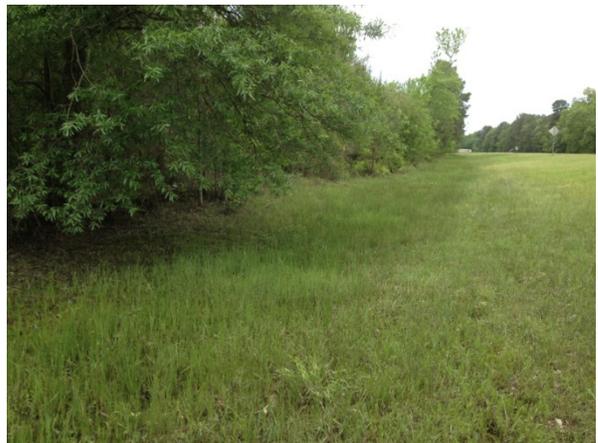
Southern end of Wetland 5 facing south.

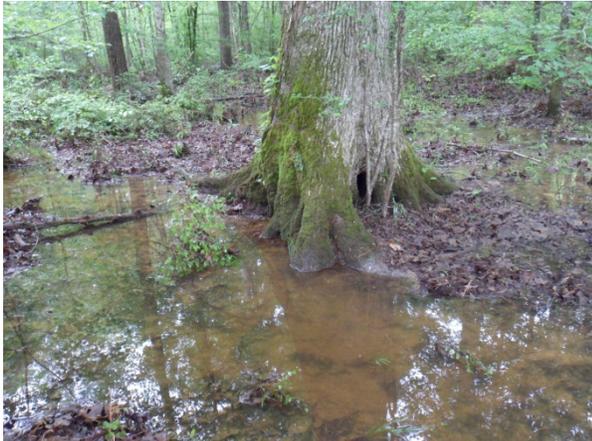
Buttressed tree trunks and water-stained leaves in Wetland 7.

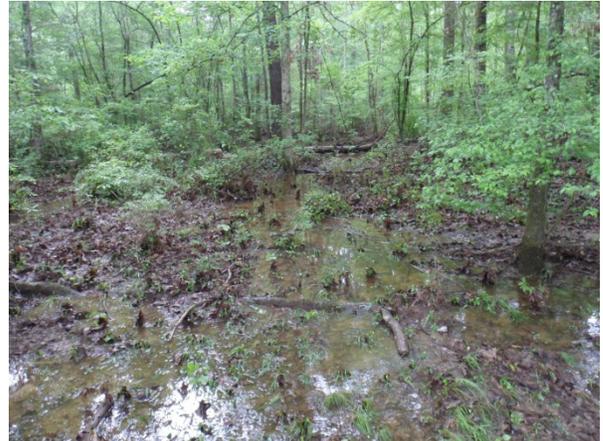
Drainage patterns in Wetland 7.

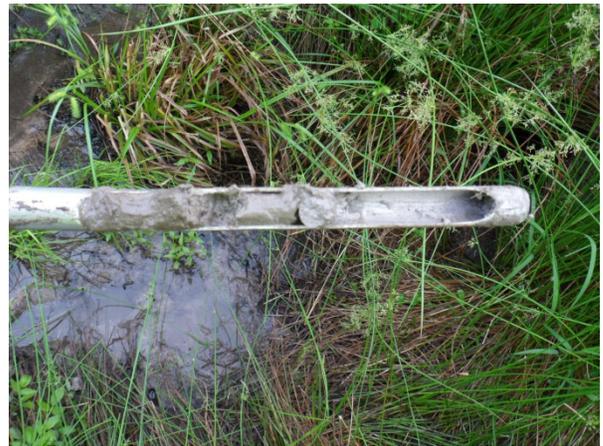
Reduced soil conditions in Wetland 9 soil core.

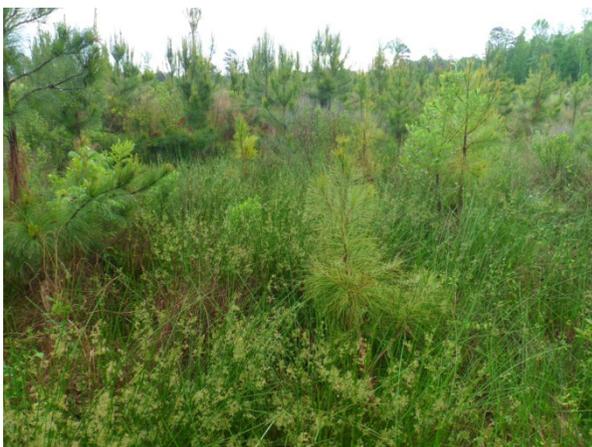
Sedge marsh in cutover of Wetland 9, note planted pines following clear cutting operation.

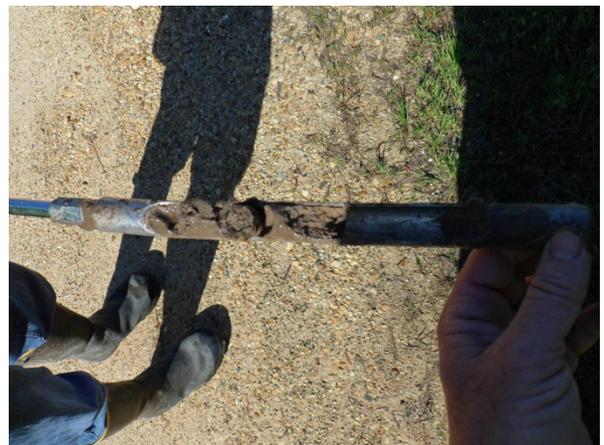
Wetland 12 soil sample showing reduced conditions.

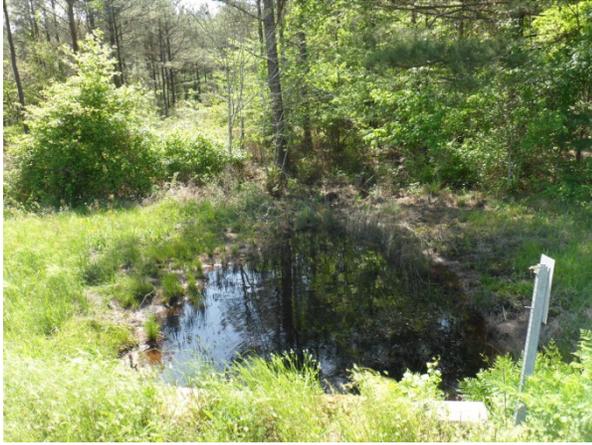
Wetland 13 has herbaceous and forested components, facing west from Highway 167.

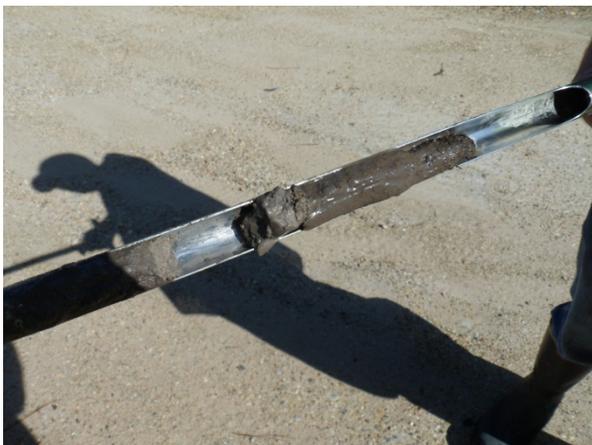
Reduced soil conditions in Wetland 13.

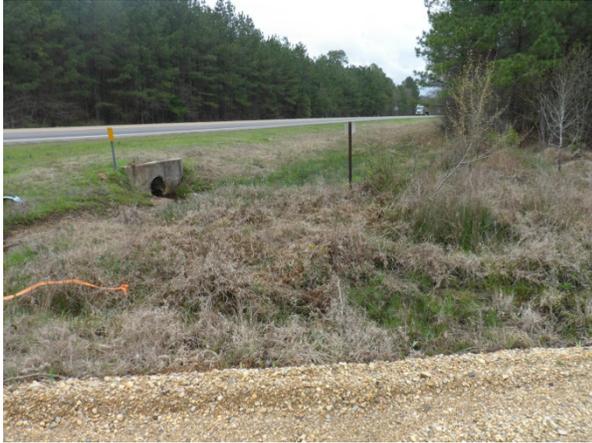
Ephemeral channel S7 culvert under Highway 167 facing north and draining Wetland 14 and road ditches.

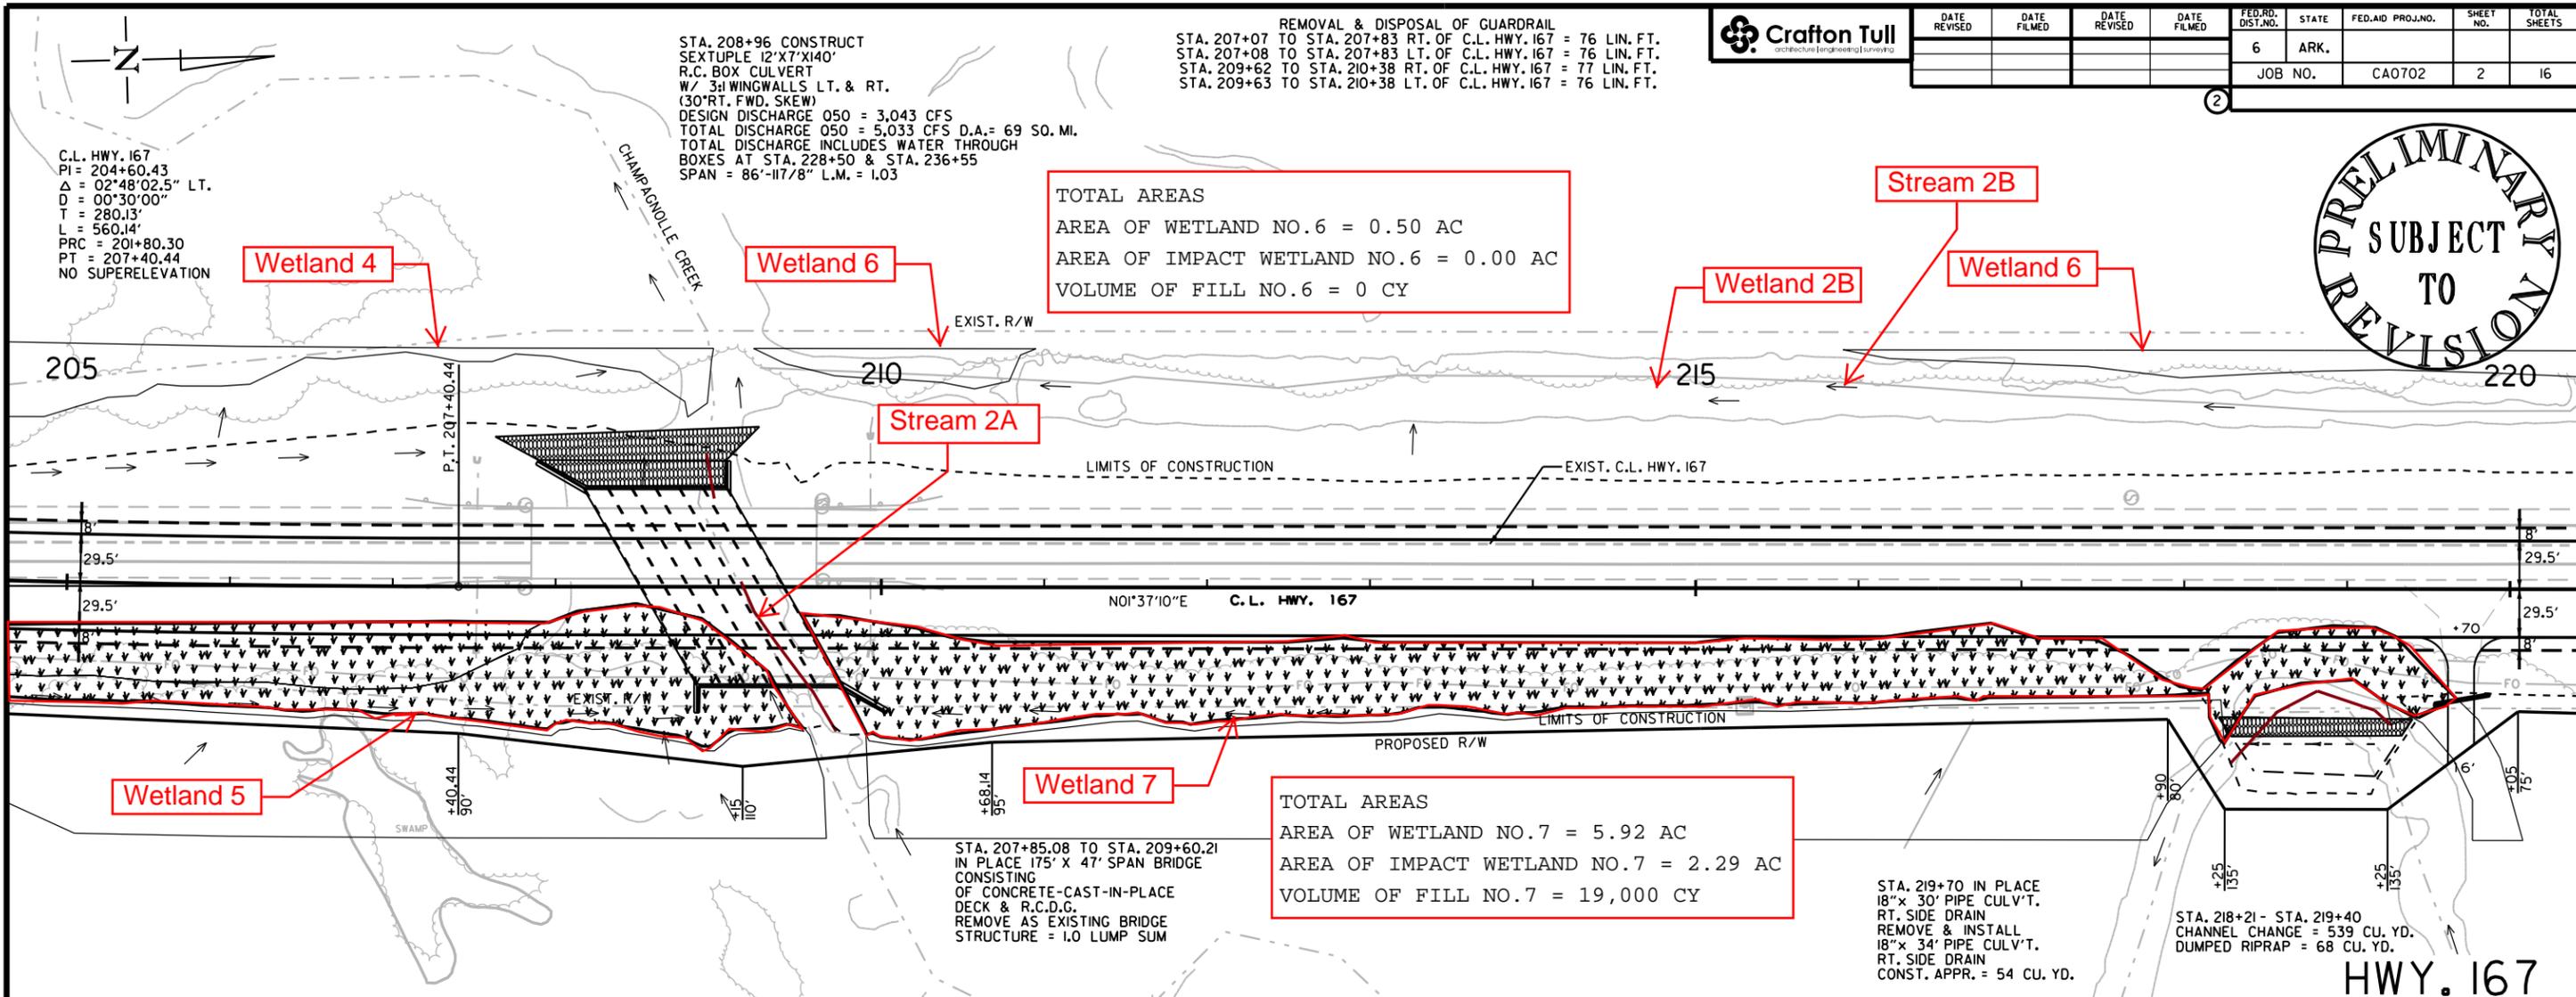
STA. 208+96 CONSTRUCT  
SEXTUPLE 12'X7'X140'  
R.C. BOX CULVERT  
W/ 3 WINGWALLS LT. & RT.  
(30° RT. FWD. SKEW)  
DESIGN DISCHARGE Q50 = 3,043 CFS  
TOTAL DISCHARGE Q50 = 5,033 CFS D.A. = 69 SQ. MI.  
TOTAL DISCHARGE INCLUDES WATER THROUGH  
BOXES AT STA. 228+50 & STA. 236+55  
SPAN = 86'-11 7/8" L.M. = 1.03

STA. 228+57 CONSTRUCT  
 QUAD. 12' X 7' X 140'  
 R.C. BOX CULVERT  
 W/ 3:1 WINGWALLS LT. & RT.  
 (30° RT. FWD. SKEW)  
 DESIGN DISCHARGE Q50 = 960 CFS  
 TOTAL DISCHARGE Q50 = 5,033 CFS D.A. = 69 SQ. MI.  
 TOTAL DISCHARGE INCLUDES WATER THROUGH  
 BOXES AT STA. 208+80 & 236+55  
 SPAN = 57'-8 1/2" L.M. = 1.40

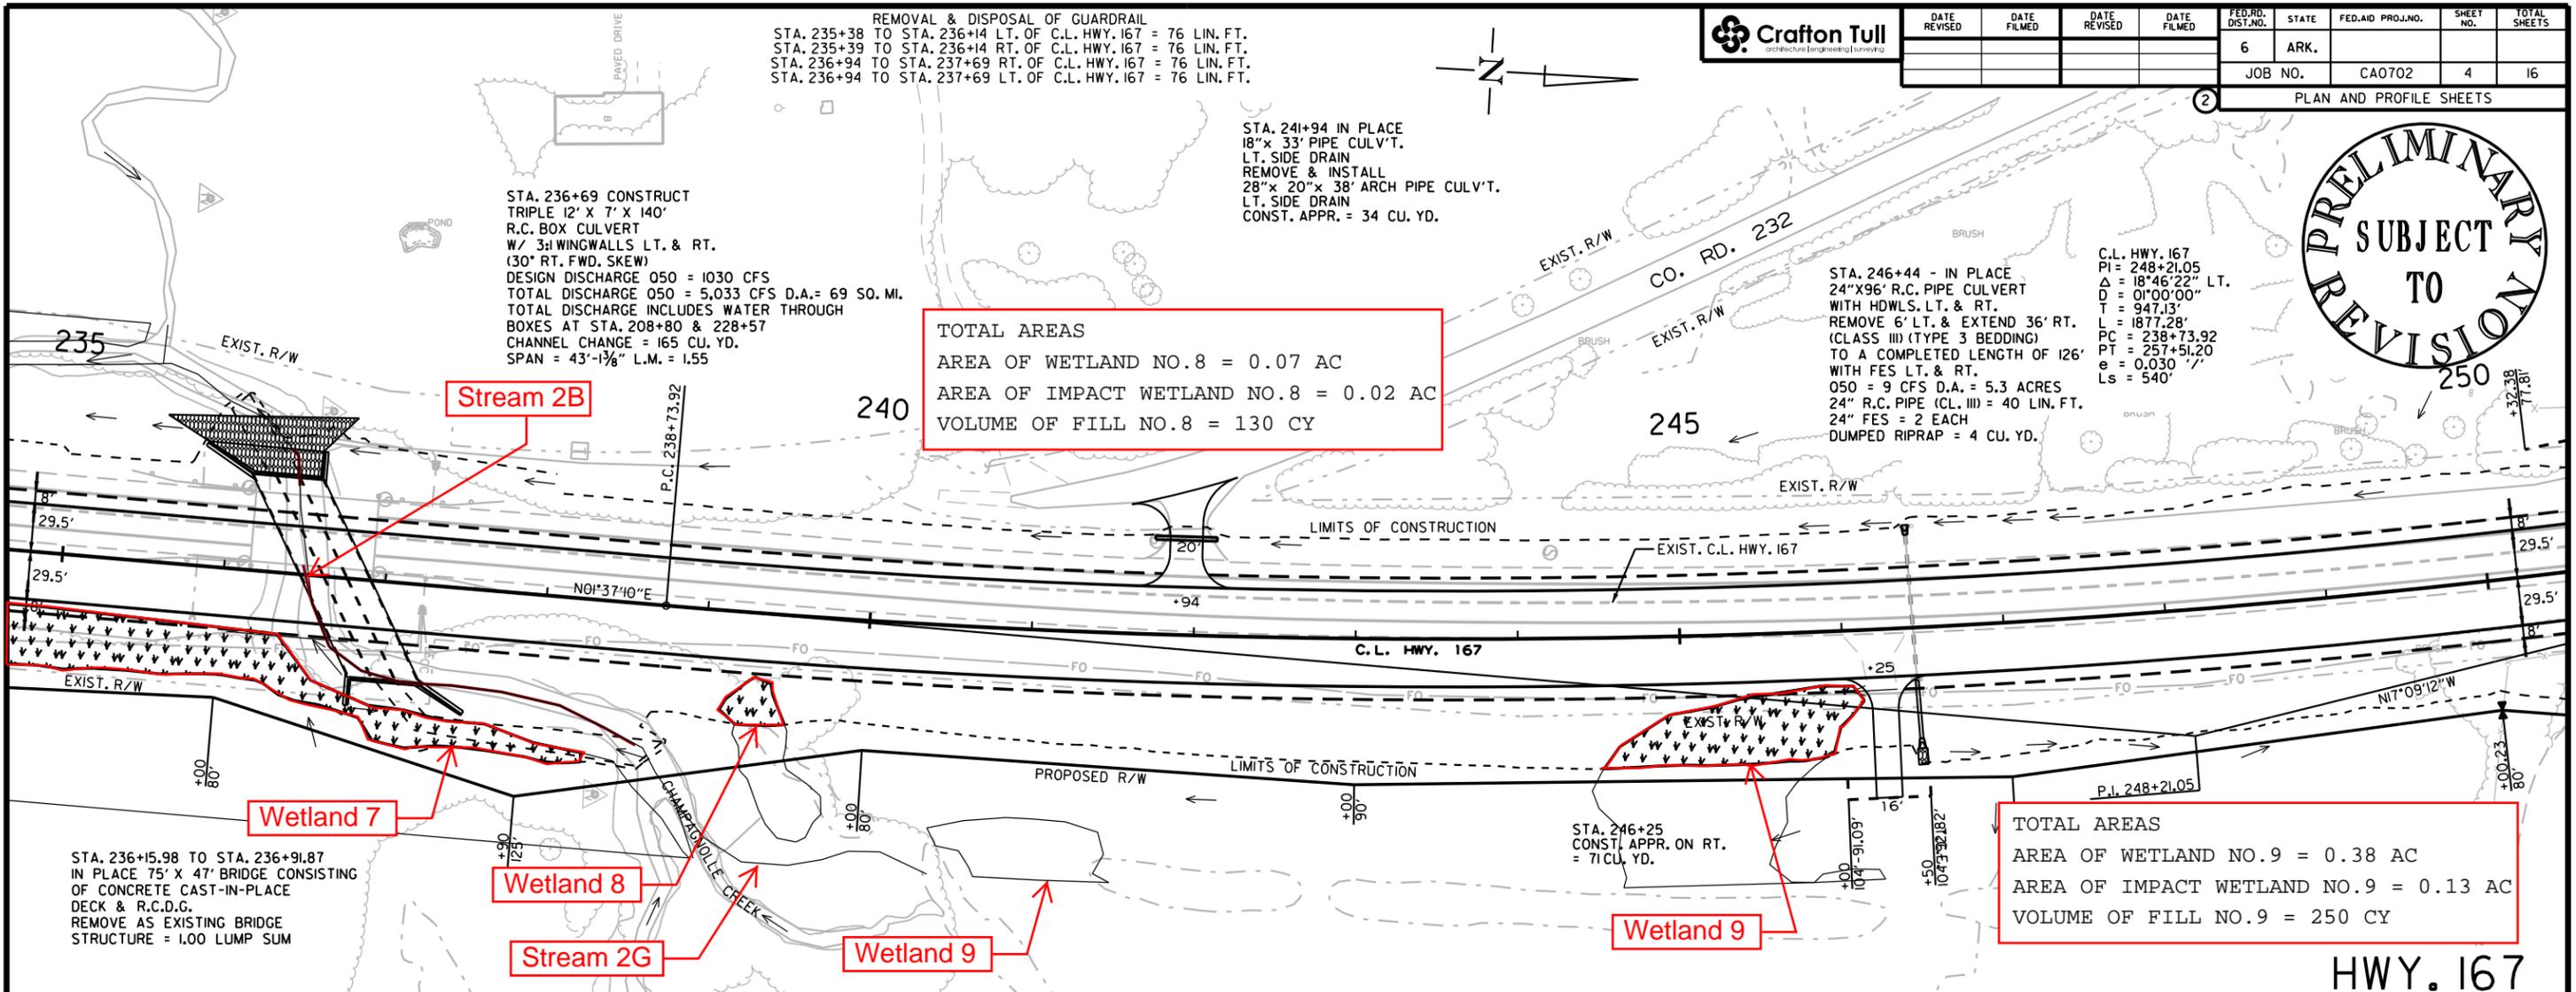
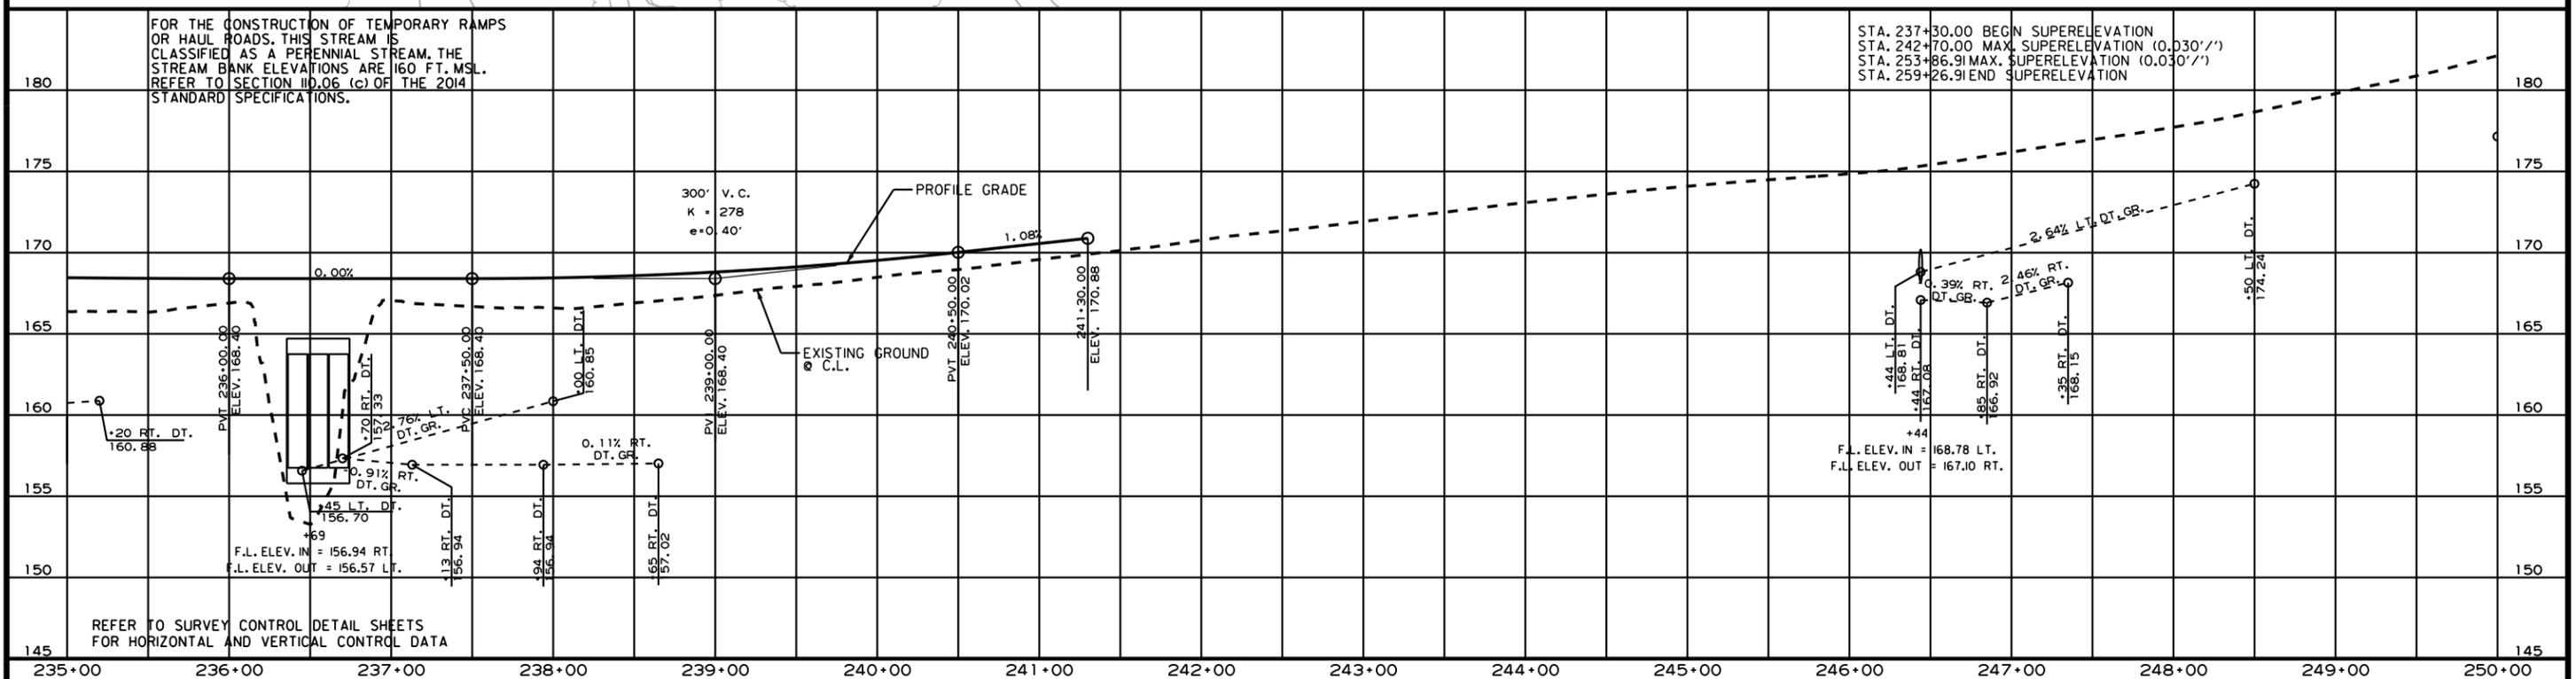
**TOTAL AREAS**  
 AREA OF WETLAND NO.9 = 0.38 AC  
 AREA OF IMPACT WETLAND NO.9 = 0.13 AC  
 VOLUME OF FILL NO.9 = 250 CY
