TIER 3 CATEGORICAL EXCLUSION

**ARDOT JOB NUMBER 040716
FAP NUMBER – STPF-0065(52)
Massard Creek – Hwy. 22 (Widening & Reloc.) (Hwy. 255) (S)
Route 255, Section 3
Route 253, Section 1
Sebastian County, Arkansas**

Prepared by
Crafton Tull Associates
Rogers, Arkansas

December 12, 2018

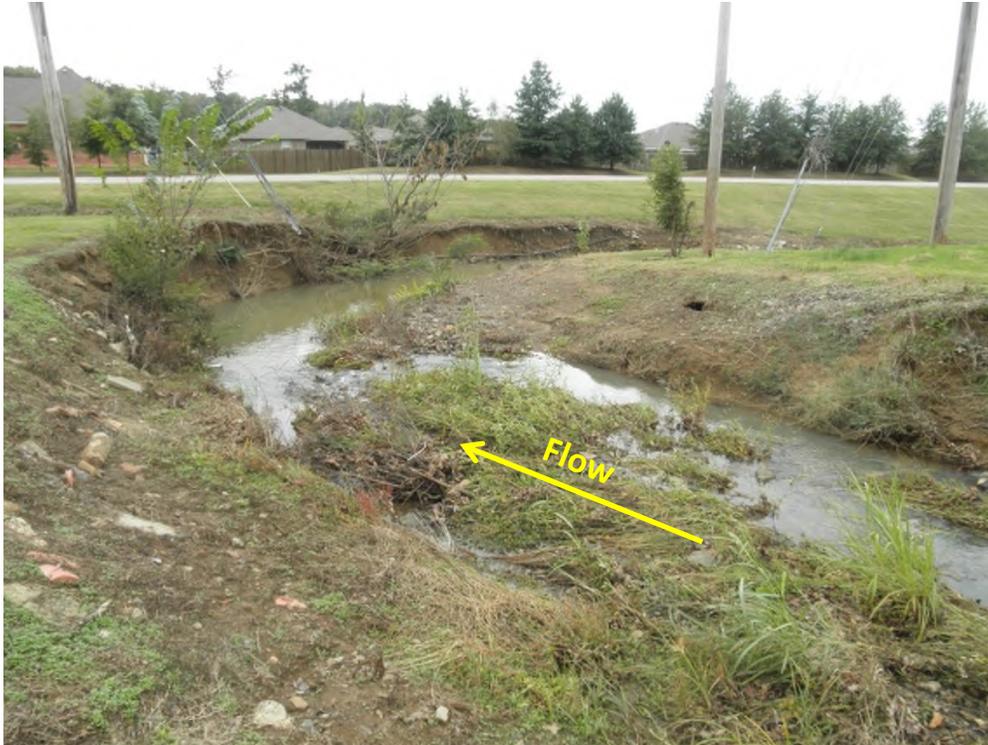
Stream 1, facing downstream north of existing Hwy. 255 at eastern end where Stream 1 enters the right-of-way.

Stream 1 is an unnamed tributary of Massard Creek that flows west along the north side of existing Hwy. 255 and enters the required right-of-way between Massard Road and Red Oak Court and again between South 92nd Street and Painter Lane. Near Red Oak Court, Stream 1 is approximately 3 to 15 feet wide and is incised 1 to 8 feet with a rock, gravel, and clay channel substrate. The water width matched the channel width variably 3 to 15 feet with a low to moderate flow averaging 4 to 8 inches deep. The channel had several large pools with depths of 1 to 2 feet where several fish species were observed. The channel appeared to exhibit variable bed and bank continuity, stream substrate, and the presence of streambed vegetation. The majority of the stream at this location is a modified, fairly straight channel with maintained grass slopes and flows adjacent to the highway. When the channel enters the right-of-way on the east end, the channel makes an s-curve and exhibits cut banks that vary from 4 to 8 feet. Based upon observed conditions, Stream 1 has an OHWM and perennial flow.

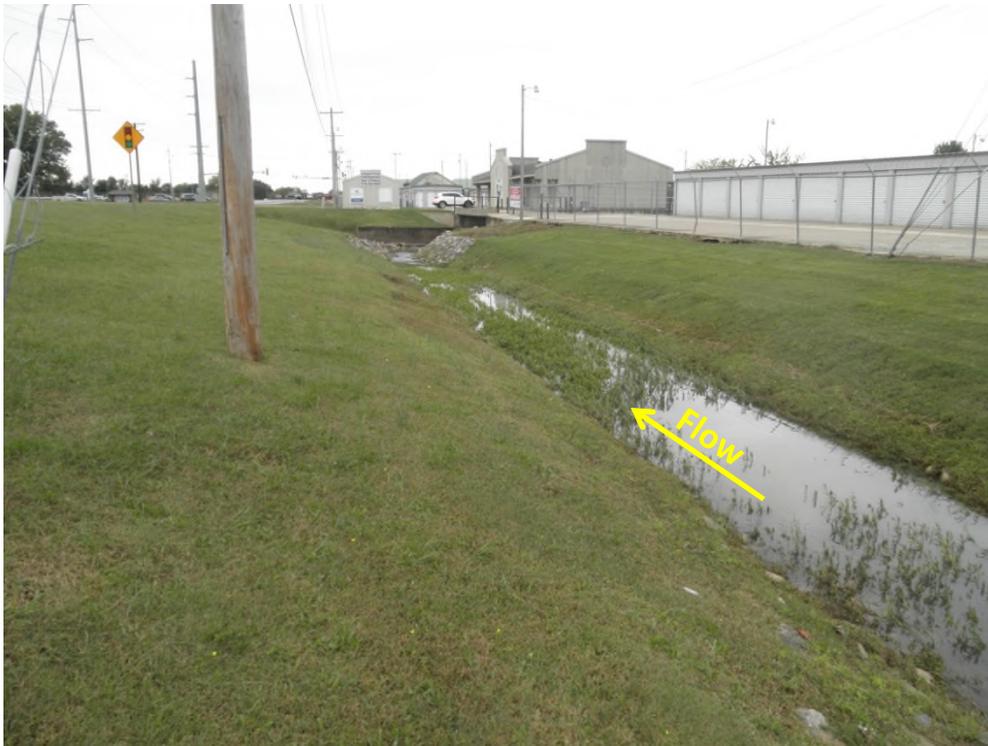
Stream 1, facing downstream north of existing Hwy. 255 at western end where Stream 1 turns northwest and exits the right-of-way.

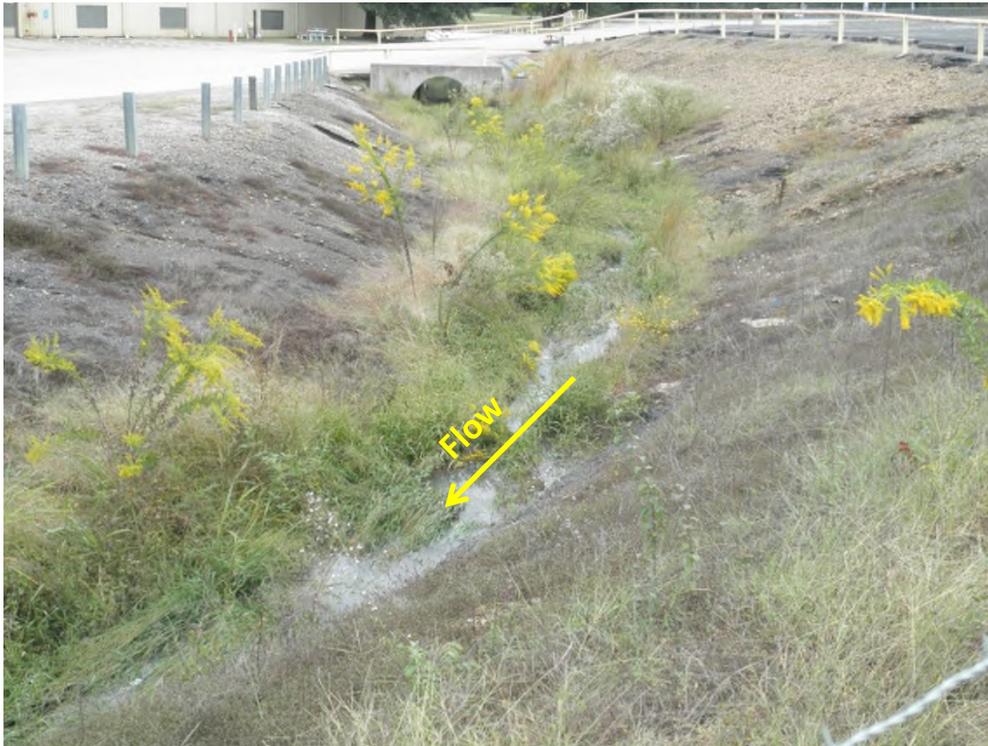
Stream 1, facing upstream north of existing Hwy. 255 at eastern end where Stream 1 enters the right-of-way.

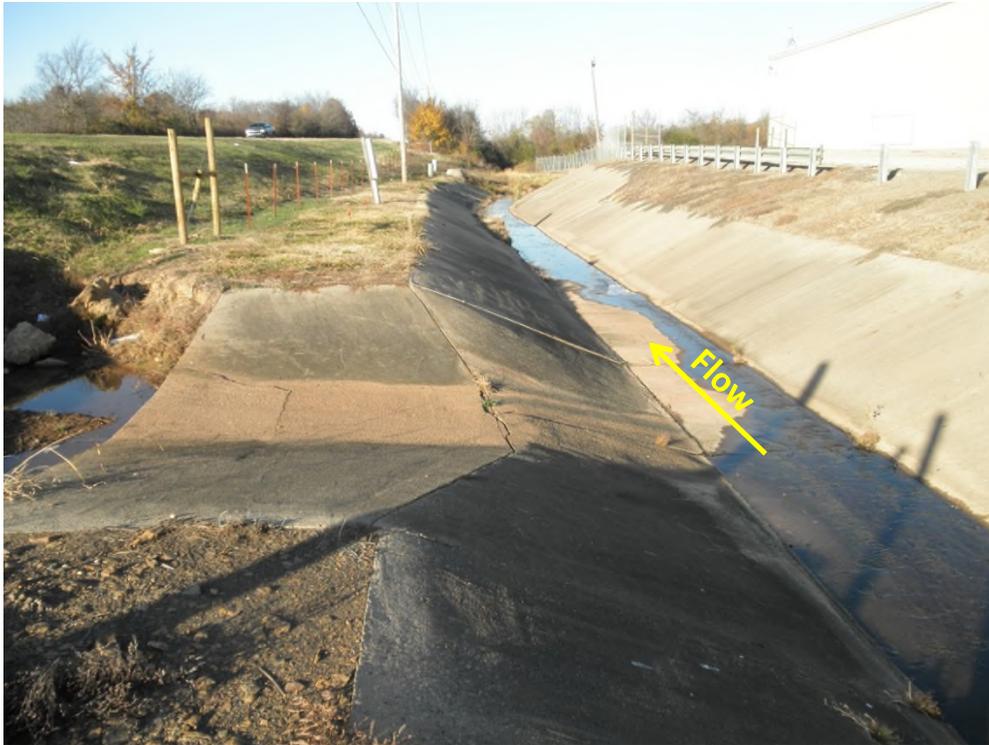
Stream 1, facing downstream north of existing Hwy. 255 where Stream 1 is concrete lined.

Near Painter Lane, Stream 1 is adjacent to a large Walmart Distribution Facility and has been modified in selected sections. Stream 1 is approximately 3 feet wide and 3 to 8 inches deep with sediment and gravel channel substrate intermixed with rock. The channel is incised 6 to 8 feet and the banks are modified slopes that appear to be sprayed to control vegetation. The water width matched the channel width variably at 3 feet with a low to moderate flow. The channel transitions to a concrete lined channel for approximately 250 feet. The channel then transitions back to a natural channel, 2 to 8 feet in width and is incised from 2 to 8 feet with a rock, gravel, and clay channel substrate. The channel appeared to exhibit variable bed and bank continuity, stream substrate, and the presence of streambed vegetation. Based upon observed conditions, the section of Stream 1 near Painter Lane also has an OHWM and perennial flow.

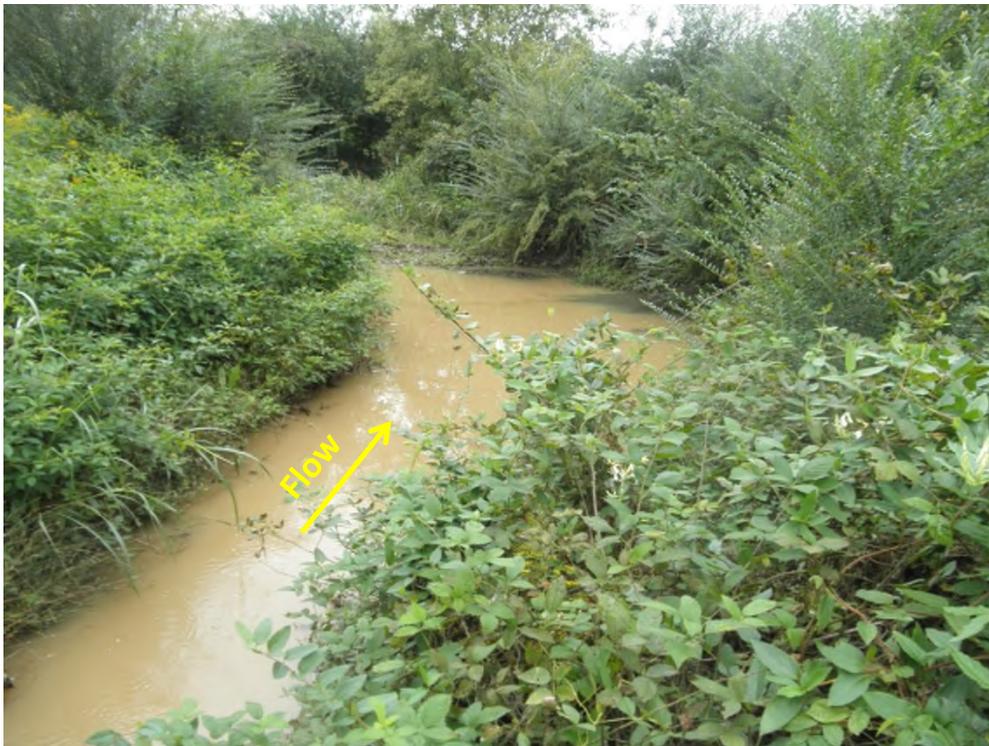
Stream 1, facing downstream north of existing Hwy. 255 at western end where Stream 2 enters and Stream 1 turns northwest and exits the right-of-way.

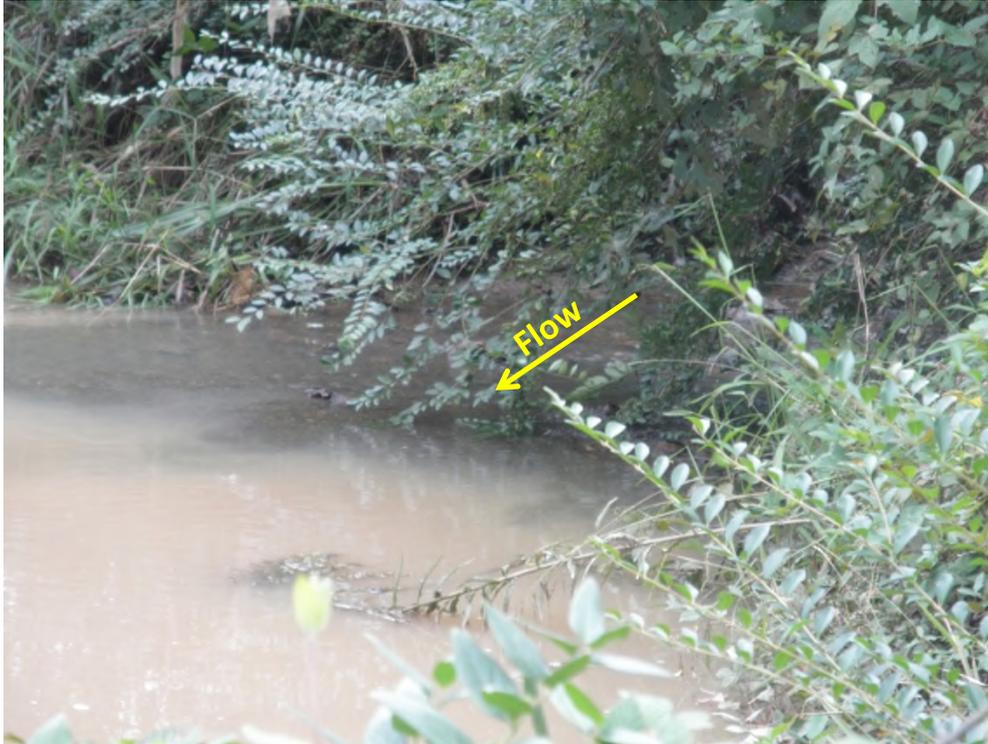
Stream 2, facing upstream as it enters Stream 1, north of Hwy. 255

Stream 2 is an unnamed tributary of Massard Creek that flows south and enters the proposed project right-of-way connecting into Stream 1 west of Painter Road and the Walmart Distribution Center. Stream 2 is approximately 3 feet wide and 1 to 6 inches deep with sediment and gravel channel substrate intermixed with rock. The channel is incised 1 to 2 feet and the banks are heavily vegetated. The water width matched the channel width variably at 3 feet with a low flow. The channel appeared to exhibit variable bed and bank continuity, stream substrate, and the absence of streambed vegetation. Based on observed conditions, Stream 2 does have an OHWM and intermittent flow.

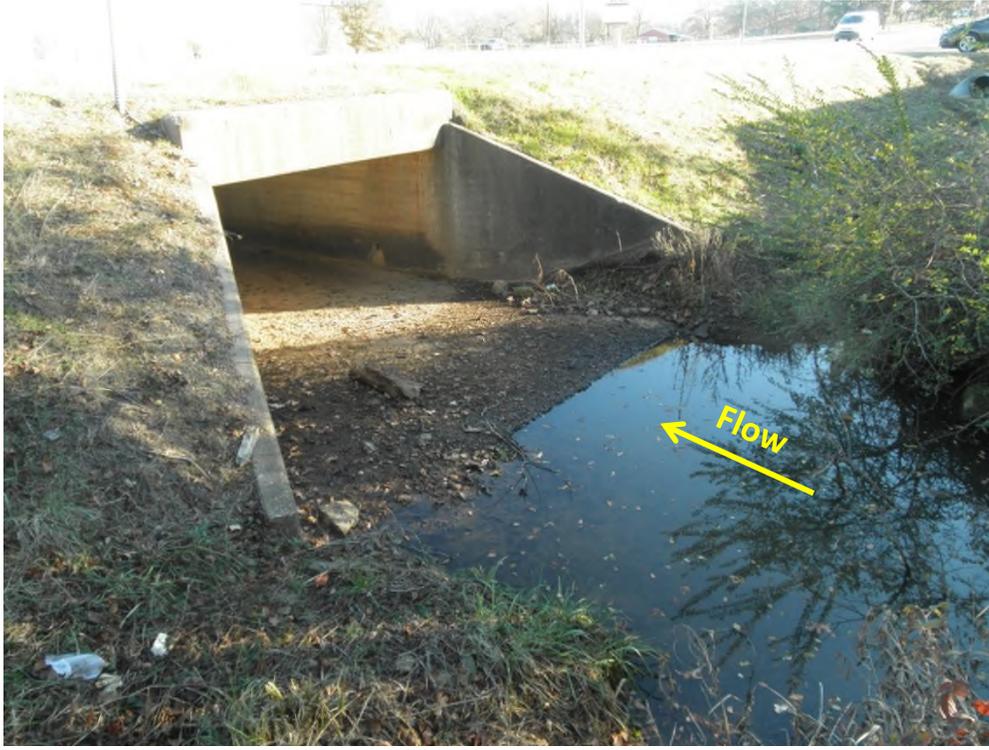
Stream 3, facing downstream south of existing Hwy. 255

the channel width (8 to 10 feet) and exhibited no flow. The channel has been heavily eroded and degraded. Based on observed conditions, Stream 3 does have an OHWM and ephemeral flow.

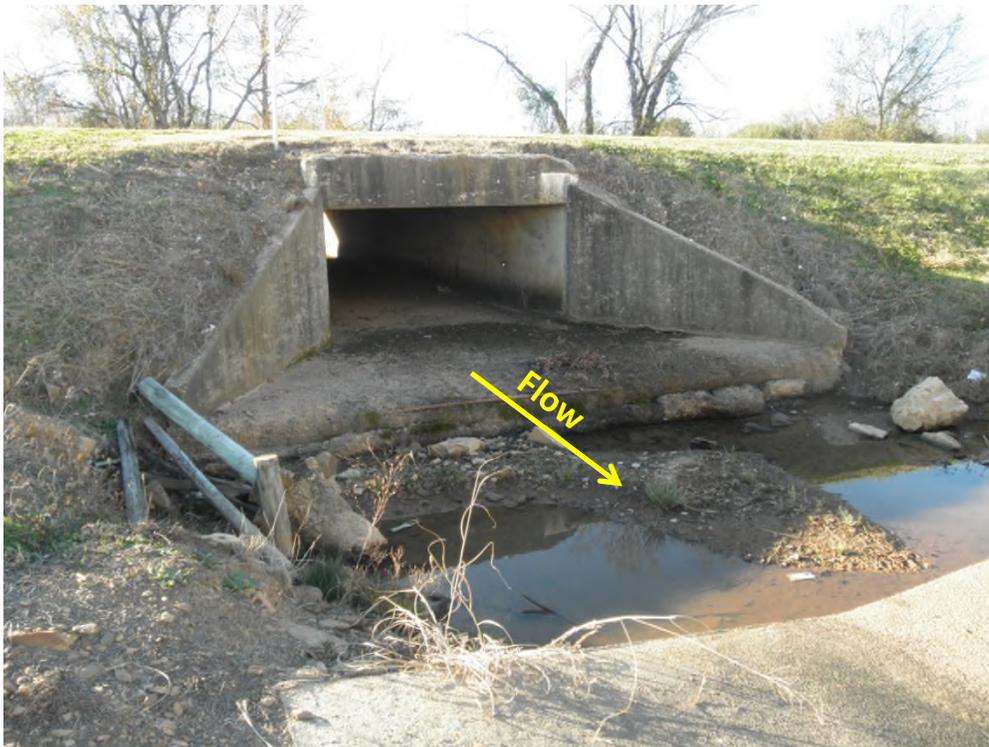
Stream 3, facing upstream north of existing Hwy. 255

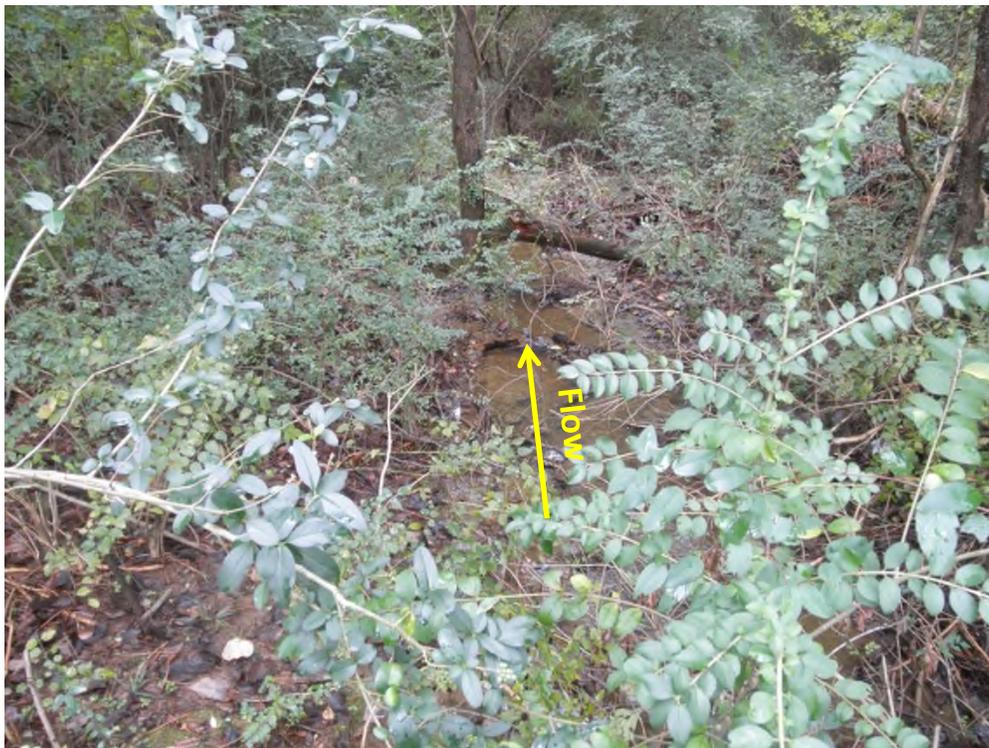
Stream 4, facing downstream south of Frontier Road

Stream 4 is an unnamed tributary of Little Vache Grasse Creek that flows southeast. This stream originates in an open, maintained grass area north of Frontier Road and crosses under Frontier Road into a forested area leaving the project area. The stream north of Frontier Road is no more than a swale with the entire channel maintained grass. South of Frontier Road, the stream is a swale through the existing right-of-way to the tree line. Inside the forested area, Stream 4 widens to approximately 4 feet and is incised 6 to 12 inches with a gravel and clay substrate. The water width varied from 1 to 3 feet with a low flow averaging 1 to 4 inches deep. Portions of the channel within the existing right-of-way have been heavily modified and re-aligned with no apparent streambed characteristics present. Inside the forested area, Stream 4 has a clearly defined channel with no stream bed vegetation present. Based upon observed conditions, Stream 4 has an OHWM and ephemeral flow.

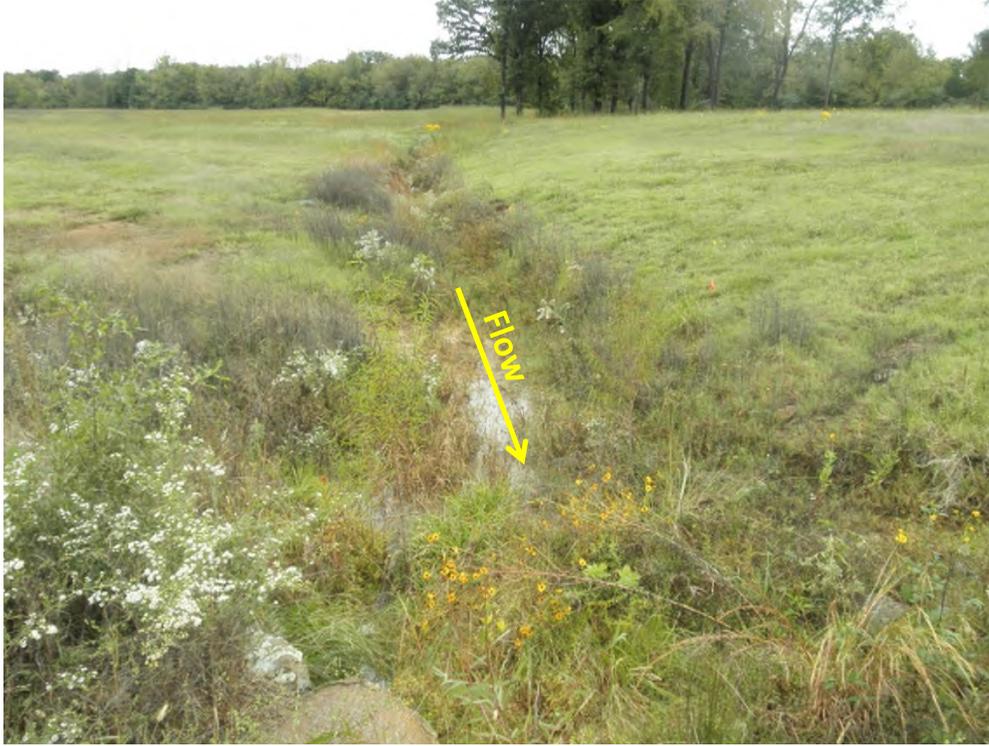
Stream 5, facing upstream north of existing Frontier Road

The water width matched the channel width variably 2 to 4 feet with a low flow averaging 2 to 4 inches deep. There are some larger pools where the banks are highly eroded. The stream channel is highly vegetated; however, the plants are not aquatic vegetation but native plants typical of a ruderal environment. Based upon observed conditions, Stream 5 has an OHWM and ephemeral flow.

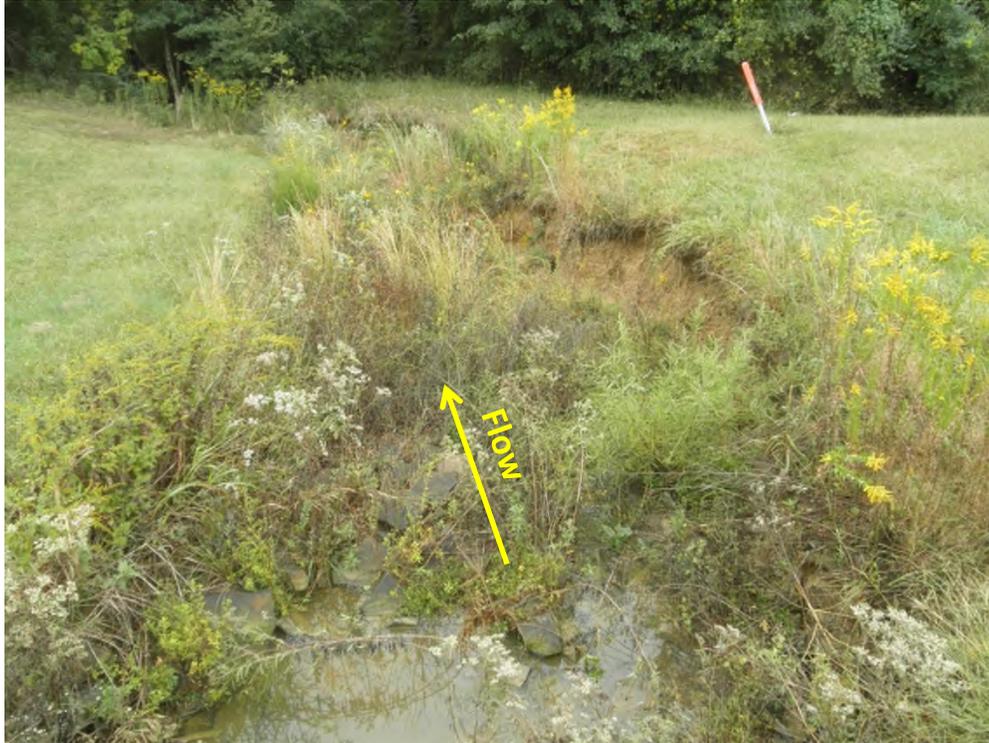
Stream 5, facing downstream south of existing Frontier Road

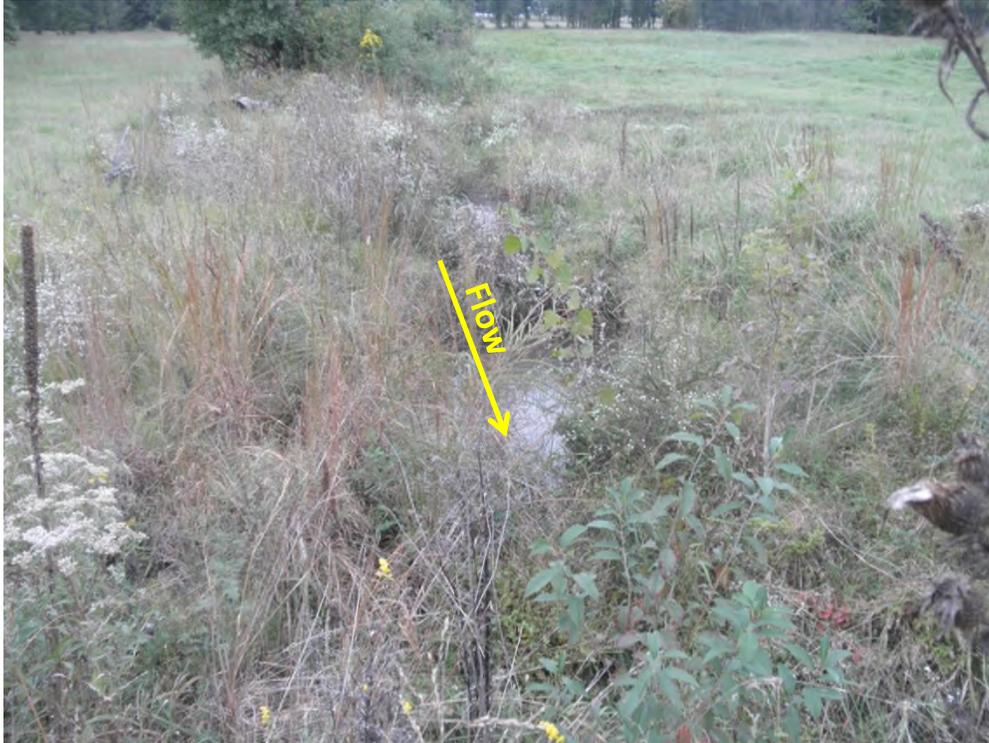
Stream 6, facing upstream north of existing Frontier Road

Stream 6 is an unnamed tributary of Little Vache Grasse Creek that flows southeast and crosses under Frontier Road just west of the ARDOT District 4 building. Stream 6 appears to have been partially channelized on both the north and south sides of Frontier Road, and is located in an open, maintained grass area that includes the roadway right-of-way. North of Frontier Road, Stream 6 is approximately 1 to 3 feet wide and is incised 1 to 3 feet with a sand and clay channel substrate. The water width matched the channel width variably 1 to 2 feet with a low flow averaging 2 to 4 inches deep. The channel is eroded and incised with deeper wash holes. South of Frontier Road, Stream 6 is approximately 2 to 4 feet wide and is incised 1 to 3 feet with a sand and clay channel substrate. The water width matched the channel width variably 1 to 3 feet with a low flow averaging 4 to 8 inches deep. The channel is more shallow and much less eroded than on the north side. The stream channel is highly vegetated; however, the plants are not aquatic vegetation but native plants typical of a ruderal environment. Based upon observed conditions, Stream 6 has an OHWM and ephemeral flow.

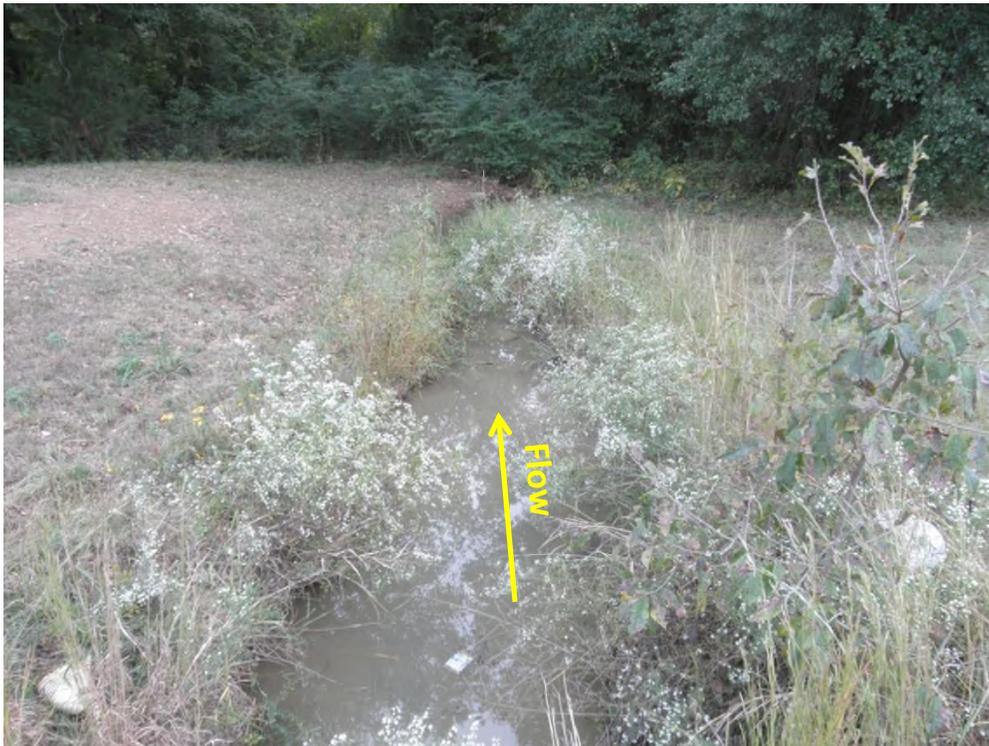
Stream 6, facing downstream south of existing Frontier Road

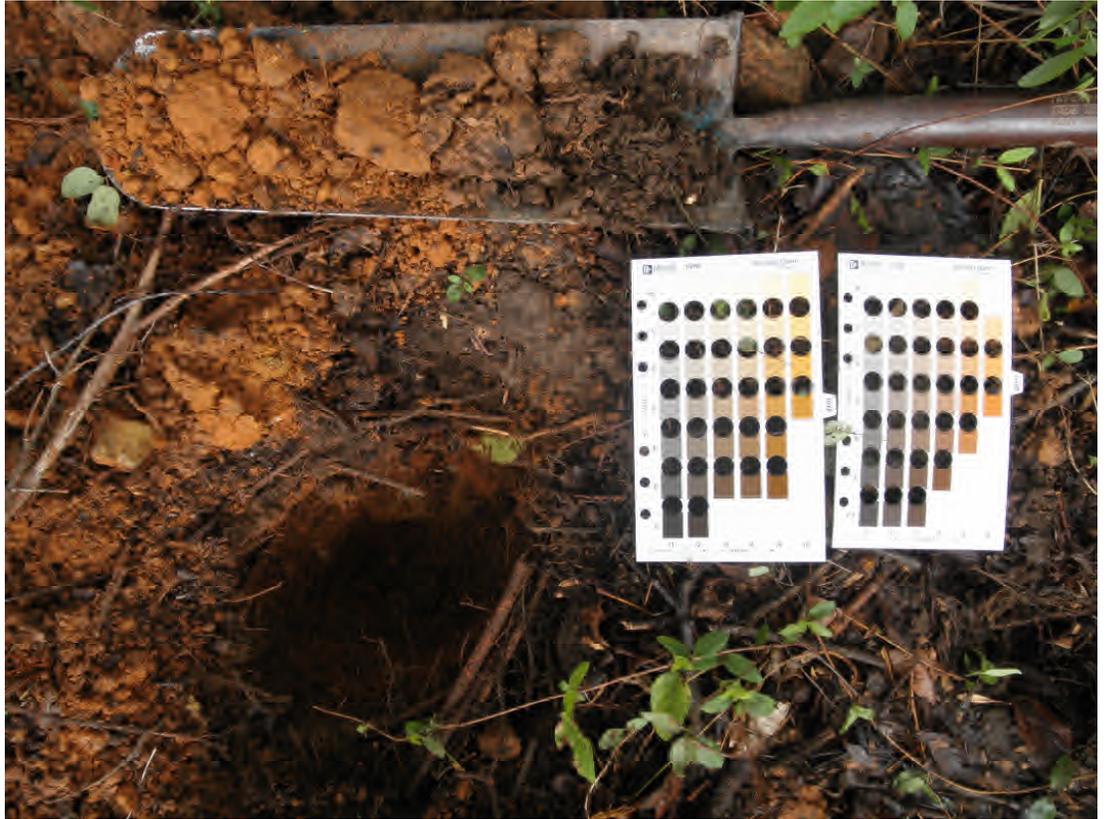
Soil pit and profile. Munsell color key was used to separate the soil profile into horizons according to the color chart value and chroma in each horizon at each observation point.

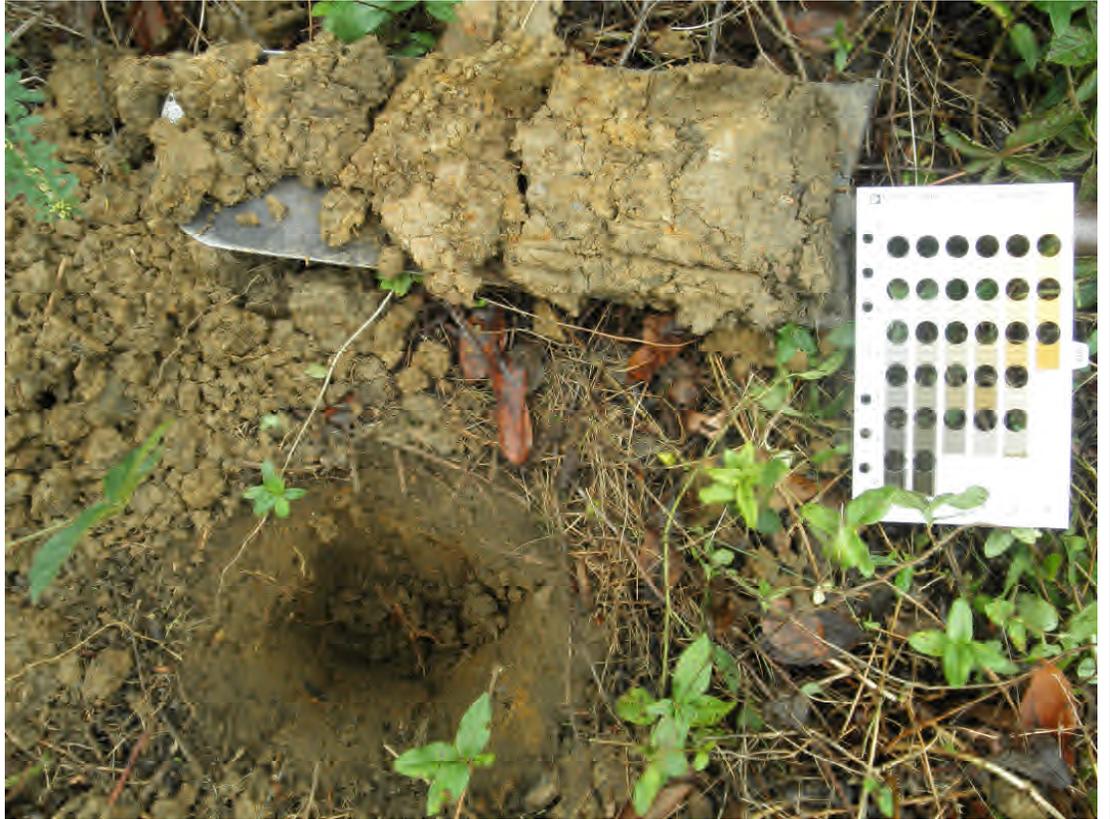
Soil pit and profile. Munsell color key was used to separate the soil profile into horizons according to the color chart value and chroma in each horizon at each observation point.

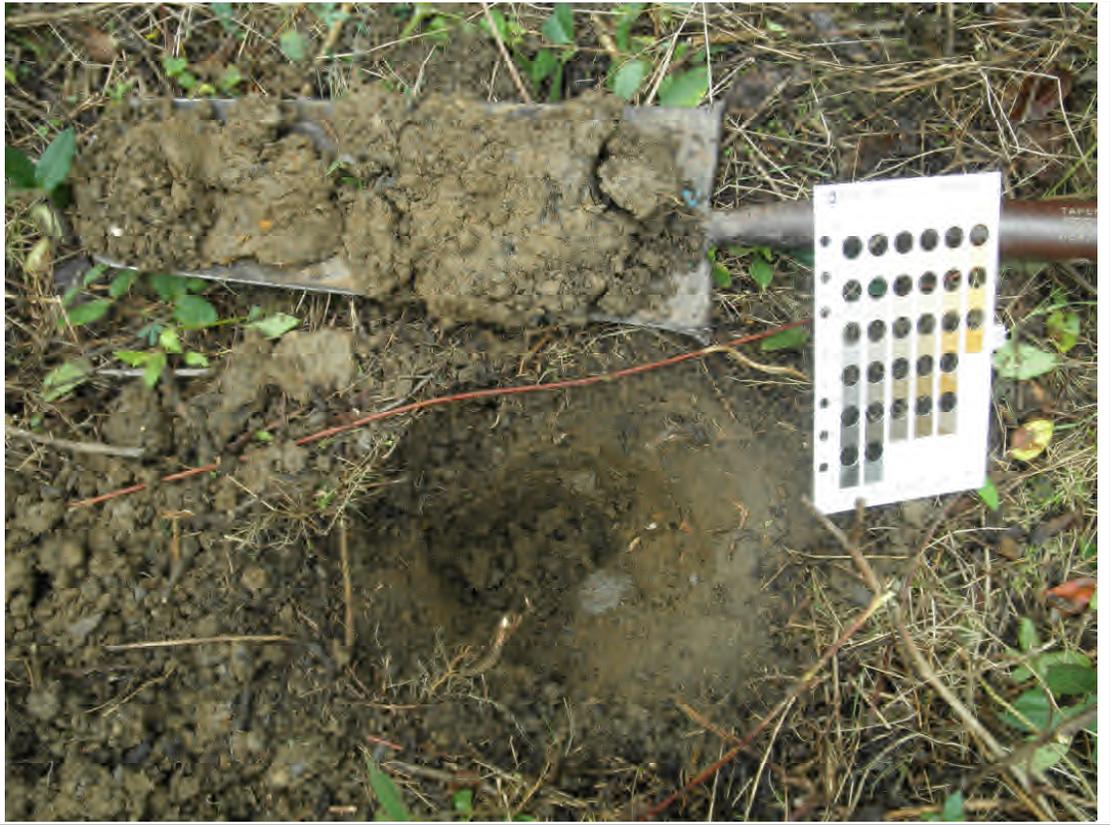
Soil pit and profile. Munsell color key was used to separate the soil profile into horizons according to the color chart value and chroma in each horizon at each observation point.

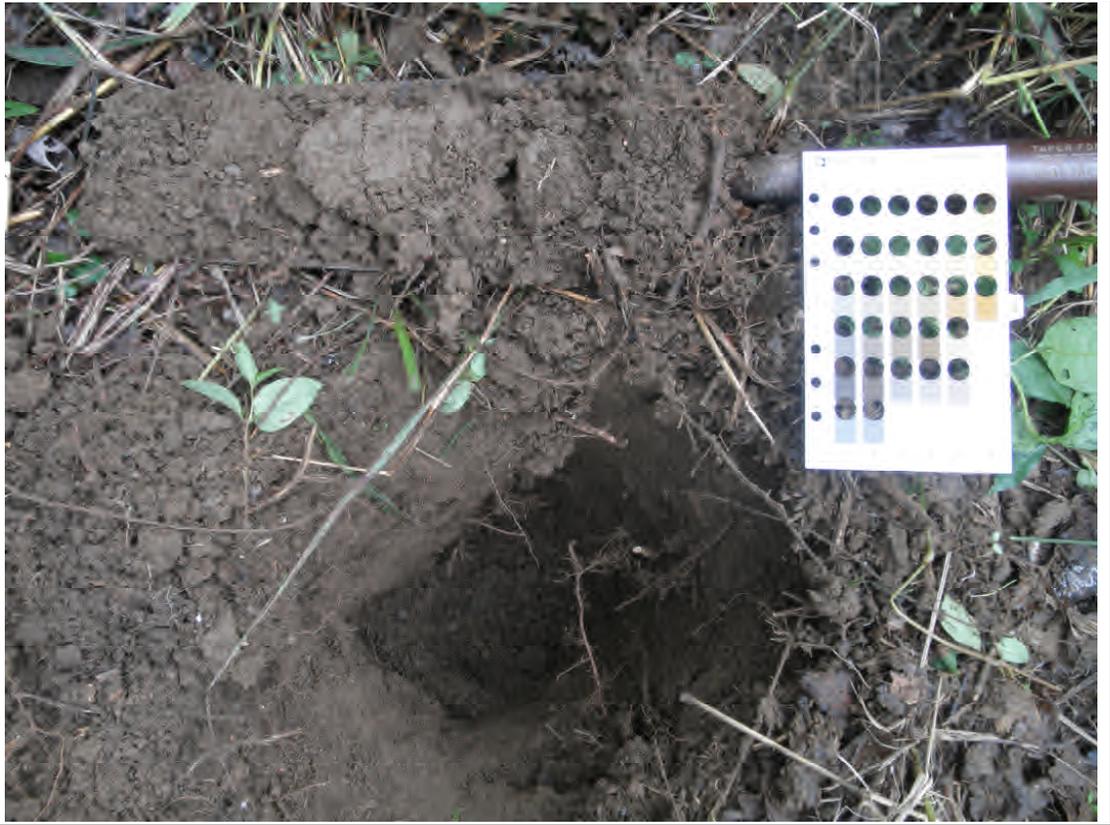
Soil pit and profile. Munsell color key was used to separate the soil profile into horizons according to the color chart value and chroma in each horizon at each observation point.

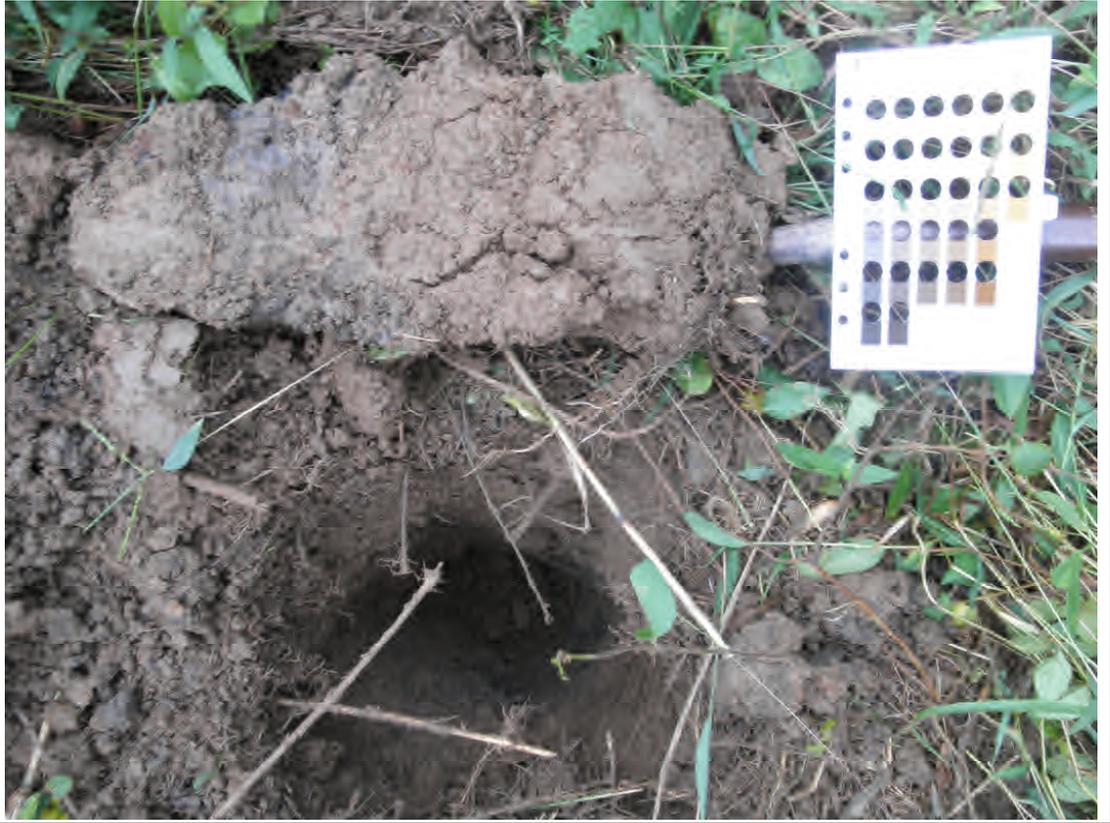
Soil pit and profile. Munsell color key was used to separate the soil profile into horizons according to the color chart value and chroma in each horizon at each observation point.

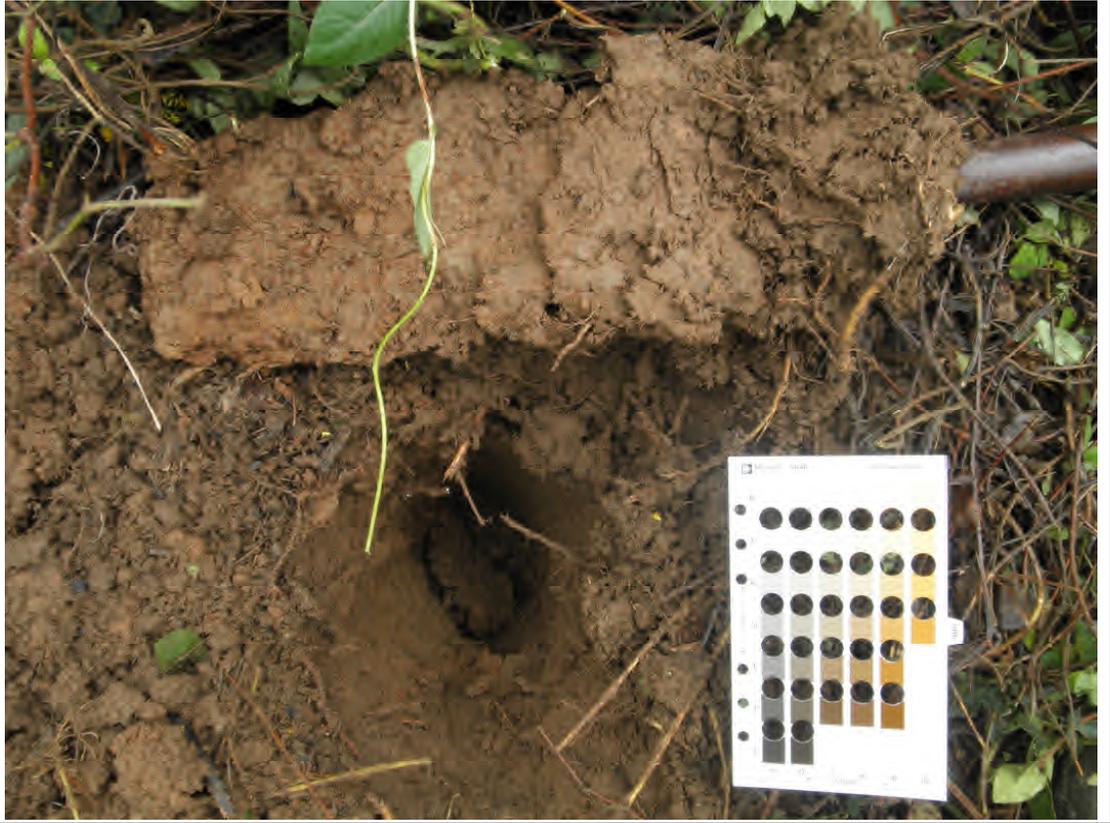
Soil pit and profile. Munsell color key was used to separate the soil profile into horizons according to the color chart value and chroma in each horizon at each observation point.

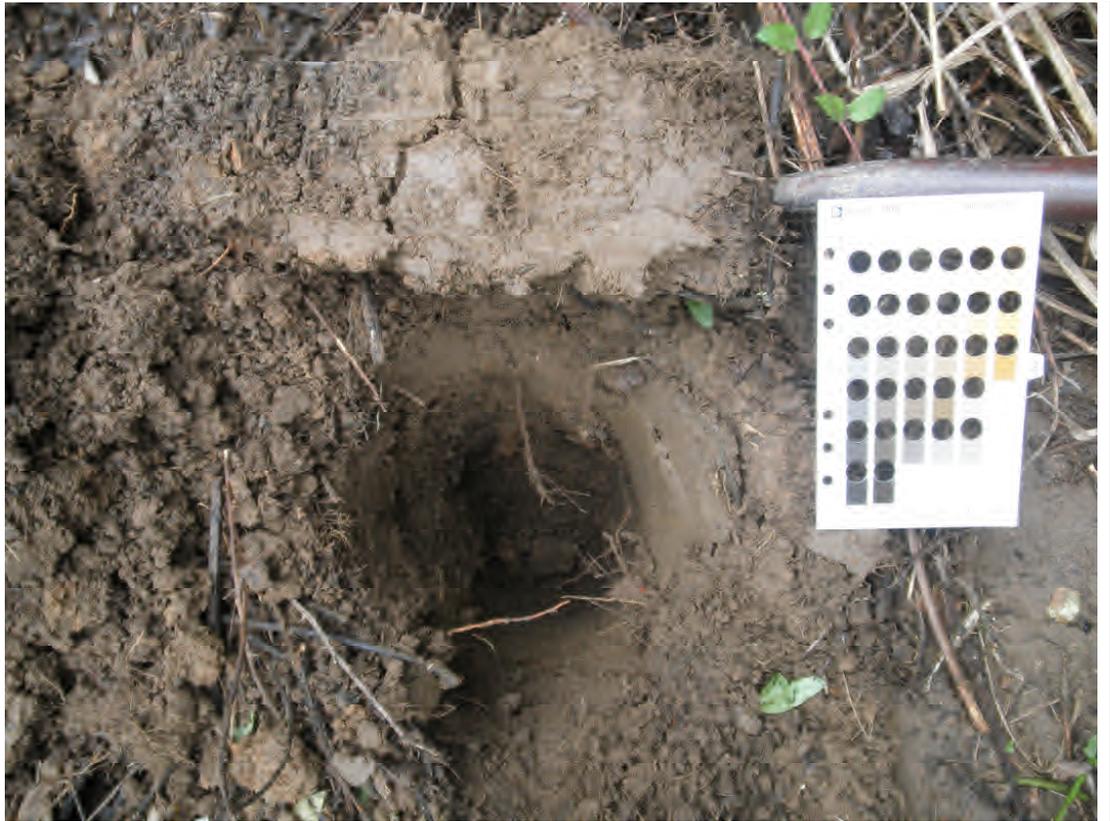
Soil pit and profile. Munsell color key was used to separate the soil profile into horizons according to the color chart value and chroma in each horizon at each observation point.

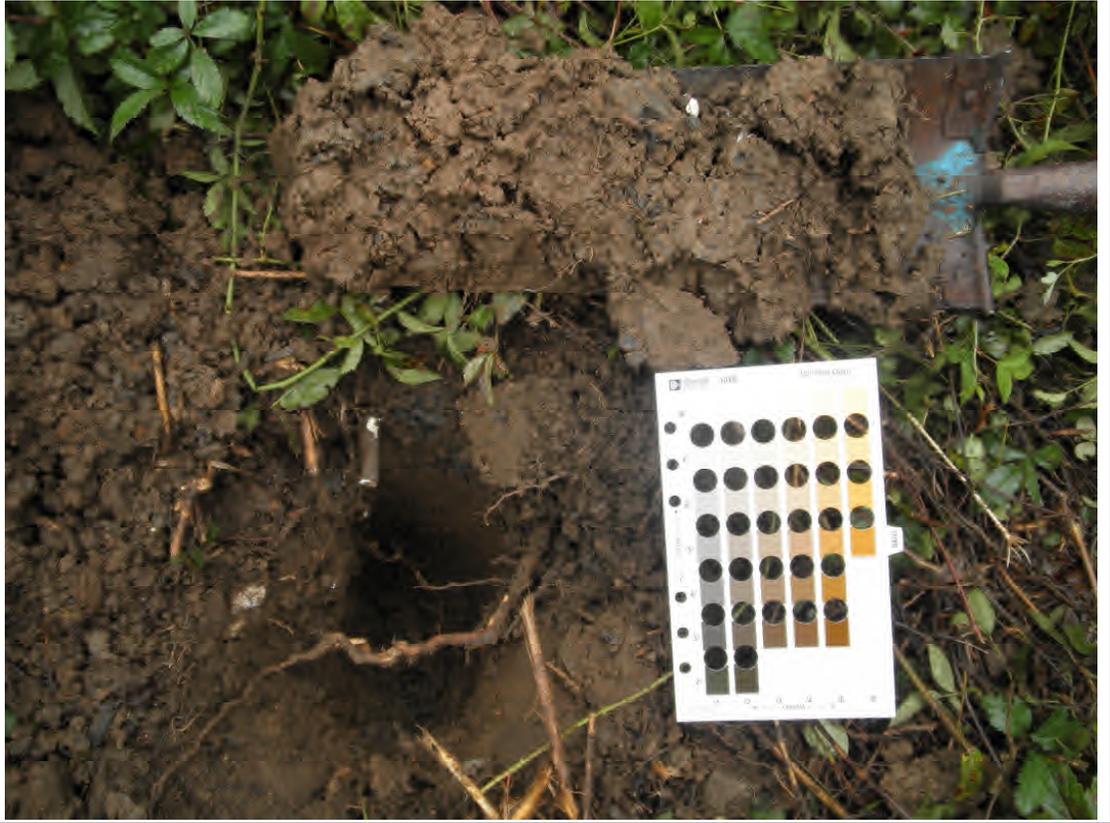
Soil pit and profile. Munsell color key was used to separate the soil profile into horizons according to the color chart value and chroma in each horizon at each observation point.

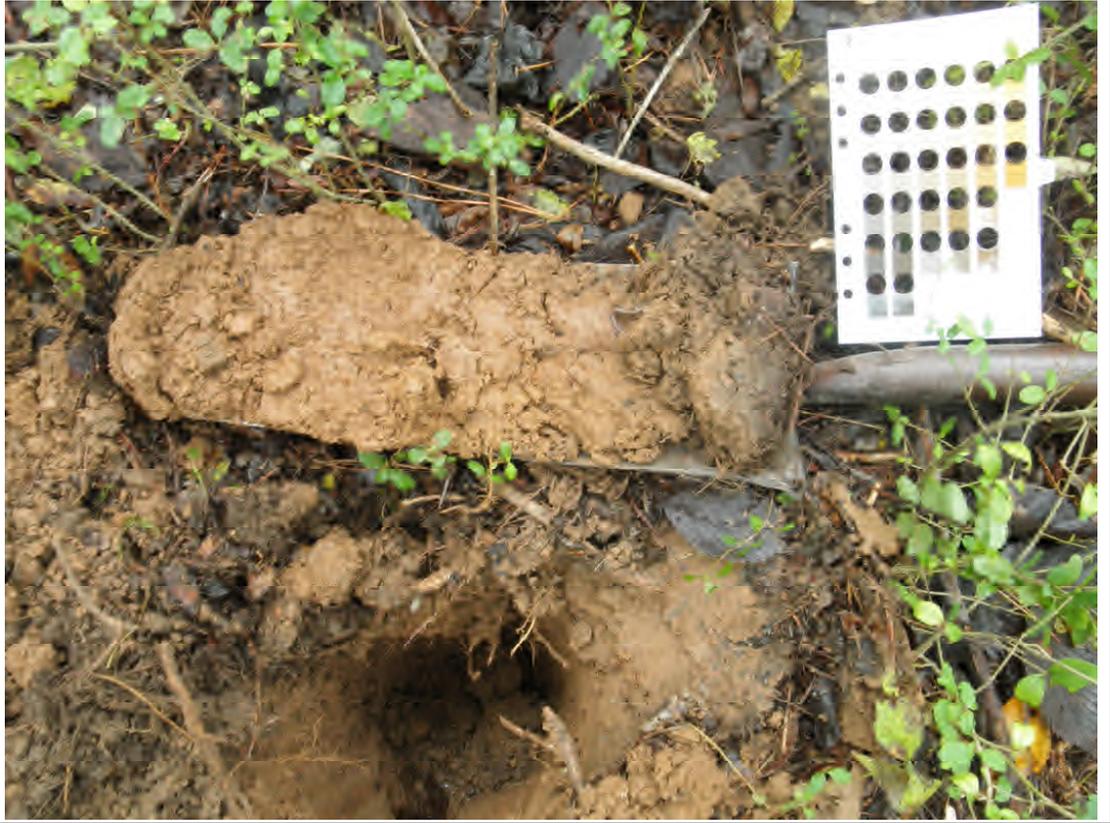
Soil pit and profile. Munsell color key was used to separate the soil profile into horizons according to the color chart value and chroma in each horizon at each observation point.
