**Slope Stability Monitoring  
Using Remote Sensing Technologies**

Final Report

FINAL REPORT: AHTD TRC-1102

SLOPE STABILITY MONITORING USING REMOTE SENSING TECHNIQUES

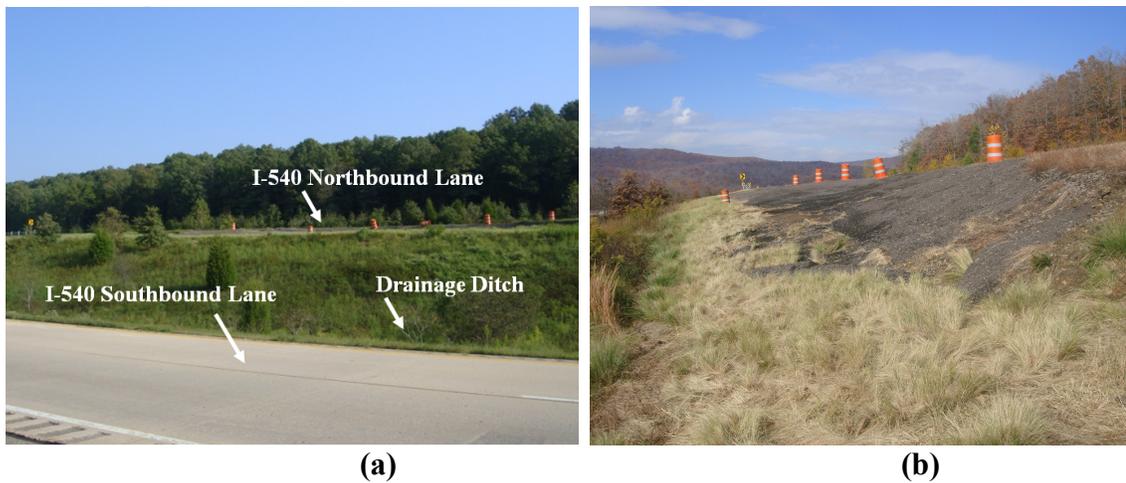
**Figure 2.2. Photograph obtained while looking Northeast across the Southbound lane of I-540 at calibration site near Chester, Arkansas.**

The location of the calibration site was ideal for research operations due to the lack of population in the area where the slide was located; however, the slope failure was located in the median of I-540, a major transportation artery in Northwest Arkansas. The surface extents of the study area was approximately 550 feet long (in the direction of the roadway) and extend from the West shoulder of the Northbound lanes to the East shoulder of the Southbound lanes (transverse to the roadway). Pictures of the calibration site, as obtained during the first site visit conducted by University personnel are presented in Figure 2.2 and Figure 2.3.

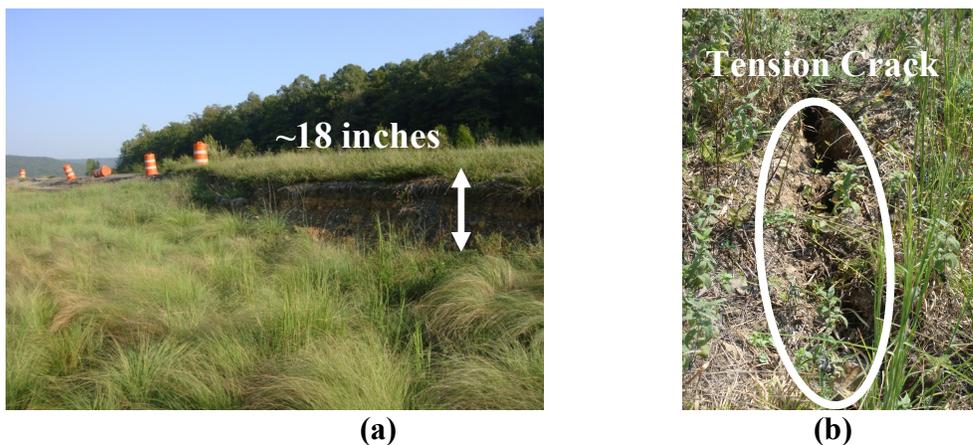
**Figure 2.3. a) Looking north, the main scarp at the calibration site located in Chester, Arkansas, and b) a tension crack observed in the median of I-540.**

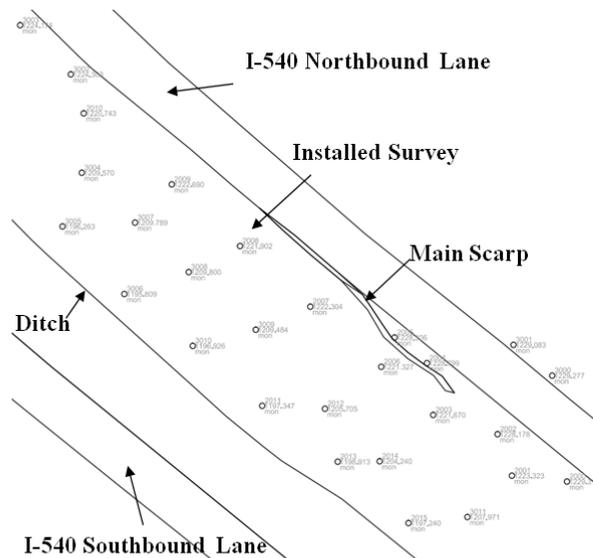
Figure 2.4. Plan view of calibration near Chester, Arkansas; the locations of survey monuments are illustrated.

To monitor the site using traditional surveying techniques, this site was instrumented with 29 (Figure 2.4) concrete monuments that encased aluminum surveying monuments mounted on rebar. These monuments served as check points. Each monument consists of a Quikrete® filled borehole (18 inches deep, 3 inches in diameter), a 24-inch long half-inch diameter rebar, and a 2-inch diameter aluminum monument (Conte, 2012). These monuments were monitored every two weeks or after a period of heavy rain. A topographic survey and the monitoring checks were performed using: a Nikon DTM-520 total station, a Leica tripod, a Carlson Explorer 600+ data collector, a Sokkia prism pole with bipod legs, and a Optima 30mm offset prism (Figure 2.5).

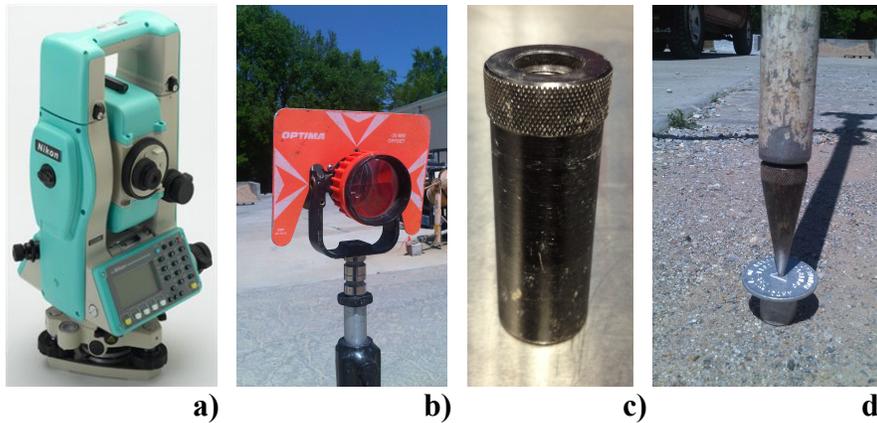
Figure 2.5. a) Nikon DTM-520 (Nikon Positioning Website, 2012), b) Optima 30mm prism, c) flat shoe for prism pole, and d) pointed shoe on the prim pole.

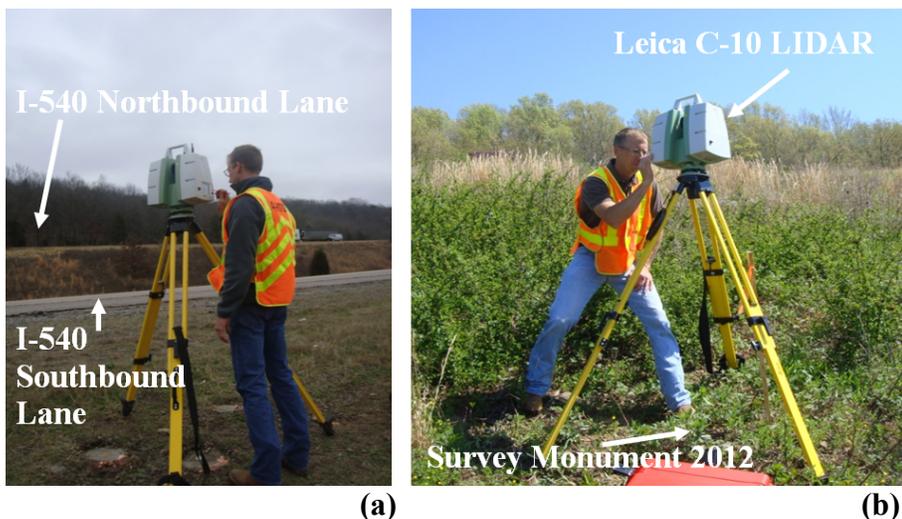
Figure 2.6. a) RADAR and LIDAR Southbound viewpoint, and b) LIDAR deployed at Point 2012.

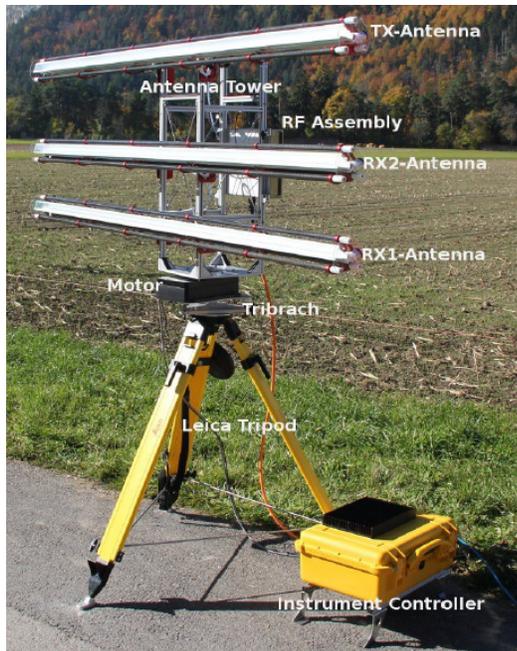
**Figure 2.7. GPRI-II features (from GAMMA Remote Sensing AG, 2011).**

GAMMA Remote Sensing recently developed and built a ground based portable RADAR interferometer referred to as a Gamma Portable RADAR Interferometer (GPRI-II). This portable RADAR, unlike previous terrestrial RADAR instruments from other manufactures, does not use aperture synthesis to obtain good azimuth resolution and is fully mobile. The instrument utilizes real-aperture antennas, with two emitter antennas and one receiver antenna (Figure 2.7), operating at a frequency of 17.2 GHz (Werner, 2008). The relatively high frequency utilized by this device allows the user to obtain high azimuth resolution (1m) and sensitivity to motion (<1cm). Minimal deployment effort was required and individual measurements were obtained in less than 36 seconds, with a field of view of 360 degrees and an operational distance of 0.1 to 4 kilometers (GAMMA Remote Sensing, 2011).

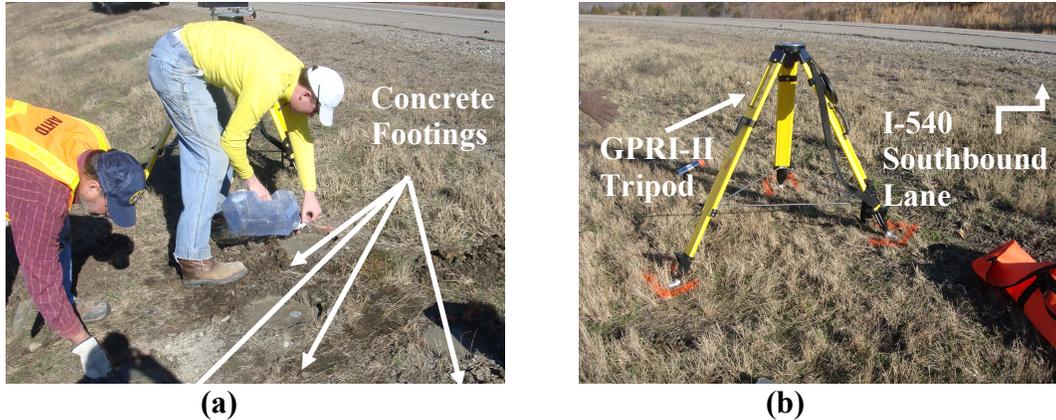
**Figure 2.8. a) Placing concrete footings for GPRI-II at the Southbound viewpoint at the calibration site, and b) tripod of GPRI-II anchored at the Southbound viewpoint near Chester, Arkansas..**

The Southbound viewpoint at the calibration site was located approximately 15 feet West of the Southbound shoulder of I-540. This location allowed for collection of RADAR data with a short field of view (i.e. the RADAR was close to the sliding mass [approximately 100 feet]). The RADAR benchmark was placed due West of the center of the main scarp (in the direction of movement). Four concrete footings were utilized to deploy the GPRI-II at this viewpoint (Figure 2.8). Three concrete footings were used to secure the tripod legs to the ground using anchors, while the fourth concrete footing contained a survey monument that served to level the RADAR in the same position during each visit. The same RADAR setup was followed during each visit. Before acquiring images at the Southbound viewpoint, the GPRI-II was aligned to the 4<sup>th</sup> fence post (located to the West of the observation point and marked with surveying flagging) using the scope of the RADAR.

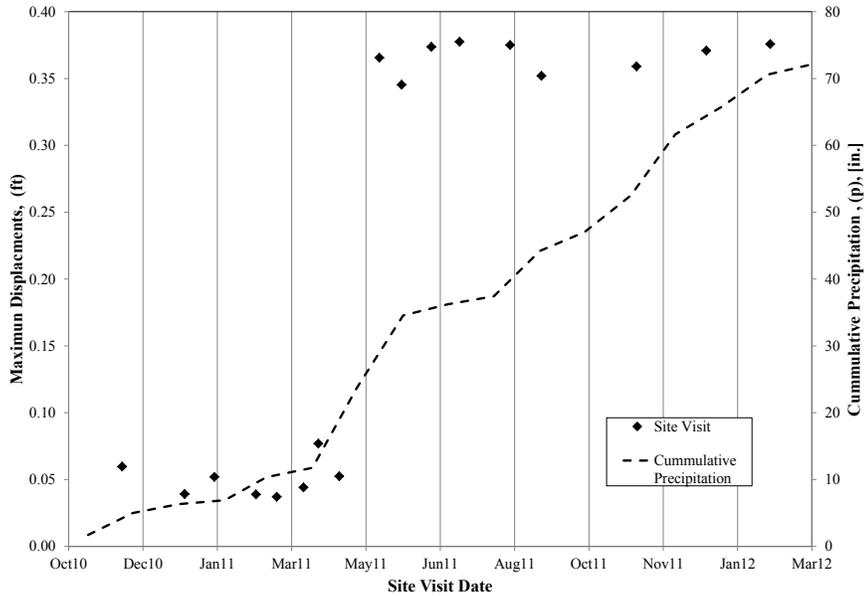
**Figure 2.9. Horizontal displacements measured and precipitation data for calibration site.**

Larger displacement values (in both the horizontal and vertical directions) were observed on and after May 2011 (Check 9) corresponding to the large amounts of precipitation experienced during the months of April and May of 2011. The precipitation and runoff saturated the soil in the slope, and the increased hydrostatic pore pressures led to a reduction in effective stress and induced/accelerated the displacement of the moving mass. The precipitation data for the 15 month period between October, 2010 and January, 2012 obtained from the National Oceanic & Atmospheric Administration (2012) is summarized in Table 1. The maximum horizontal displacements and maximum elevation differences observed using the total station for each of the site visits were plotted with the precipitation data. The horizontal displacements and elevation differences are plotted as a function of time including precipitation data (Figure 2.9 and Figure 2.10, respectively).

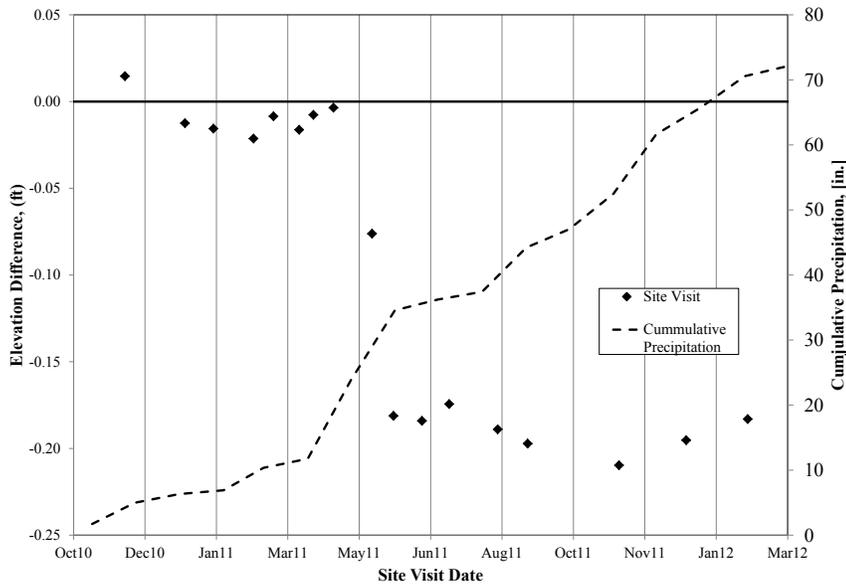
**Figure 2.10. Elevation differences measured and precipitation data for calibration site.**

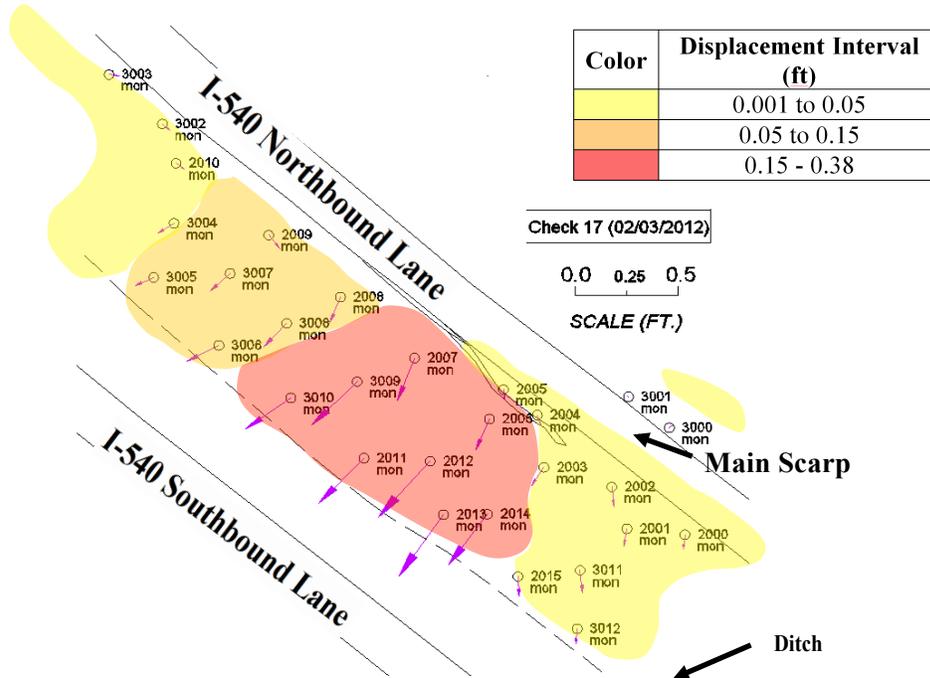
**Figure 2.11. Displacement areas for the calibration site; different colors represent the different displacement intervals [in color].**

Three distinct displacement areas were delineated to characterize the moving mass (Figure 2.11). The red zone was the area where the largest horizontal displacements were observed; the monuments bounded by orange zone had moderate horizontal displacements. Large amounts of movement of the survey monuments were expected to occur in the area below

the main scarp which is in agreement with the observed movements. The yellow zones were established where the monuments experience zero displacement or low displacements values.

used to monitor horizontal displacement of the slope. Although limited point data obtained from the total station, the data were observed with each scan, allowing for horizontal displacement monitoring of the slope, as shown previously in Figure 2.11.

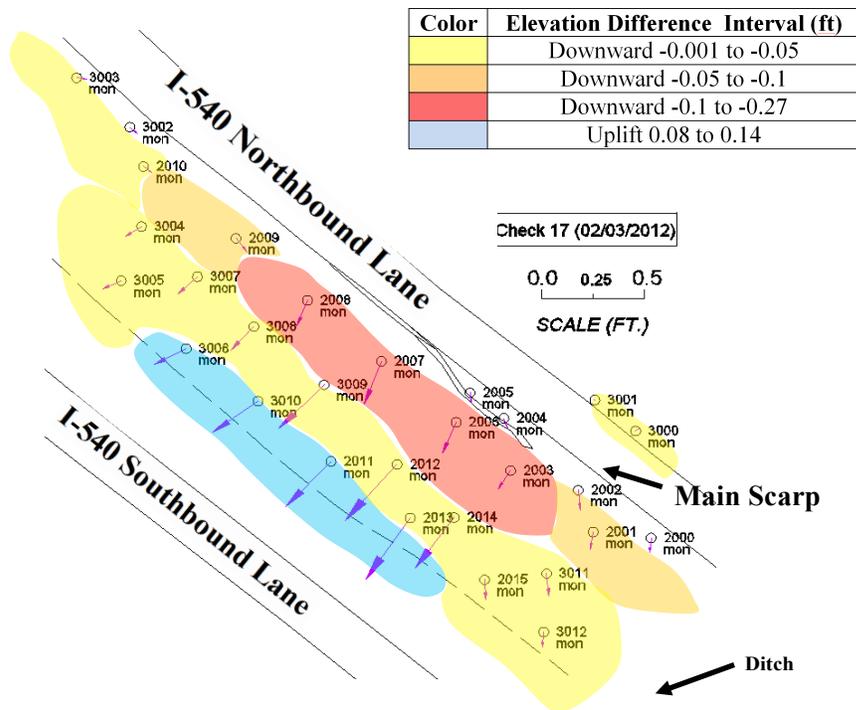
**Figure 2.12. Zones of vertical movements for the calibration site; red zone represents largest down movements, orange zone represents down medium movements, yellow areas low to zero down movement, and blue areas represent uplift movement [in color].**

Similarly, four distinct zones were delineated to characterize the vertical movement of the slide after analyzing the elevation differences measured on each survey monument during the checks. Vertical displacements were grouped in different intervals depending of the amount and direction of movement that was experienced. A rotational behavior was observed in the landslide at the calibration site. Downward movements were observed in the survey monuments installed at the head area of the slide and uplift movements were measured in the monuments installed at the toe area of the slide. A schematic illustrating the four different sections of elevation difference is presented in Figure 2.12.

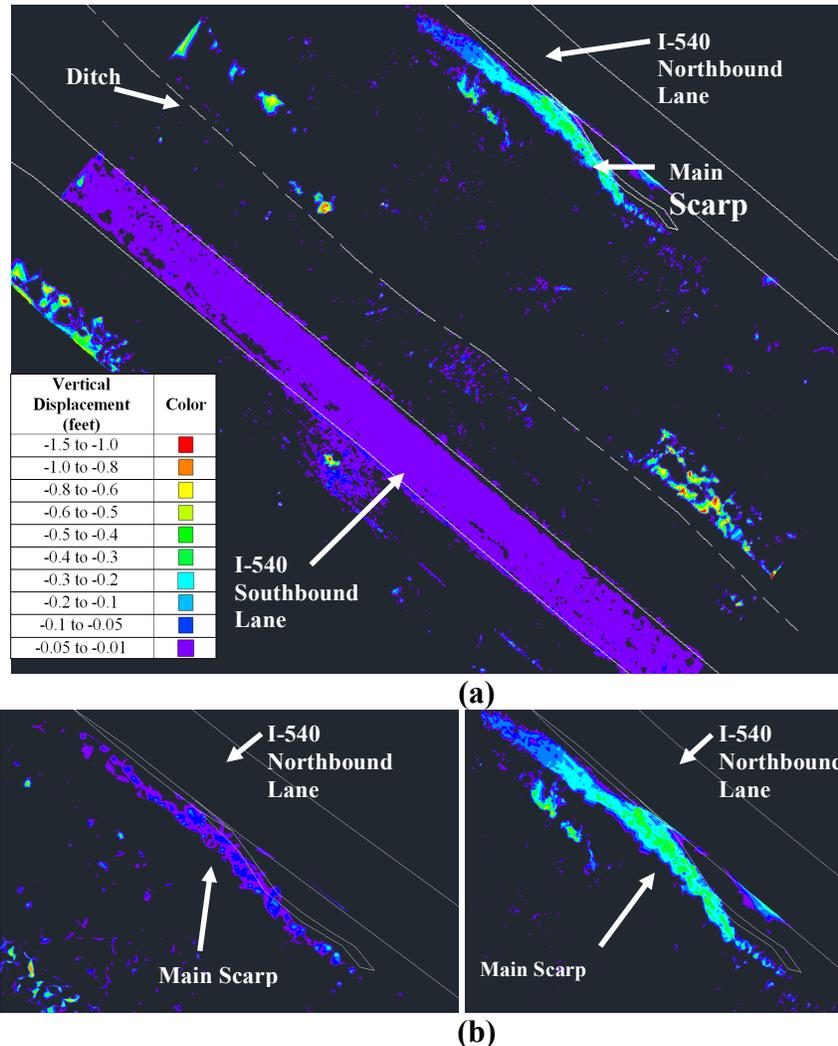
**Figure 2.13. a) Volume surface 03/17/11 to 06/08/11 (obtained using bare earth correction method) where maximum elevation difference on the main scarp was observed, and b) zoomed view to the main scarp where progressive movement was observed from 05/17/11 to 06/08/11 [in color].**

Negative (downward) displacements were detected in the Southbound lane of I-540. The downward movements observed in the I-540 Southbound lane were the result of the expansion and contraction of the concrete pavement. The main scarp location, as obtained using the LIDAR bare earth method, also matched the location obtained with the total station measurements. The volume surface obtained using the LIDAR bare earth correction method for the site visits

between March 17<sup>th</sup>, 2011, and June 6<sup>th</sup>, 2011, is presented in Figure 2.13a. Progressive movement of the main scarp from the May 17<sup>th</sup>, 2011, surface to the June 8<sup>th</sup>, 2011, surface are illustrated in Figure 2.13b.

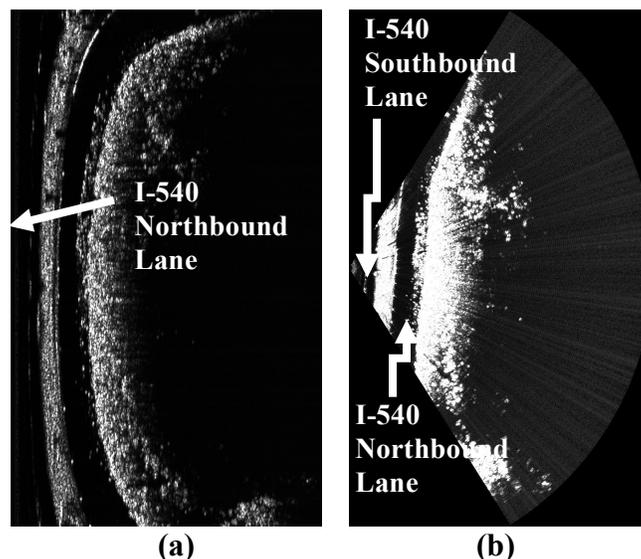
**Figure 2.14. a) MLI RADAR image obtained from southbound viewpoint in polar coordinates using 250ms chirp, and b) MLI RADAR image obtained from southbound viewpoint in rectangular coordinates using 250ms chirp.**

Radar images obtained using the 250ms chirp permitted a closer and better interpretation of the site than longer chirp lengths. In fact, due to the RADAR data acquisition proximity to the site; a lower chirp would have produced better MLI images, but the system only allowed for 250ms to be the lowest chirp possible. The I-540 Northbound lane, the I-540 Southbound lane, the ditch, and the terrain located to the East of the I-540 Northbound lane are appreciated in the produced MLI images. Some saturation is observed in the images due to the traffic of vehicles traveling along the I-540 lanes. The MLI data, as obtained after the initial processing of the RADAR (GPRI-II) data for the calibration site using the 250ms chirp, are presented in polar and rectangular coordinates in Figure 2.14.

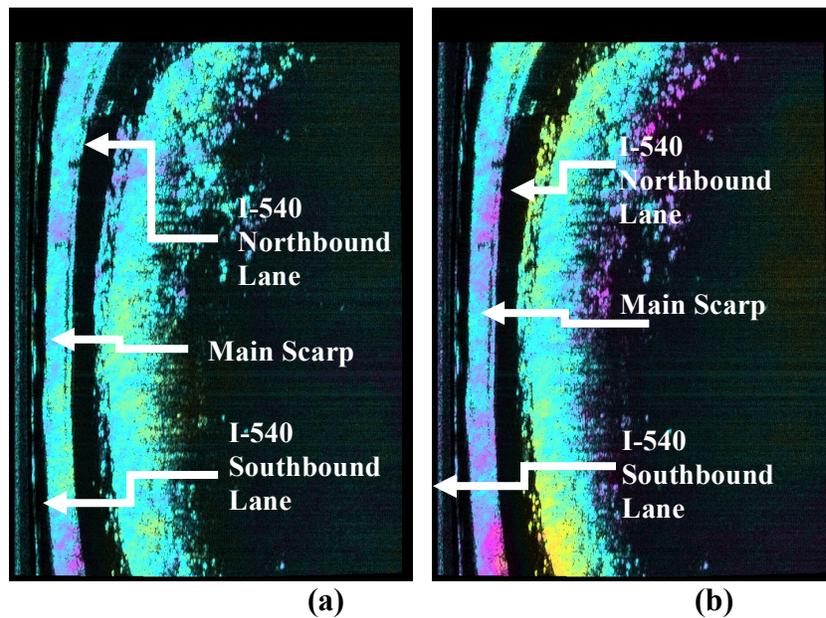
**Figure 2.15.** a) Southbound viewpoint interferogram from 03/08/11 to 03/26/11, and b) southbound viewpoint interferogram from 03/08/11 to 02/26/12.

Interferograms were created for the different visits to the Southbound viewpoint in calibration site. The interferograms developed for the different visits to the Southbound viewpoint do not show a progressive movement of the landslide or main scarp with time. Vegetation was believed to be the major factor affecting the images for the interferograms. In the interferograms images, the green color represents zero movement and purple color represents movement values of 1.77cm. Two interferograms developed for the Southbound viewpoint, one with a time span of one month and a second with a time span of 11 months are presented in polar coordinates in Figure 2.15.

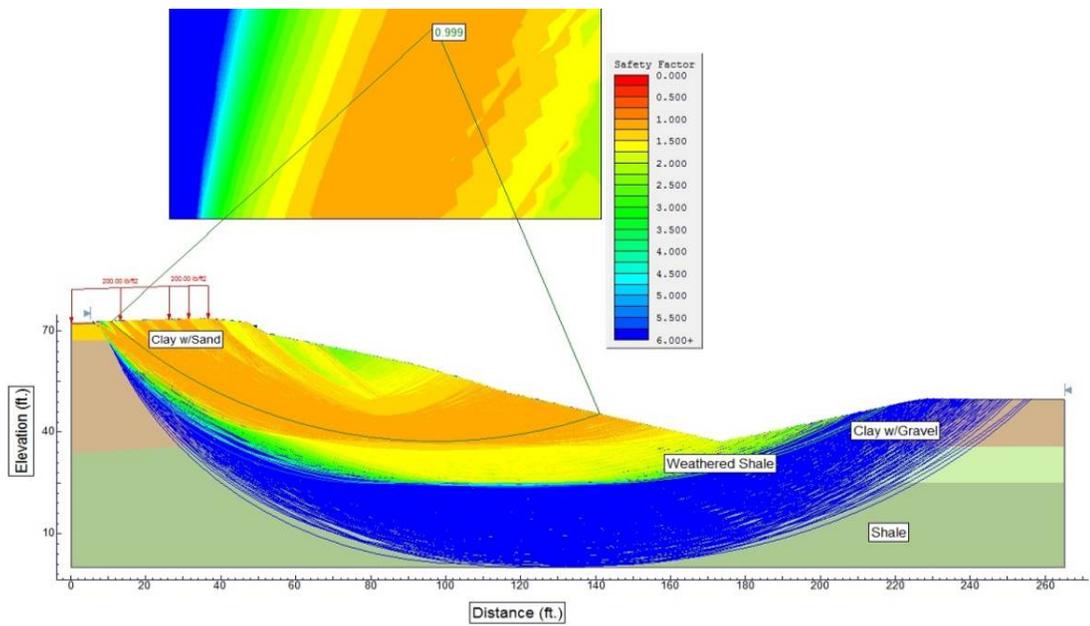
**Figure 2.16. Computed UARK slip surfaces using SLIDE 5.044 (2010).**

The parameters that were utilized within the slope stability analysis for the Chester slide are presented in Table 2.1. The obtained factors of safety against sliding are presented Table 2.2, and the results of the SLIDE v. 5.044 (2010) limit equilibrium slope stability analysis are displayed in Figure 2.16. A factor of safety of 0.999 was obtained from the analysis. Based on

this factor of safety, movement of the slope was anticipated. This back-analysis of the slope provided justification for the movement that was observed at the site.

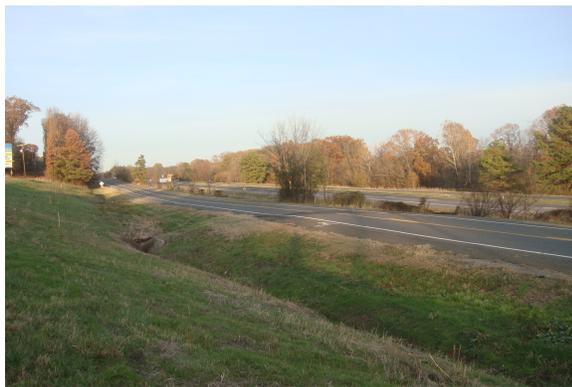
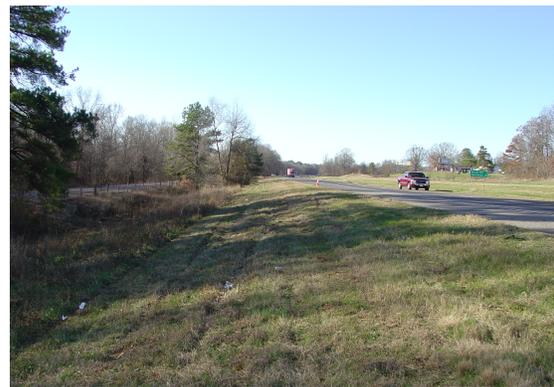
**Figure 3.2. a) Looking Southwest from the hillside between Highway 84 and I-30, and b) looking west towards I-30 at the validation site near Malvern, Arkansas in December 2010.**

Although the landslide at this site had previously unknown extents, the effects of the landslide were noticeable. The site is composed of private land on a hillside, a two lane highway (Highway 84), a median between Highway 84 and the interstate (Interstate 30), a median between the Westbound and Eastbound lanes of I-30, a median between I-30 and Haltom Road, Haltom Road, and a strip of vegetation between Haltom Road and the Ouachita River. The Ouachita River is believed to contribute to the instability of the site by removing the toe of the landslide and adding changes in the pore water pressure. Photographs of the site, taken by UofA personnel during the site visit in December 2010, are presented in Figure 3.2.

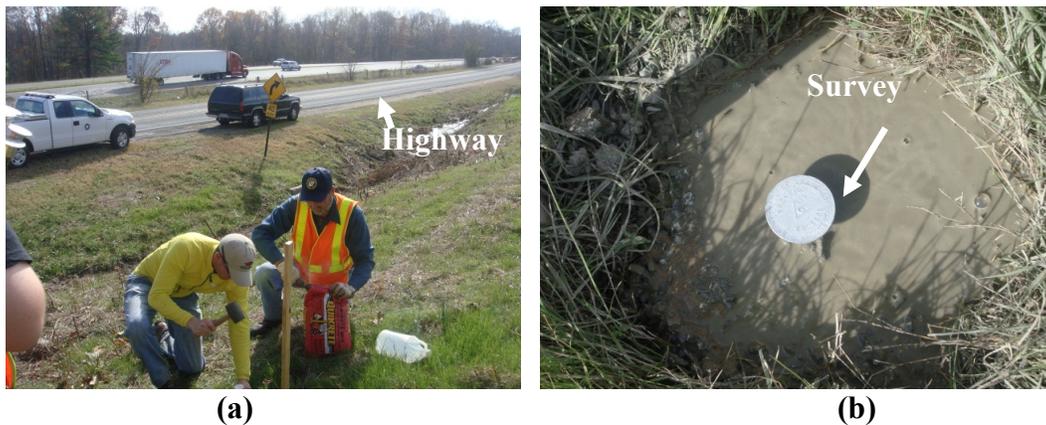
**Figure 3.3. a) Installation of survey monument in the ground by UofA and AHTD personnel, and b) survey monument installed in the ground using Quickcrete®.**

The Malvern site was instrumented with 53 survey monuments using the same procedures that were used at the Chester site (as previously described for calibration site). Forty-one monuments were installed on December 3<sup>rd</sup>, 2010 and twelve monuments were installed on January 6<sup>th</sup>, 2011. The monuments (Figure 3.3) were installed in five lines (Figure 3.4) along the interstate (East-West direction). From North to South, the first line (6 monuments) was located north of the Highway 84; the next two lines were installed in a staggered (zigzag) pattern, and were located in the median between Highway 84 and the Westbound lane of I-30 (22 monuments); the next line (where the total station benchmark [Point 1000] was located) was in the median between the I-30 lanes (12 monuments); the fifth line was located just South of the I-30 Eastbound lane (12 monuments, these were the monuments installed on January 6<sup>th</sup>).

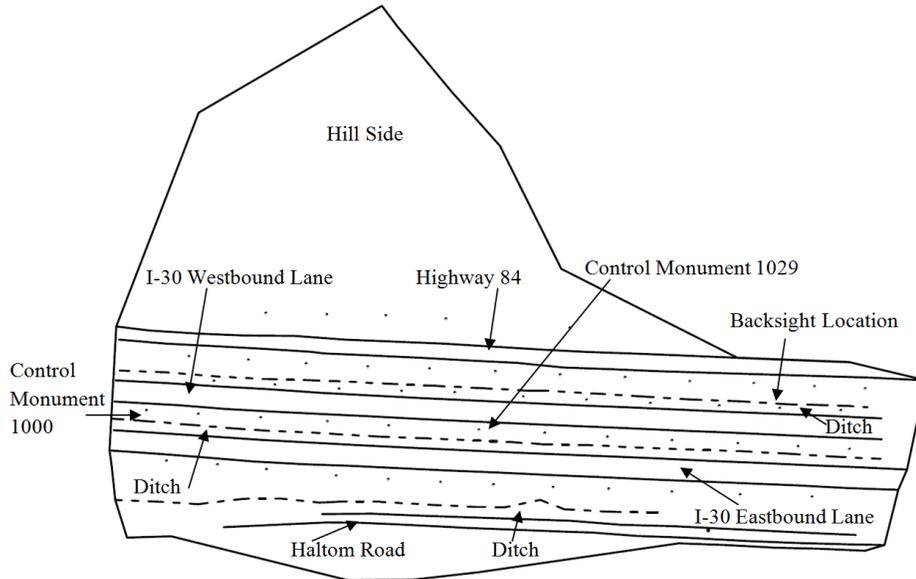
**Figure 3.4. Plan view of survey monument positions installed in validation site near Malvern, Arkansas.**

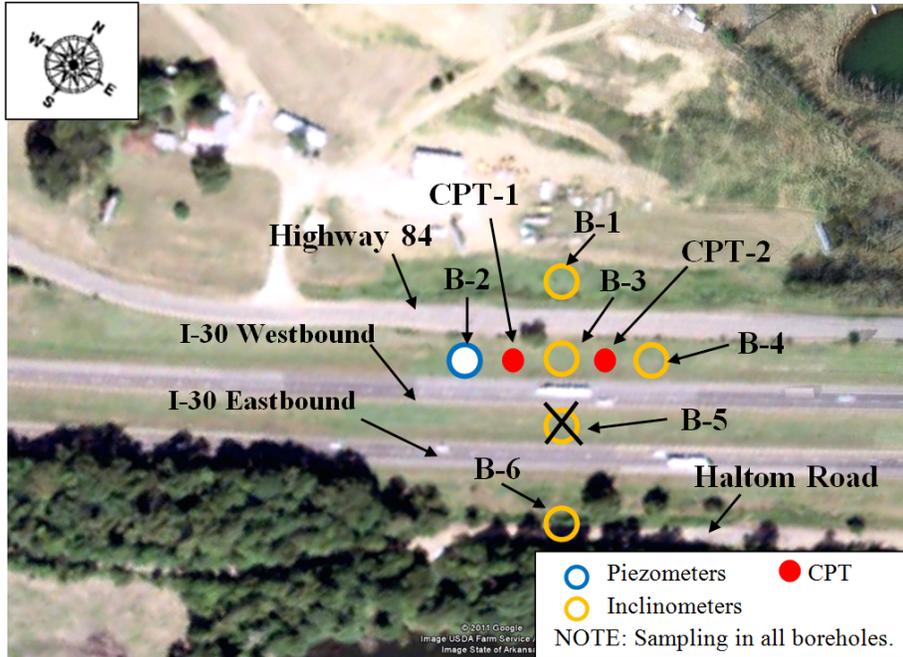
**Figure 3.5. Geotechnical investigation borehole locations at the validation site (modified from Google Maps, 2011).**

Alternating Shelby Tube (ST) and Standard Penetration Test (SPT) samples were collected on alternating 5 foot intervals to a depth of 65 feet. Continuous ST sampling was conducted from a depth of 65 feet to a depth of 75 feet below the ground surface. This sampling program was intended to allow for sampling of the material at the sliding interface (as identified previously from inclinometers data collected at the site [Westerman, 2006]). After 75 feet the sampling procedure consisted of alternating ST and SPT every 5 feet. When a Shelby tube could not be pushed or became bent, a SPT test was conducted; rock coring was then conducted until the final depth of the borehole. Due to time constraints and safety concerns, Borehole B-5 (Figure 3.5) located in the median of I-30 was canceled, and was not drilled.

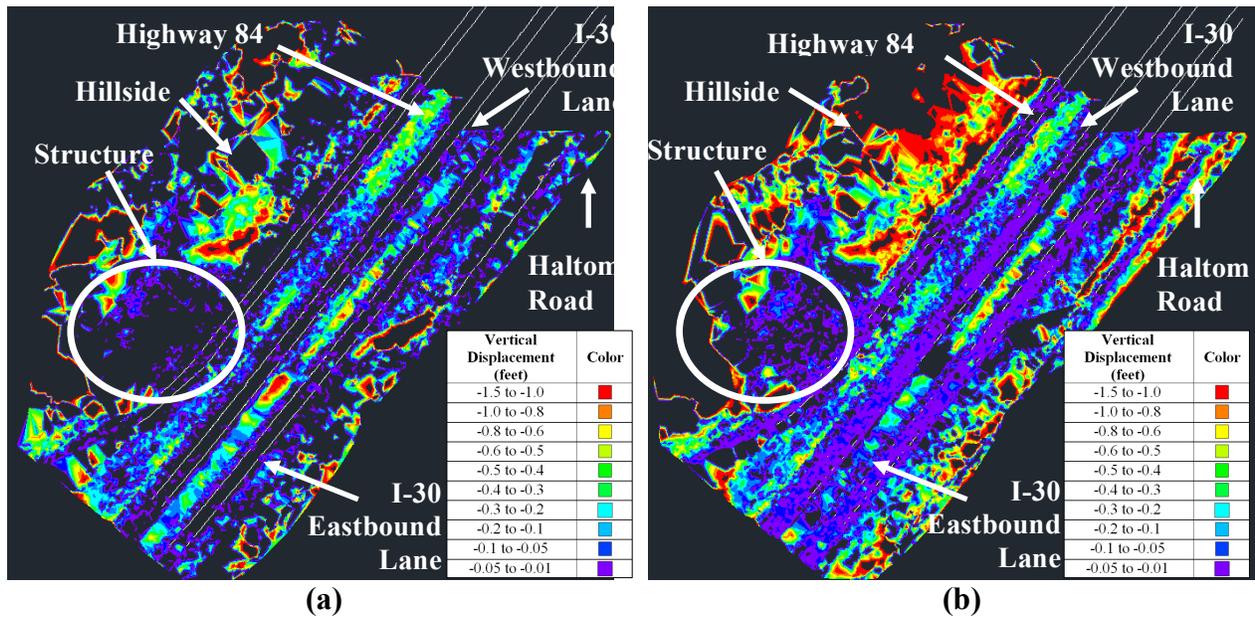
Figure 3.6. a) Volume surface (062711-080111) using bare earth correction method, and b) volume surface (062711-120211) using bare earth correction method [in color].

the movement of the landslide located at the validation site was not fully detected using LIDAR. Specifically, the size, complexity, and topography of the site prevented detection of the moving mass. The variability in the sensor setup may have introduced some noise into the final images. After analyzing the data from the monitoring devices utilized at the validation site it was concluded that the four LIDAR scans locations were inside the moving mass. Therefore, the LIDAR movements obtained were not relative to a fixed point, resulting in the poor correlation that was observed. The progressive downward elevation difference of the validation site in a time span of six months is shown in Figure 3.6.

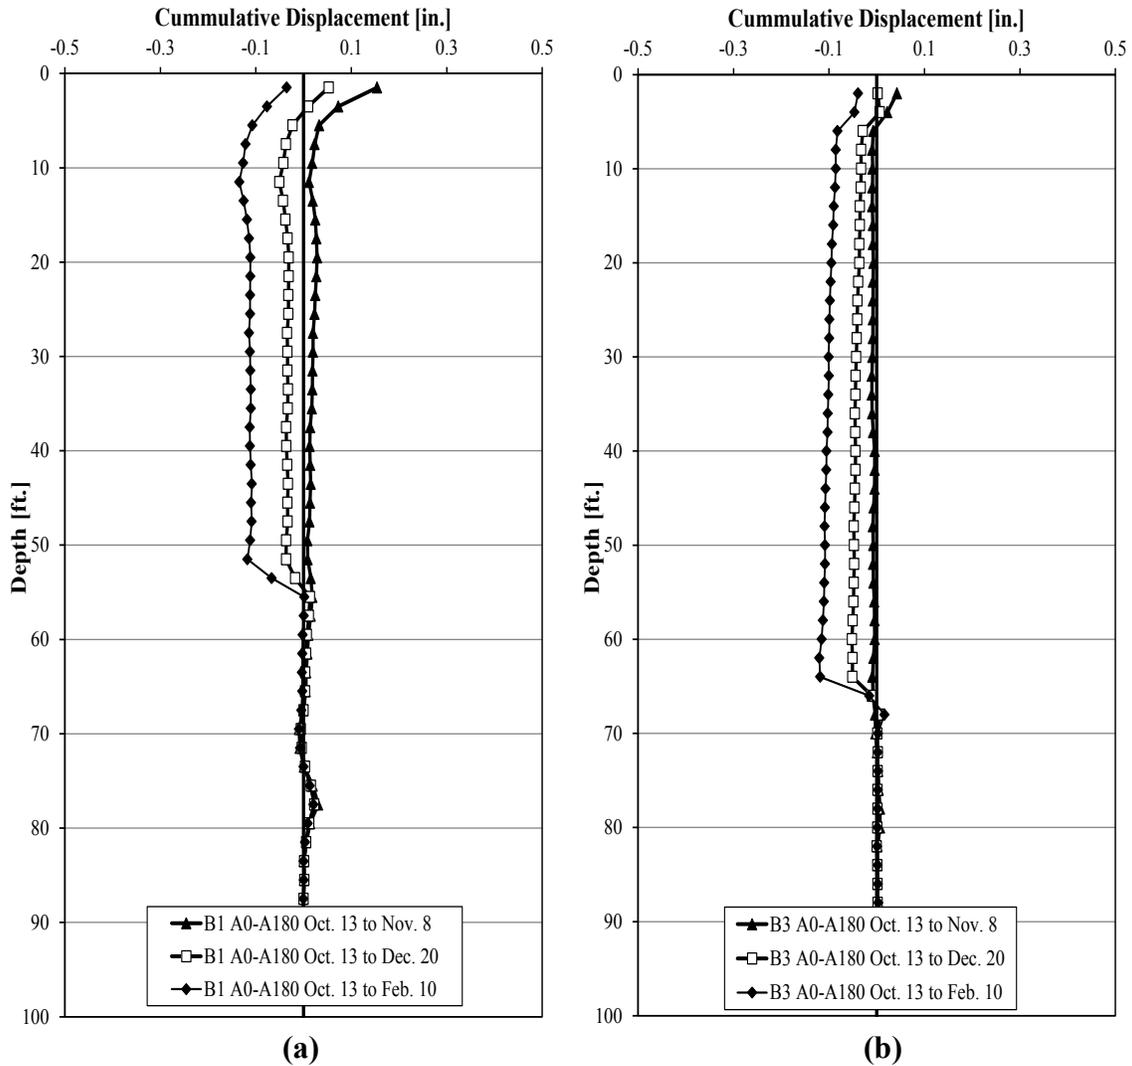
**Figure 3.7. Profile of the slope inclinometer installed at B-1 location for the site visits to the validation site, and b) Profile of the slope inclinometers casing installed at the B-3 location for the site visits to the validation site.**

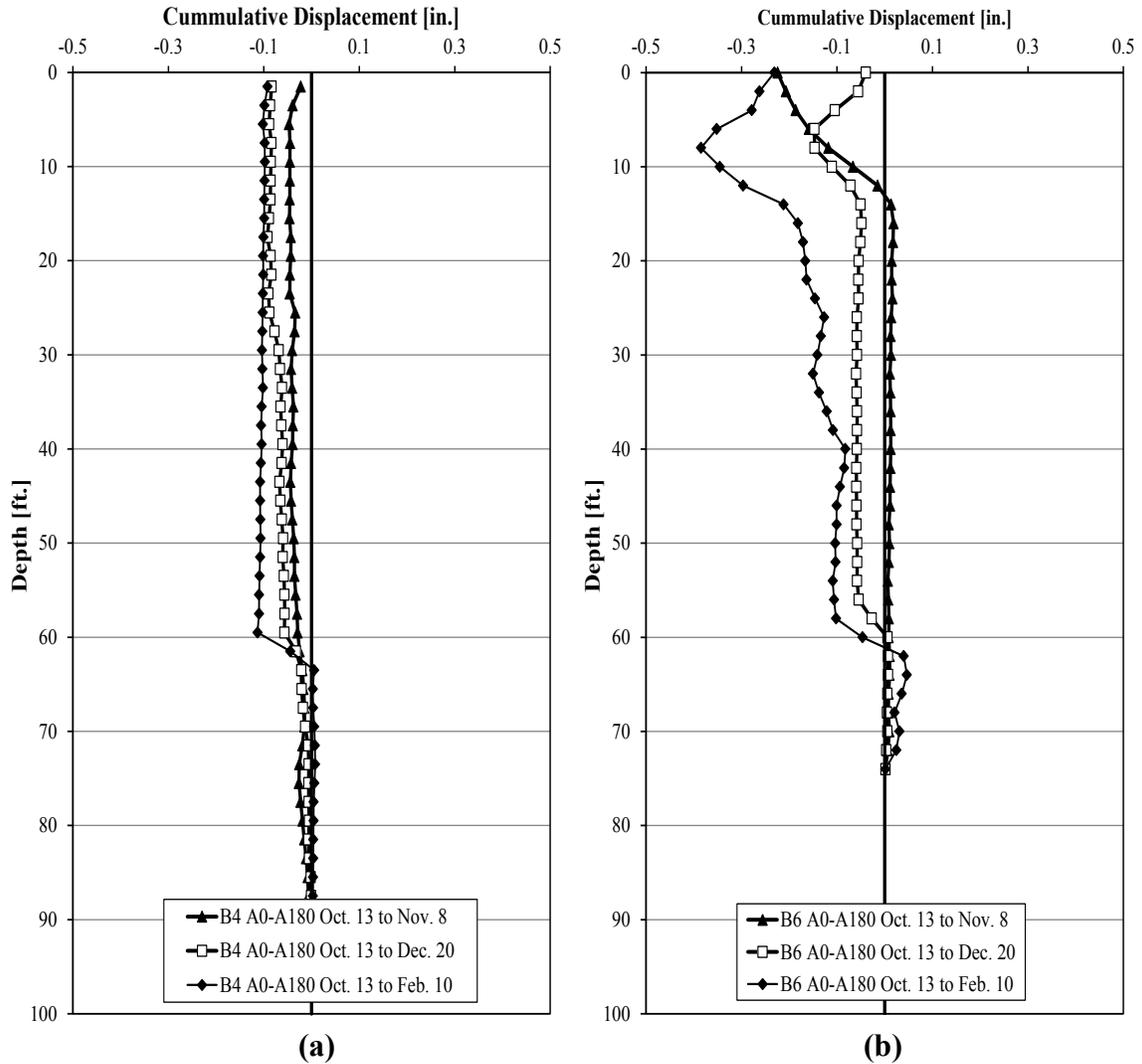
**Figure 3.8. Profile of the slope inclinometer installed at B-4 location for the site visits to the validation site, and b) Profile of the slope inclinometers casing installed at the B-6 location for the site visits to the validation site.**

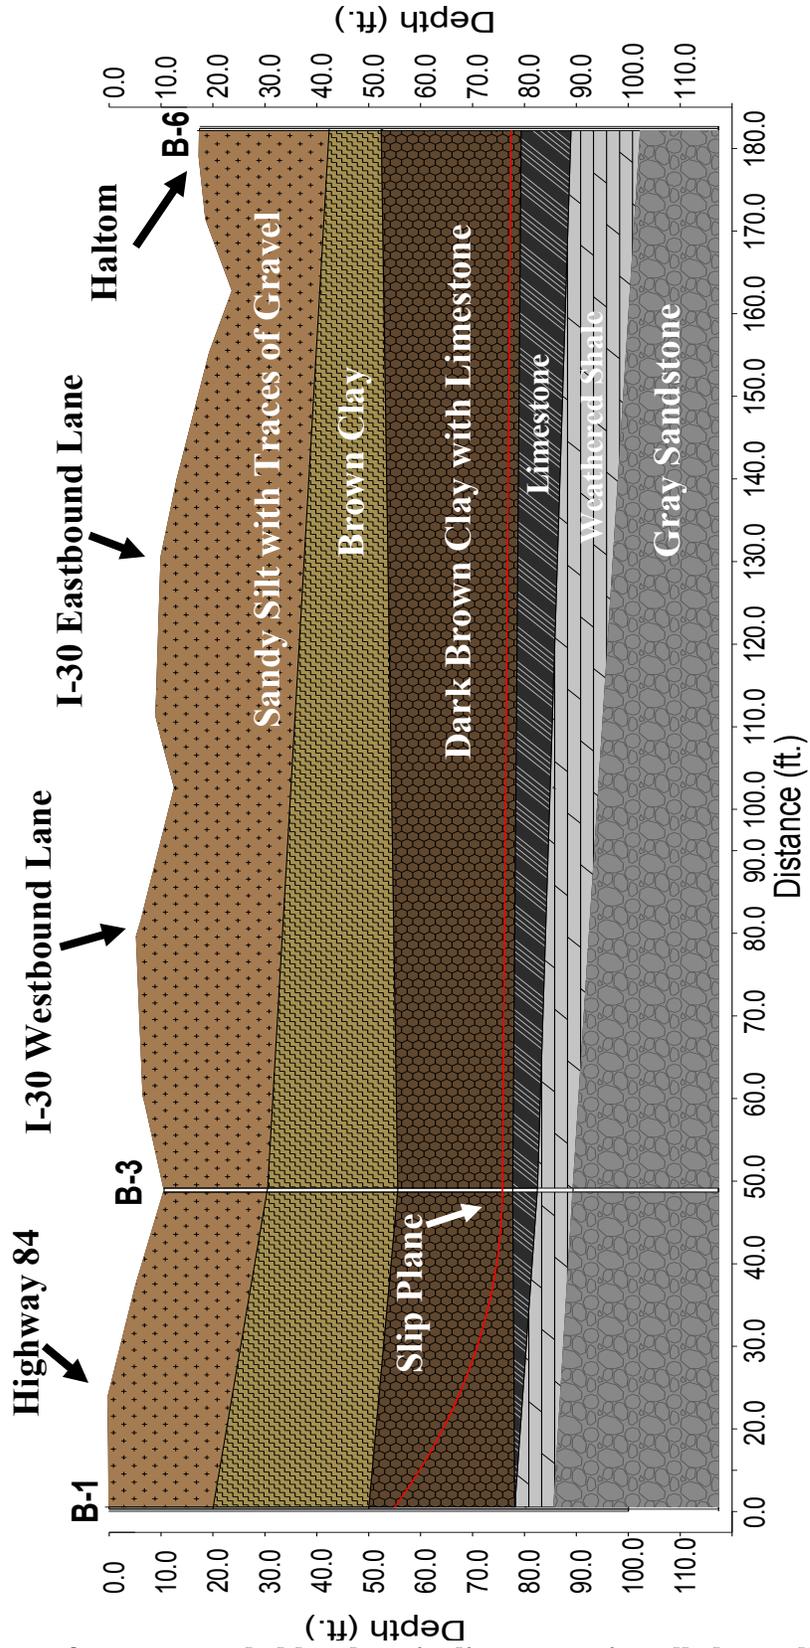
Figure 3.9. Sliding surface as recorded by slope inclinometers installed at validation site [in color].

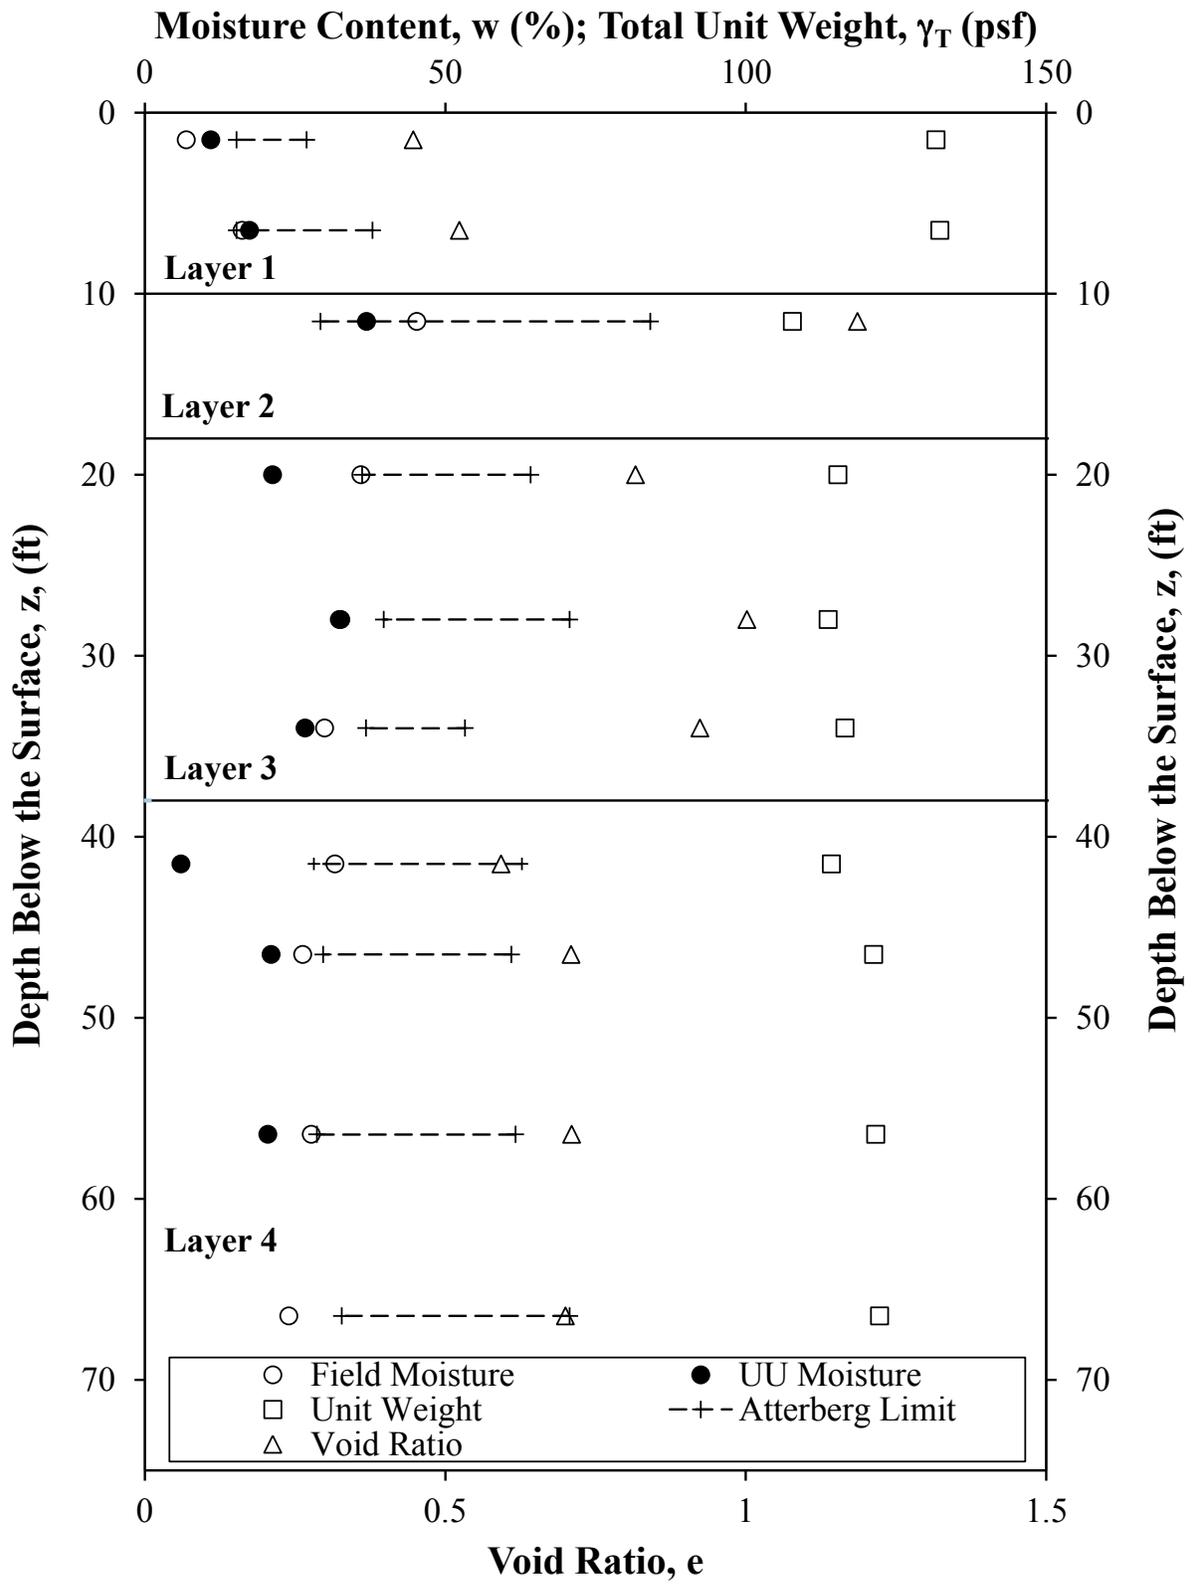
Figure 3.10. Design moisture content, unit weight and Atterberg Limits profile.

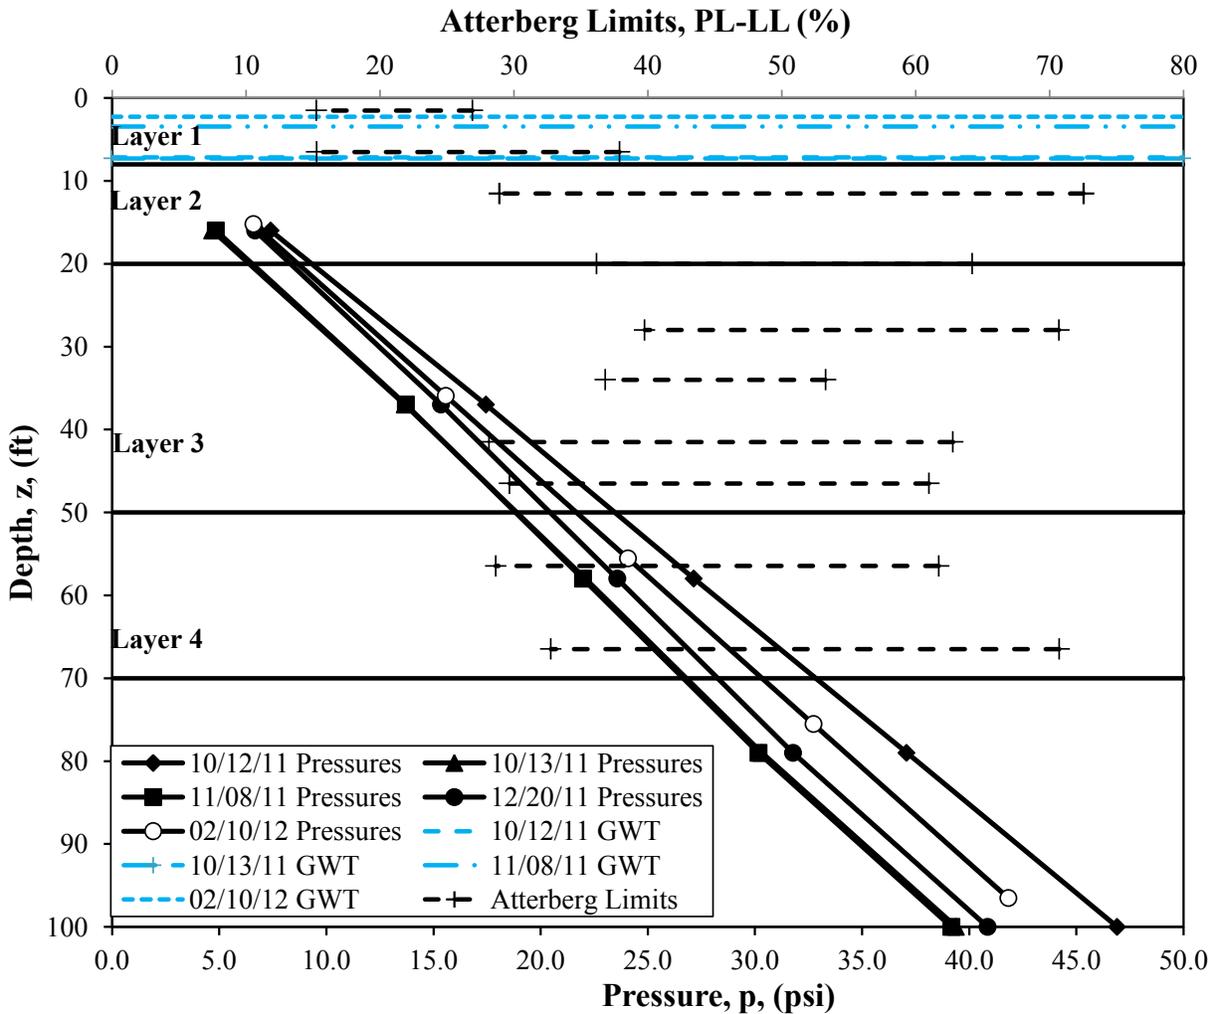
**Figure 3.11. Pressure obtained from the nested vibrating wire piezometer [in color].**

Pressure changes at the location of the slip surface (as measured with the inclinometers) were not observed with the nested vibrating wire piezometer installed within Borehole B-2. However, artesian conditions could have affected the obtained measurements. The ground water table (GWT) depth was inferred from the pressures measured by the transducer sensors (installed at different depths) during the different visits. The GWT was consistent (except for the last site visit) at an approximate depth of 7.3 feet below the ground surface. The GWT depth measured with the nested vibrating wire piezometer coincided with the change in strata as indicated by a change in plastic index (PI) that was obtained from the subsurface investigation. During the last visit to the site, the calculated GWT was at a depth of approximately 2 feet below the ground surface (Figure 3.11). The increased elevation of the GWT correlated with, and was causative of, the increase in displacements rates measured by the inclinometers.
