**Slope Stability Monitoring  
Using Remote Sensing Technologies**

Final Report

FINAL REPORT: AHTD TRC-1102

SLOPE STABILITY MONITORING USING REMOTE SENSING TECHNIQUES

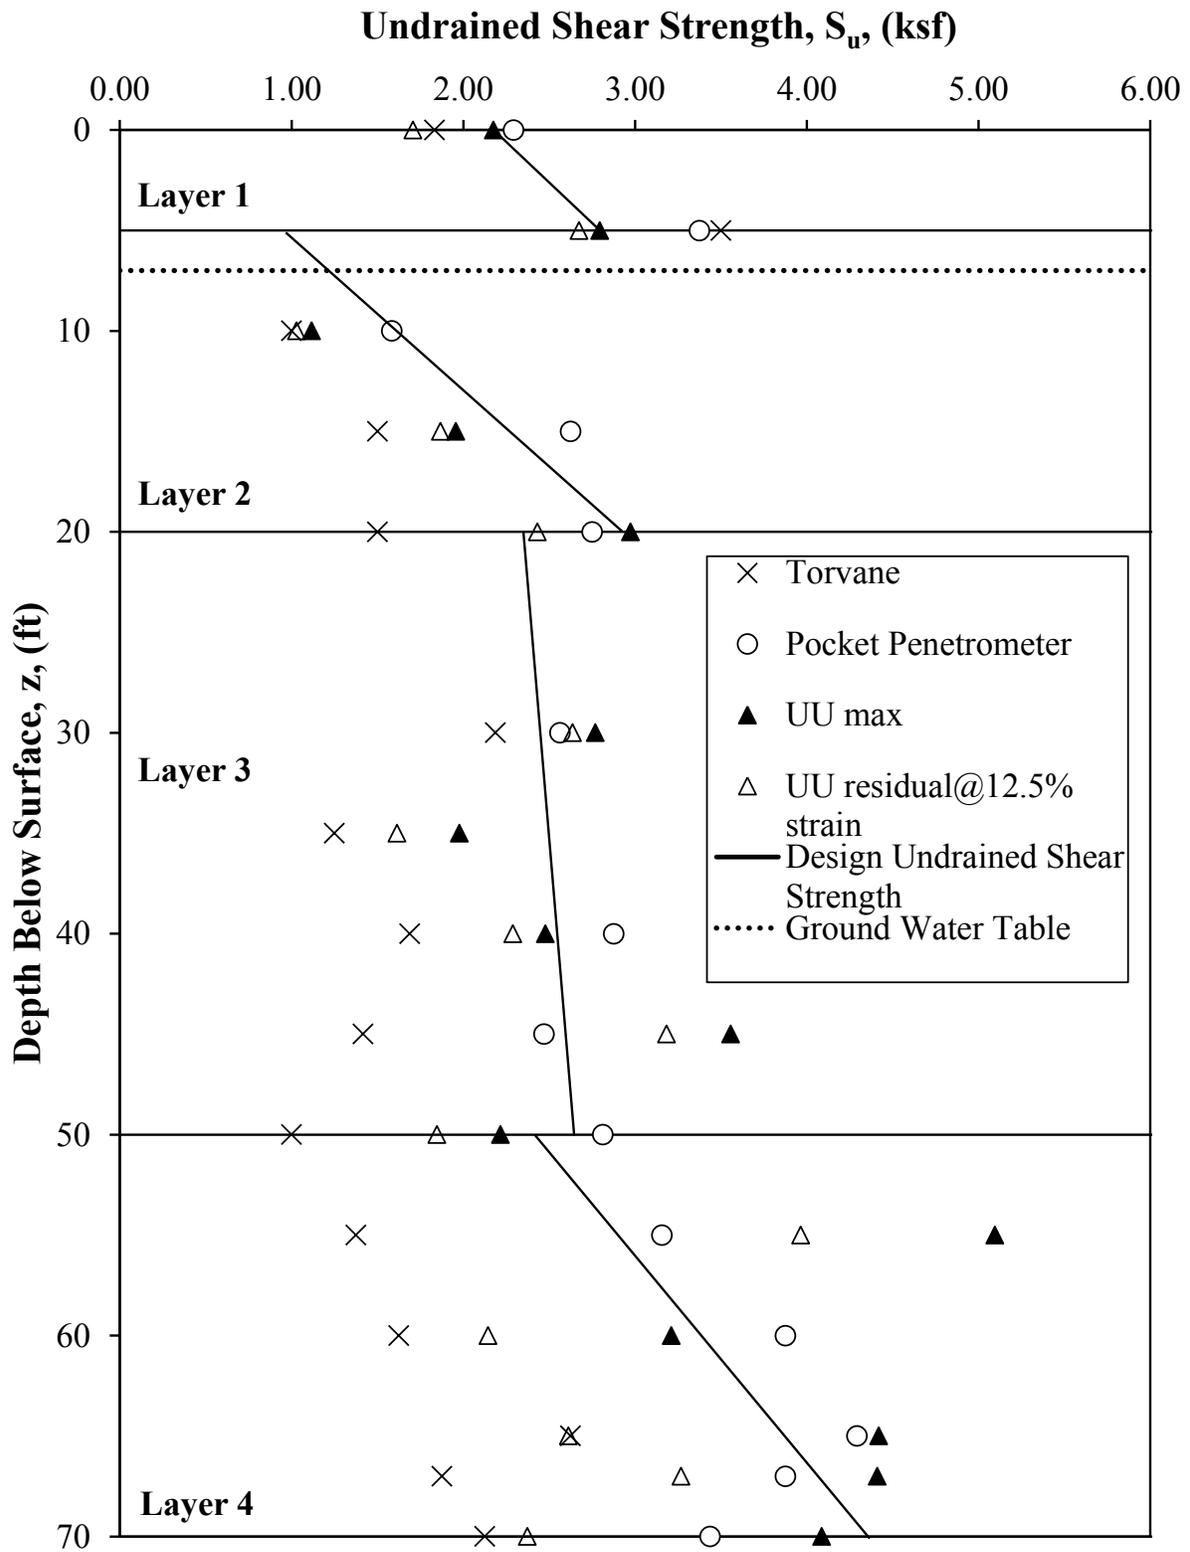
Figure 3.12. Design strength profile for validation site near Malvern, Arkansas.

Unconsolidated Undrained triaxial (UU) tests were performed on the clay samples obtained from the Shelby tubes recovered at the validation site. The UU tests were performed in accordance with (ASTM D2850, 2007). A deviation from ASTM D2850 was that the measurement of the piston friction force at the beginning of the test was obtained by leaving a small gap between the piston and the top cap of the specimen. The results obtained from the strength investigation are presented in Figure 3.12.

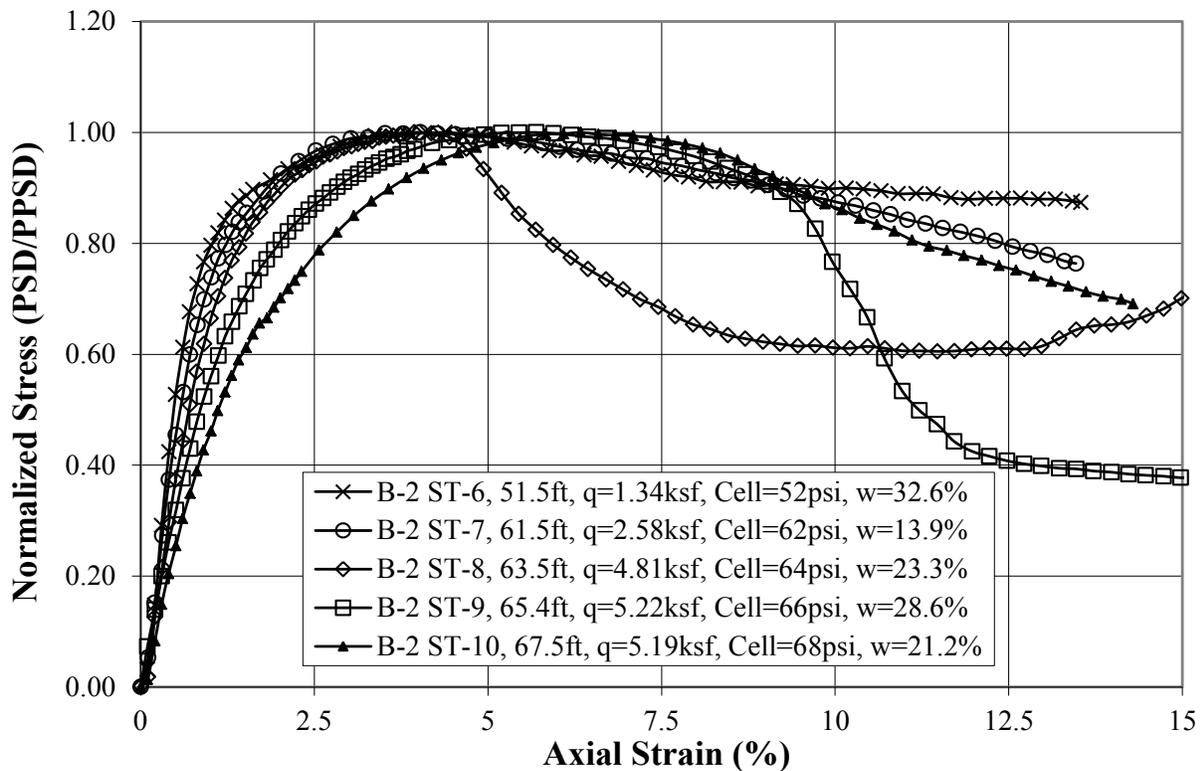
Figure 3.13. Normalized stress-strain graph of UU test results obtained from Boring B-2 specimens at validation site.

Softening behavior was observed in all the specimens during UU testing. The maximum undrained shear strength values obtained varied with the depth of the sample, the moisture content and the soil type. Important parameters such as: the Peak Principal Stress Difference (PPSD), the peak maximum undrained shear stress ( $q$ ), the axial strain at PPSD, the axial strain at 50 percent PPSD, and the residual undrained shear stress at 12.5 percent axial strain were calculated for each test. A distinct loss of shear strength was observed to occur between the peak undrained shear stress values and the residual undrained shear stress values for most of the specimens recovered from depths greater than 61 feet below the ground surface. Normalized stress-strain curves were developed for each UU test. Normalized stress-strain graphs for the Boring B-2 specimens between 51.5 feet to 67.5 feet (the location of the anticipated sliding surface) are presented in Figure 3.13.

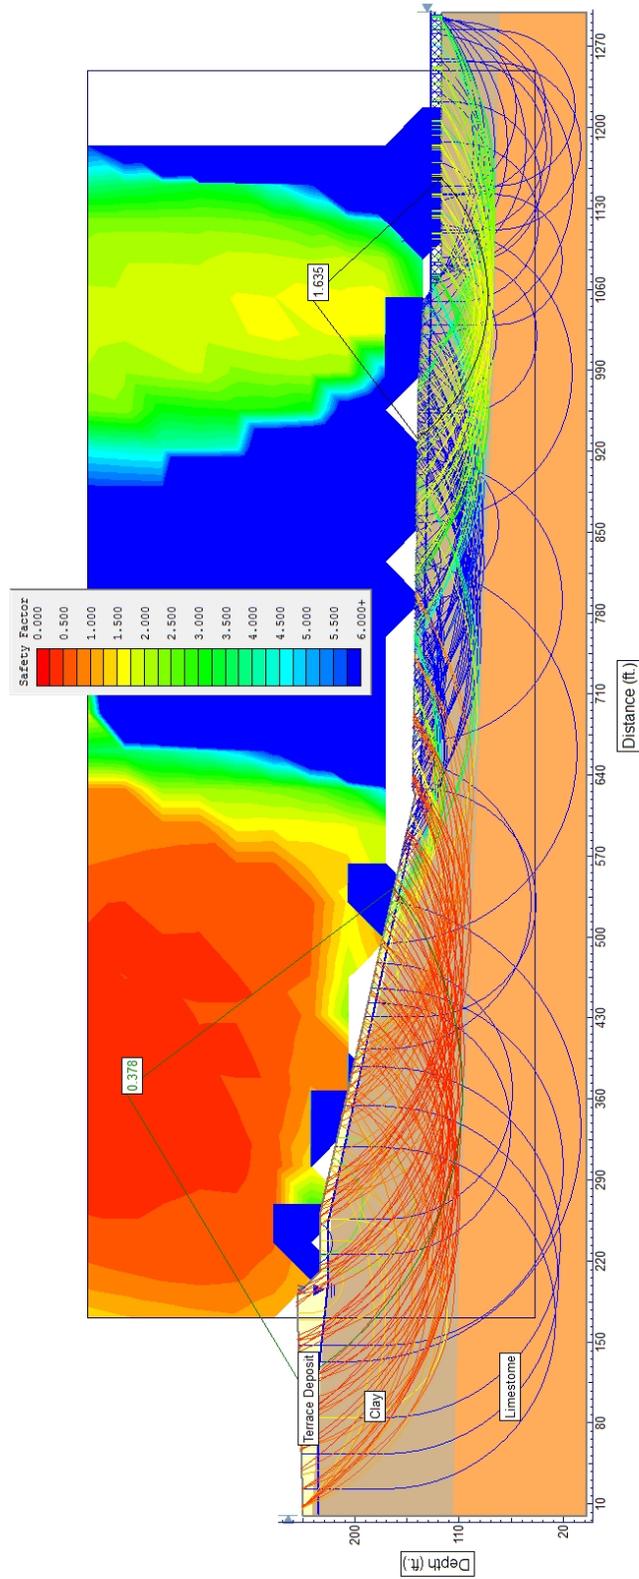
Figure 3.14. Preliminary slope stability model for validation site using UARK correlation.

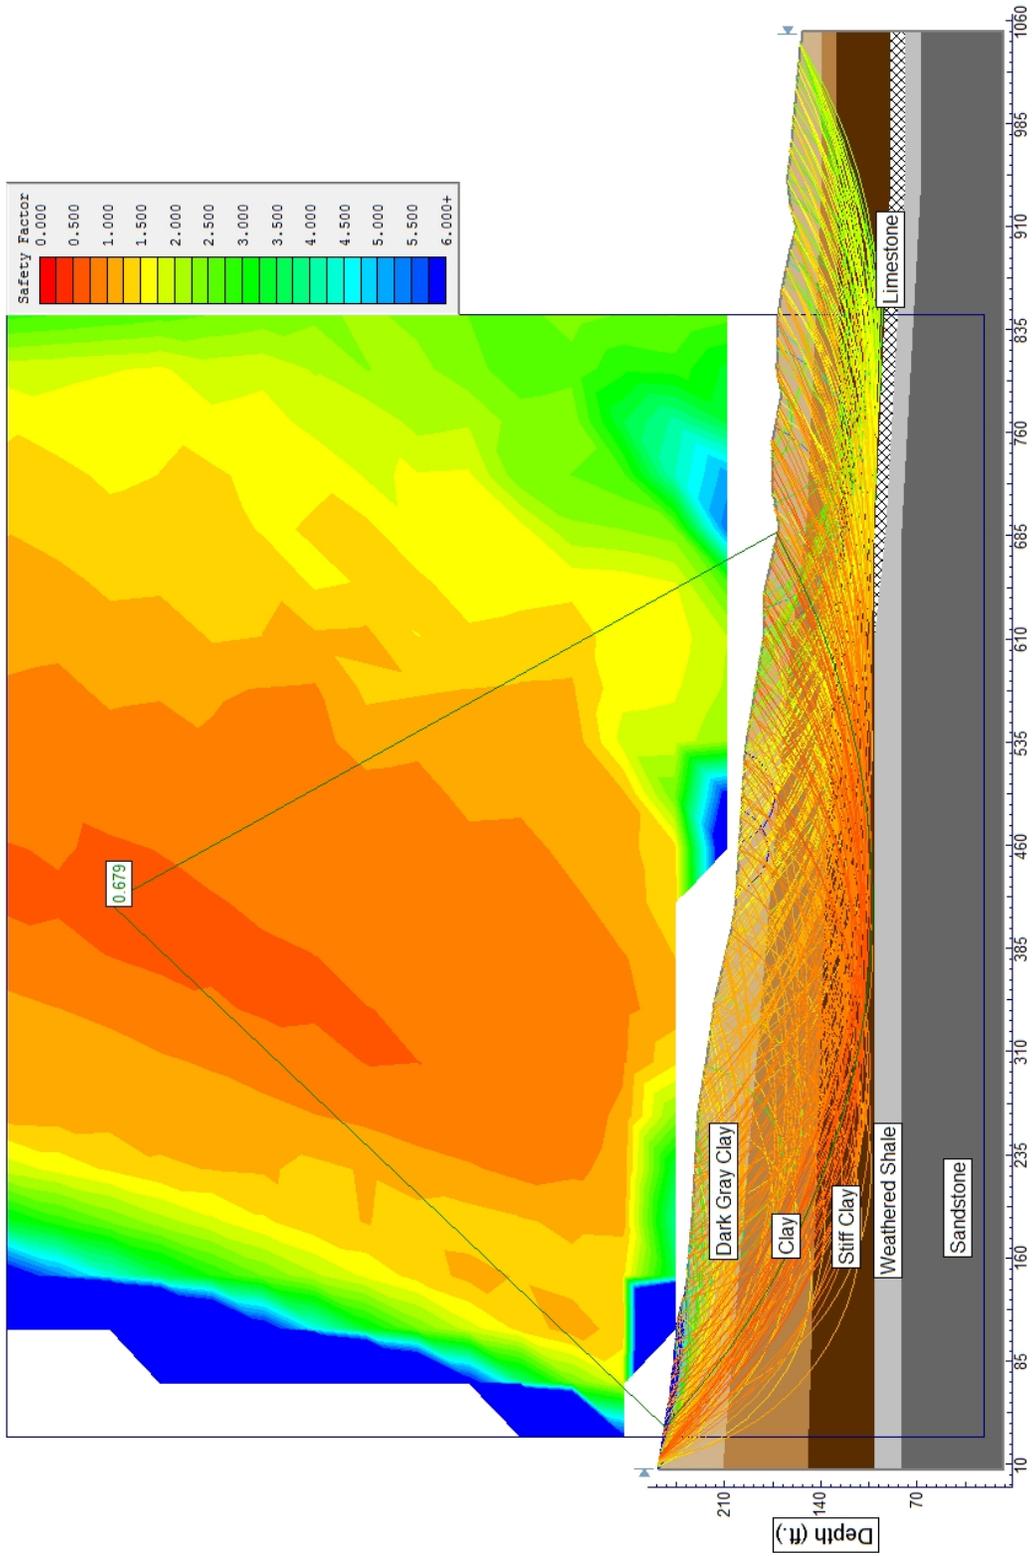
Figure 3.15. Refined slope stability model for validation site using UARK correlation.

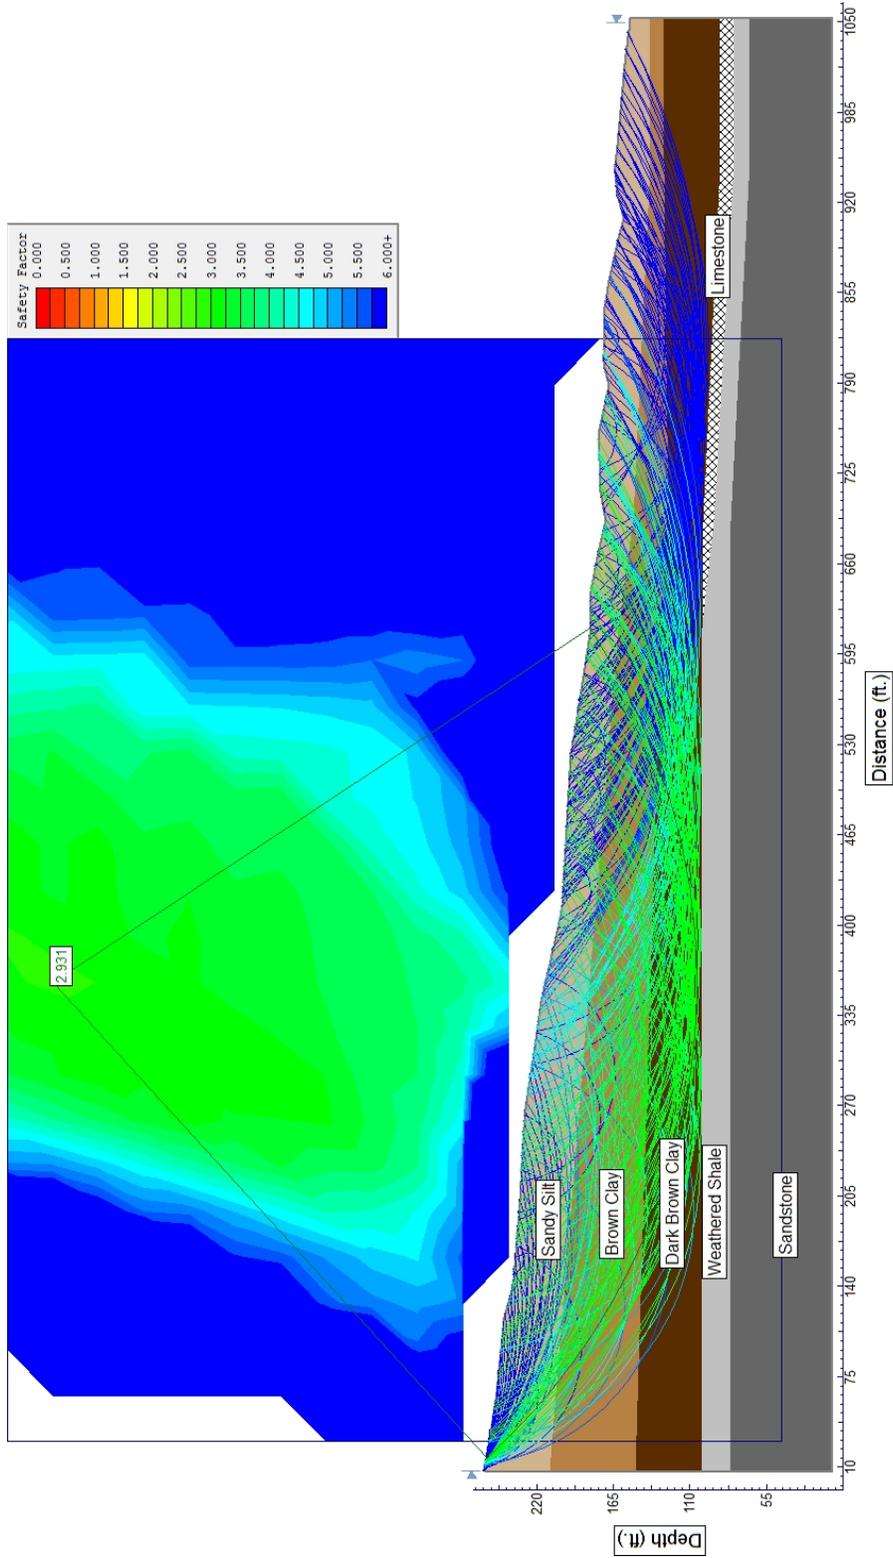
**Figure 3.16. Refined slope stability model for validation site using UU test results (residual undrained strength).**

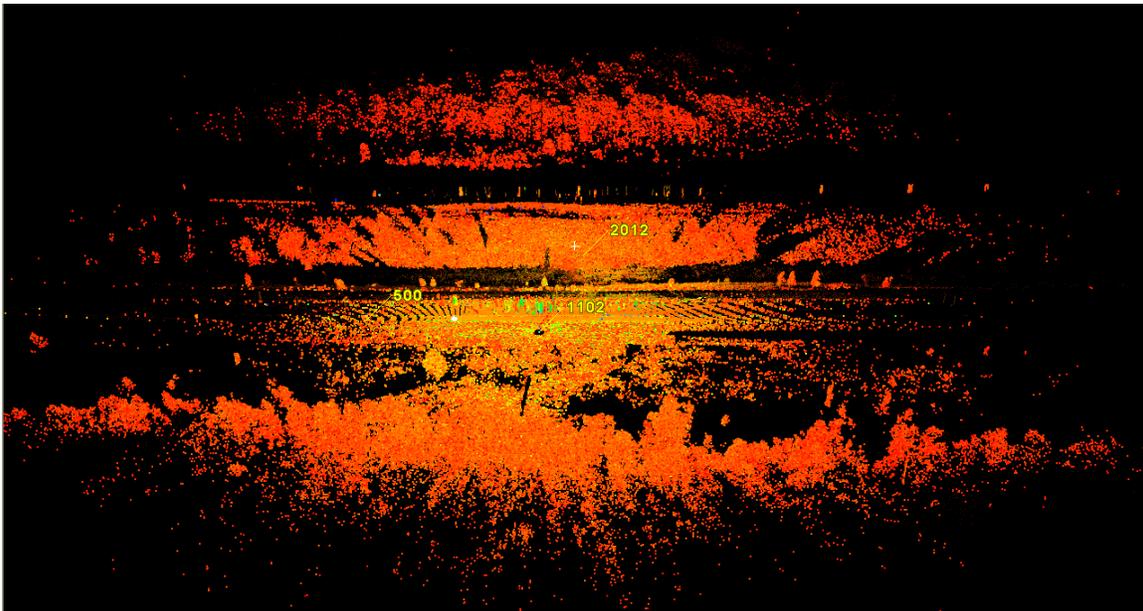
**Figure A.1. Point cloud for Chester site in Leica Geosystems Cyclone software suite.**

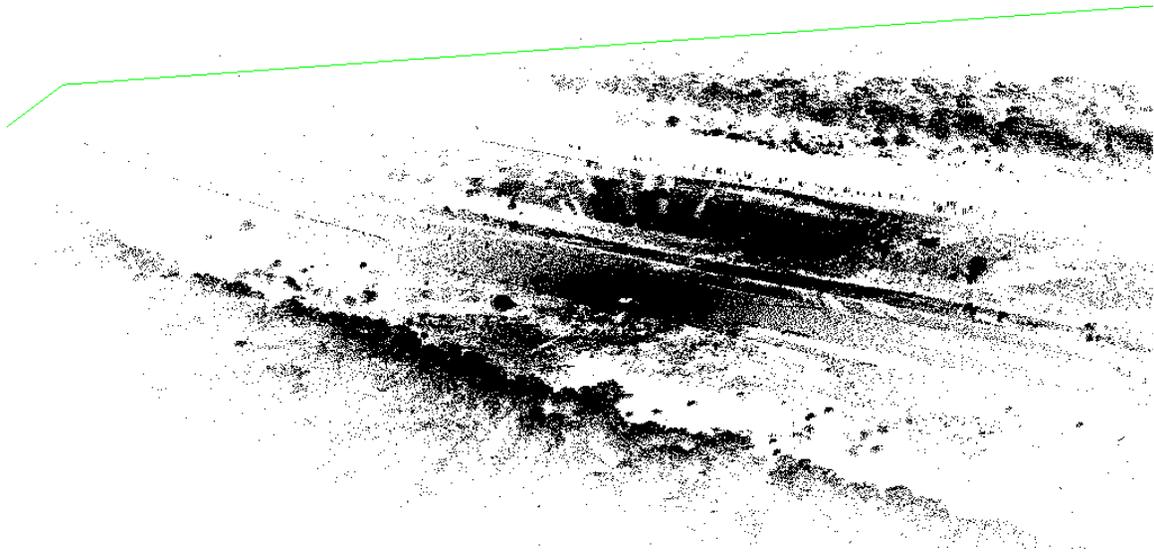
**Figure A.2. Unified point cloud (.las) as viewed in lastools lasview.exe.**

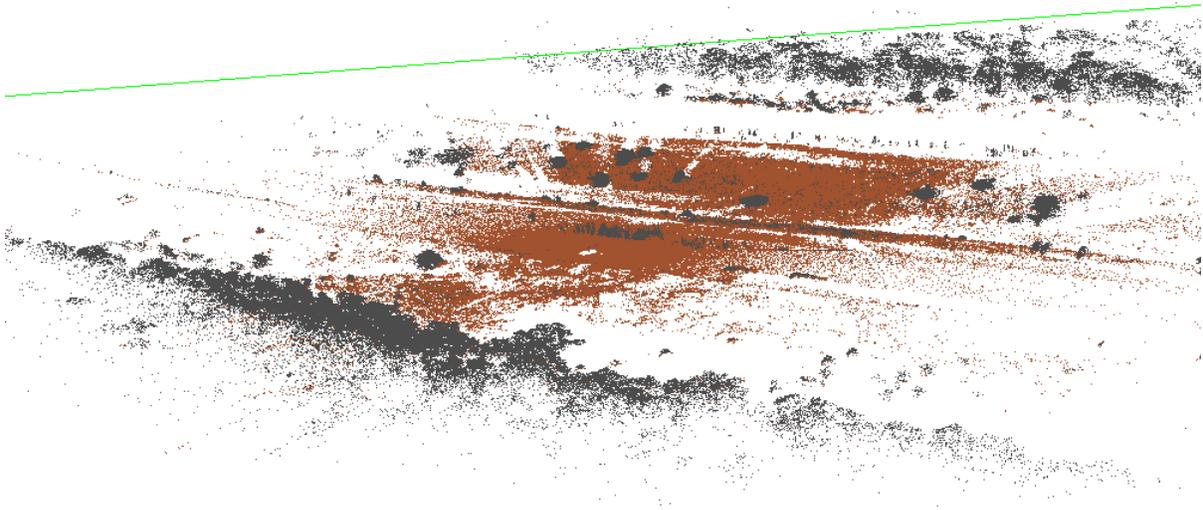
**Figure A.3. Both vegetation and non-vegetative points.**

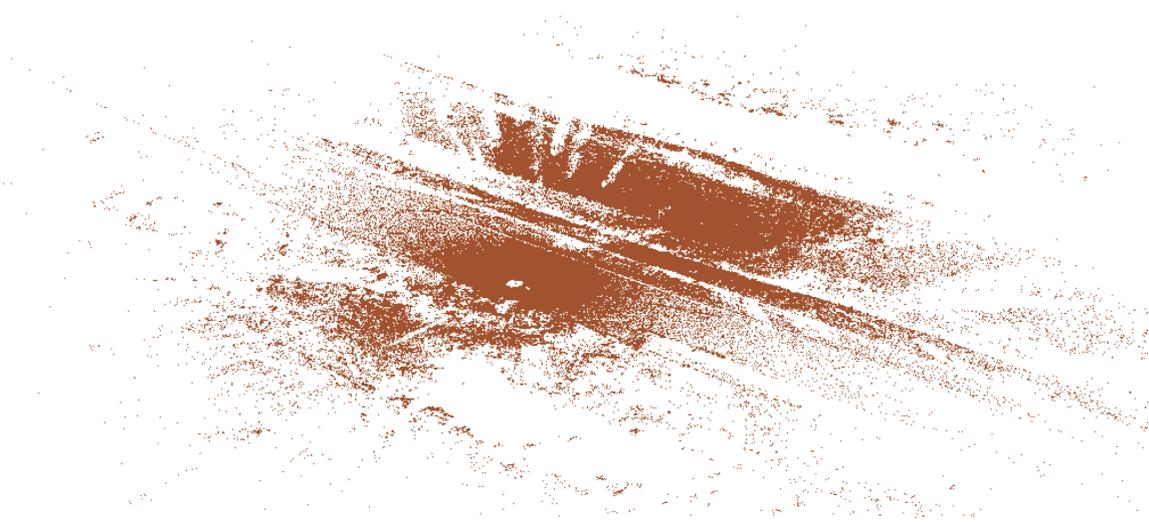
**Figure A.4. Ground point cloud after separation.**

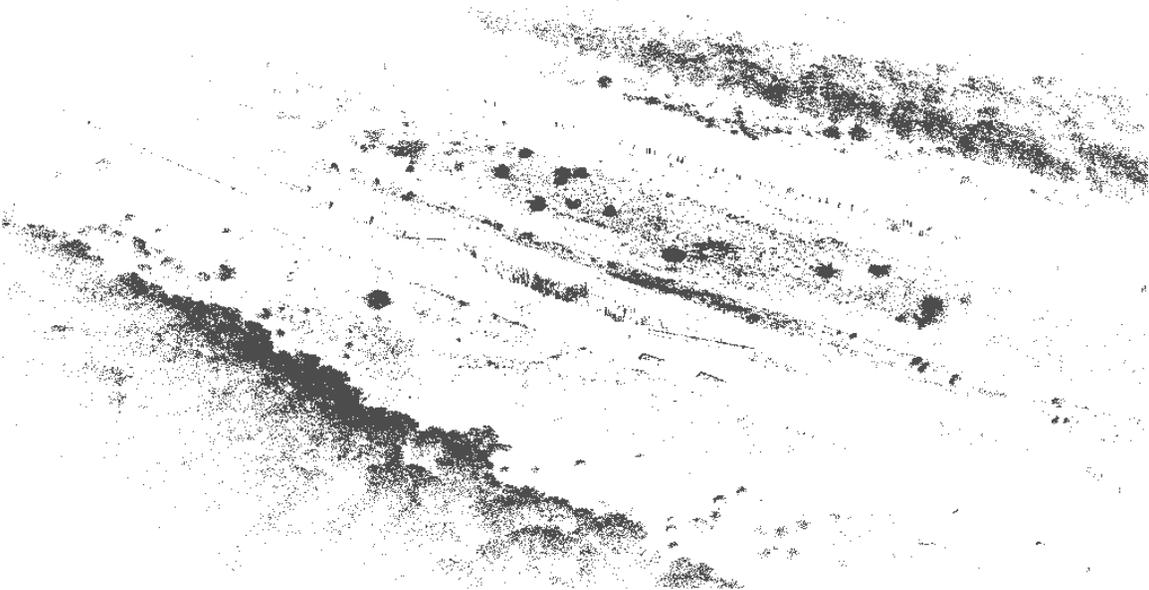
**Figure A.5. Vegetation points after separation**

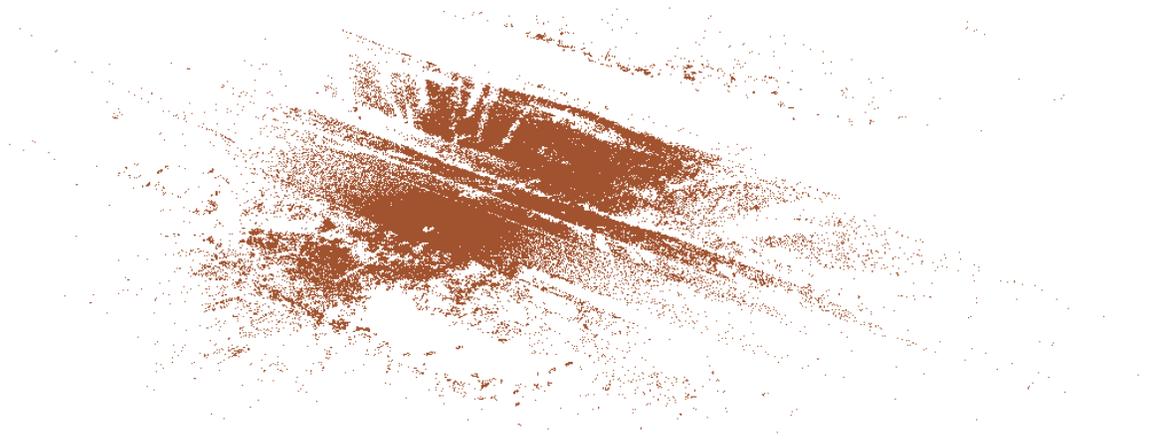
**Figure A.6. Ground point cloud after thinning.**
