**The Structural Evaluation of
Precast Concrete Slab Panels in
Bridge Superstructures**

Final Report

June 2004

**Sponsored by the
Arkansas State Highway and
Transportation Department**

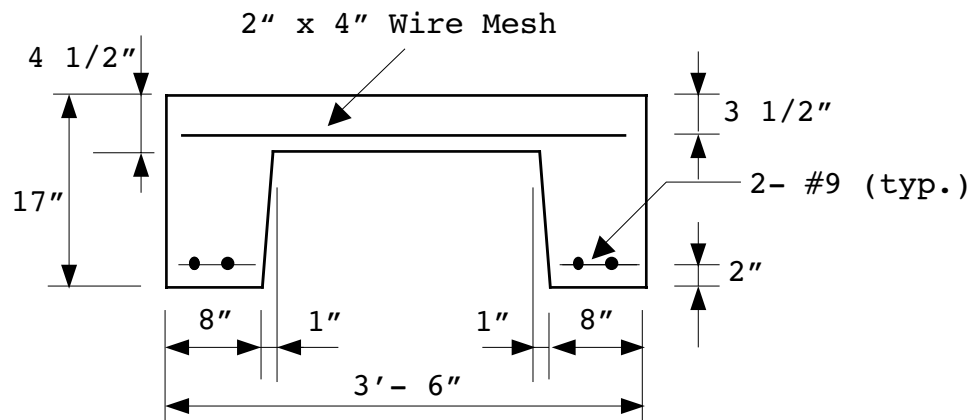
Figure 1: Cross-Section View of Interior Channel Beam

Recently, the Arkansas State Highway and Transportation Department (AHTD) discovered that several precast, non-prestressed, concrete channel beam bridge superstructures are experiencing extensive deterioration. The deterioration is due, at least in part, to reinforcing steel corrosion. The particular precast channel beam sections studied in this technical report have a 19 ft span length and were constructed without shear reinforcement. Design details for the studied sections were developed in 1952 and were designed for a H15 truck loading. A detailed cross-section of a single interior beam section is shown in Figure 1 with an elevation view shown in Figure 2.

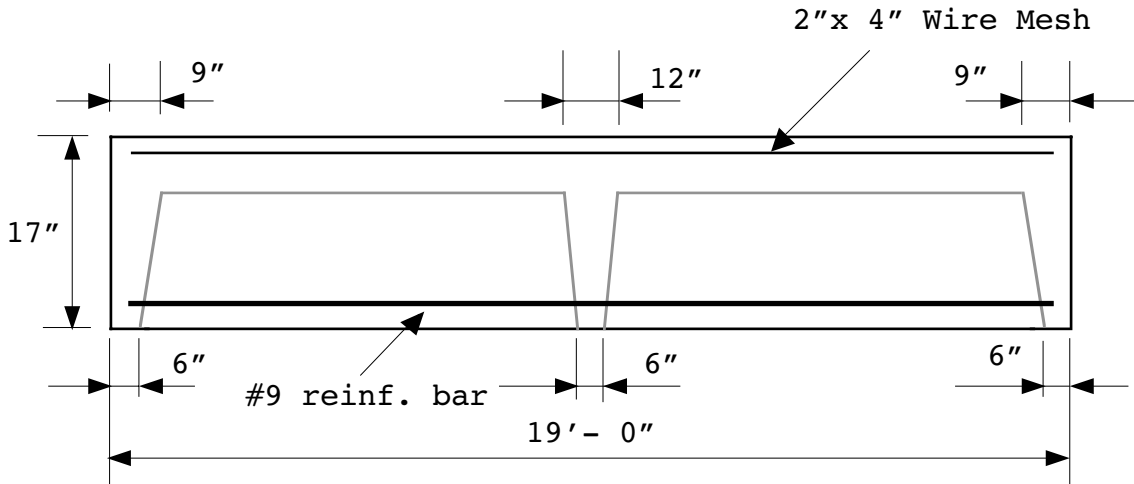
Figure 2: Elevation View of Interior Channel Beam

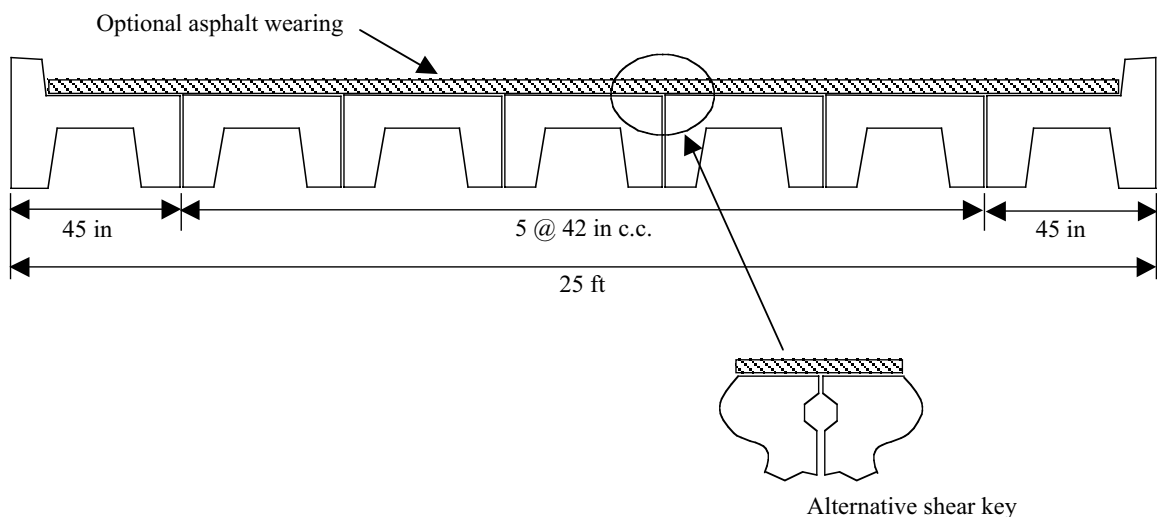
During the period from the mid-1950's through the mid-1970's a large number of bridges were constructed throughout Arkansas using a then standard, 19 ft long precast, non-prestressed, concrete channel beam. When positioned side-by-side and end-to-end, and subsequently bolted together, these beams become the superstructure of the bridge. This configuration is extremely practical as the stems of the channel resist both flexure and shear forces while the flange acts as the bridge deck, Figure 3.

Figure 3: Bridge Cross-Section

Six beams were selected by AHTD personnel from the Jenkins’ Ferry Bridge. This bridge spans over the Saline River on State Highway 46 in Grant County, Arkansas. The bridge cross section was consistent with that depicted in Figure 3. An asphalt overlay was removed from the surface of the beams prior to load testing at ERC. The sections were noted as being in “Poor” condition due to extensive longitudinal cracking, reinforcing steel corrosion, concrete spalling, and exposed reinforcement. Half of the beams tested were previously field repaired using a shotcrete method. These three sections are labeled “Repaired” in this report.

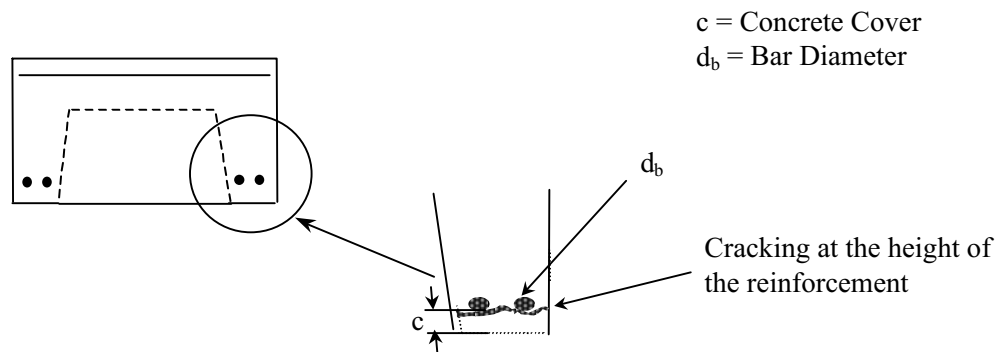
Concrete cover acts to protect the reinforcing steel from corrosion. The concrete cover (c) to bar diameter (d_b) ratio is an indicator for the potential of longitudinal cracking and spalling of the concrete, which then exposes beam reinforcement to water seepage [1], Figure 4. Emmons shows that with a c/d_b ratio of 7, concrete begins cracking when the level of corrosion reaches 4% [1]. However, when the c/d_b is lowered to 3, cracking begins with only 1% corrosion.

Figure 4: Corrosion-Induced Cracking

The c/d_b ratio for the beams examined in this report is approximately 1.3, suggesting that very little corrosion is required before cracking is initiated. This explains the excessive cracking located adjacent to the stem reinforcement. Most importantly, corrosion leads to

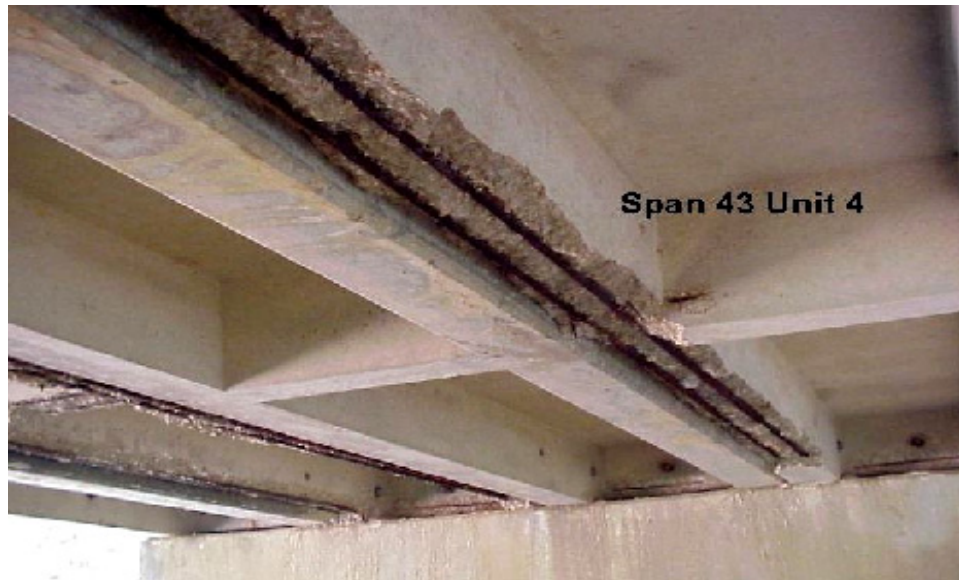
During the 2000 inspection of a channel beam bridge located near Jenkins' Ferry, AR, a lack of concrete cover and longitudinal reinforcing steel corrosion in the beam stem raised a concern for the structural integrity of the bridge. An underside picture of span 43 of the bridge is shown in Figure 6.

Figure 6: Deterioration of Jenkins' Ferry Bridge

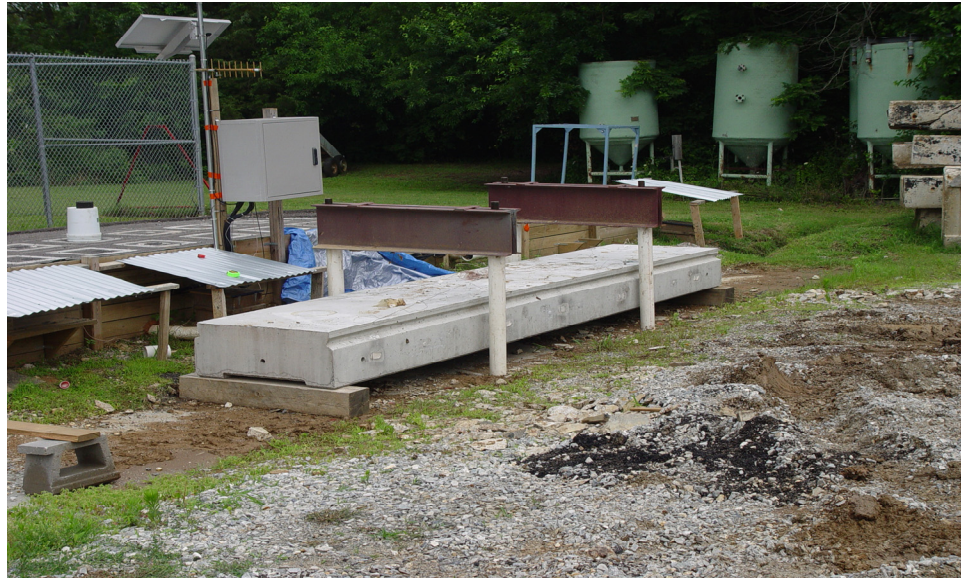
Figure 8: Precast Channel Beam in “New” Condition

Visual inspection was used to categorize the beam sections as New, Good, Average, Poor, or Repaired. Categorizing the beams was subjective and primarily based on the percentage and location of exposed longitudinal reinforcing steel. A “New” section, Figure 8, is a newly fabricated section. A “Good” section, Figure 9, is one with little evidence of deterioration. A section defined as “Average,” Figure 10, has visible cracks, may have concrete staining on the beam stem, and may have limited spalling. Sections with extensive spalling and reinforcing steel corrosion are denoted as “Poor” as shown in Figure 11. A “Repaired” section is one that has undergone a field repair typically using a shotcrete technique, Figure 12.

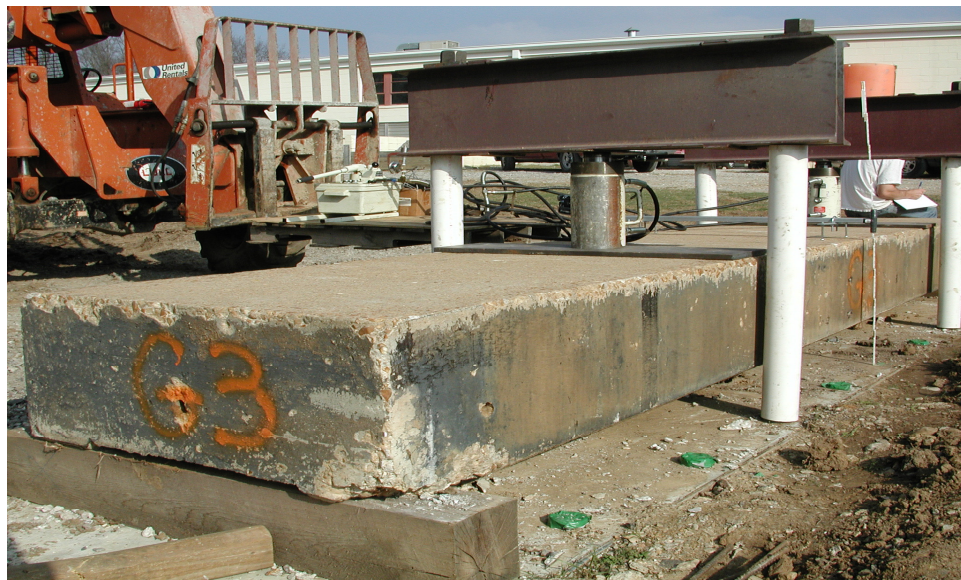
Figure 9: Precast Channel Beam in “Good” Condition

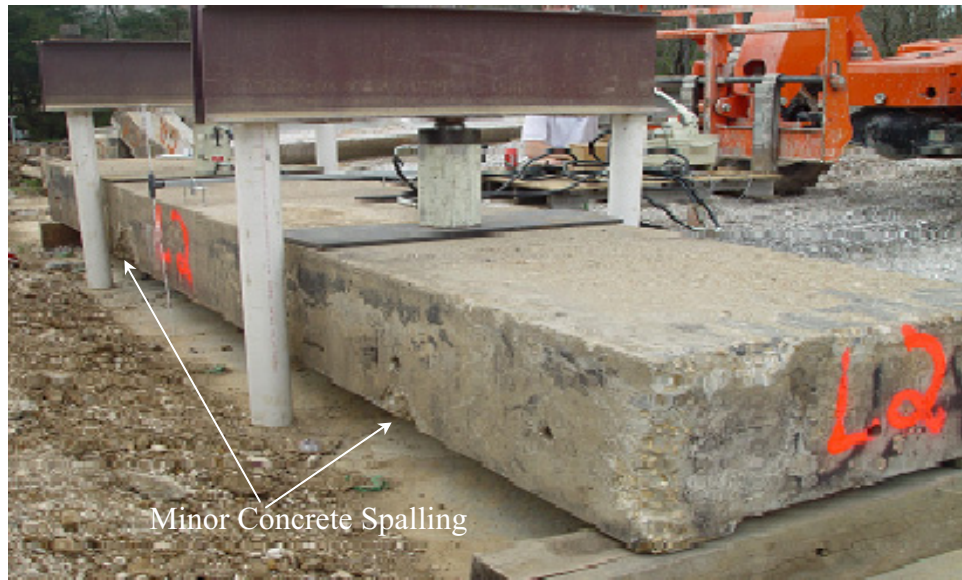
Figure 10: Precast Channel Beam in “Average” Condition

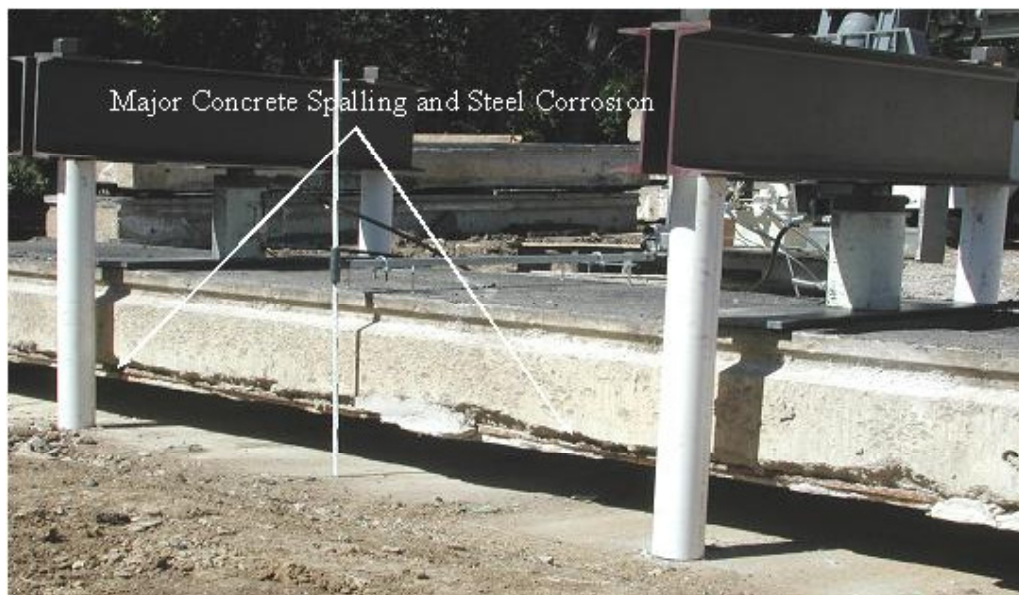
Figure 11: Precast Channel Beam in “Poor” Condition

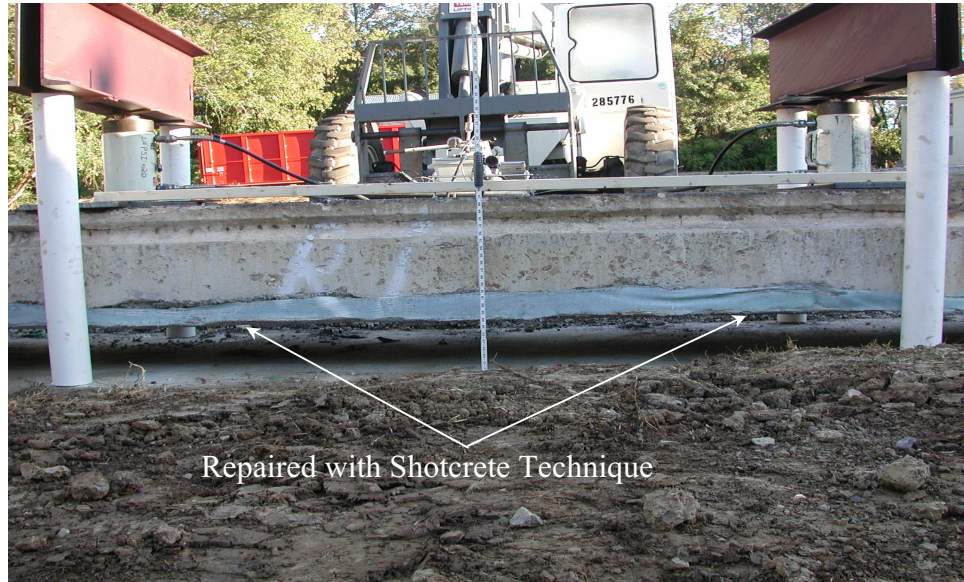
Figure 12: Precast Channel Beam in “Repaired” Condition

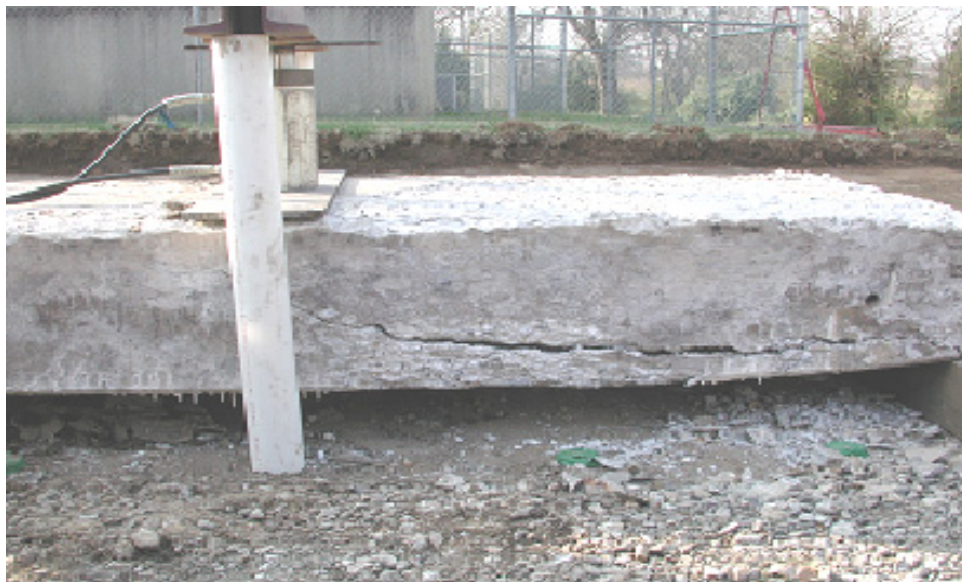
Eight beams were selected from the Little Osage Creek Bridge on State Highway 12 near Cave Springs, AR, in Benton County. This two-lane bridge is near a Wal-Mart® distribution center. Consequently, these units were subjected to a large number of heavy truck loadings over several years. Longitudinal cracking and concrete spalling accompanied by poor quality concrete, resulted in the “Poor” classification of these beams. An examination of the underside of this bridge revealed the widespread presence of white-colored “stalactites”, Figure 13. Many of these “stalactites” were located along the longitudinal joints between the precast panels, suggesting that water is traveling between the beams and seeping to the steel reinforcement. An asphalt overlay was removed prior to load testing and revealed a heavily deteriorated concrete surface with concrete chunks that could easily be removed by hand.

Figure 13: Stalactites on Underside of Panel

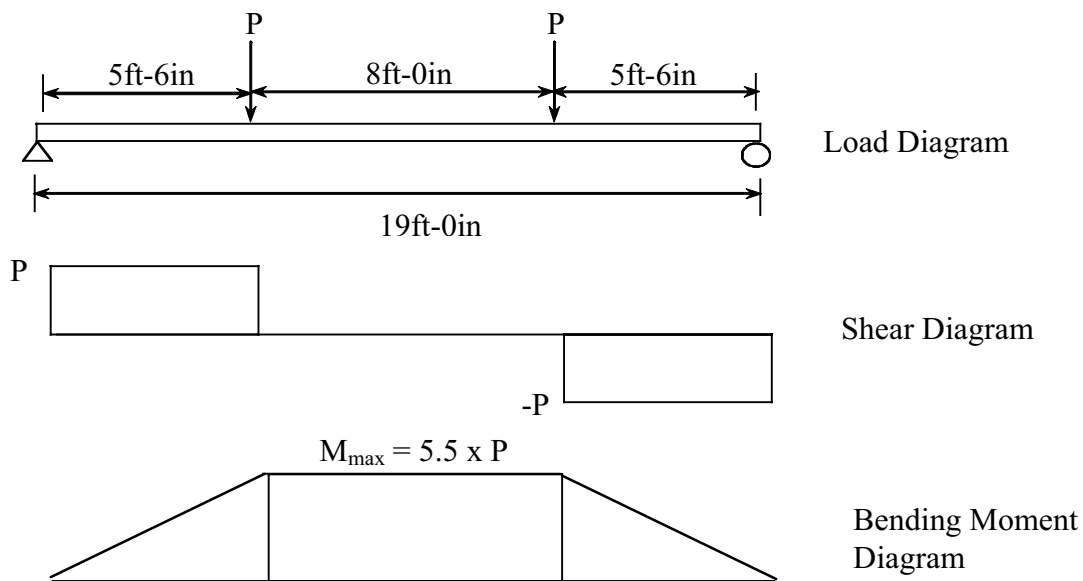
The channel beams were positioned onto the testing bed using an 8 k all-terrain forklift. Each end of a beam rested on an 8-in x 8-in x 48-in solid oak timber block. The length of the end support is similar to that provided by a pier cap in the field. Once the beam was positioned, four 2-1/4-in diameter threaded steel bars, 5 ft in length, were screwed into the reaction beam, Figure 16. A rod was positioned on each side of the beam adjacent to the point loads. A four-inch diameter PVC pipe, approximately 3 ft - 5-in long, was placed over each steel rod for protection and to support a welded double channel cross-member. Nuts were threaded onto each rod, above the built-up channel section, to lock the channels in place.

Figure 14: Equivalent Force Diagram

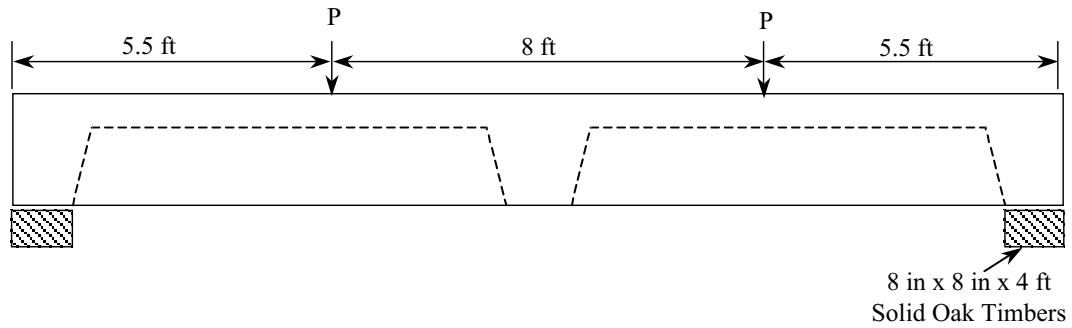
A hydraulic jack was placed on the concrete beam beneath each of the two double welded channel sections to produce a concentrated force on the beam. A 12-in x 42-in x 0.5-in steel plate was used beneath each jack in order to uniformly distribute the load across the width of the beam. The jacks were linked in parallel, each applying an equal force to the two concentrated load points. Load was applied using a manually actuated pump and monitored by a digital pressure gauge attached to the hydraulic lines supplying each jack. Pressure was then converted to load using the known jack surface area. During loading, midspan deflection was continuously recorded using a digital video camcorder. The camcorder was attached to the beam and measured the midspan beam deflection relative to a stationary measuring stick. Load and midspan deflection were recorded in load increments during testing.

Figure 15: Side View of Loading Configuration

The precast channel beams were load tested to failure to determine the load carrying capacity of each section. During Task 2, the correlation between applied load and midspan beam deflection, mode of failure, crack propagation, and elastic-plastic behavior was investigated. A four-point loading scheme was used to determine the load capacity of each beam. Two, 200 k reversible hydraulic jacks located 5 ft – 6-in from each beam end were used to apply two concentrated forces to the beam. This loading configuration produces a constant and maximum bending moment in the center 8 ft section of the beam, and a constant and maximum shear in the outer spans. The loading, bending moment, and shear diagrams due to the applied loading are shown in Figure 14. The side view and cross-sectional views of the load frame are given in Figure 15 and Figure 16 respectively.

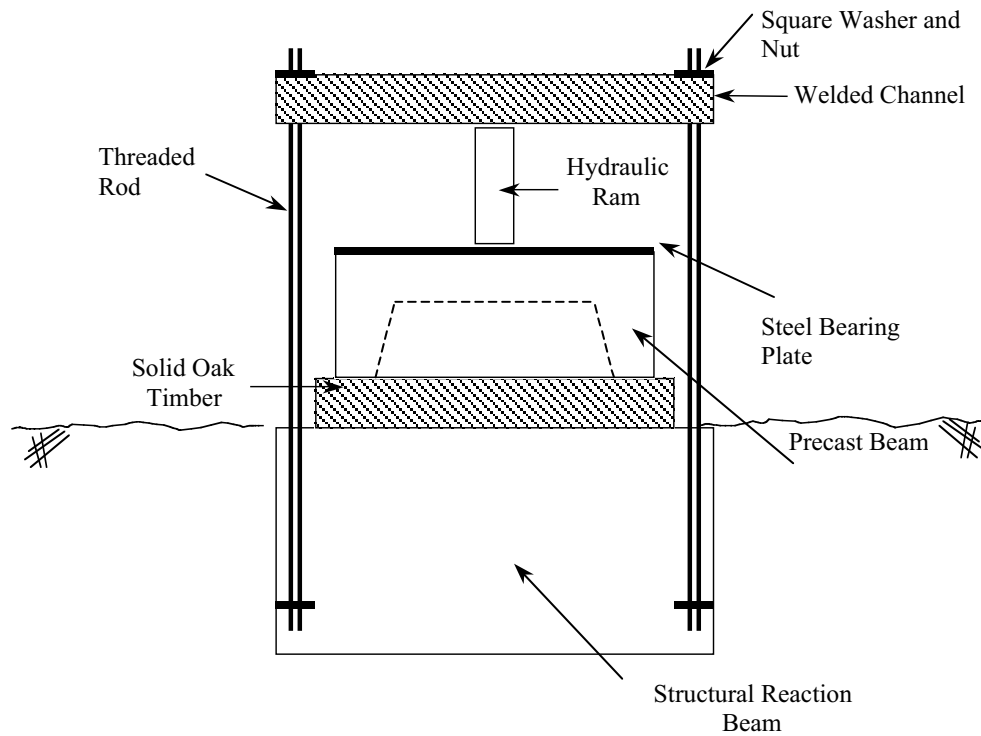
Figure 16: Cross-Section of Loading Configuration

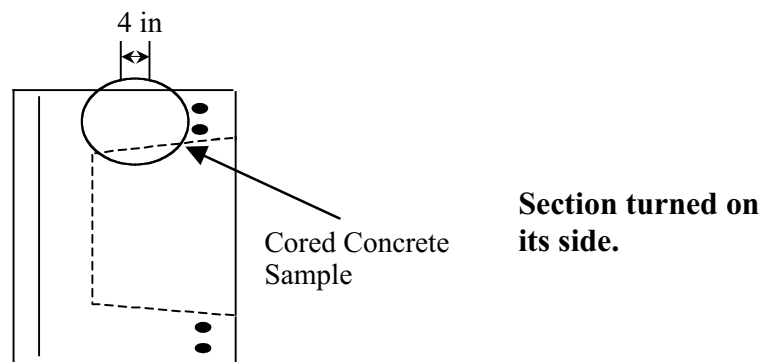
were cut with an acetylene torch to a 12-in length. Each #9 bar was then cut to an 8-in length and turned down by a machinist to a 0.5-in diameter. An extensometer was mounted on each specimen and tension loaded in an MTS machine. The yield and ultimate strengths were identified from the test data using the “Direct Method,” as described in ASTM E8. The yield strength was recorded as the average of the three bars tested at each bridge location.

Figure 17: Method of Obtaining Concrete Compressive Sample

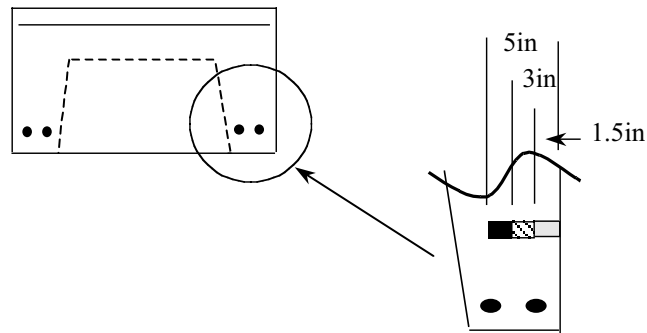
height at a distance of 1.5-in, 3-in and 5-in from the outside surface of the beam stem as shown in Figure 18. The chloride samples were then analyzed by Challenge Environmental Laboratory, LLC of Fayetteville, Arkansas.

Figure 18: Method of Obtaining Chloride Sample

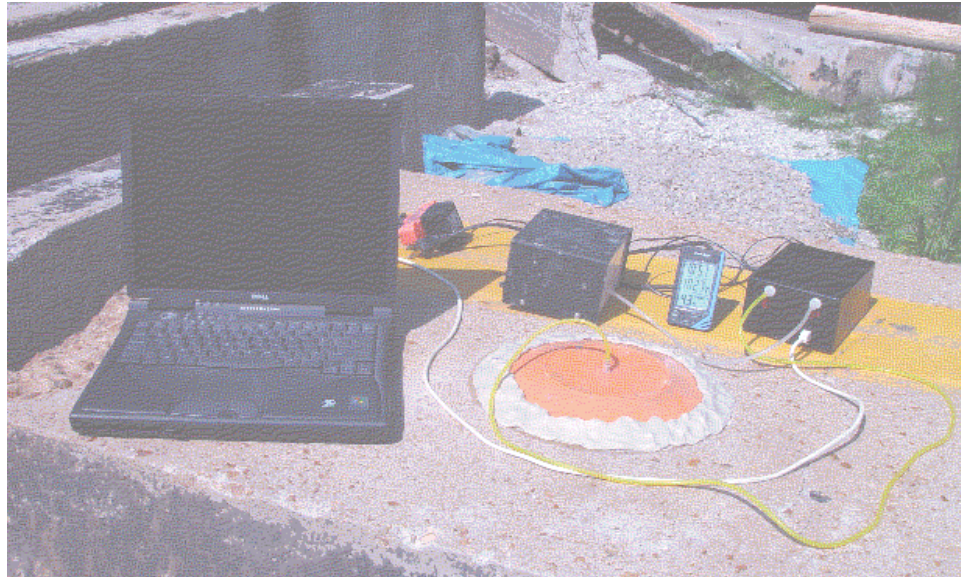
Water seepage due to high concrete permeability was investigated as a possible cause of reinforcing steel corrosion using a non-standard, but highly accurate permeameter, the Kuss Permeameter. The Kuss Permeameter is a recently developed testing device to quickly establish a relative permeability for a given concrete sample. In the procedure, a 2-in wide ring with a 12-in outside diameter is sealed on the surface with a clear spray-on sealer. An 8-in diameter pressure difference plate is then sealed to the ring. A nominal pressure difference is applied to the plate to measure permeability. The permeability setup is shown in Figure 19. The volume of air required to maintain the pressure difference is measured to determine a relative permeability.

Figure 19: Kuss Permeability Setup

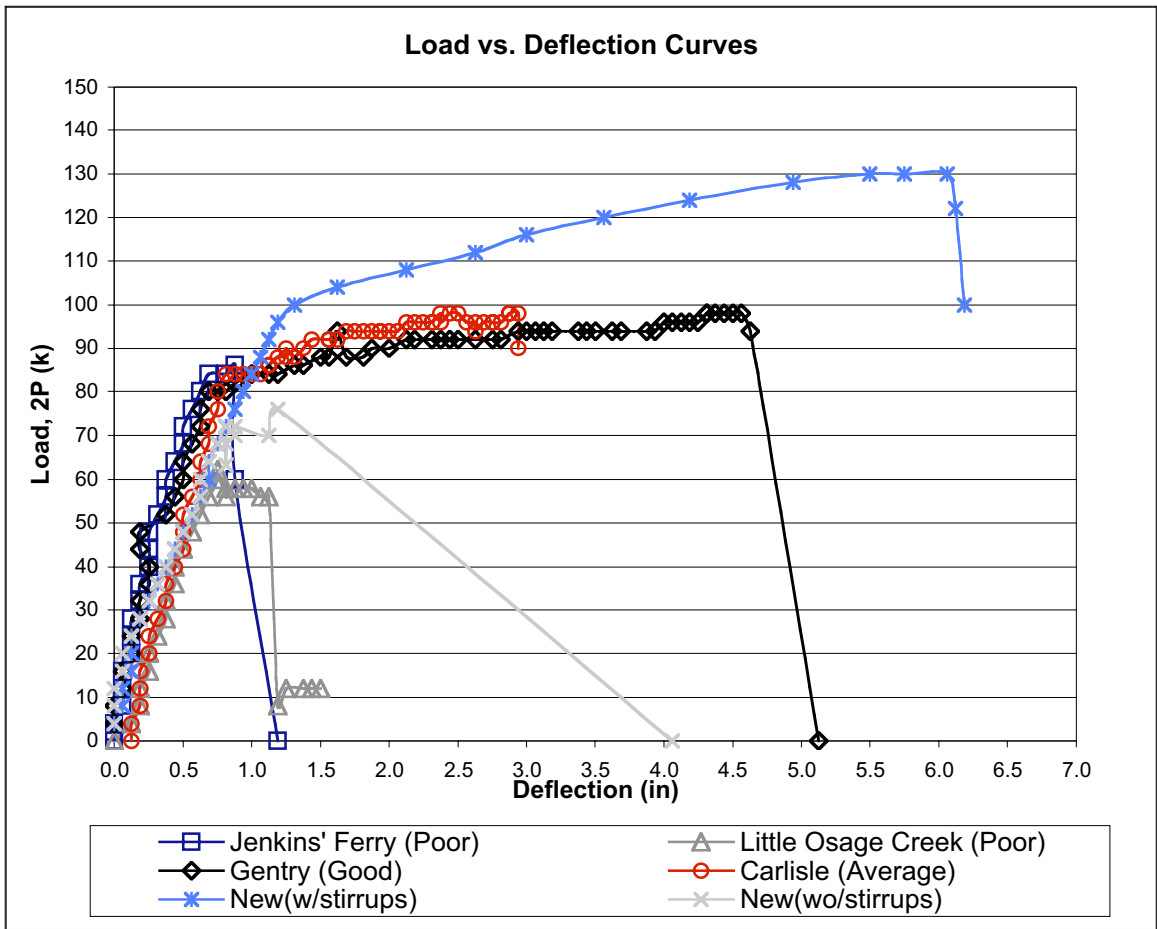
Figure 20: Typical Load Versus Deflection Behavior

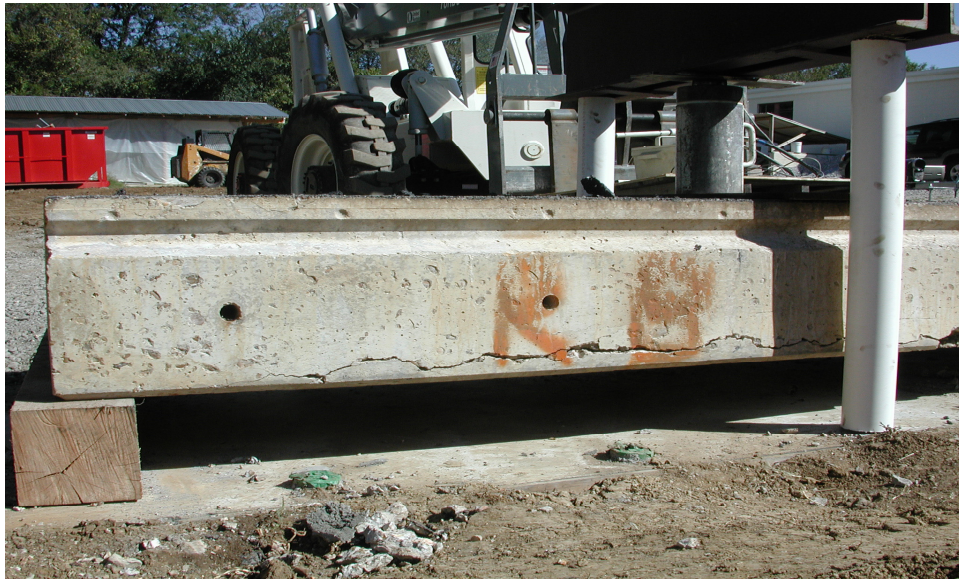
binder interface at the concrete deck surface. The water is trapped at this interface since the overlay drastically reduces water evaporation. Considering this condition, a possible seepage path is from the deck surface to the longitudinal reinforcing steel causing bar corrosion.

Figure 21: Longitudinal Cracking at the Height of the Reinforcement

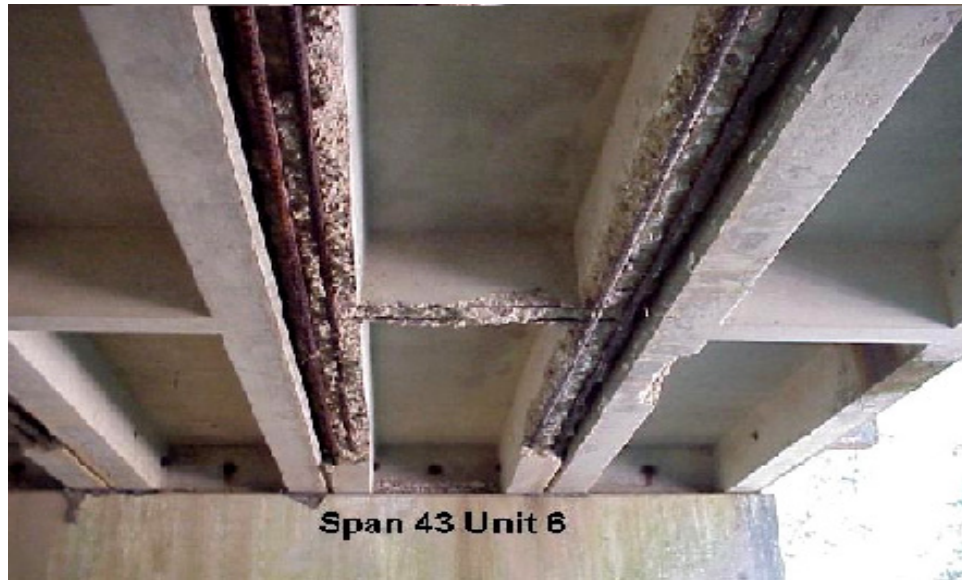
Figure 22: Concrete Spalling and Reinforcement Corrosion

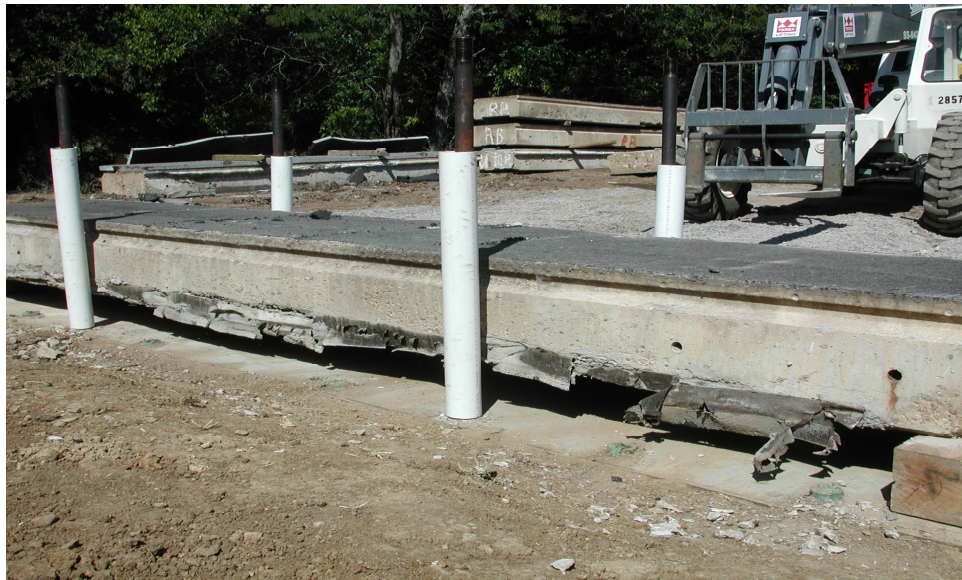
Figure 23: Shotcrete Technique Repair

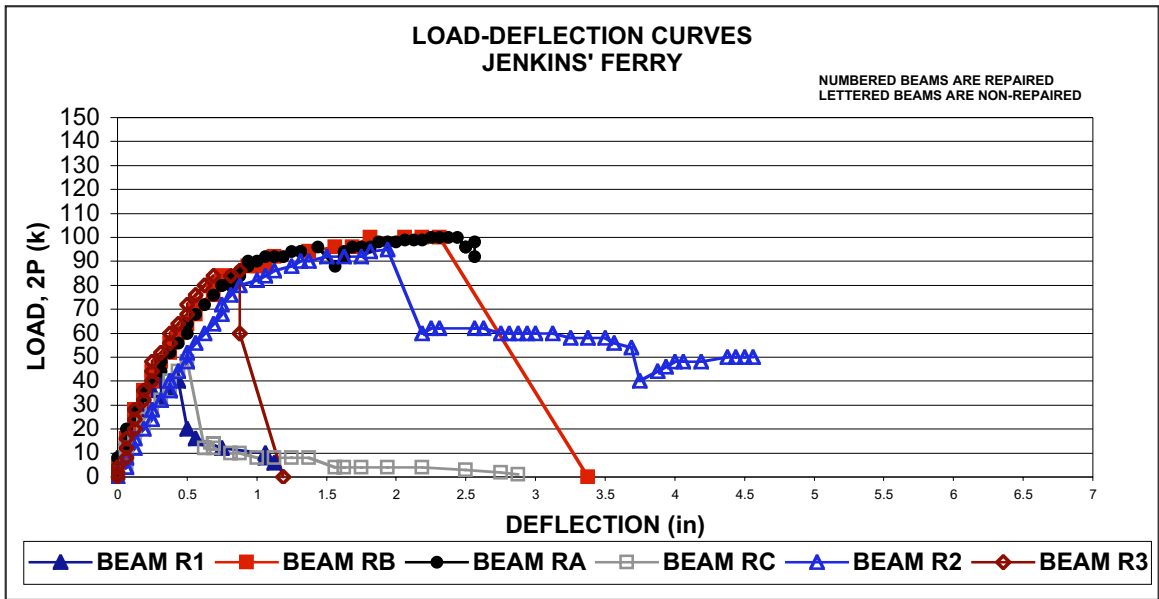
On average, the maximum load capacity, $2P$, for these sections was 78.2 k, which translates to a bending moment, excluding self-weight, of 215.1 ft-k. On average, a 2.6-in maximum midspan deflection was measured. Even though these sections were categorized as “Poor”, two units had failure loads of 100 k with 2.6-in and 3.4-in midspan deflections. Figure 24 is a plot showing the load – deflection relationship for this beam group.

Figure 24: Jenkins' Ferry Load Versus Deflection Results

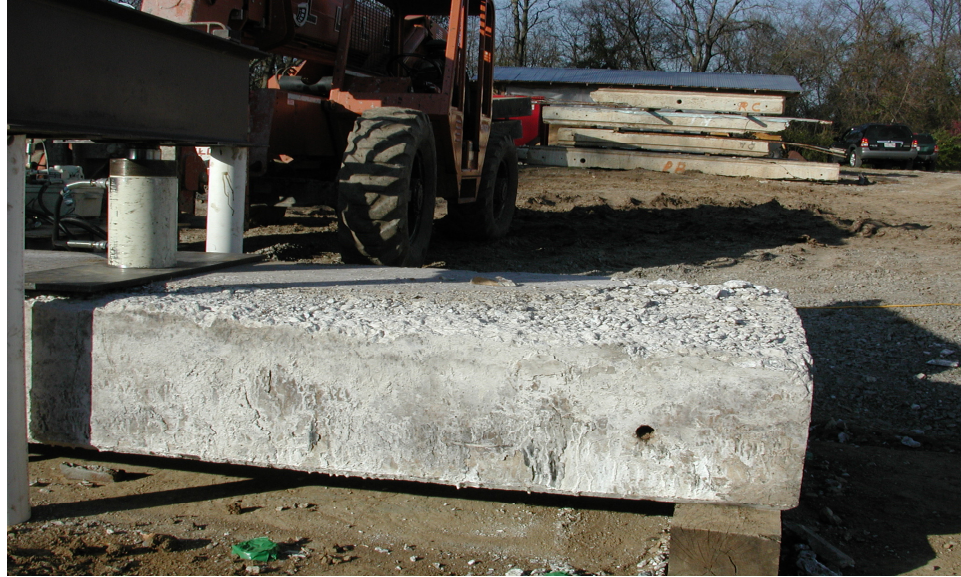
All of the Cave Springs units were categorized as being in "Poor" condition by visual inspection. Similar to the Jenkins' Ferry Bridge, the Cave Springs bridge beams had an asphalt overlay. When the overlay was removed, the underlying concrete was severely deteriorated, Figure 25. Deterioration was severe enough that concrete pieces could manually be removed from the beam. Overall, the concrete had a very white and powdery appearance due to lime leaching from the cement paste. Permeability readings were very high for these sections, which agrees with the poor concrete quality.

Figure 25: Poor Aggregate-Paste Bonding on Top of Beam

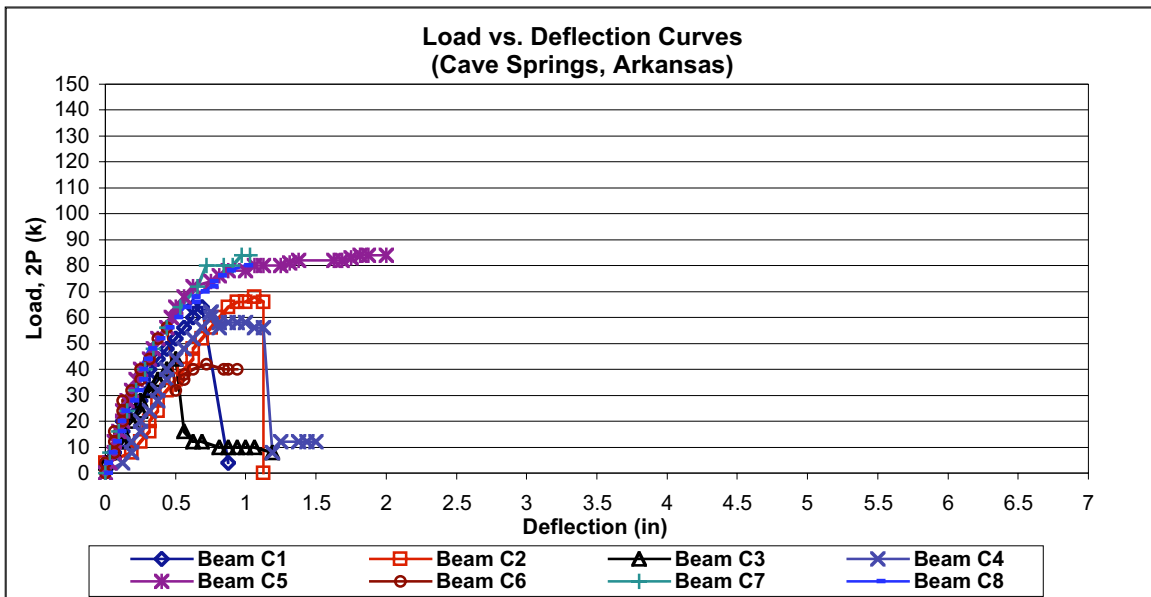
The average load capacity, $2P$, of the Cave Springs beams was 71.3 k, equivalent to a 196.0 ft-k bending moment, excluding self-weight. Load versus deflection plots are shown in Figure 26 and drawn to the same scale as the other load-deflection plots for comparison. Concrete spalling along the underside of the beam occurred during loading. All of the Cave Springs sections failed in shear at small midspan deflections, with minimal visual or audible warning.

Figure 26: Cave Springs Load Versus Deflection Results

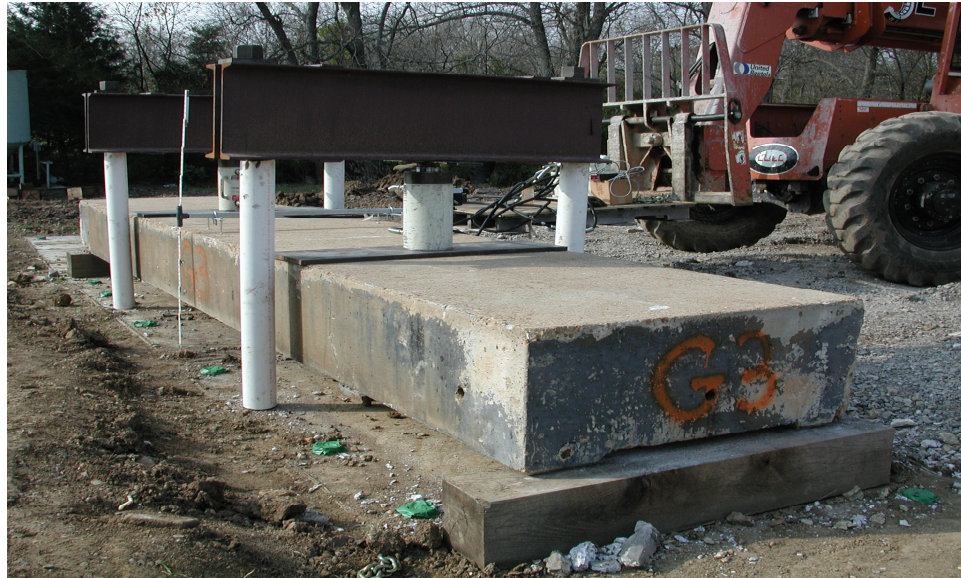
Figure 27: Gentry Beam with No Signs of Distress

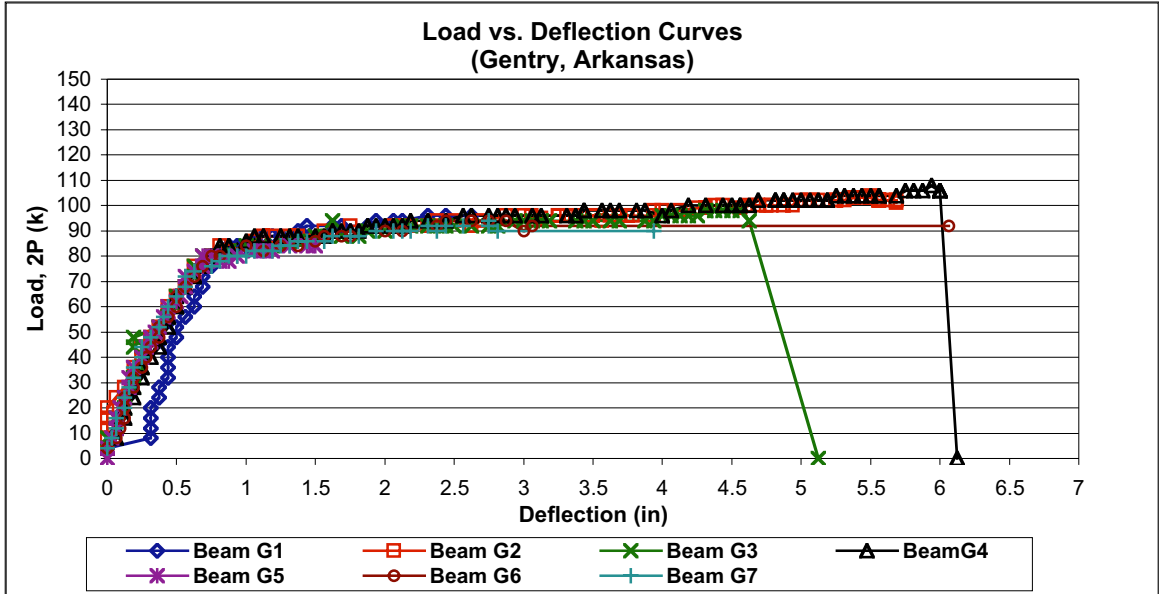
The average load capacity, 2P, of the Gentry beams was 96.5 k, which corresponds to an average maximum bending moment of 265.4 ft-k, excluding self-weight. Midspan deflections reached a maximum of just over 6-in as shown in Figure 28.

Figure 28: Gentry Load Versus Deflection Results

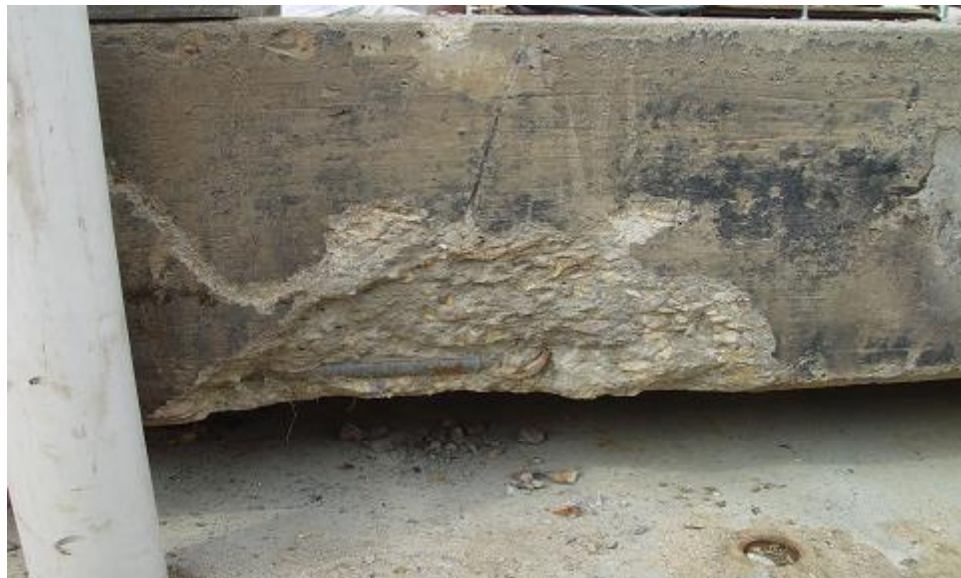
Figure 29: Carlisle Beam with Minor Evidence of Deterioration

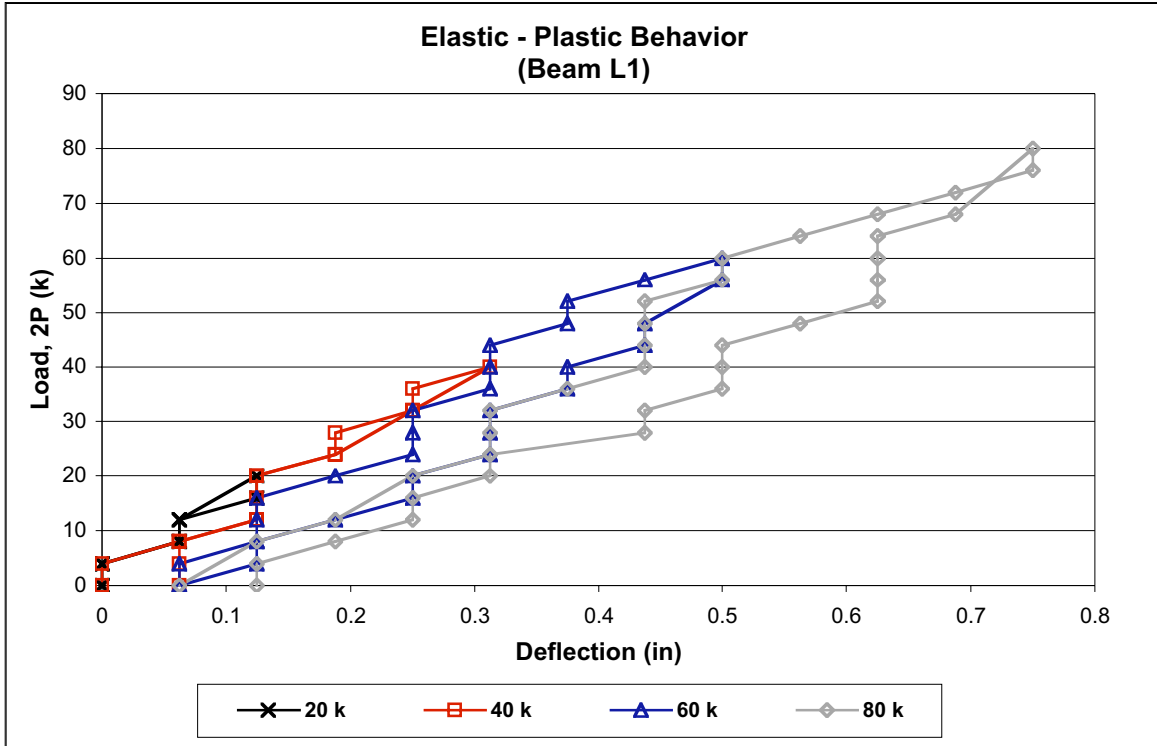
Figure 31: Elastic – Plastic Behavior for Beam L1

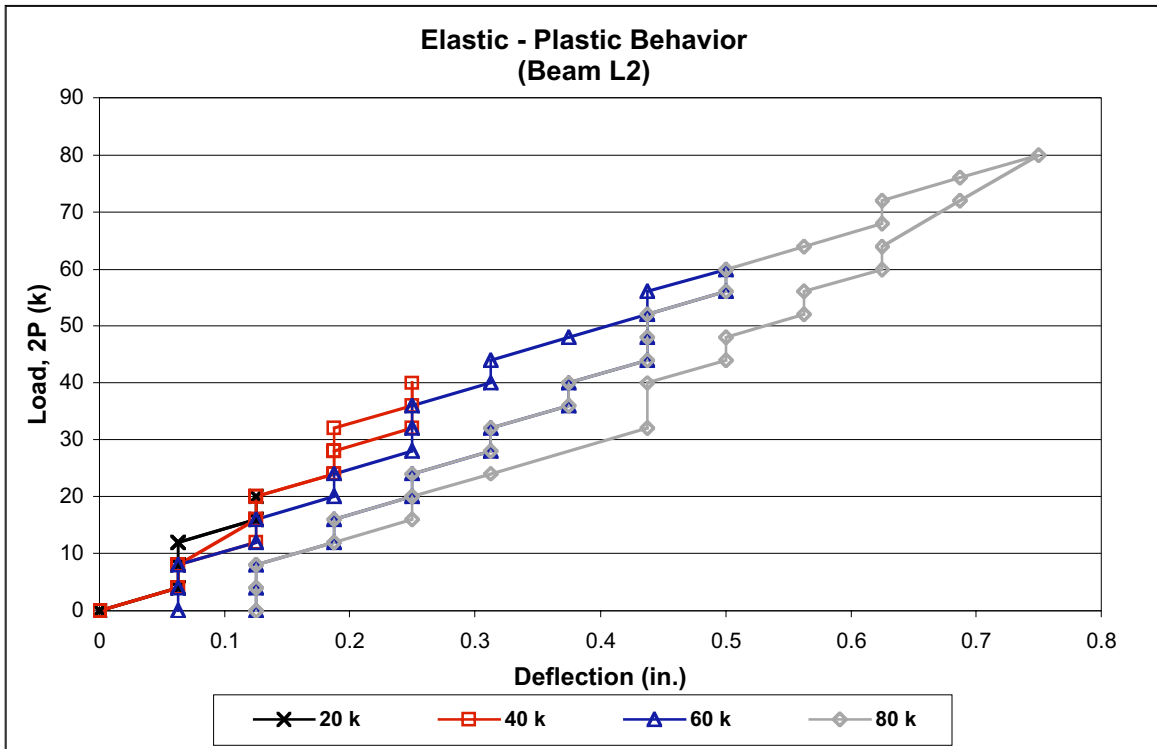
Figure 32: Elastic – Plastic Behavior for Beam L2

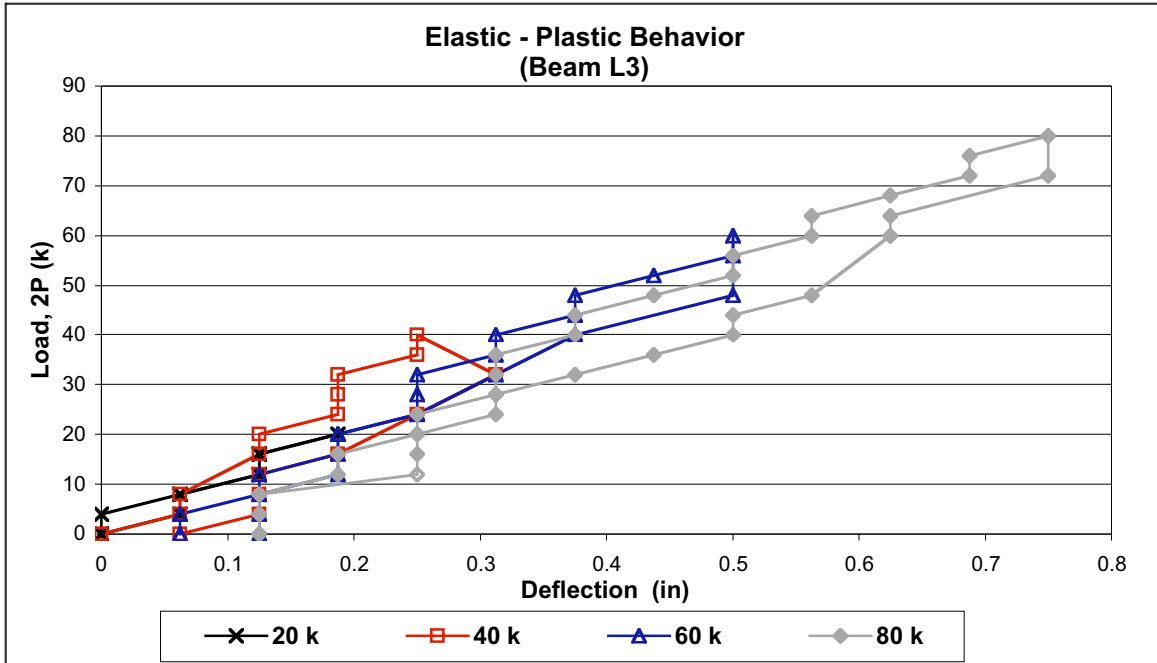
Figure 33: Elastic – Plastic Behavior for Beam L3

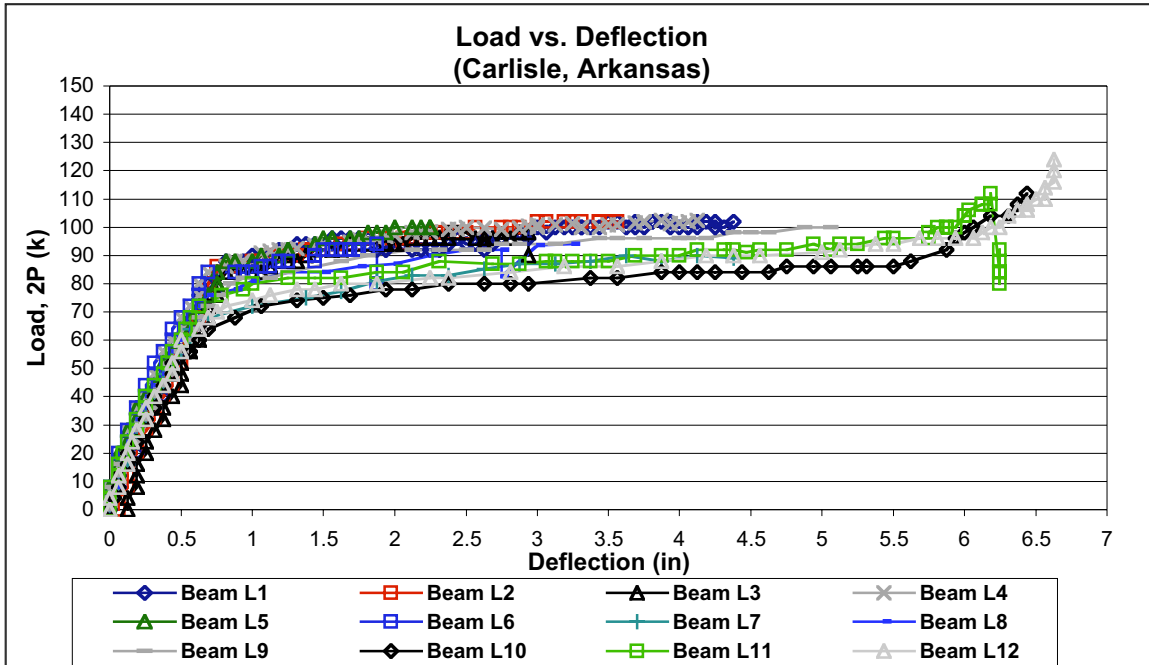
occurred quickly after a shear crack formed at approximately d , depth of beam, from the support. The load-deflection plot for all Carlisle beams is shown in Figure 34.

Figure 34: Carlisle Load Versus Deflection Results

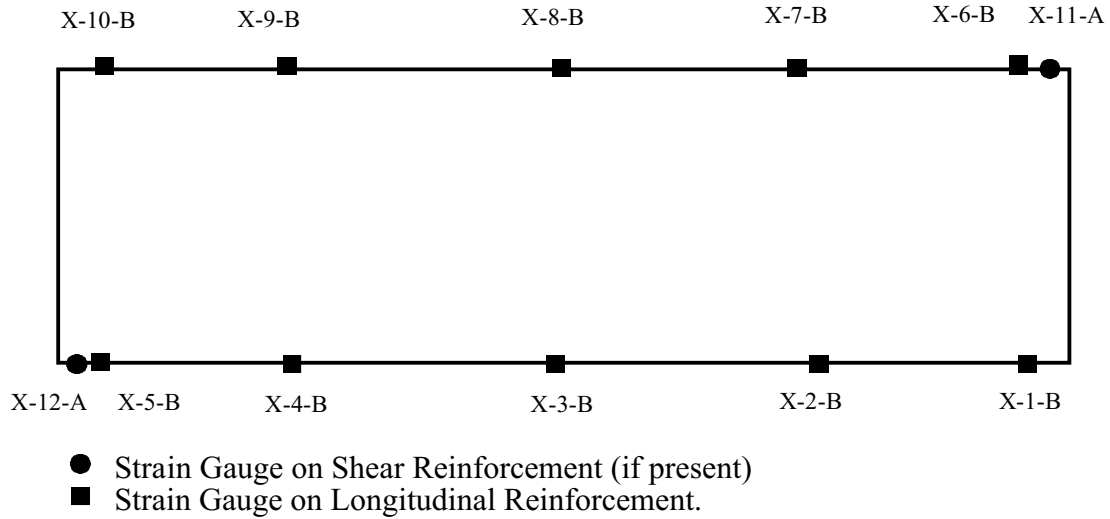
Reinforcing steel behavior was monitored using strain gauges. Gauges were located approximately 18-in, 78-in, and 114-in from each beam end. In addition, two strain gauges were placed on the shear stirrups of beams N1 and N2. A plan view of the beam showing relative gauge locations is given in Figure 35.

Figure 35: Plan View Showing Approximate Locations of Strain Gauges on “New” Channel Beams

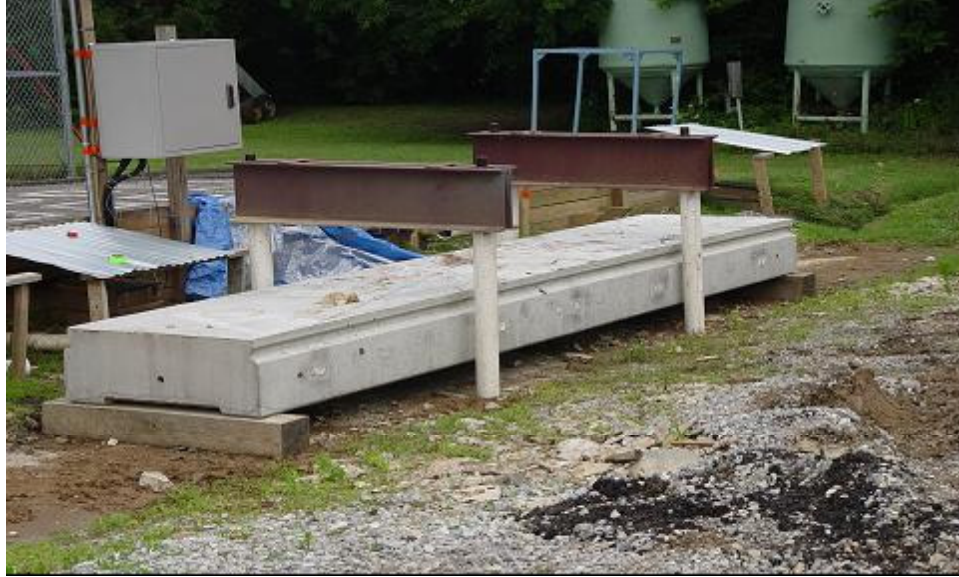
These sections showed no signs of distress. A “New” beam is shown in Figure 36.

Figure 36: Newly Fabricated Channel Beam
