**The Structural Evaluation of
Precast Concrete Slab Panels in
Bridge Superstructures**

Final Report

June 2004

**Sponsored by the
Arkansas State Highway and
Transportation Department**

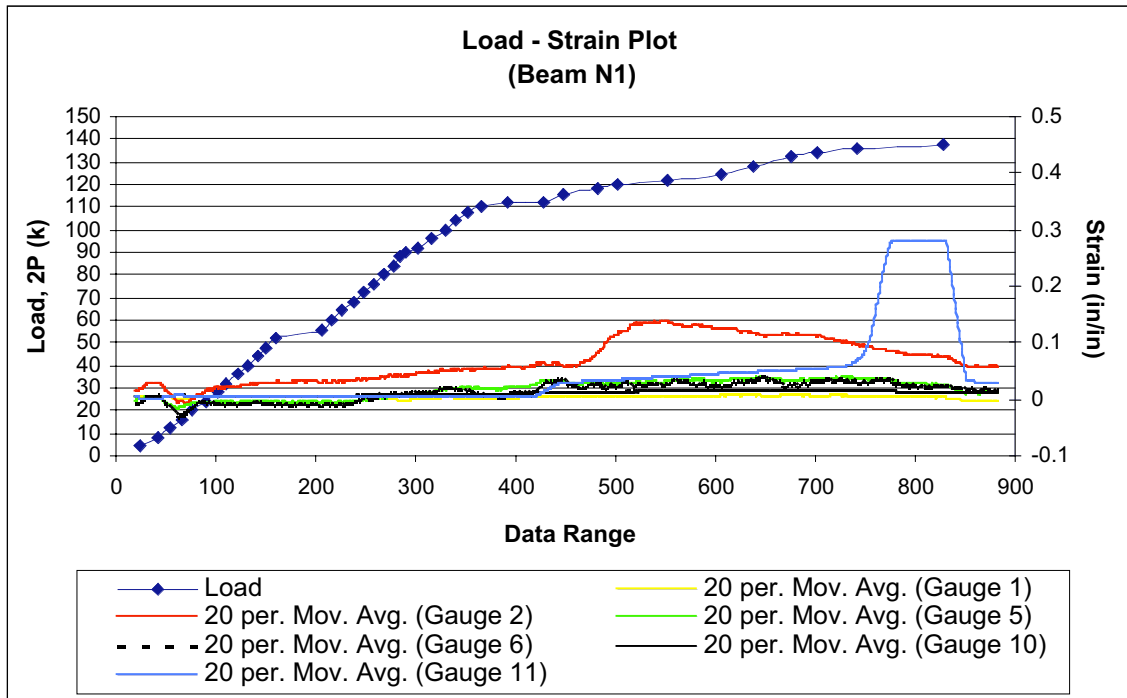
Figure 37: Load – Strain Plot for Shear Reinforced Channel Beam N1

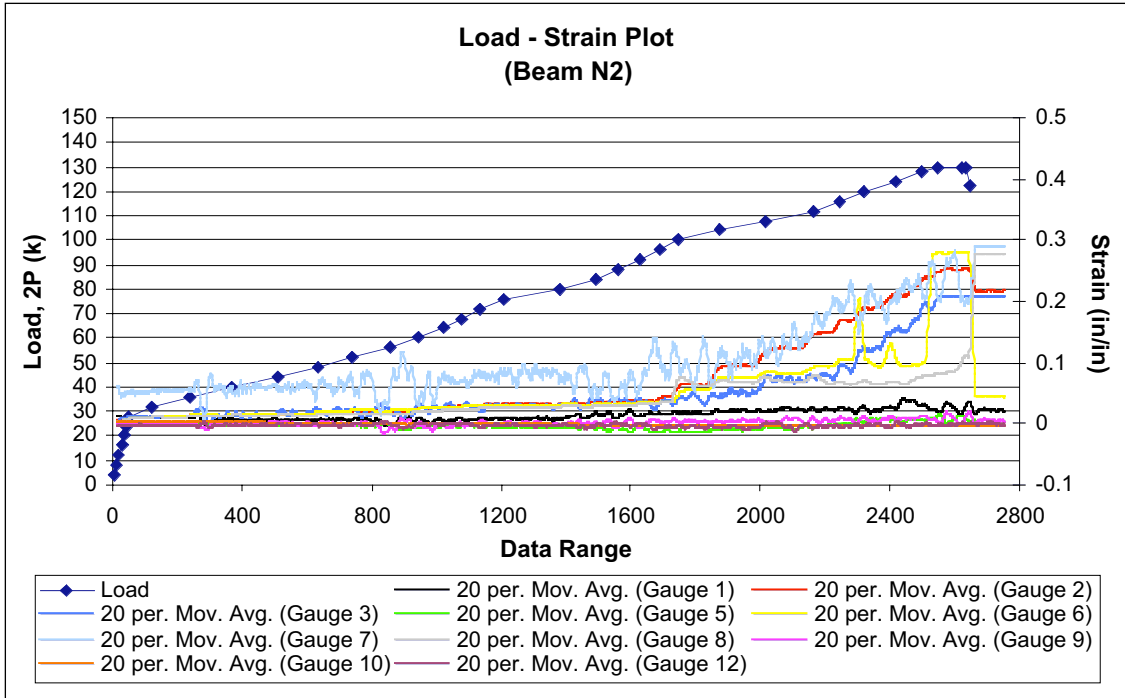
Figure 38: Load – Strain Plot for Shear Reinforced Channel Beam N2

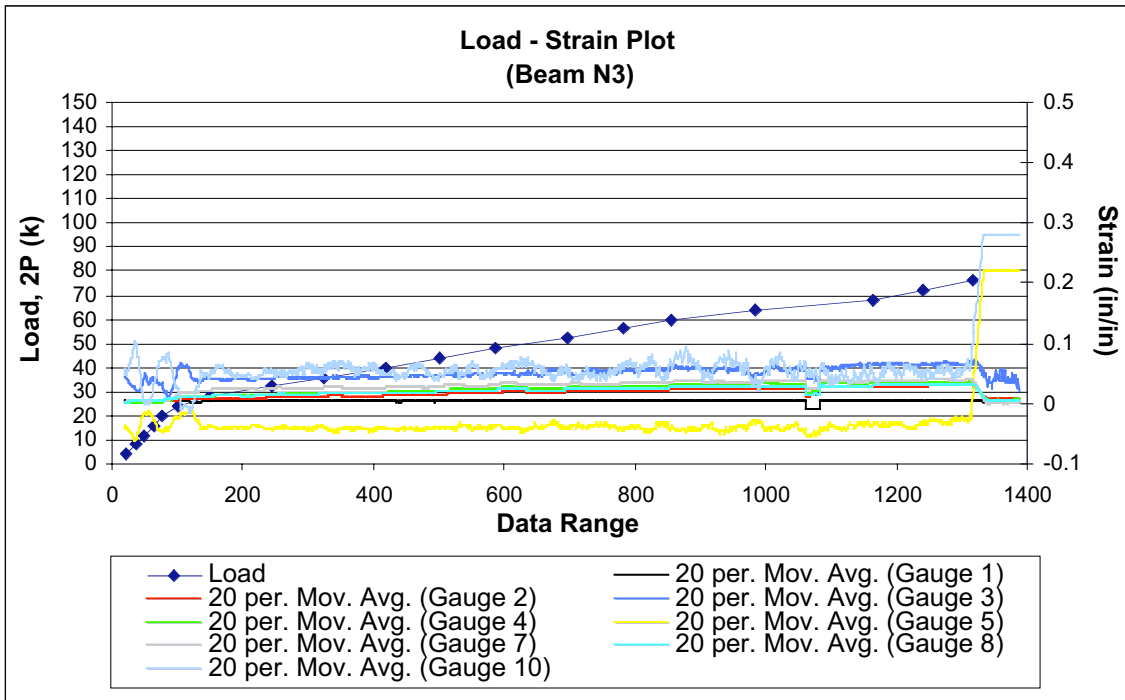
Figure 39: Load – Strain Plot for Non-Shear Reinforced Channel Beam N3

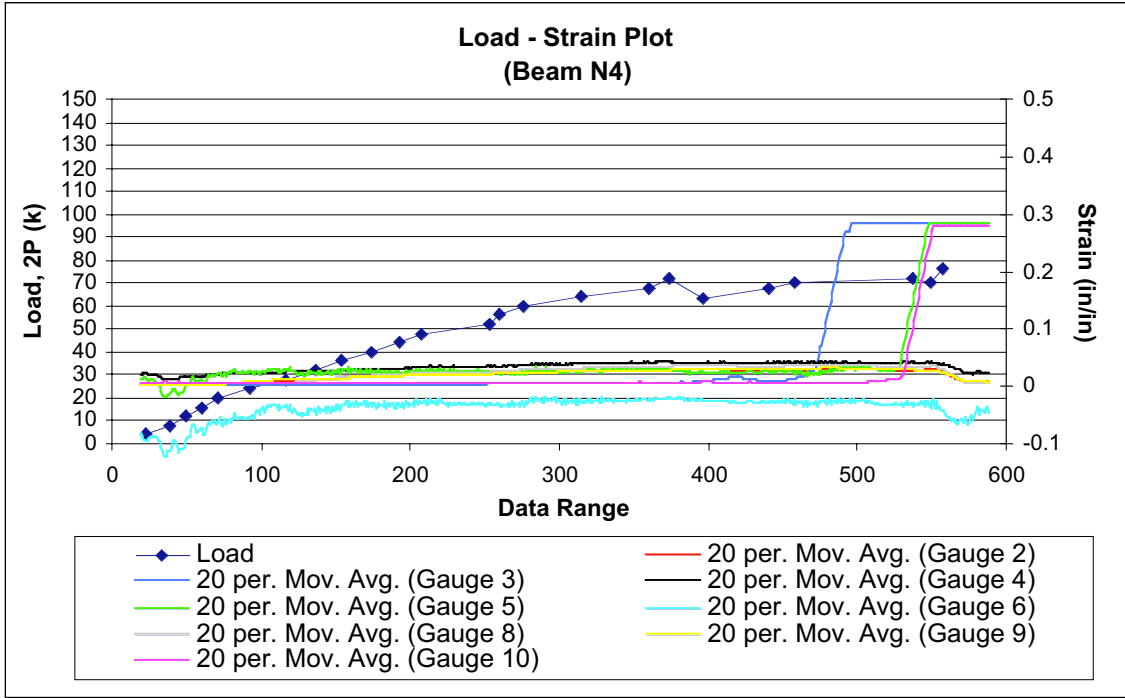
Figure 40: Load – Strain Plot for Non-Shear Reinforced Channel Beam N4

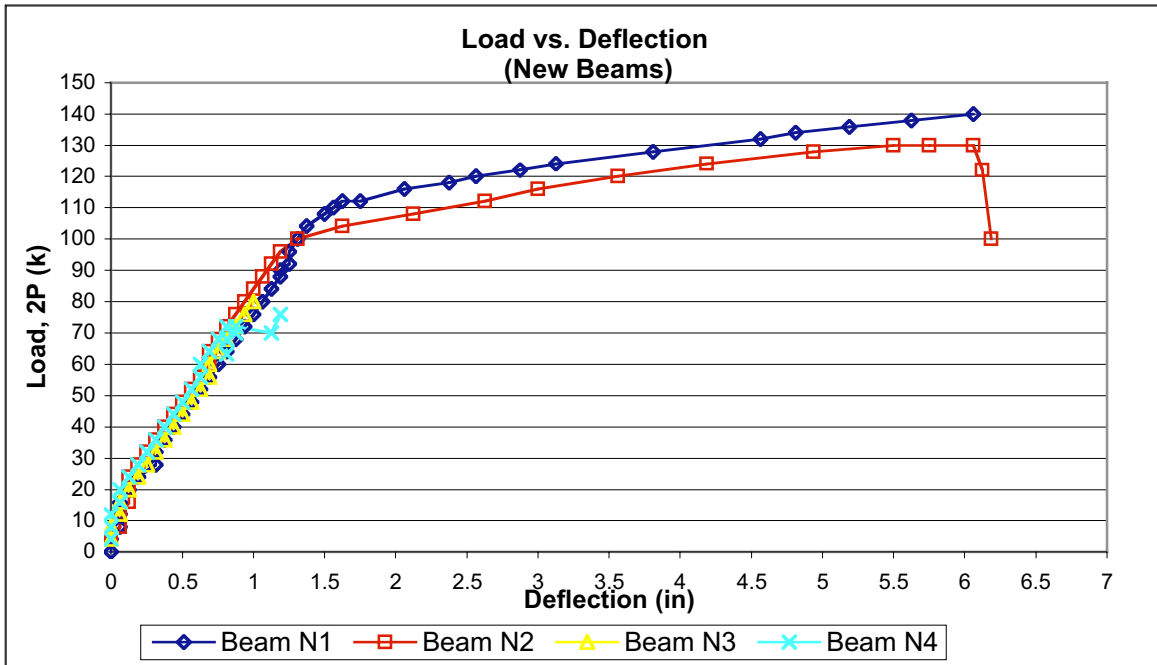
were constrained by the stirrups. Conversely, beams without stirrups failed at an average 2P load of 78 k with 1.094-in deflection. Based on the AASHTO nominal concrete shear strength, the predicted load carrying capacity, 2P, is 76 k. The load versus deflection plot for the “New” beams is shown in Figure 41.

Figure 41: New Beams Load Versus Deflection Results

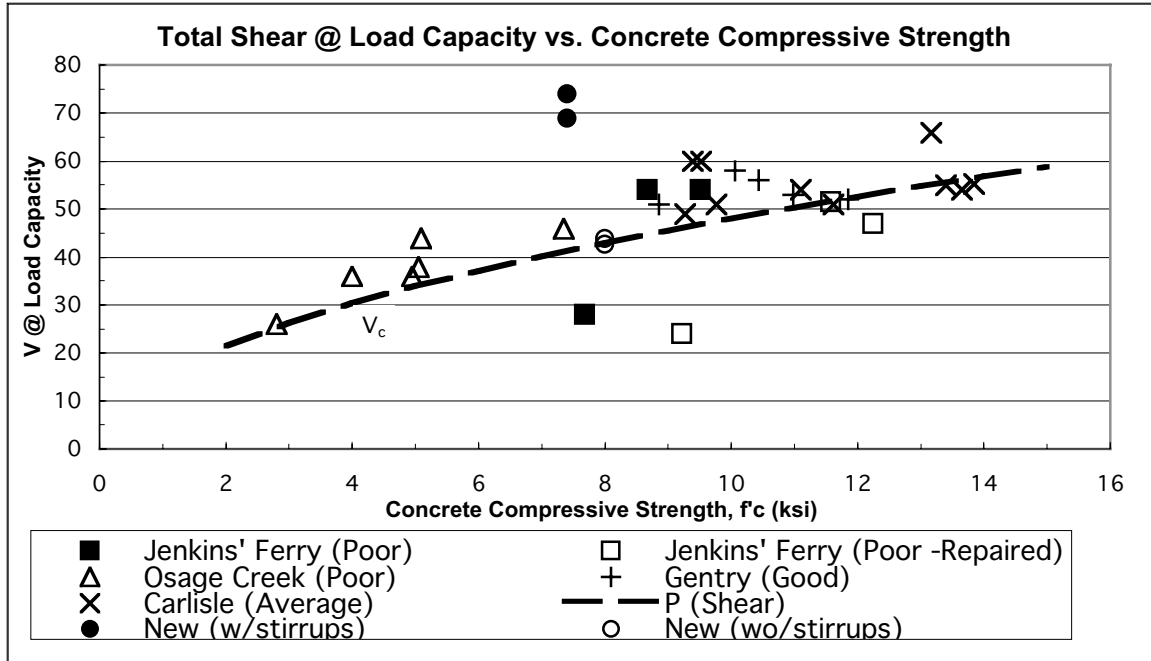
Except for two sections in “Poor” condition from Jenkins’ Ferry Bridge, the measured load capacity was consistent with the calculated shear capacity of the section. The two sections that fall significantly below the superimposed concrete shear strength line were beams that had shear cracks along with excessive concrete spalling prior to testing.

Figure 42: Load Capacity Versus Concrete Compressive Strength

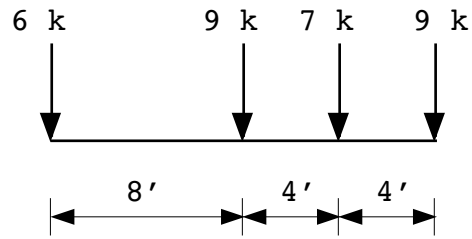
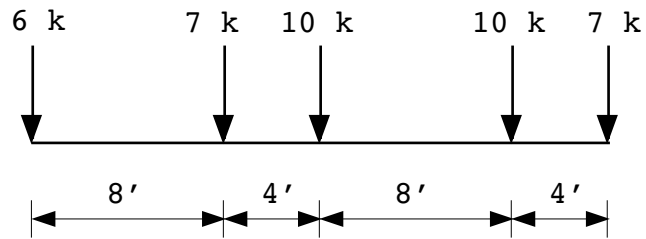
T4 (62 k Legal) CODE 9

T3S2 (80 k Legal) CODE 9

Figure 43. Weight Limit Posting Vehicles (wheel loads)

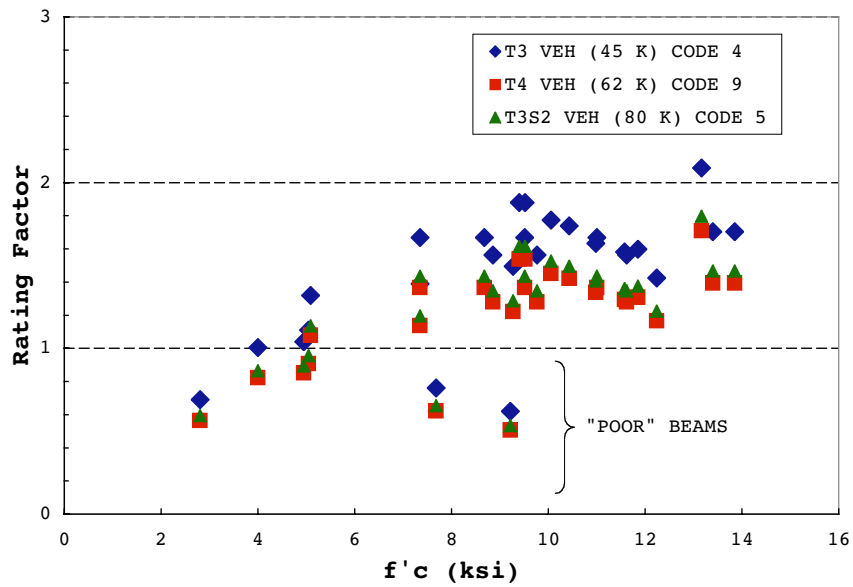
Compressive strengths were determined for twenty-seven of the thirty-three used beams and these values are compared with their rating factors in Figure 44. Of the twenty-seven beams, six beams had rating factors below one. These six beams were taken from Jenkins' Ferry and Cave Springs, which were considered "poor" by visual inspection before load testing.

Figure 44. Rating Factor as a Function of Concrete Compressive Strength
