# **Geosynthetic Drains for Slope Stability & Rehabilitation**

Final Report

2015

11. Contract or Grant No. <b>TRC0506</b>	
12. Sponsoring Agency Name and Address <b>Arkansas State Highway and Transportation Department P.O. Box 2261 Little Rock, AR 72203-2261</b>				13. Type of Report and Period covered <b>Final Report 1 July 2005 thru 30 June 2009</b>

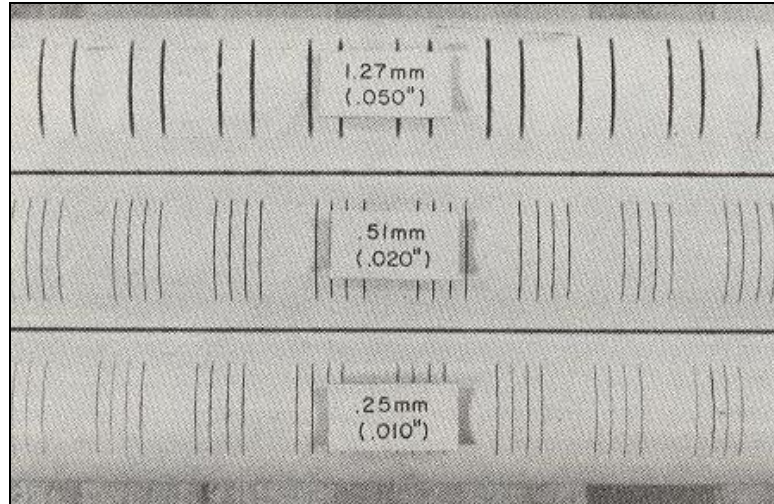
Figure 2-1: Conventional slotted PVC drain pipe (Royster, 1980).

Since the first installation of metal perforated pipes, the equipment, materials and installation procedure have changed markedly (Royster, 1980). The availability of a wider variety of auger bits such as fishtail bit and later tri-cone roller bit were invented in 1949 so that the drilling could be made through stiffer material. While improvements to the drilling equipment were important in promoting the method, the most significant improvement in the horizontal drainage method was the development of a new drain material, polyvinyl chloride (PVC) pipes were introduced in the 1950s,(Royster, 1980). This type of material was unaffected by corrosion from the environment, and could extend the lifespan of the drain pipes to more than the 30-40 years that was usually obtained from the steel pipes. A PVC drain pipe is usually 5 cm (2 in.) in diameter and manufactured with a series of 0.25 mm (0.01 in) to 1.27 mm (0.05 in) wide slots distributed in a multi-slot configuration around the perimeter of the pipe at 6 mm (0.25 in) intervals. Figure 2-1 illustrates three PVC drain pipe samples with different slot widths ranging from 0.25 mm (0.01in.) to 1.27 mm (0.05 in.). Drill rigs with hollow stem augers were used to drill a nearly horizontal hole in soil or soft rock in order to install the PVC drain (Seegmiller, 1979). The slotted PVC pipe was inserted into the hole through the hollow stem after the desired drilling depth was reached. Then the auger stem was removed, leaving the drain behind in the hole.

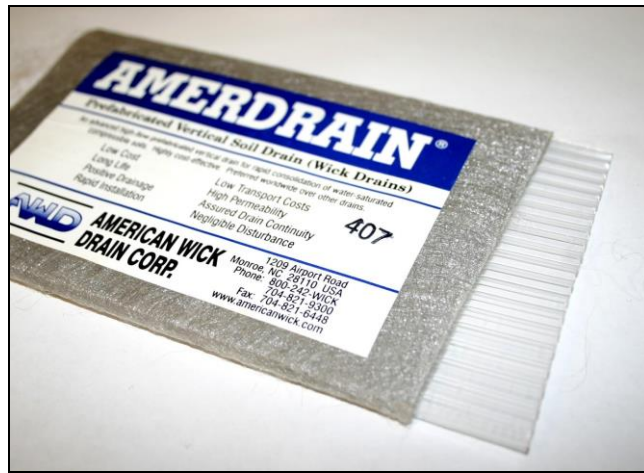
Figure 2-2: Illustration of a typical wick drain.

Figure 2-2 illustrates a sample of wick drain currently available on the market. As shown in Figure 2-2, wick drains consist of a corrugated plastic core which is covered by a gray-colored nonwoven geotextile jacket. The grooved core of the wick drain provides a high flow capacity, which can be as high as 1.6 gallons per minute under 300 KPa confining pressure (American Wick Drain specification, 2008), while the geotextile jacket prevents clogging of the drain by serving as a filter to prevent the surrounding fine materials from entering the core. The conventional direction of wick drain installation for the acceleration of consolidation is vertical. Santi (1999) was the first researcher to document an experiment in which wick drains were installed in a horizontal direction to drain water from a slope. Since then a few studies have been conducted to evaluate the workability of this new type of material for horizontal drains. However, these

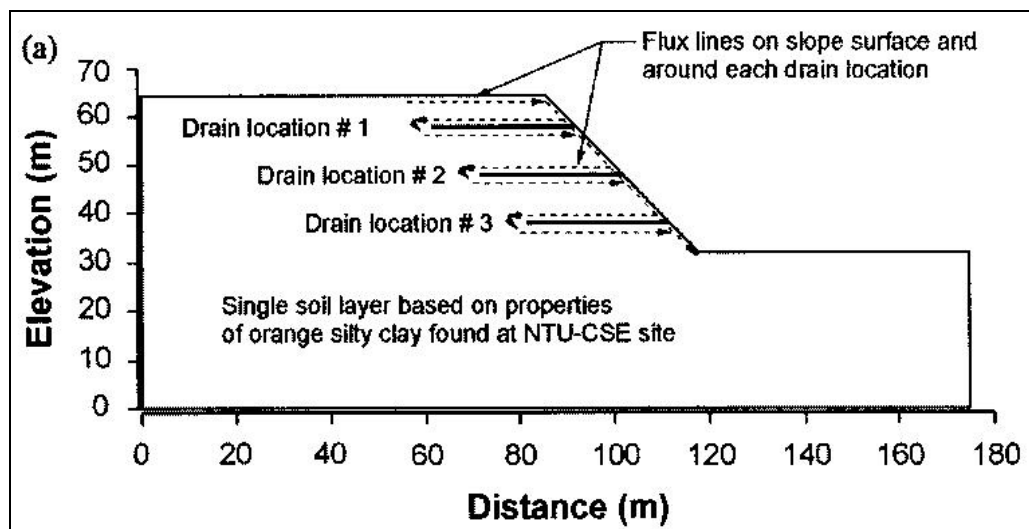
Figure 2-3: Slope geometry and drain configurations used in the research of Rahardjo, Hritzuk, Leong, and Rezaur (2002).

2002). A 30m-high slope model with a face inclination of  $45^\circ$  was created with three drain layers that were evenly spaced from the toe to the crest of the slope. Figure 2-3 illustrates the geometry of the modeled slope and the locations of the drain layers used in the model. To investigate the influence of drain location on the stability of the slope, five scenarios were created with different drain configurations. The first scenario was used as the control and had no drains installed. The next three scenarios were created with only one drain layer performing individually, and the last situation was the combination of the three drain layers working together..

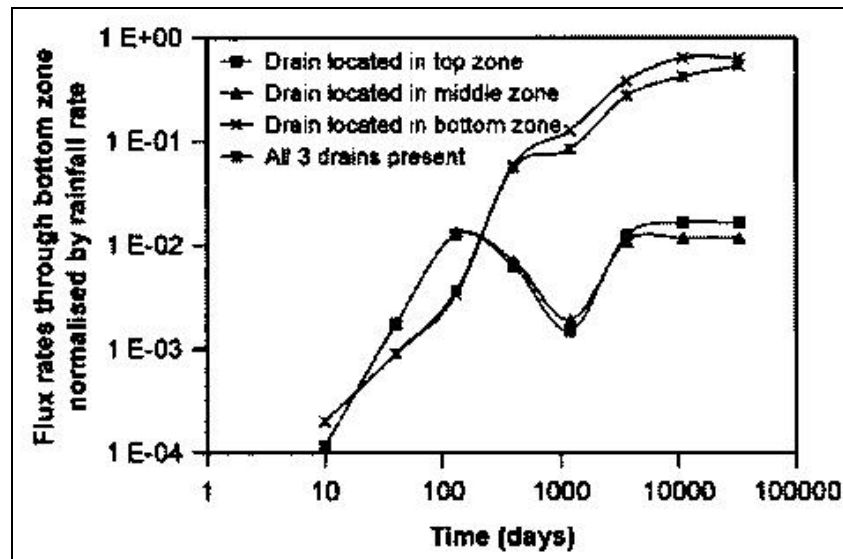
Figure 2-4: Summary of the computed flux through the bottom zone of the slope as a function of time for the various drain configurations (Rahardjo, et.al., 2002).

The hydraulic conductivity was previously measured at  $k_{sat} = 7.8 \times 10^{-7}$  m/s,. The analysis from the seepage program showed that it would take more than 20,000 days of continuous rainfall for the slope to reach equilibrium. This meant that the soil within the slope would never become saturated; however, the results were still helpful to evaluate the effect of drain location on slope stability. The profiles of pore water pressure head for each drainage scenario from the Seep/W analysis were transferred to the Slope/W program for the calculation of a factor of safety for each drainage condition. Flow was measured through any cross section of the model using the flux rate calculated by the program. Figure 2-4 presents the results of the measured flux from Seep/W in the last four drain scenarios and Figure 2-5 expresses the changes in the FOS as a function of time for each of the five scenarios .

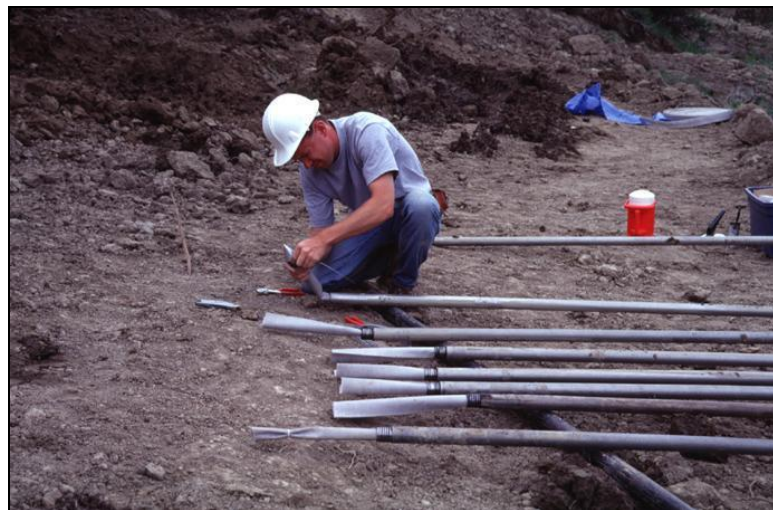
Figure 2-10: Wick drains are embedded inside steel pipes (Santi, personal communication, 2006).

Prior to installation, precut lengths of the wick drains that are slightly longer than the length of the drive pipe are preloaded or imbedded inside the sections of drill pipe as illustrated in Figure 2-10.

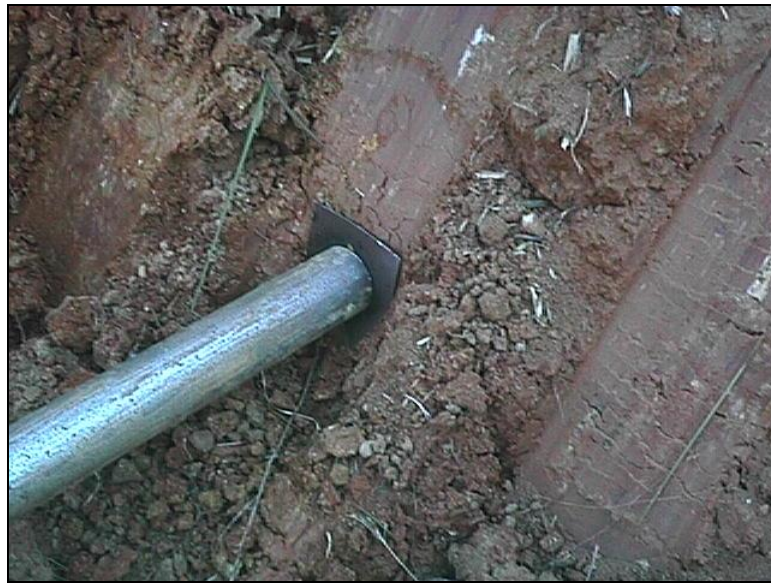
Figure 2-11: A sacrificial plate is attached to the first steel pipe (Santi, personal communication, 2006).

The sacrificial drive plate is then placed at the front of the first steel pipe section to be installed as illustrated in Figure 2-11, and is attached to the front end of the wick drain using a hose clamp. Next, the drive head is placed over the back end of the first pipe, and the wick drain is folded out of the way as shown in Figure 2-12.

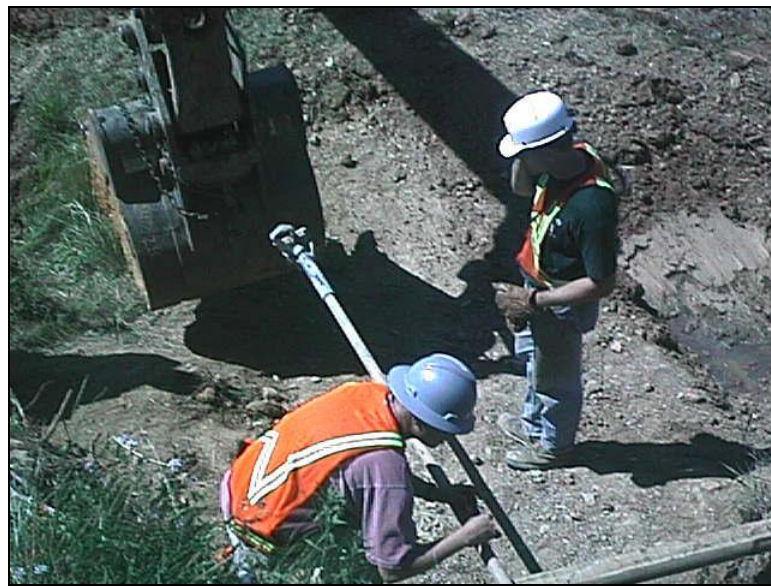
Figure 2-13: Pushing the steel pipe by the bucket of a trackhoe (Santi, personal communication, 2006).

After being aligned, the first pipe is pushed into the slope by a bulldozer or the bucket of a tracked excavator as illustrated in Figure 2-13. Additional sections of drain are installed by splicing the protruding wick sections together with a stapler, as shown in Figure 2-14, threading the pipes together, and repeating the driving. When the desired depth is reached, the pulling head is attached to the protruding end of the pipe and, the pipe is gently pulled out of the slope by the bulldozer or trackhoe with the use of a chain, as illustrated in Figure 2-15. Because the sacrificial drive plate anchors the wick in place and provides resisting force against withdrawal, the wick drain remains inside the slope as the pipe is removed.

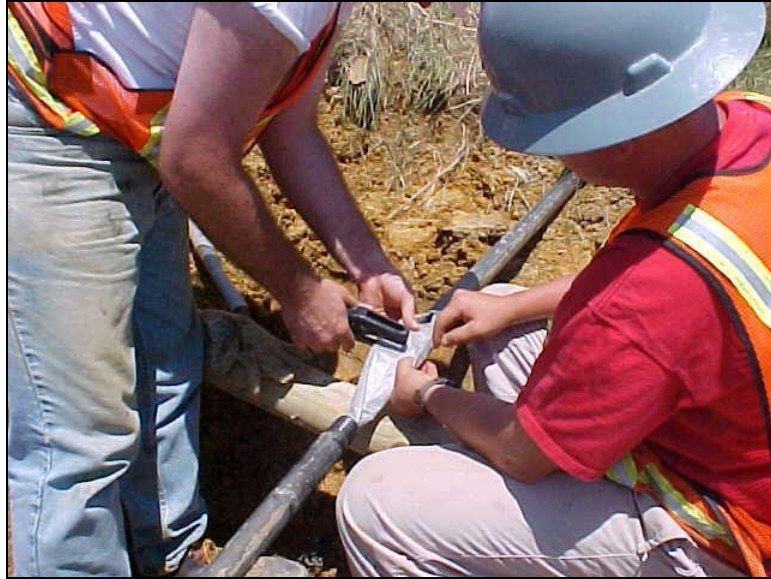
Figure 2-14: The drains are spliced by a stapler (Santi, personal communication, 2006).

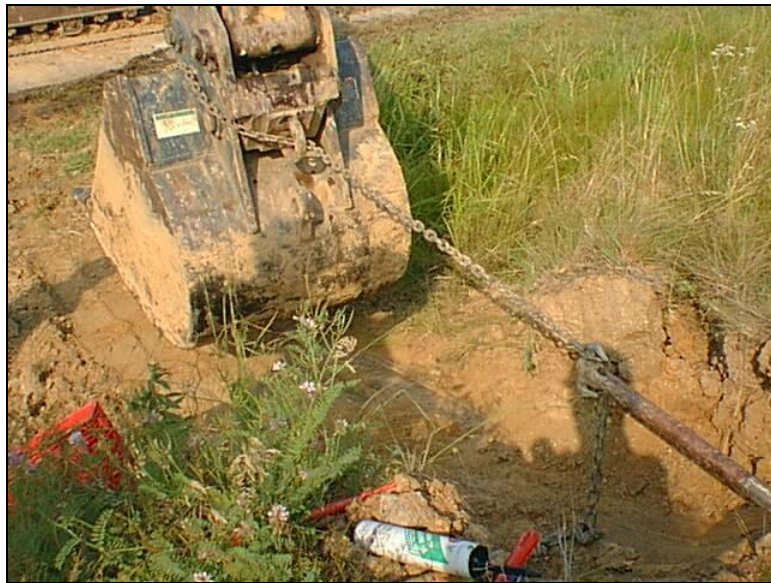
Figure 2-15: The pipe is pulled out through a chain connected to the pulling head (Santi, personal communication, 2006).

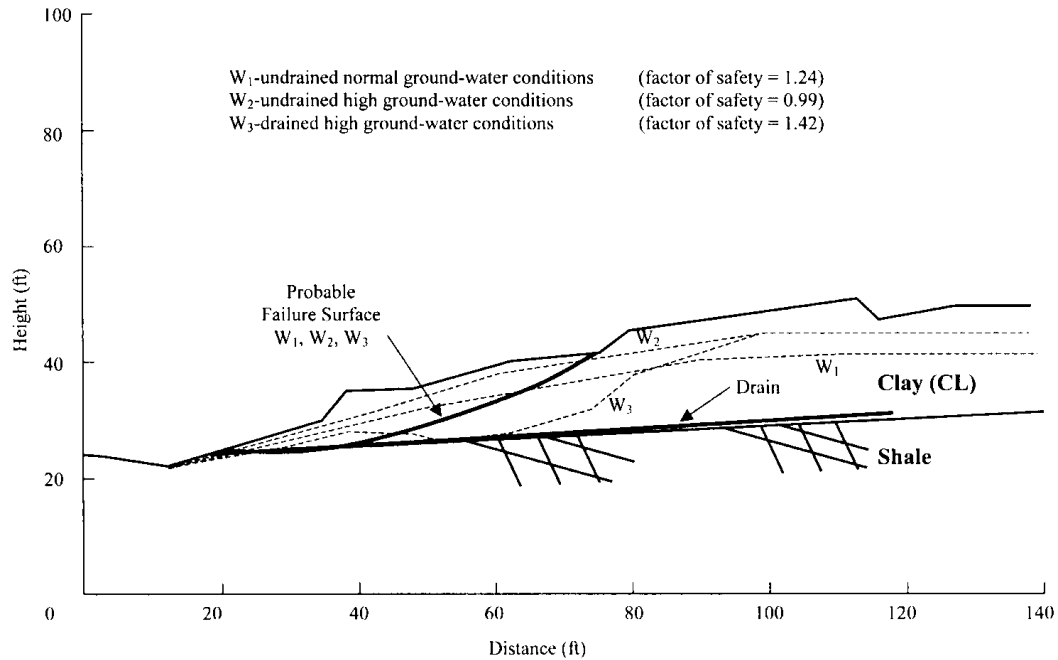
Figure 2-17: Results of slope stability analyses for the slope at the Jasper, IN site, (Santi, Creenshaw, and Elifrits, 2003).

The results of the FOS analyses for all three water conditions for this slope's geometry are illustrated in Figure 2-17. The dashed lines in the figure express the water levels corresponding to three conditions applied to the slope with W1 standing for condition 1 as explained earlier, and so forth. As can be seen in Figure 2-17, the factors of safety (FOS) for the three scenarios are 1.24, 0.99, and 1.42, respectively. This means that during the dry months with normal GWT location, the FOS is 1.24, and the slope is stable. Whenever a heavy rainfall occurs, the stability of the slope drops below unity which can cause a landslide. However, when the drains are installed in the slope, described by condition 3, the FOS is increased 11% over the dry season condition and 43% over the critical high GWT condition. This represents a significant improvement in slope stability, supporting the effectiveness of the horizontal wick drain in slope stabilization.

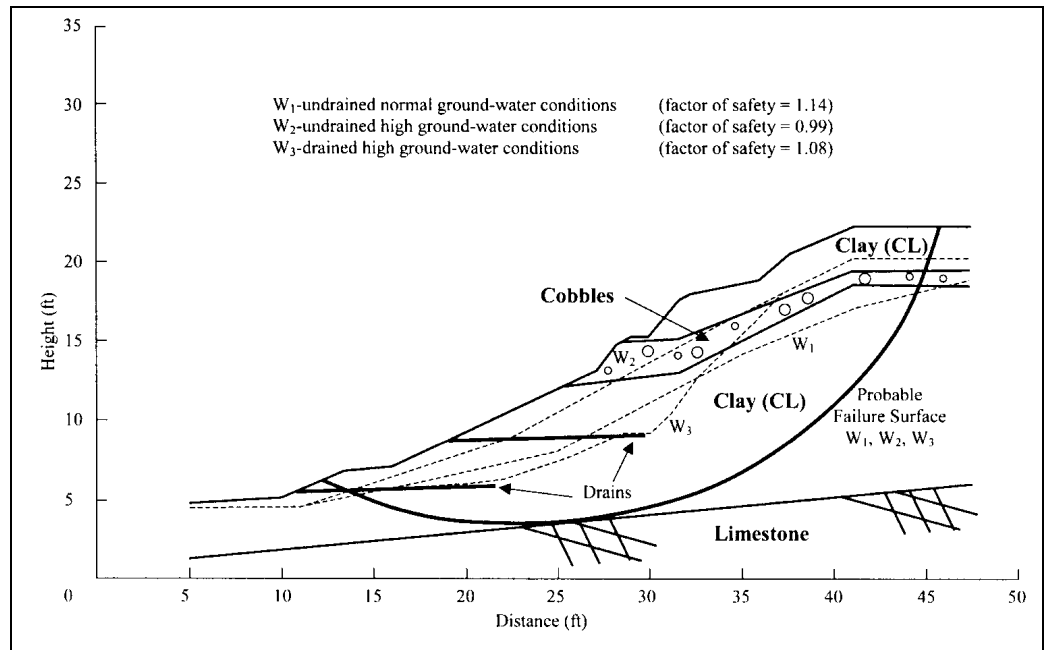
Figure 2-18: Results of slope stability analyses for the Boonville, MO site (Santi, Greenshaw, and Elifrits, 2003).

FOS of 1.08 is usually not acceptable for transportation projects. However, according to the authors, the results are acceptable due to the conservative parameters used in the analysis. Therefore, the improvement in slope stability is expected to reduce the potential for landslides.

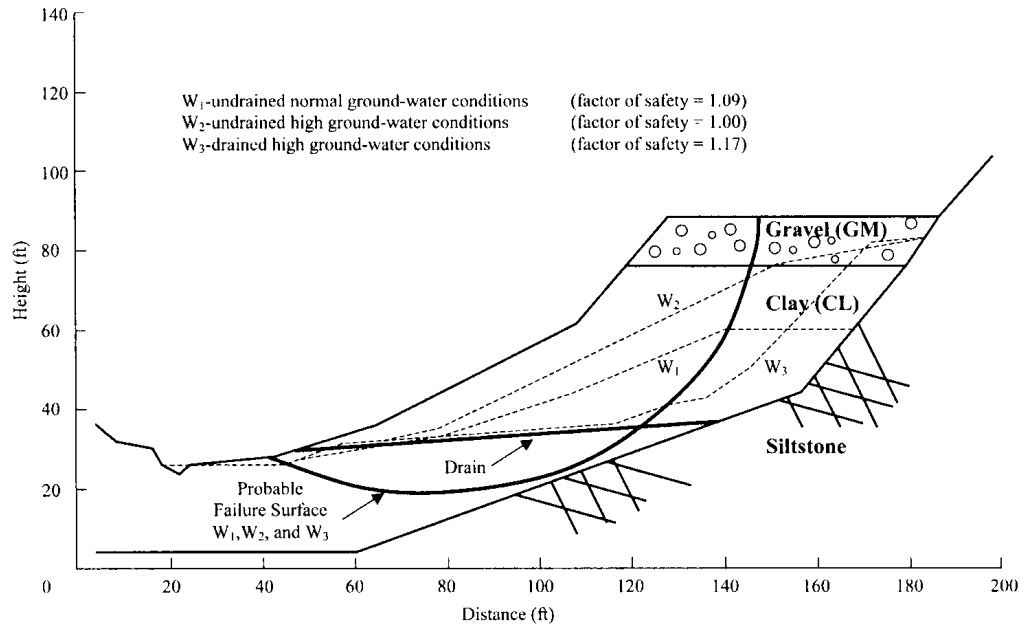
Figure 2-19: Groundwater conditions and results of slope stability analyses for the Meeker, CO site (Santi, Creenshaw, and Elifrits, 2003).

The same conditions were used to evaluate the effectiveness of the drains in the Meeker slope as were used for the Jasper and Boonville landslides. The results of the computer analyses for this site are shown in Figure 2-19 below.

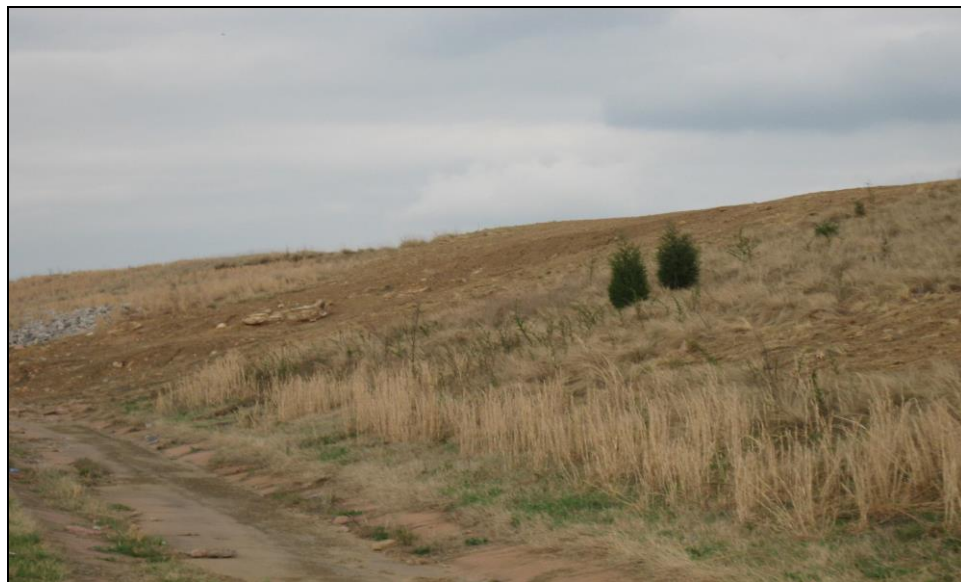
Figure 3-3: Initial geometry of the slope used in the study..

The site selected for this study was located at mile marker 38 on the east side of the north bound lanes of interstate I-540. The study location is within a cut slope that was excavated during the construction of Interstate I-540. The slope had a height of 6 m (20 ft) and a slope angle of 3:1 (H:V). Figure 3-1 displays the location of the chosen slope in the primary highway system of the state of Arkansas. An aerial view of the site is illustrated in Figure 3-2, and the initial geometry of the slope is shown in Figure 3-3. There was initially some vegetation on the surface of the slope. This vegetation was dry in the winter as illustrated in Figure 3-3 but was very densely vegetated and green in the spring and summer, indicating the presence of water within the slope. Moreover, there was a slope failure in the vicinity of the selected site. These indicators of instability caused the study team to believe that there would be a slope failure at this site if remediation measures were not taken, (Dennis, personal communication, 2006). Since

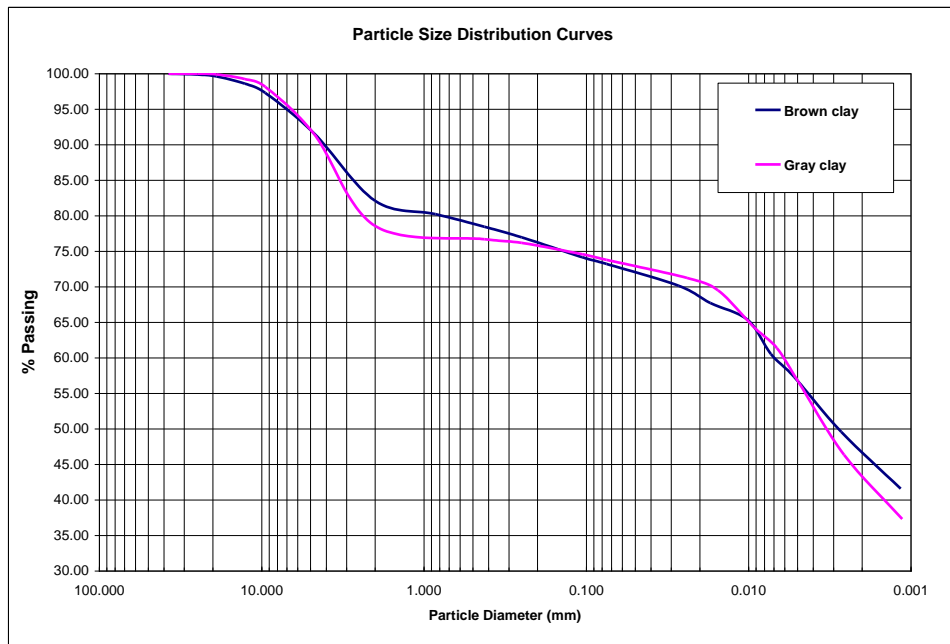
Figure 3-4: Particle size distribution curves of the soils at the site.

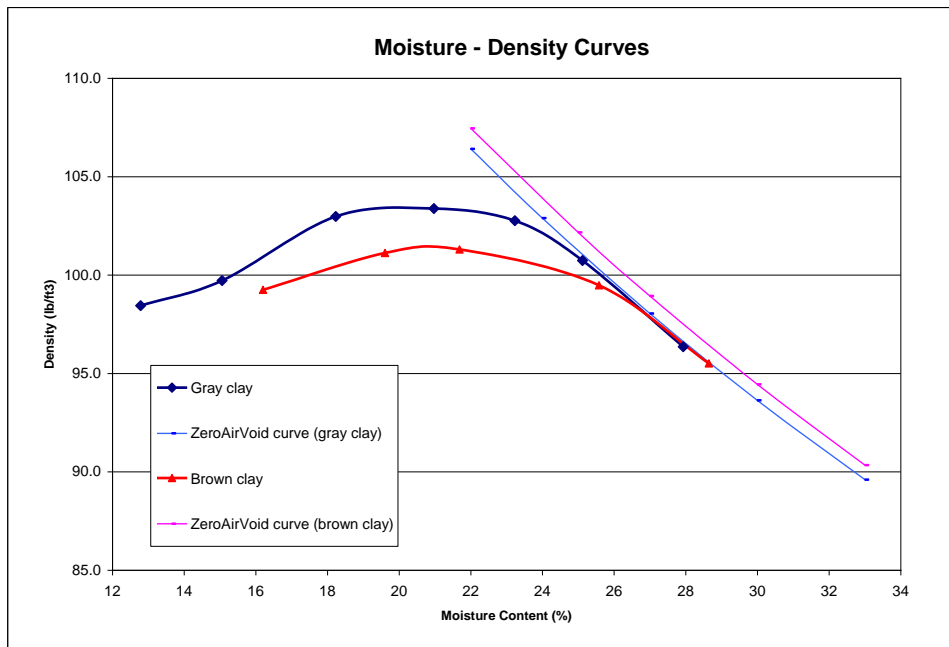
Figure 3-6: Moisture-Density curves of the soils at the site, created using standard effort in accordance with ASTM D-698..

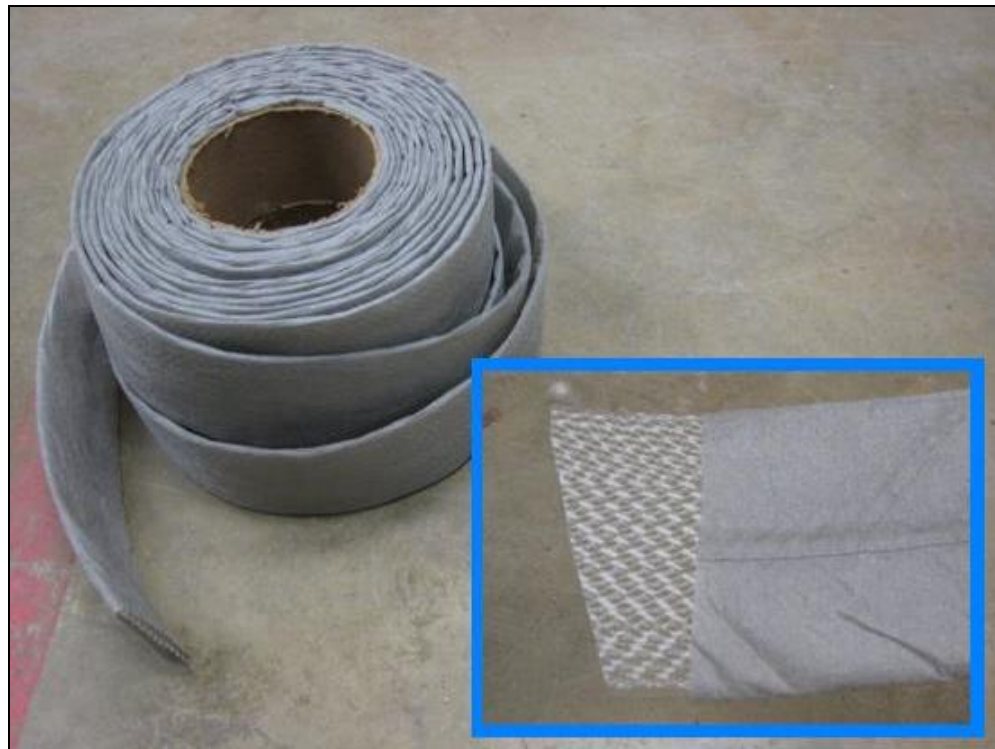
Figure 3-10: Wick drain material used in this study.

In order to install the drains they had to be rolled into a cylindrical shape so that they could be inserted into the carrier drill pipe. As fabricated, the drains were four inches by one quarter inch and were shipped to University of Arkansas in 1000-ft rolls as illustrated in Figure 3-10. The drains were rolled into a cylindrical shape and bound at one-ft. intervals along their length by a wire tie as illustrated in Figure 3-11. The fabricated drains were transported to the site in 30 foot sections.

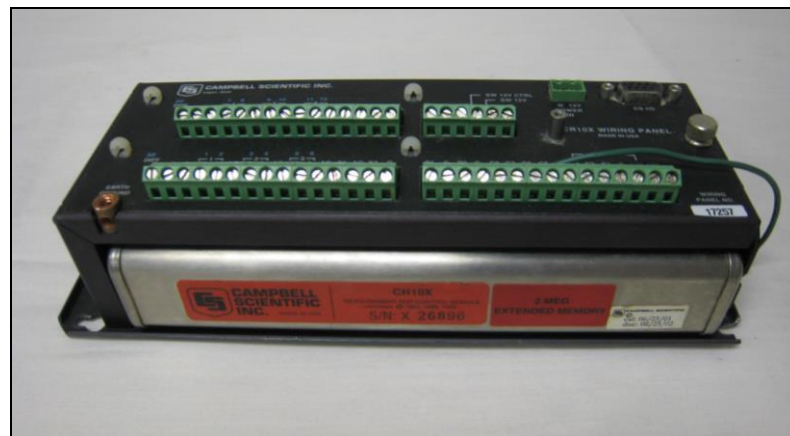
Figure 3-12: A datalogger CR10X used in the research.

Figure 3-12 displays a CR10X datalogger manufactured by the Campbell Scientific Company, Logan, Utah. It is equipped with many control ports which can be used for various applications depending on the devices which are connected to them. According to CR10X Measurement and Control System Operator's Manual (2000), the devices which can be connected to the CR10X include thermocouples for temperature measurement, tipping bucket rain gauges for rainfall intensity or flow capacity measurement, anemometers for wind velocity measurement, etc. In general you can connect devices that produce a voltage signal or a voltage pulse. You cannot directly connect strain gages, TDR devices or other instruments that have special circuit balancing or accurate timing requirements. In order for the connected devices to produce and record an engineering measurement, specific commands must be programmed into

the datalogger. These commands are programmed by many instructions in the *Edlog* module of LoggerNet software, which will be described later. Through the use of a software program called Loggernet, users can create and load control programs in the onboard memory of the data logger to execute a specific control functions or sampling processes. These operations include sending power to the measuring devices through the control ports, timing of measurements, and storage of the acquired data. Data were stored in the 2-megabytes of built-in memory, which allowed for the storage of about a week's worth of data before it was transferred to a computer for later analyses.

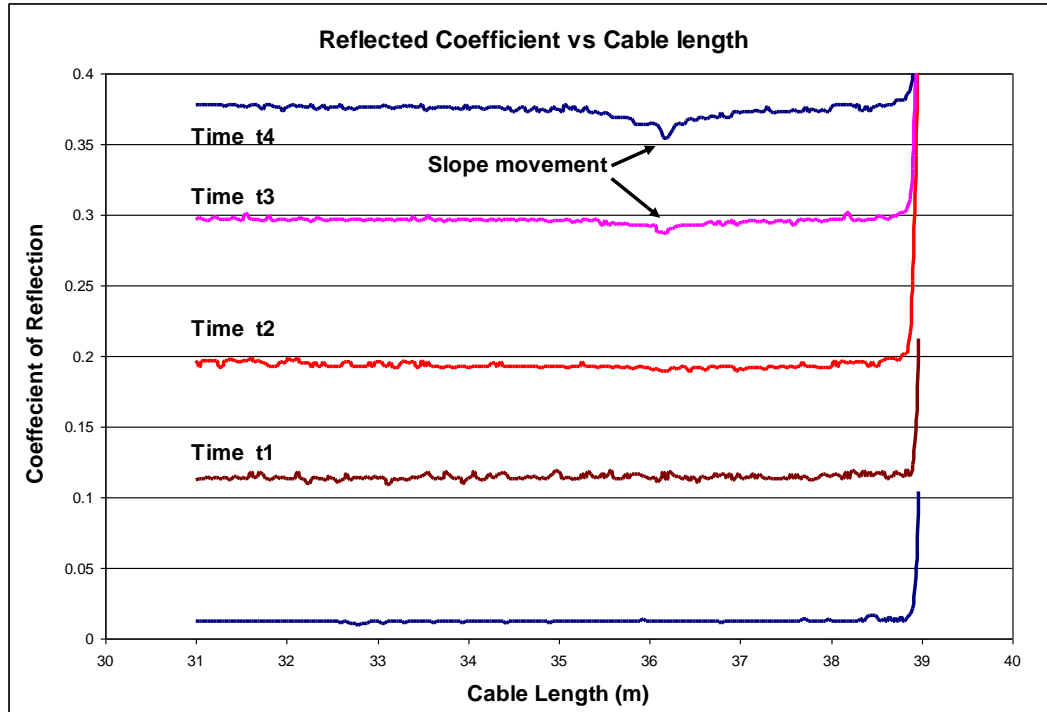
Figure 3-14: Typical TDR cable signatures in slope movement detection.

In the application of slope movement detection, a TDR cable is installed into a borehole within the slope passing the suspected slip zone and grouted with a mixture of cement and bentonite. After the installation of the TDR cable is completed, an initial waveform, or cable signature, is obtained before any slope movement occurs and is used as the baseline for future comparison. This signature expresses no change in geometry of the cable whereas any change in geometry of the cable due to slope failures or slope movements is characterized by a difference of the reflection coefficient in the later readings compared to the initial signature. An example of many TDR signatures indicating slope movement is illustrated in Figure 3-14 below.

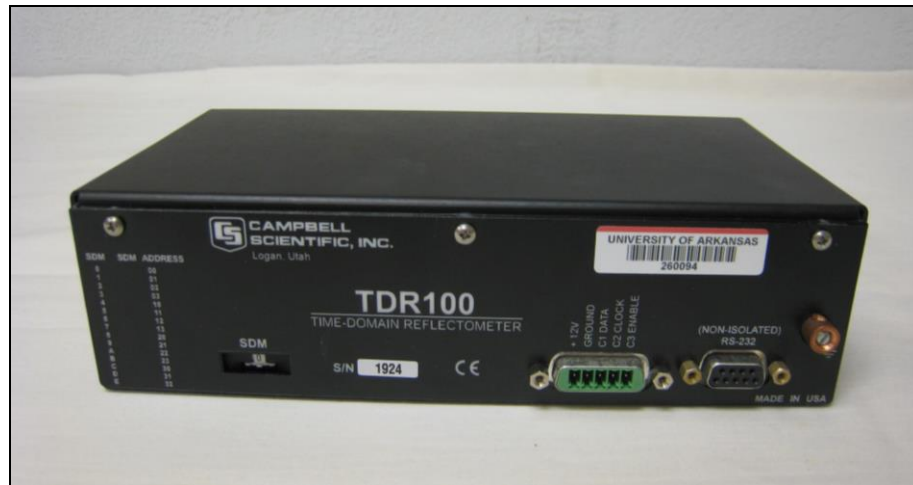
Figure 3-15: A Campbell Scientific TDR100 used in the research.

Figure 3-15 illustrates the TDR100 used in this study. This device is produced by the Campbell Scientific Company, Logan, Utah. The TDR100 is a combination pulser-receiver that is used to acquire a cable waveform that can be used to measure the moisture content of the soil, using a moisture probe, or to locate the position of a failure surface and the magnitude of movement along that surface using a TDR cable probe.

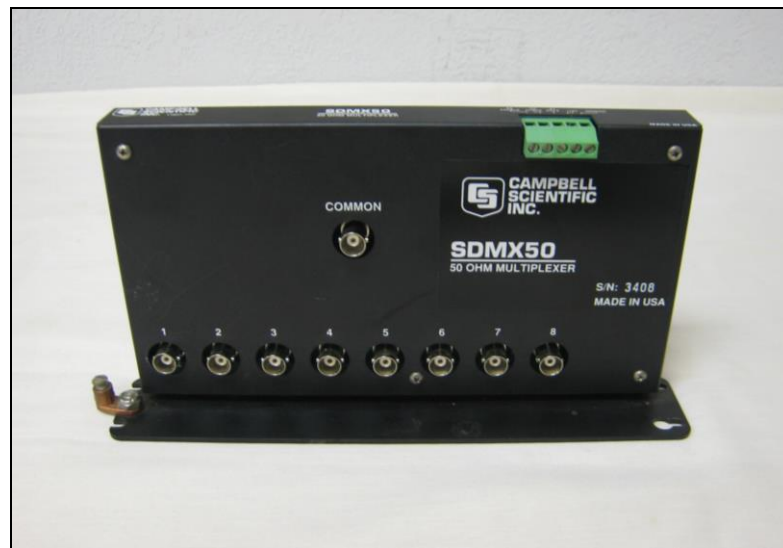
Figure 3-17 A Campbell Scientific SDMX50 multiplexer used in this study.

The TDR100 has only a single port and if measurements from more than one probe are to be measured its capacity must be expanded. In this study a SDMX50 multiplexer, manufactured by the Campbell Scientific Company was used to expand the capacity of the TDR 100. A multiplexer allows more than one cable or moisture probe to be connected to the TDR100. As shown in Figure 3-17, the SDMX50 multiplexer has one output, or common, plug and eight input plugs. Each input plug can be connected to a TDR cable or a moisture probe, or to an the common plug of another multiplexer.. According to the TDR100 manual (2005), three levels of multiplexers can be addressed which creates a total of 512 ports for attachment of TDR devices. A three level multiplexer arrangement is illustrated in Figure 3-28.

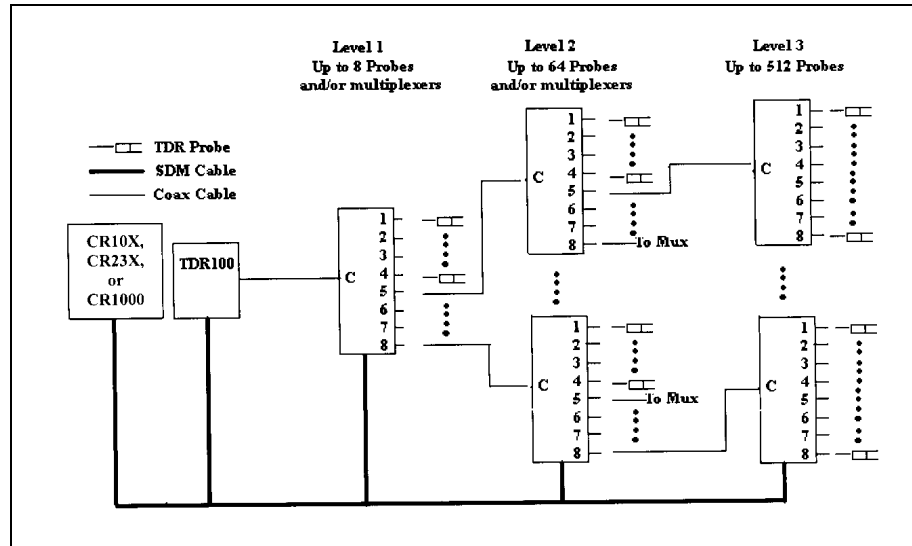
Figure 3-18: Diagram of a 3-level SDM50 multiplexer (Campbell Scientific TDR100 Manual, 2005).

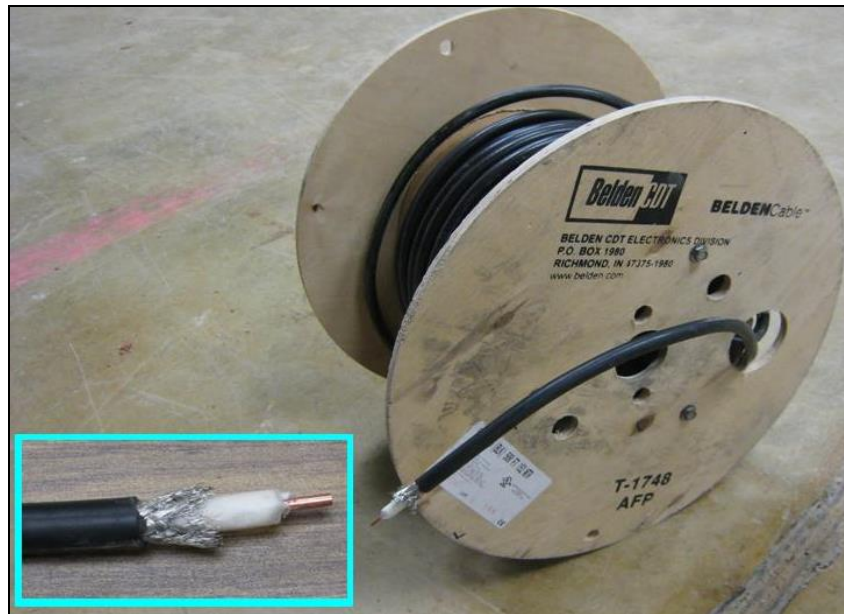
Figure 3-19: The RG8 TDR coaxial cable used in the research.

cable was purchased from Belden Incorporated, St. Louis, Missouri in 500 foot rolls. The cable roll is illustrated in the main picture in Figure 3-19 and the detail component layers of the RG8 coaxial cable are shown in the inset picture at the bottom-left corner of Figure 3-19. In this study four TDR cable probes were used to monitor slope movement, two in the drained section and two in the undrained section.

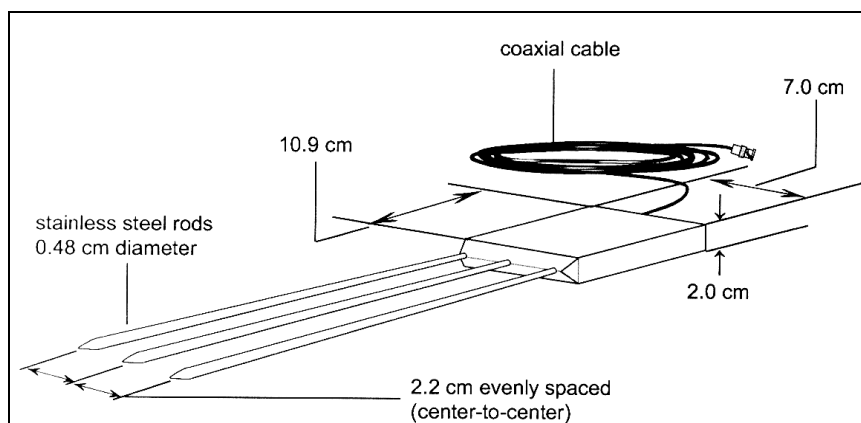
Figure 3-20: Schematic of the Campbell Scientific CS-615 moisture probe (TDR100 manual).

The CS-615 can be polled by the TDR100 at a rapid frequency (every hour in this study) and thus has the ability to provide an almost continuous record of moisture content of the soil at any depth of installation without the need to collect a soil sample or use some manual technique to obtain a measurement. This sensor type treats the soil between the metal rods as a dielectric material. As the moisture content of the soil between the rods changes its dielectric properties change and the electronic signature of the probe changes. Figure 3.22 illustrates a typical cable signature for the CS-615 moisture probe. The distance between the two spikes in the cable signature indicate the apparent length of the metal rods of the probe. When this length is compared to the actual length of the rods the soil's dielectric constant can be determined by Equation 3.2 which is based on electromagnetic pulse theory. Once the dielectric constant of the soil is known the volumetric moisture content can be empirically correlated using either Equation 3.3 or 3.4.

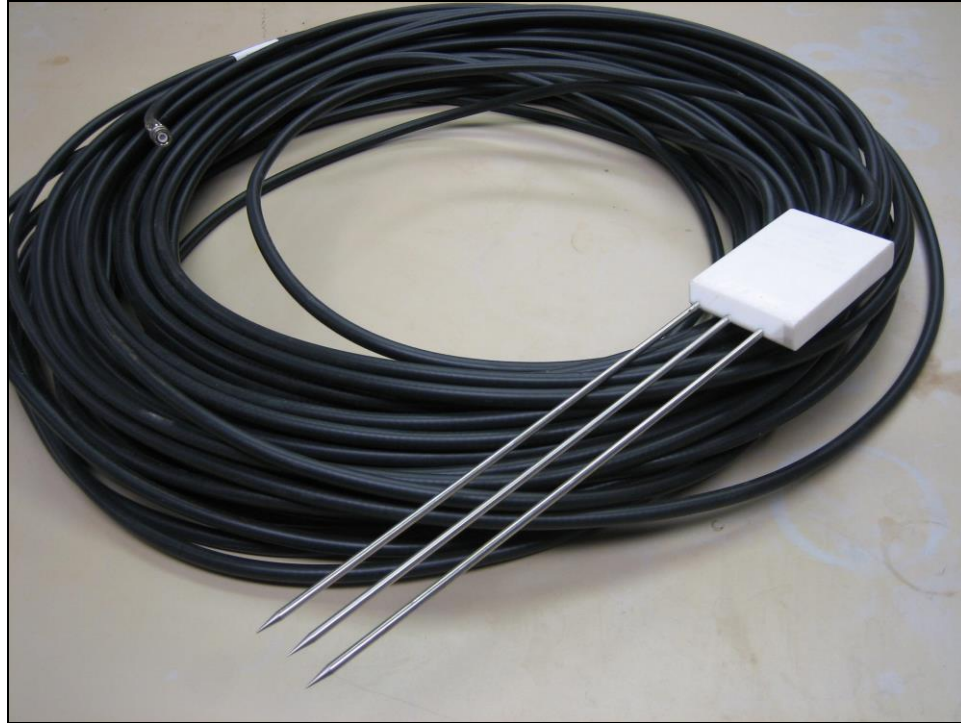
Figure 3-21: A CS610 moisture probe used in the study.

The moisture probes used to measure soil moisture content within the slope in this study were the Model CS615, manufactured by Campbell Scientific Company, Logan, Utah. As illustrated in Figures 3.20 and 3.31, this type of moisture probe has three 1ft (30cm) stainless steel rods connected to a polycarbonate head. The probe is connected to the TDR100 or a multiplexer with RG8 coaxial cable, as illustrated in Figure 3-20. In this study, ten CS615 moisture probes were used to monitor the changes in moisture content

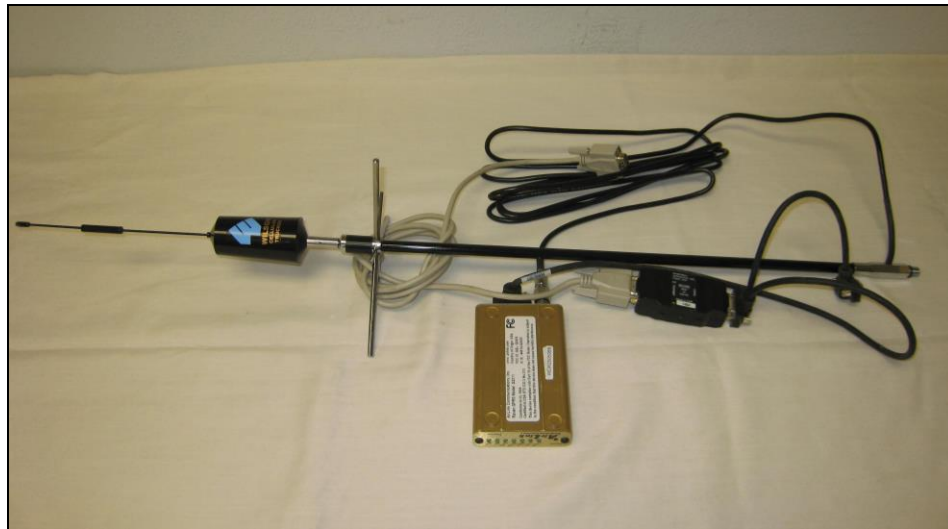
Figure 3-23: The telecommunication system used to in the study.

A telecommunication system was used in this study to transfer the data that was recorded and stored in a datalogger at a remote location to a base computer located in Bell Engineering Center. Without this component, an engineer must visit the site to collect data manually at least once a week. The telecommunication system included dual band cellular antenna, a data translation device and a cellular digital modem as shown in

Figure 3-23. The antenna operated at frequencies of 900 and 1900 MHz, which are the two frequencies utilized by the AT&T cellular system. The data translation device was a Campbell Scientific produced serial cable that was used to convert data signals from the Campbell Scientific logic used by the CR10X datalogger to standard RS-232 logic used by the communication industry and standard computers. This device served as the interface between the datalogger and the modem. The cellular modem was Raven II, Manufactured by Airlink Communications, San Jose, CA. It was designed to operate on AT&T's GSM system and could transmit data at a Baud rate of 9600 cps. When powered on the modem could automatically call a polling computer or could be called by a polling computer.

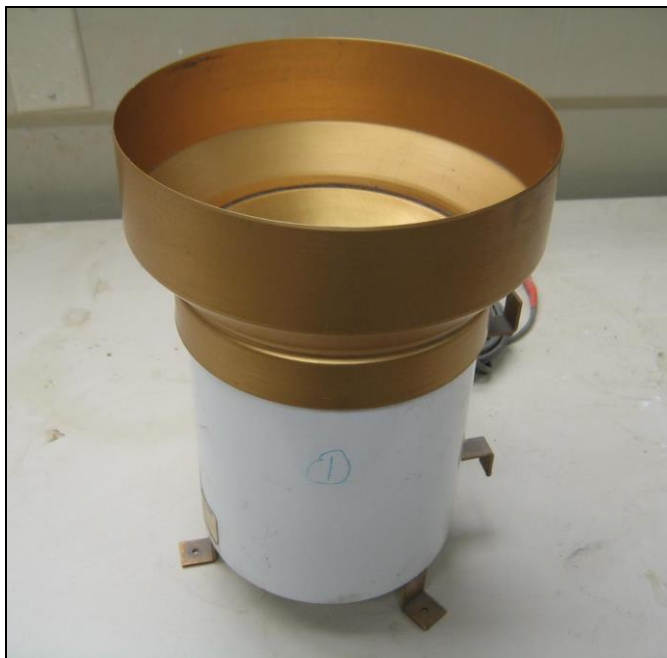
Figure 3-24: Model rain gauge used in the study.

station. Figure 3-24 illustrates the model TR-525USW rain gauge, manufactured by Texas Electronics, that was used in this study. This device contains a calibrated bucket that tips when 0.01 of an inch of rainfall is collected in the collection funnel. Each tip creates a voltage pulse that is sent to the data logger. The voltage pulses are counted by the datalogger as a function of time so rainfall intensity can be recorded as inches of precipitation per unit of time.

In order to use this device as a flow measuring device the exact amount of liquid required to make the tipping bucket tip had to be established. In addition the maximum pulse rate that the data logger could count had to be ascertained as described earlier.

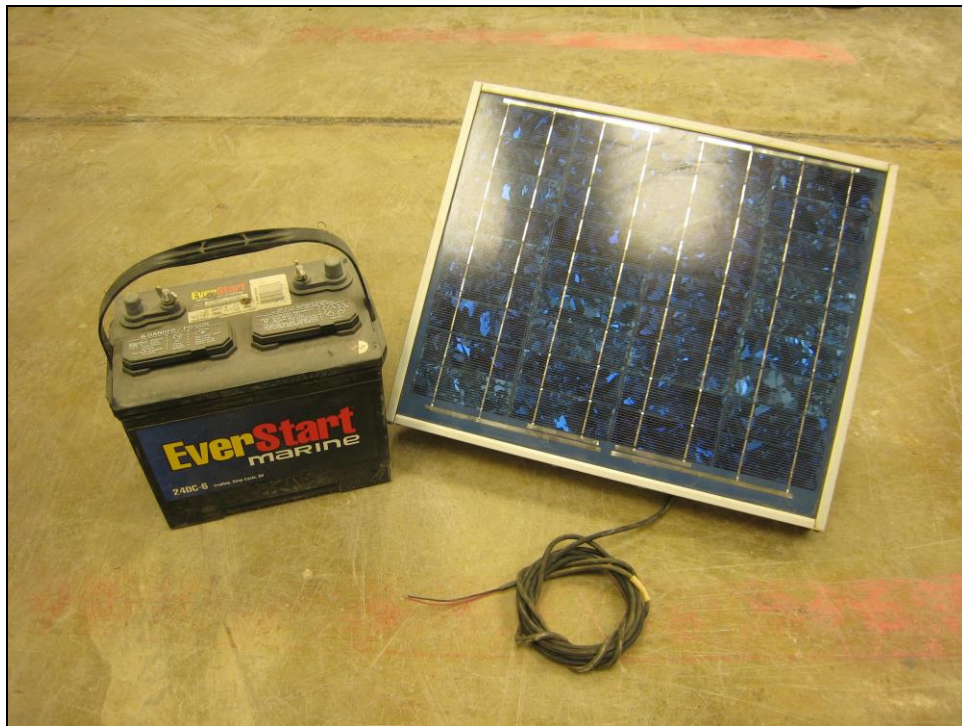
Figure 3-25: Solar panel and 12-V battery used to supply power to the TDR system.

comprised of a 12 Volt storage battery and a 20 Watt solar panel was created to fill this need. The major components of this system are illustrated in Figure 3-25. Figure 3-26 shows the weather-resistant enclosure used to contain the data acquisition system, communication system and the 12-V battery with charge controller. This enclosure was a Fiberglass Reinforced Plastic Model PS3030A case, produced by Vynckier Enclosure Inc, Houston, TX. Its function was to prevent damage to the equipment by weather or other sources (manmade or natural) that might jeopardize the study.

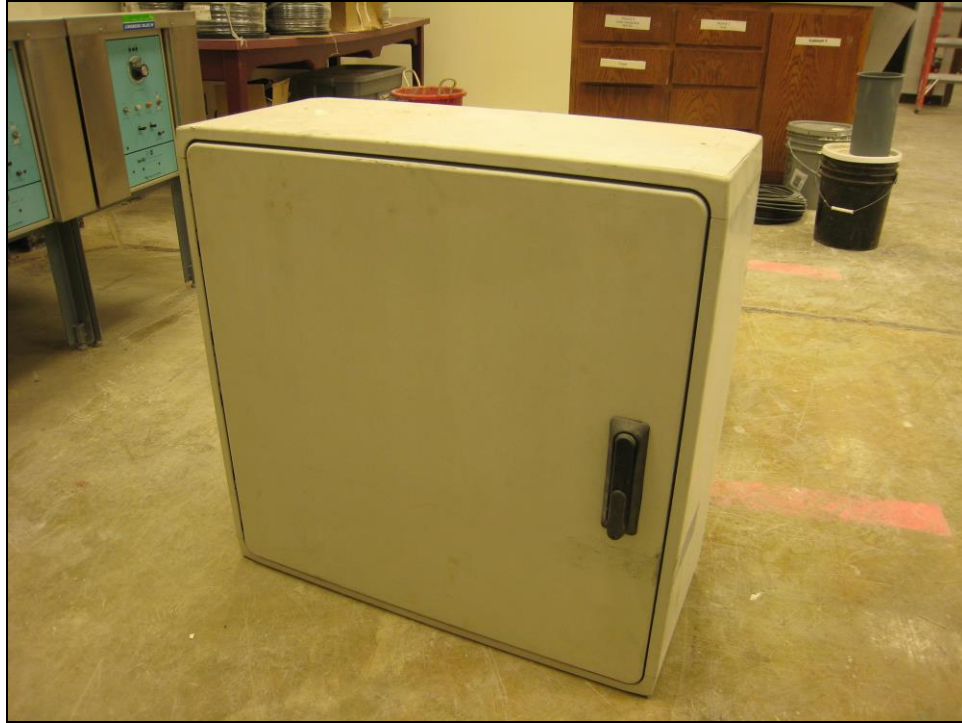
Figure 3-26: A weather-resistant enclosure housing the data collection system.

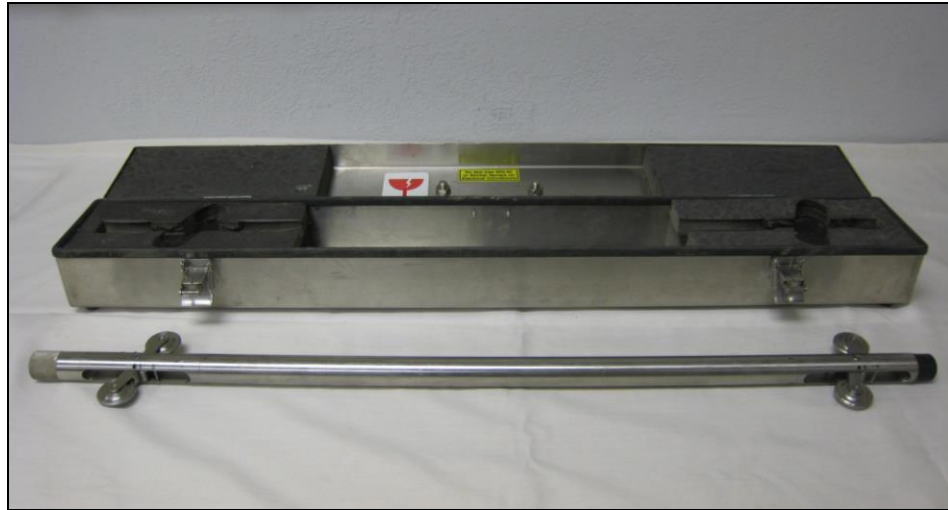
Figure 3-30: The Slope Indicator inclinometer probe and its container.

The complete operating principles of a probe inclinometer is described in Appendix A. The traversing inclinometer probe used in this study was manufactured by Slope Indicator, Inc. and was purchased from the Stone Mountain, GA office. Figure 3-30 shows the 30 inch long stainless steel traversing probe. The force accelerometers for this probe are located at the wheel locations which are 24 inches apart. The power supply/data recorder mated to this probe is a Digitilt DataMate® also produced by Slope Indicator, The DataMate is shown in Figure 3-31. According to the manufacturer's specifications, the maximum storage capacity of this readout unit is 2,500 readings, which translates to about 40 casing surveys. Data must be offloaded to a computer when

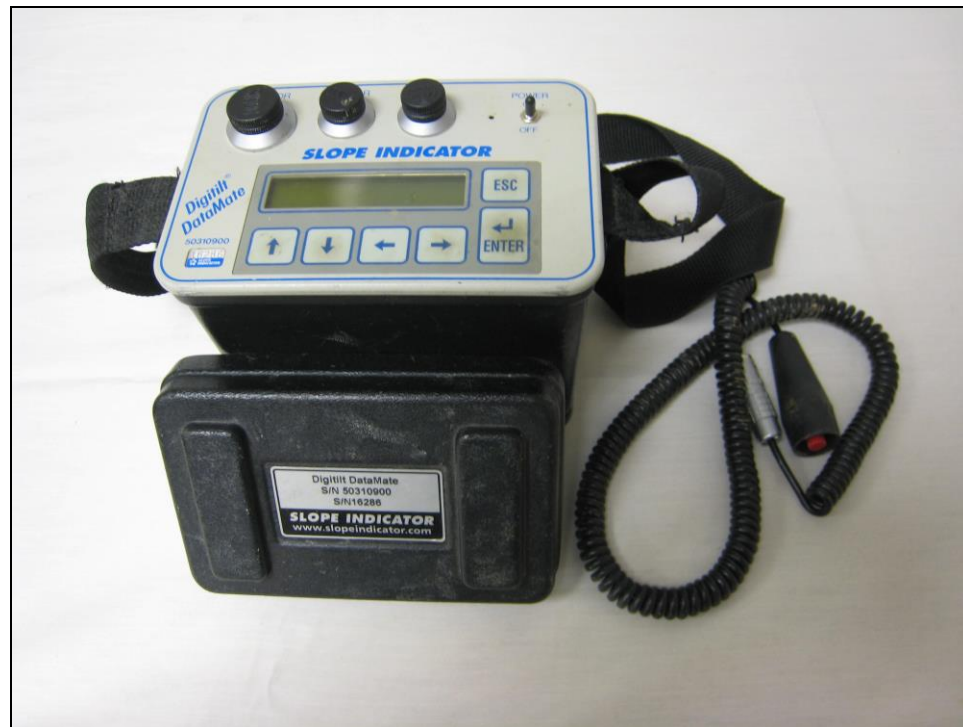
Figure 3-31: The Digitilt DataMate® readout unit (After Slope Indicator).

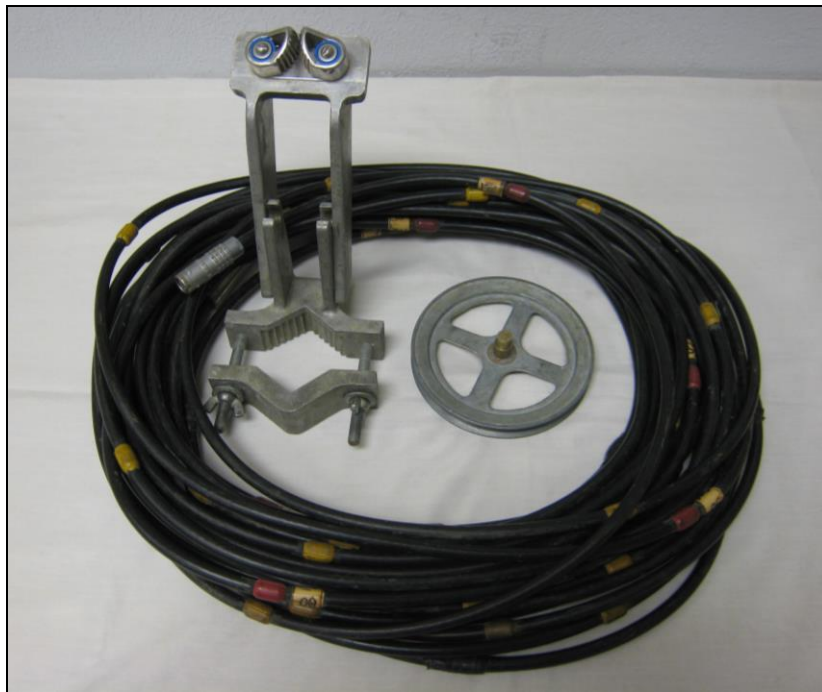
Figure 3-32: The control cable and the pulley assembly for inclinometer system.

Illustrated in Figure 3-32 is the 100 foot control cable and the pulley assembly used for the inclinometer surveys in this study. The pulley assembly attaches to the top of the inclinometer casing and helps to position and hold the inclinometer probe in place within the casing while making a measurement. The cable has rubber depth markers fused to the jacket at 2 foot intervals. Using the depth markers the operator knows the exact position of the middle of the inclinometer probe, referenced from the top of the inclinometer casing, at each measurement location.
