# **Geosynthetic Drains for Slope Stability & Rehabilitation**

Final Report

2015

11. Contract or Grant No. <b>TRC0506</b>	
12. Sponsoring Agency Name and Address <b>Arkansas State Highway and Transportation Department P.O. Box 2261 Little Rock, AR 72203-2261</b>				13. Type of Report and Period covered <b>Final Report 1 July 2005 thru 30 June 2009</b>

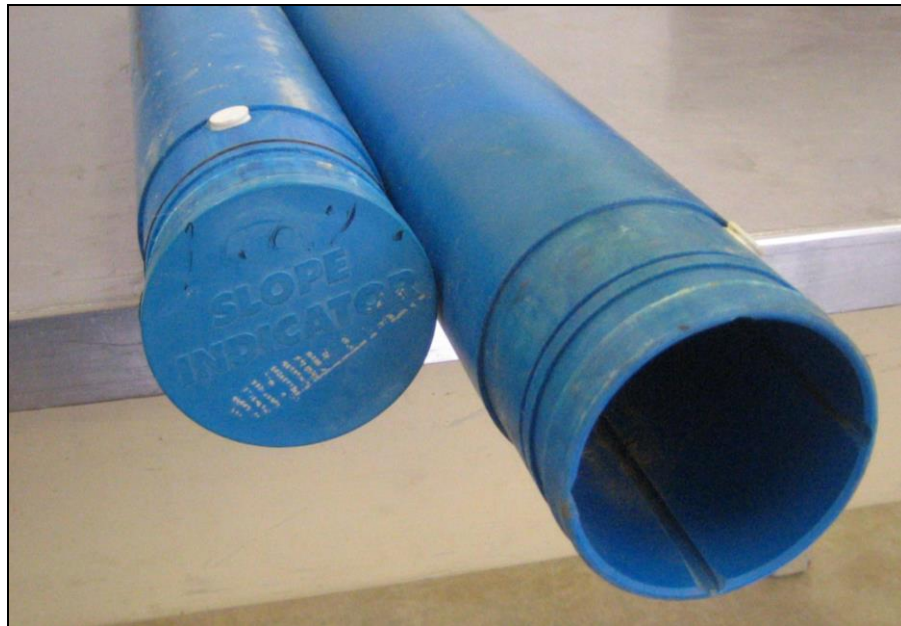
Figure 3-32: Quick Connect (70 mm) inclinometer casings used in the study.

The ABS plastic casings that were grouted into the slope at the study site were 70 mm (2.75 inches) in diameter and were also produced by Slope Indicator, Inc. Standard inclinometer casing comes in standard lengths of 5 and 10 feet and can be connected

together in the field with the snap-together connection to create casings of any length. The quick connect casing used in this study are produced in two sizes 85 and 70 mm in diameter. The 70 mm diameter casing diameter was used in this study because of the shallow depth of study and the anticipated small movements in the slope. The casings are grouted into a vertical borehole using grout or gravel that has approximately the same stiffness as the surrounding soil. As the slope moves the grout column and casing are deformed and this deformation is detected by the probe inclinometer.

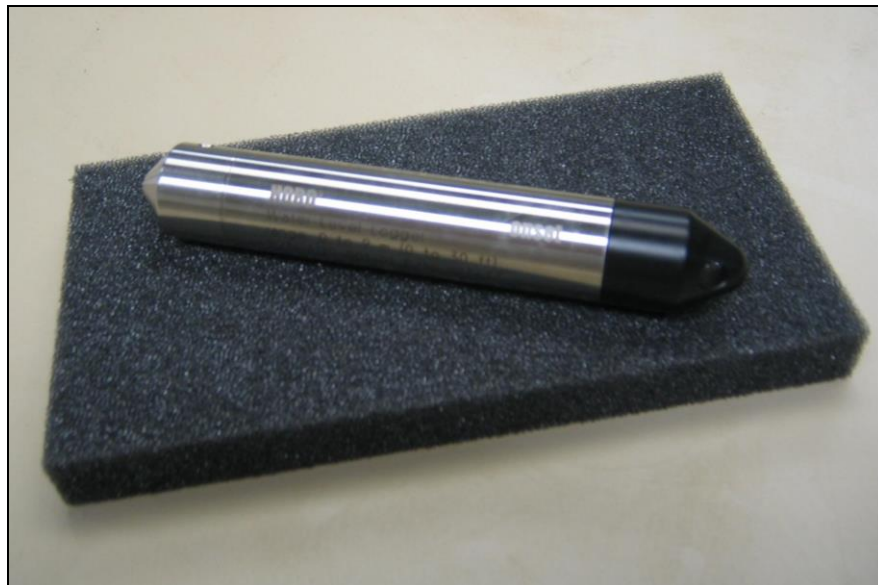
Figure 3-35: A piezometer used in the study.

The piezometer, manufactured by Onset Computer Corporation, used for monitoring the position of the ground water table (GWT) within the slope is illustrated in Figure 3-35. This device is self-contained, autonomous, recorder that can be lowered into a borehole to continuously monitor the location of the GWT. According to the manufacture specifications, the on-board memory capacity of this piezometer is about 64K bytes, which allows storage of up to 21,700 readings, and the battery life can sustain continuous recording for up to 5 years with data being taken at one-minute intervals. These piezometers were placed in the modified inclinometer casings to maintain a record of the water level in the slope during this study. The inclinometer casings were modified by cutting a series of evenly spaced (4 in the radial direction) 3mm x 8 mm slots at 6mm intervals along the length of the lowest 5 feet of the casing. The casings were then backfilled with pea gravel to within 3 feet of the surface. The final three feet of the

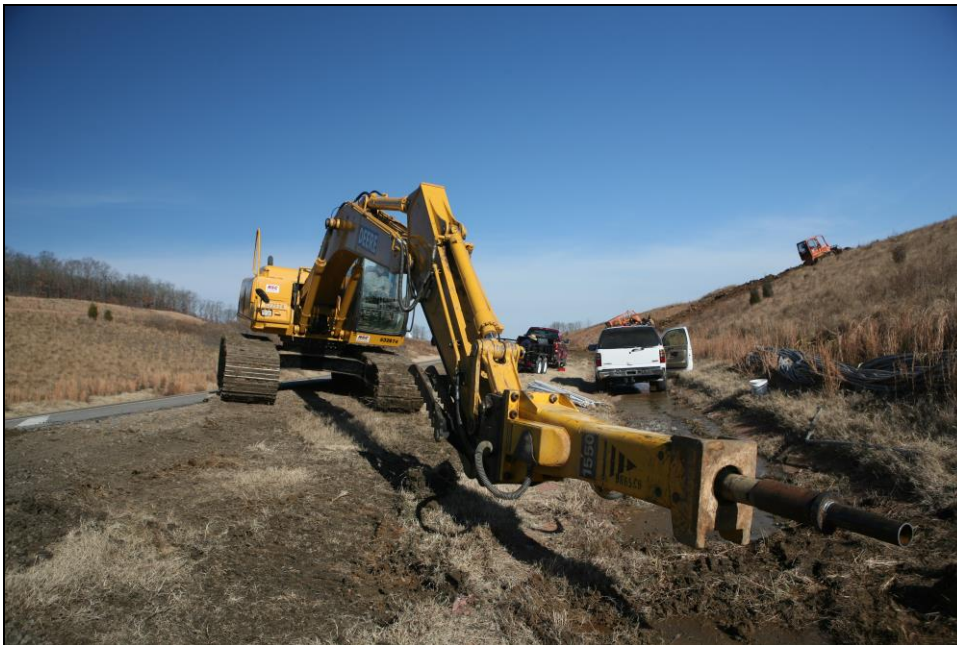
Figure 3-41: The track hoe and paving breaker used for wick drain installation. installation operation are described in the ensuing photographs. In Figure 3-42 the pulling-head, drive head, steel cone drive point, and the slotted drive tube the for wick drain installation are illustrated. At the conclusion of driving the drive tube is removed

Illustrated in Figure 3-41 is the final equipment configuration used to drive the drill rod into the slope and install the wick drains. Each piece of equipment and segment of the

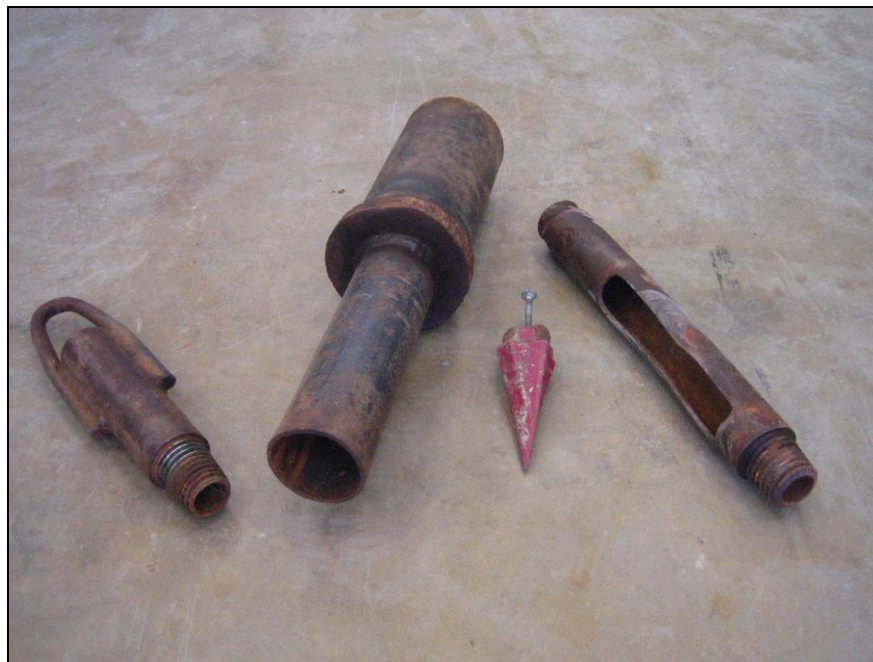
Figure 3-42: From left to right, pulling-head, drive head, steel drive point, and slotted drive tube used in the wick drain installation.

and the pulling head is threaded into the tail of the drill string. A cable is attached to the eye in the pulling head and either the arm of a tracked excavator or a bulldozer winch is used to extract the drill string from the slope. The drive head is a device that is attached to the maul point of the paving breaker and slips over the drive tube of the drill string to transfer energy from the paving breaker to the drill string. The drive tube threads into the female end of the drill rod and contains a slot so that the wick drain can be routed out the rear of the rod assembly and not damaged by the driving operation. The drive point is constructed from a splitting wedge whose driving head has been machined so that it fits the inside diameter of the drill rod.

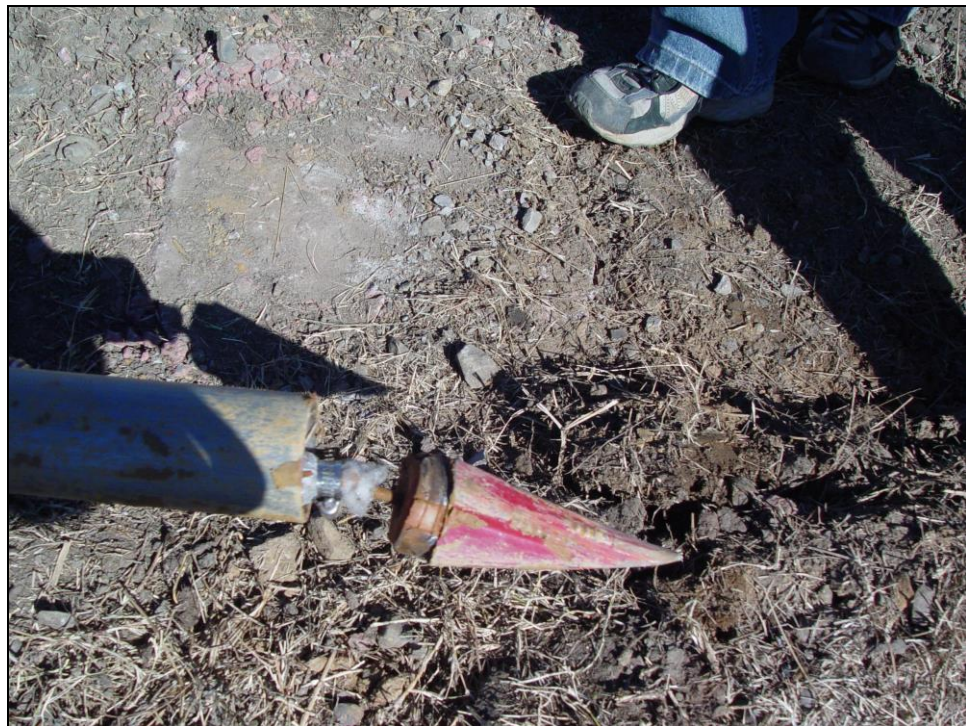
Figure 3-44: The leading edge of wick drain attached to the driving point.

then attached to the carriage bolt of the sacrificial drive point using two hose clamps, as illustrated in Figure 3-44. The drive tube was threaded into the rear of the first section of drill rod and the wick drain was pulled through the slot and moved out of the way as illustrated in Figure 3-45. The first section of pipe was now ready to be inserted into the slope. As illustrated in Figure 3-46 the drill pipe was properly positioned and the drive head, which was attached to the maul point of the paving breaker, was slipped over the drive tube. The combination of static force of the excavator arm and the dynamic force of the paving breaker was then used to drive the first section of drill rod into the slope at an angle that was nearly horizontal. Once the first section of pipe was driven all the way into the slope the excavator was disengaged, the drive tube was removed and the wick drain was threaded through a second section of drill pipe. This section of drill pipe was threaded to the first section, as illustrated in Figure 3-47 and the driving was resumed. This process was repeated until the drill pipe had been driven to the desired depth or until the pipe could be advanced no further. At this point the drive tube was removed from the rear of the drill pipe and replaced with a pulling-head as illustrated in Figure 3-48. A cable was attached to the pulling head and the drill pipe was extracted from the slope using the winch of a bulldozer as illustrated in Figure 3-49.

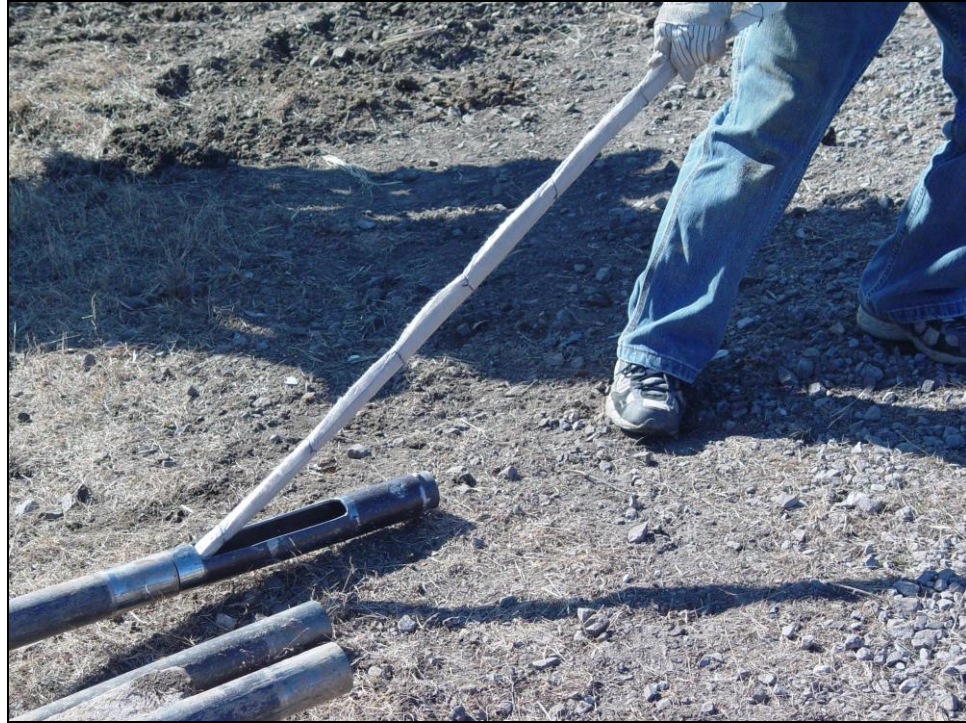
Figure 3-45: Wick drain extended through the driving tube.

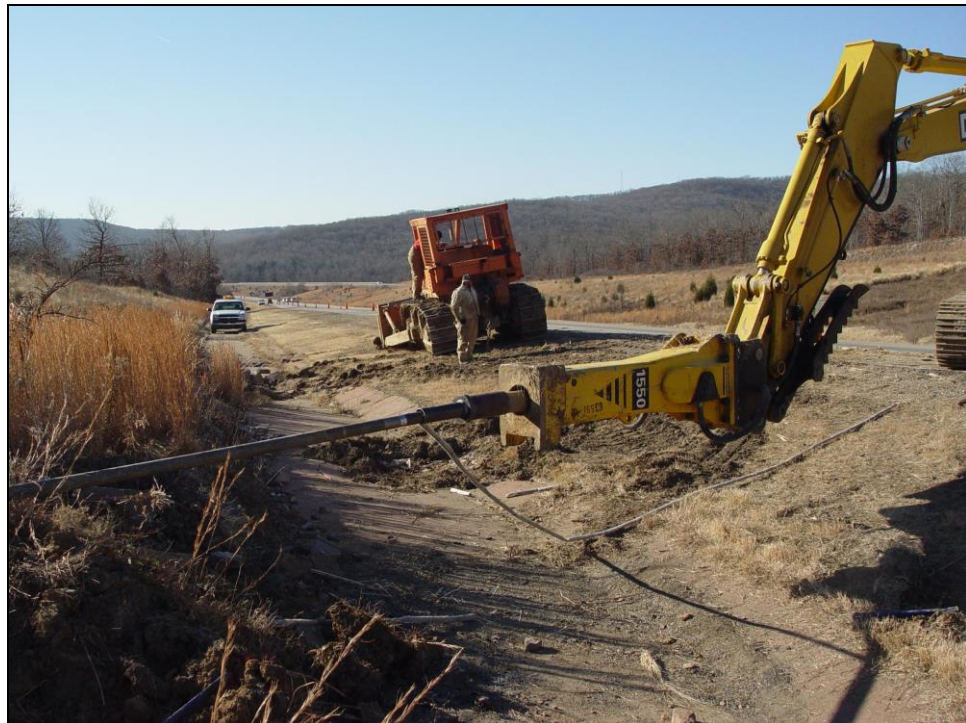
Figure 3-46: Driving the drill rod into the slope using a paving breaker.

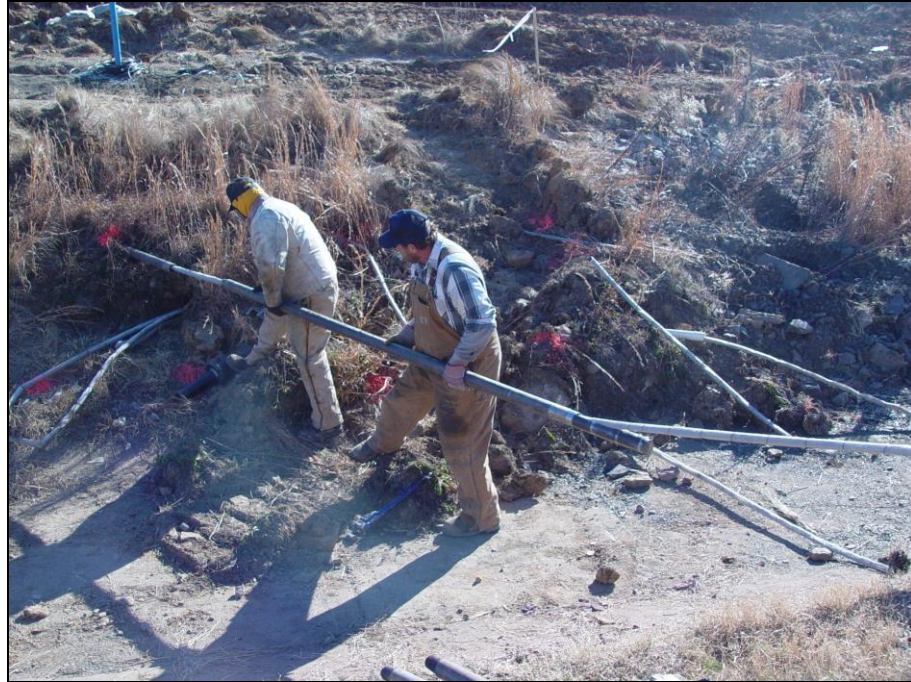
Figure 3-47: Threading drain through additional drill rod section.

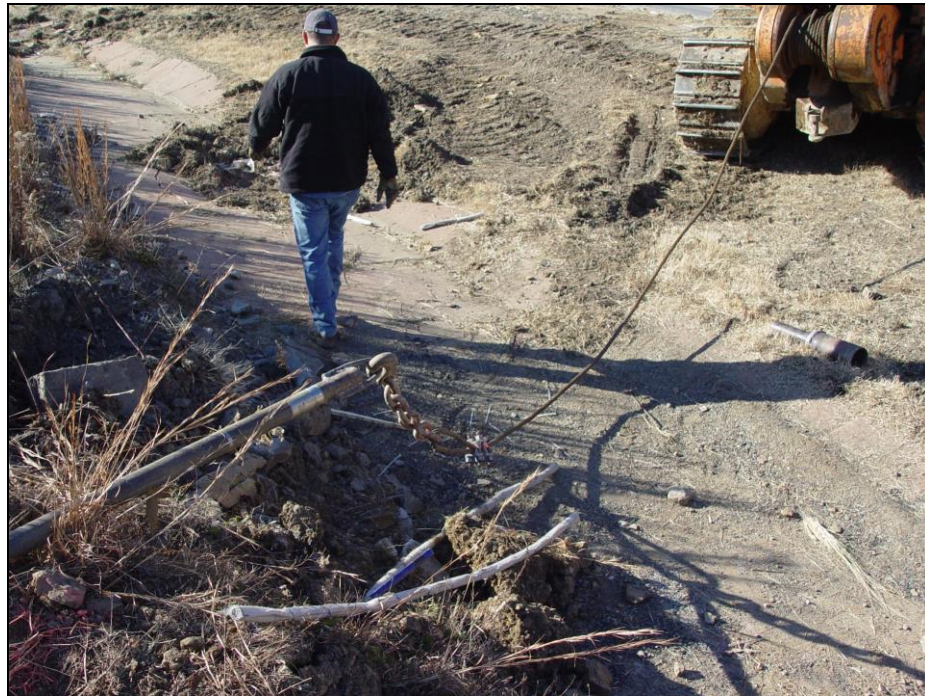
Figure 3-48: The pulling-head attached to final section of drill rod.

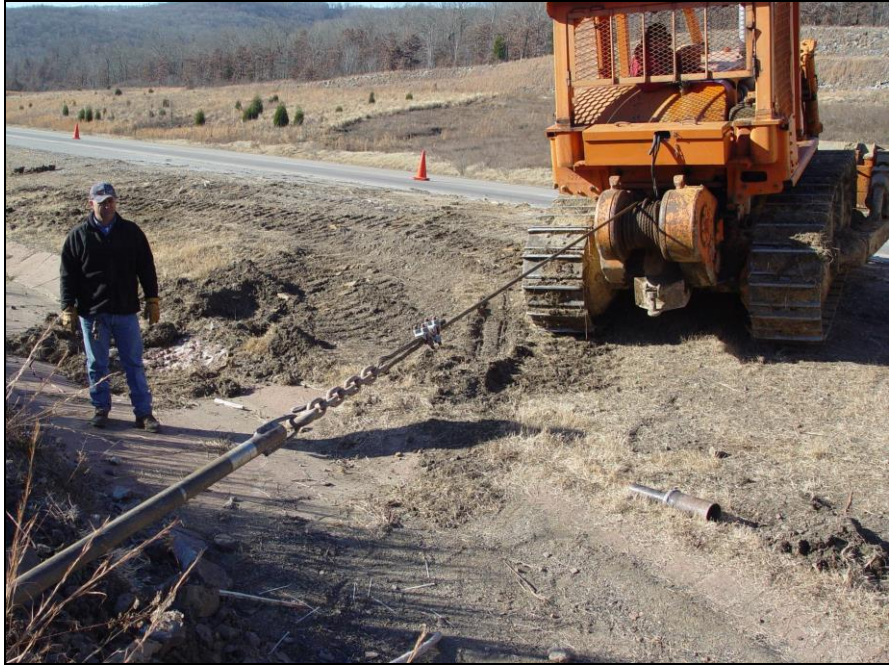
Figure 3-49: Extracting section of drill rod with the bulldozer winch.

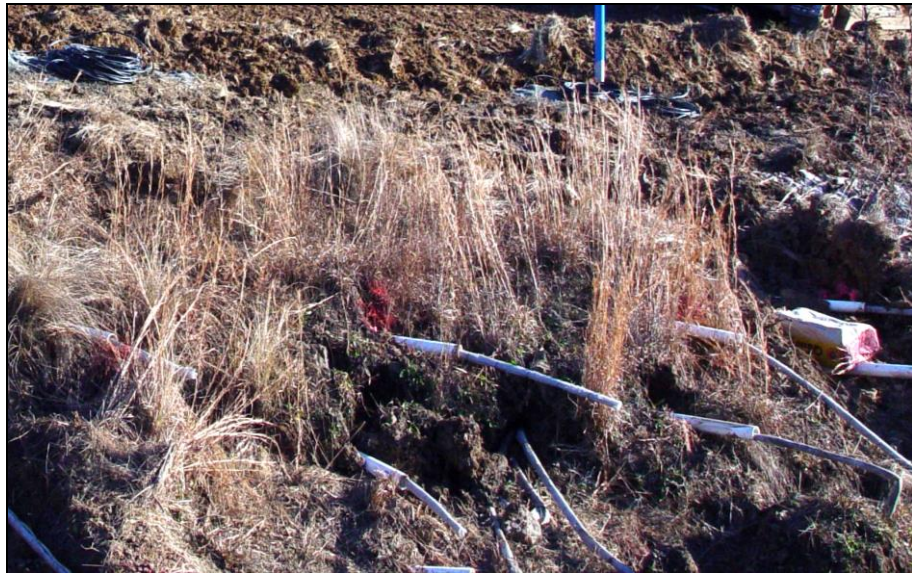
Figure 3-50: Drain end sealed in the slope with a PVC pipe drain termination.

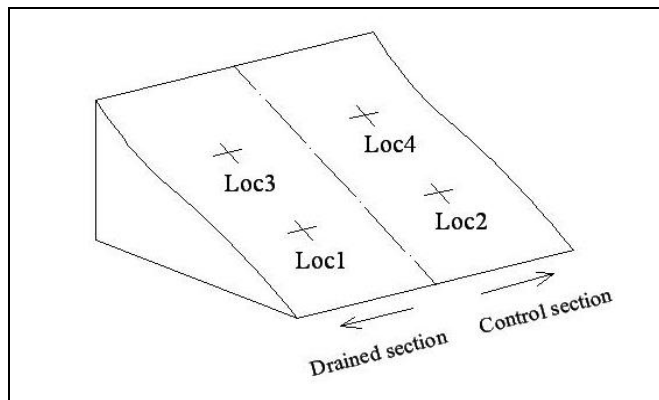
Figure 3-51: Schematic of the four instrumentation locations at the test site.

The installation of the inclinometer casings, TDR cables, and moisture probes began after the wick drain installation was finished. Instrumentation was installed in both the drained section and the control section to evaluate the drain performance. The TDR cables, inclinometer casings and moisture probes were installed in two locations in both the control and drained sections of the slope. One location was in the top-half near the slope crest and the other was near the toe of the slope resulting in a total of four locations as illustrated in Fig 3-51.

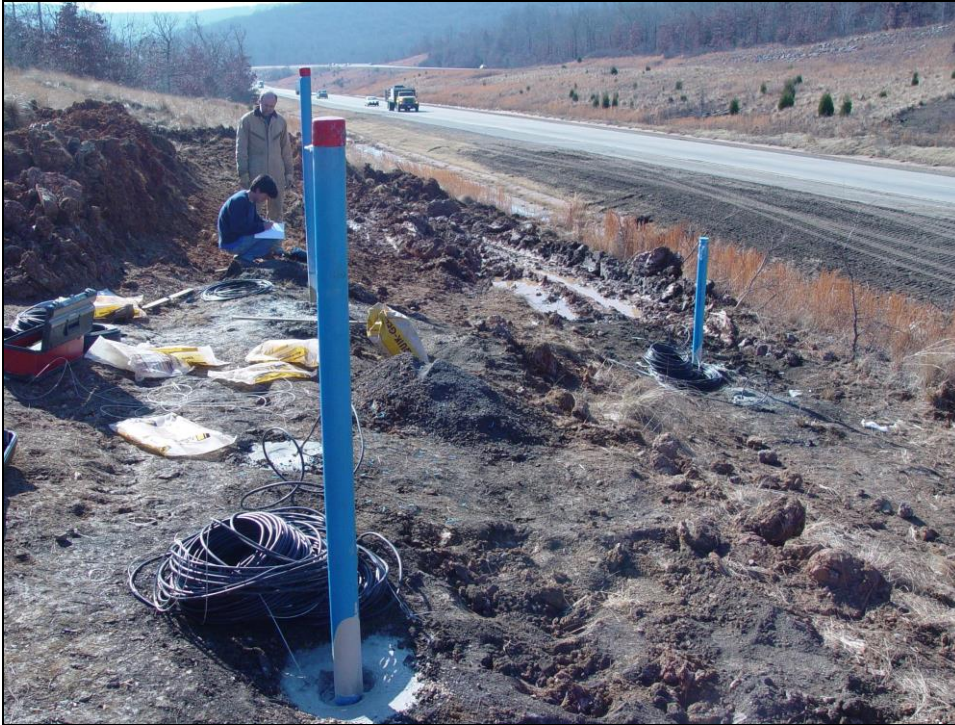
Figure 3-52: Inclinometer casing and TDR cable boreholes filled with grout.

(4 in) auger for the TDR cable installation. All boreholes were advanced well into the stable clay shale formation. Boreholes in the upper locations were advanced 20 feet from the ground surface while those at the lower locations were advanced 15 feet. Immediately after the boreholes were created at a location the inclinometer casing and the TDR cable were inserted to the bottom of the holes. The inclinometer casing was previously perforated with a series of small holes so that it could collect water from the slope and function as a monitoring well for determining the ground water location. Pea gravel was poured to fill the borehole to more than half of the depth of the inclinometer casing then a cement-bentonite grout mixture was poured into the remaining annular space to fill the hole. The grout mixture for the inclinometer casing consisted of a 47 lb. of Portland cement, 13 lb. of powdered bentonite, and 30 gallons of water. The TDR cable completely grouted with a grout mixture consisting of 94 lbs. of cement, 10 lbs. of powdered bentonite, and 30 gallons of water. The grout mixture for the inclinometer casing was designed to have a similar stiffness as the surrounding soil. The grout mixture for the TDR cable was intended to be stiffer than the surrounding soil so it would shear rather than deform if the earth moved. The TDR mixture also had to be strong enough to deform the TDR cable. In the remaining 200 mm (8 in) diameter borehole, two or more moisture probes were lowered to desired depths, and the borehole was filled with native soil to replicate the insitu unit weight of the soil. The installation of the TDR cables, inclinometer casings, and moisture probes at the other locations were completed in the same manner as the first location. Figure 3-52 illustrates the partially completed

installation of the inclinometer casings and TDR cables.

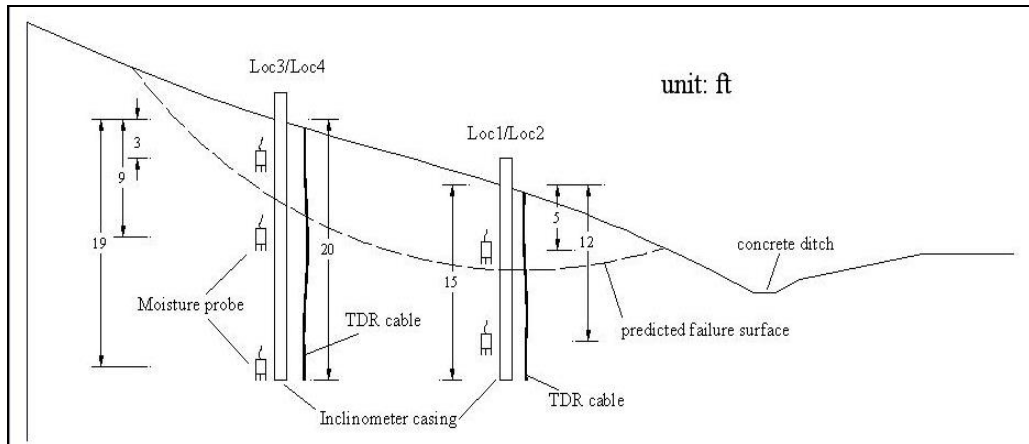
Figure 3-53: Side view of the slope with the installed monitoring equipment.

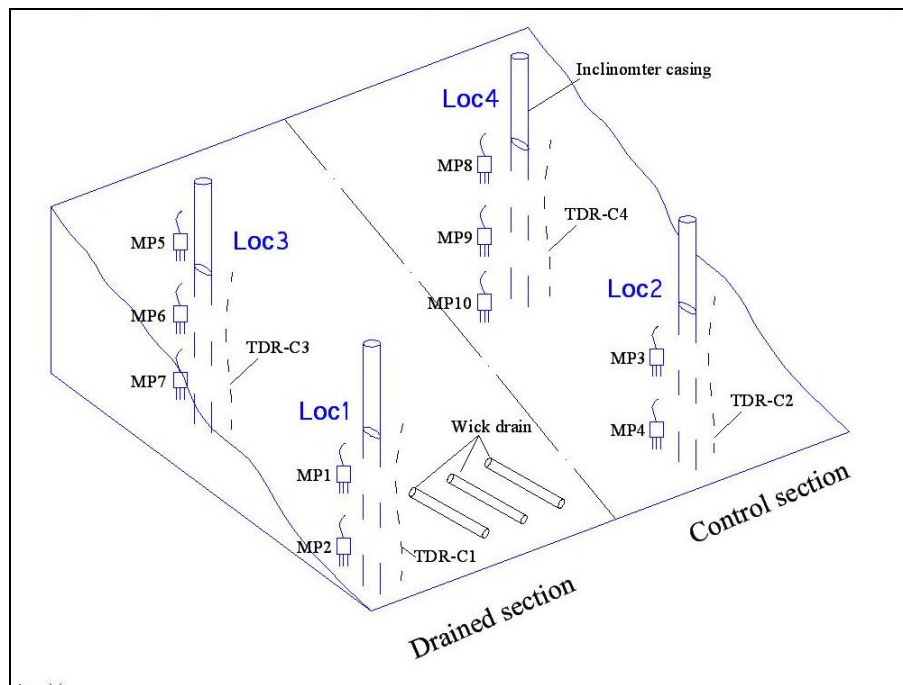
Figure 3-54: 3-D view of the monitoring equipment installed within the slope.

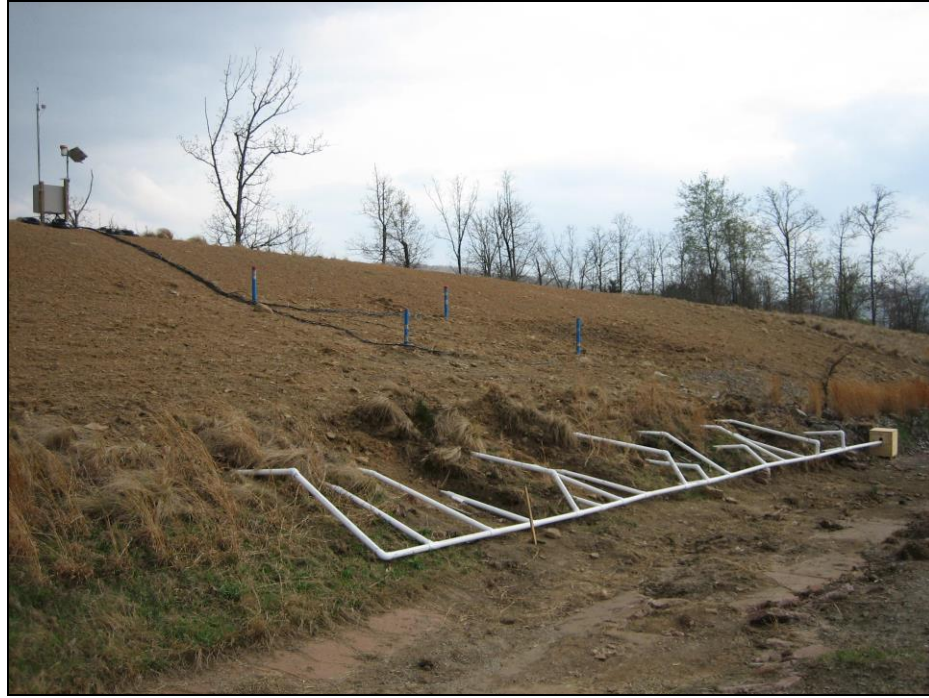
Figure 3-56: Completed slope monitoring and drainage collection system.

The drains were installed in early December when there was little if any precipitation and the near surface of the slope was frozen. As a result, there no flow was observed from any of the drains. Within two months a manifold system was created to connect each drain to a common discharge location. This system, which terminated at a tipping bucket rain gauge to measure discharge, is illustrated in Figure 3-56.

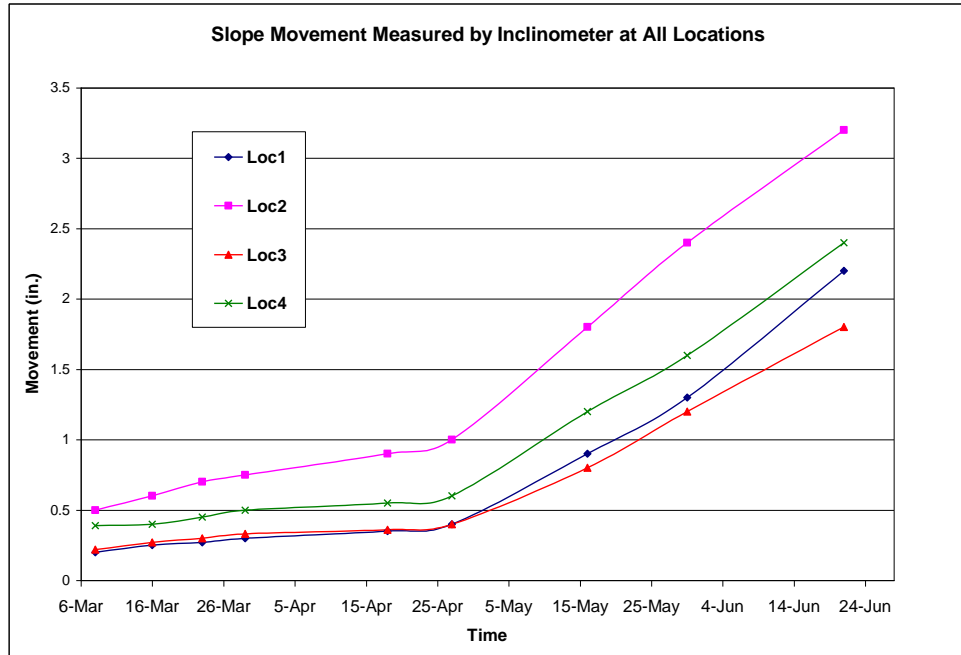
Figure 4-9: Slope movement measured at all locations by the inclinometer.

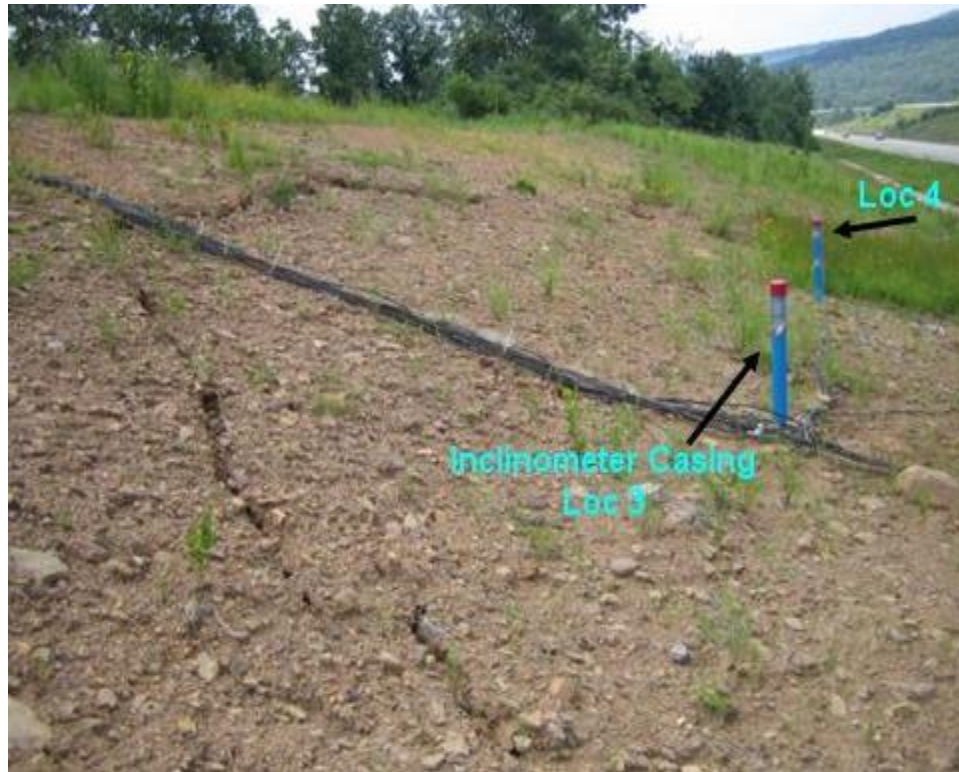
Figure 4-10: Location of the crack on the slope surface.

Since the slope moved such distance of 3.2 in. at Loc2, as measured by the inclinometer, a failure eventually occurred and a crack was found on the slope surface. This crack was observed to happen in the middle of June, after many large rainfalls occurred. The crack was seen on the upper part of the slope and above the inclinometer casings at Loc3 and Loc4, as illustrated in Figure 4-10. It progressed most in the right side of the slope, or in the control section, while a small portion of the crack developed in the drained section. Figure 4-11 and Figure 4-12 illustrate the progress of the crack and its termination in the drained section and in the control section, respectively.

This crack prolonged with an average width of 4 in. on the drained section while its width measured on the control section was about 6 - 8 in. Especially, a big opening was found on the slope surface as the crack progressed. This opening was on the control section, at the right side of the Loc4. The position of this fissure on the slope surface is specified in Figure 4-11 and its widest opening was measured approximately 14 in., as illustrated in Figure 4-13. With the information of the crack captured from Figure 4-10 to Figure 4-13, a layout of the failure was created in Figure 4-14 to illustrate the progression of the crack on the slope surface. From this figure, it can be seen that the failure mainly occurred on the control section. Although the slope actually failed in both sections, the crack progressed on the drained section might be the consequence of the development of the failure on the control section. The failure was hypothesized to occur on the control section first and it expanded onto the drained section as the crack became larger, resulting

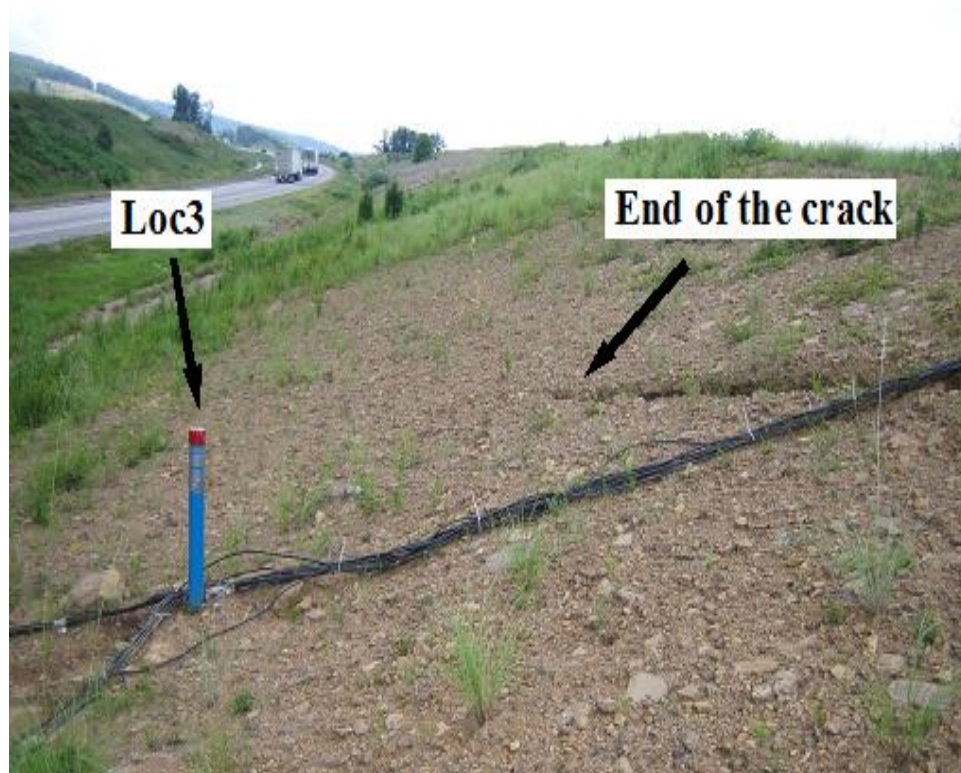
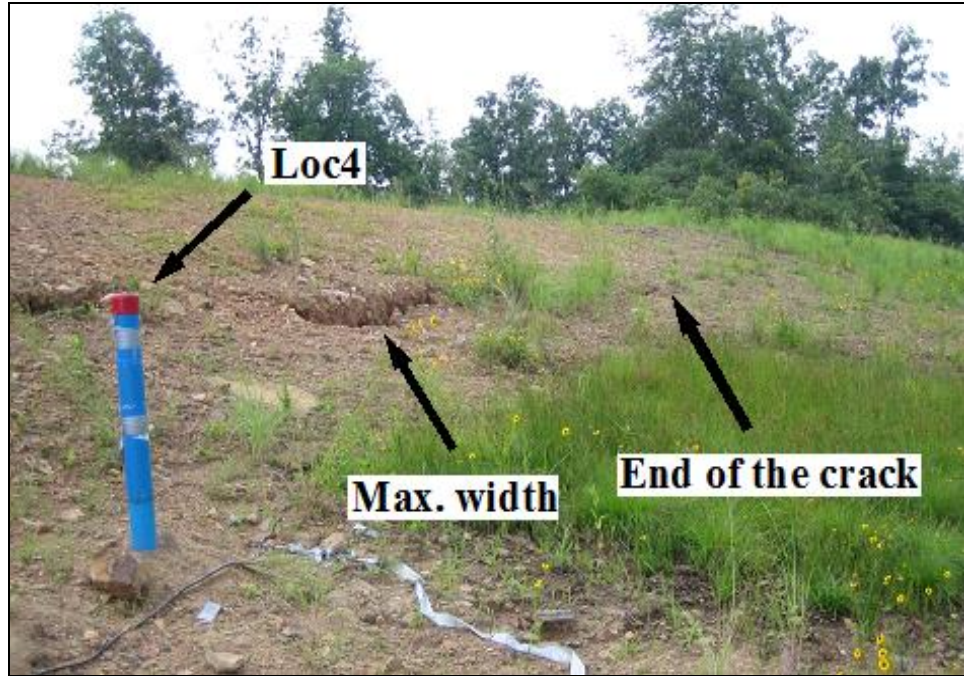
Figure 4-11: The progress of the crack and its termination on the drained section.

Figure 4-12: The progress of the crack and its termination on the drained section.

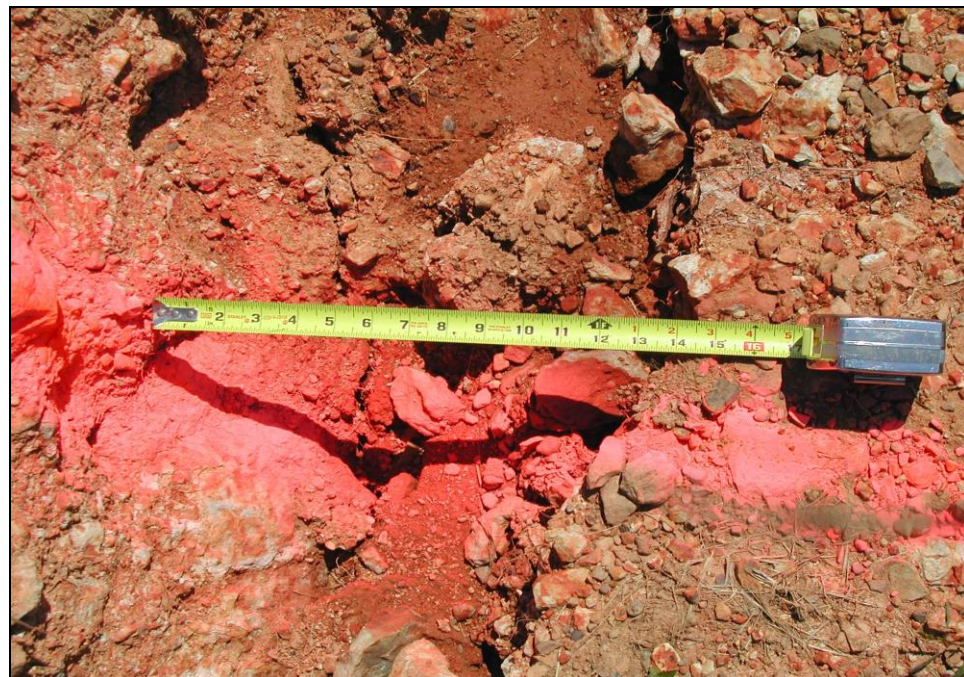
Figure 4-13: The width of the opening measured by a tape measurement.

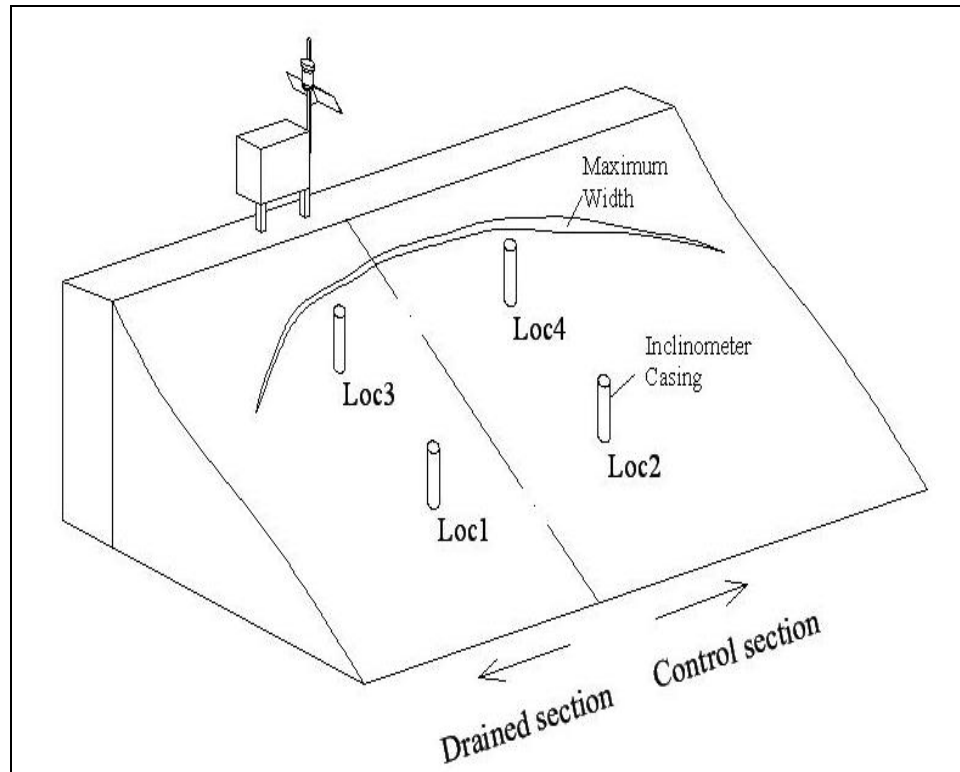
Figure 4-14: The lay out of the failure developed on the slope surface.

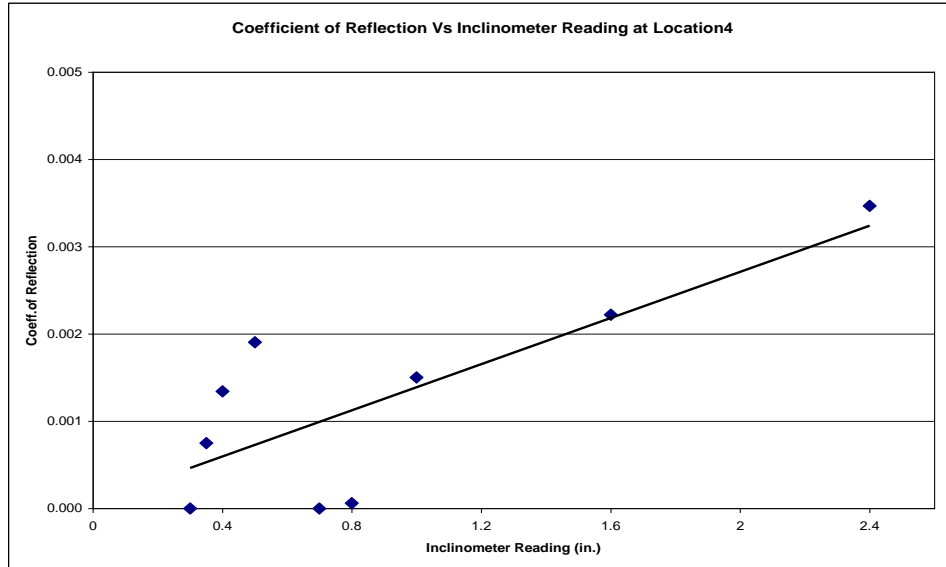
Figure 4-30: Relationship between the slope movements measured by inclinometer and TDR cable methods at Loc4.

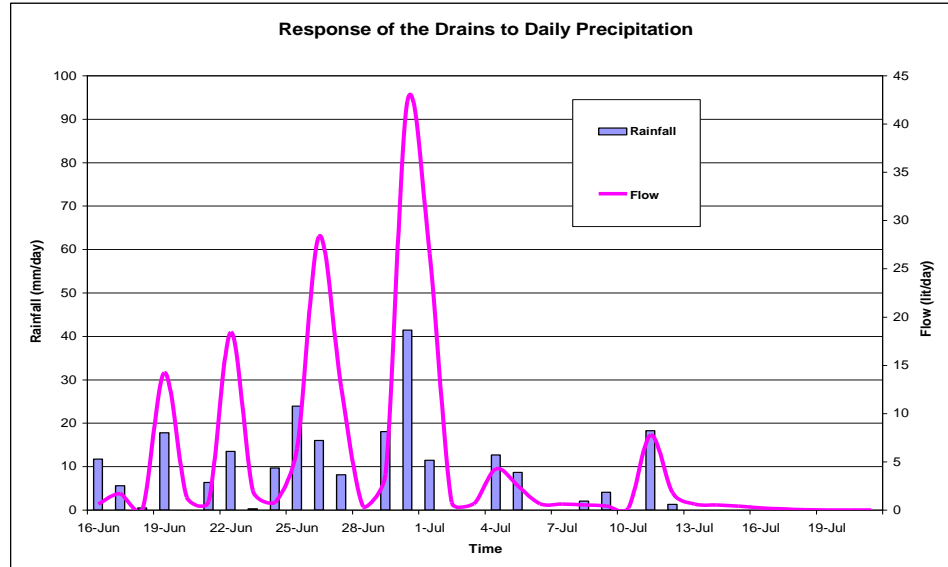
Figure 4-37: Response of out flow from the drain system to daily precipitation at the site.

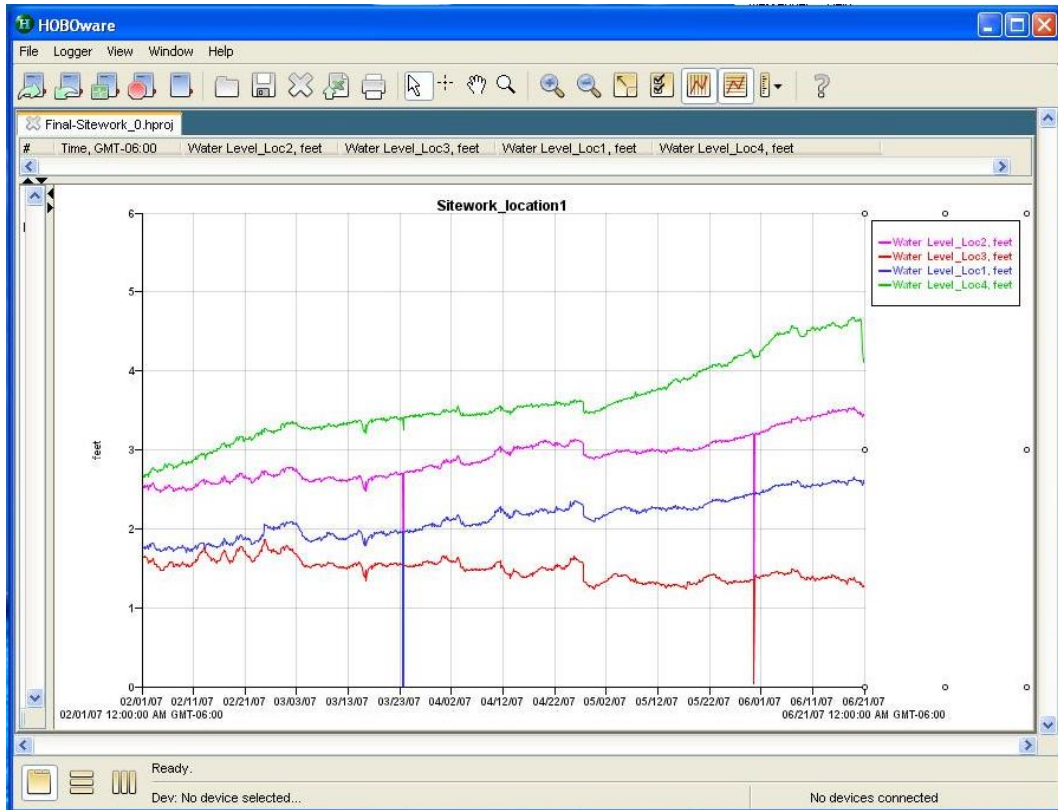
Figure 4-40: Ground water table profile at all locations.

In this study, the ground water table (GWT) within the slope was measured by four piezometers and the data were plotted by the HOBOTM Ware software for the duration of the monitoring. These piezometers were located at the bottom of the casings to record the changes of water level at all locations. The results of the GWT monitoring at four locations were displayed in Figure 4-40 below. Since the piezometers were placed at the bottom of the casings at all locations, the depths of the GWT reported from the bottom of these locations. As can be seen in this figure, the highest GWT was measured at Loc4 while the piezometer at Loc3 recorded the lowest value of GWT. However, all of these GWT results were recorded far below the slope surface, and the highest GWT recorded was about 5 ft above the bottom of the casings. Since the depths of the casings buried at Loc/Loc2 and Loc3/Loc4 were respectively about 15 ft and 19 ft below the slope surface, it can be said that the GWT did not come up to the slope during the experiment. Therefore, the location of the GWT recorded by these piezometers indicates that the GWT did not impact slope instability at the location of the respective boreholes.

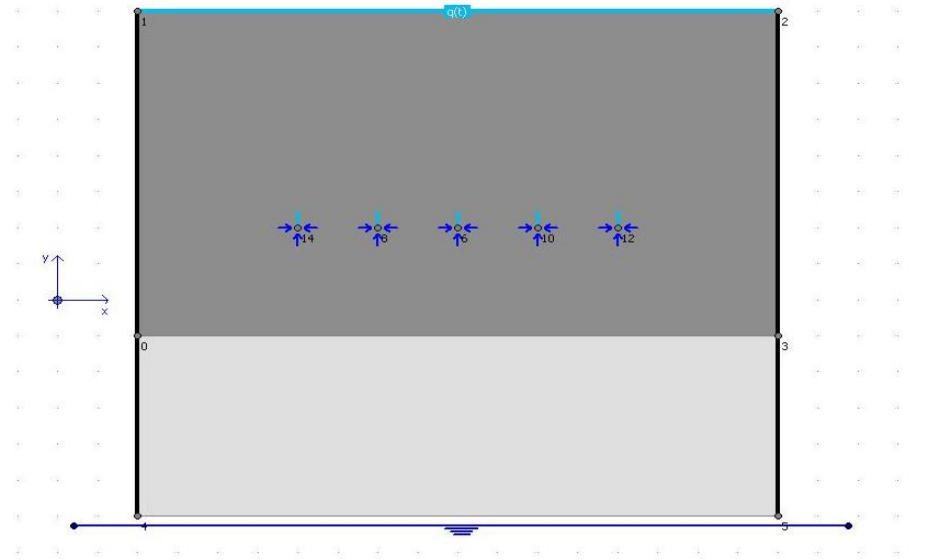
Figure 4-44: A cross section model in the drain spacing determination.

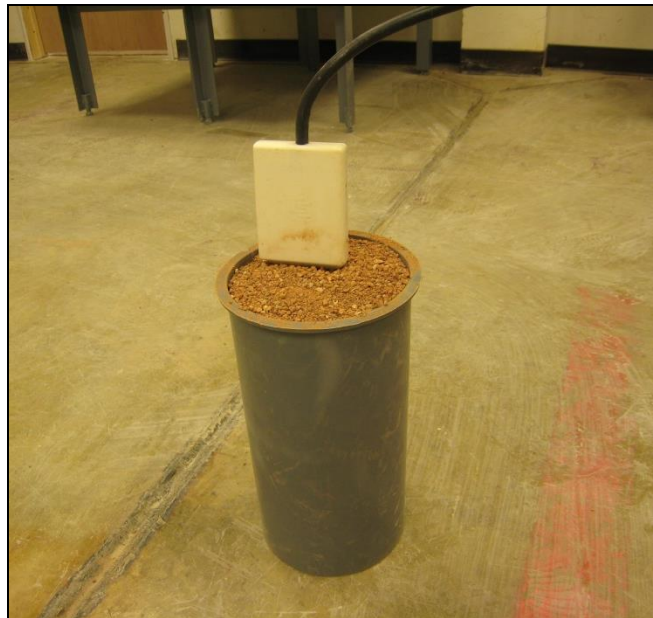
Figure B-2: The plastic cylinder mold for site specific calibration.

The above procedure was repeated many times with an increment in water content for each trial. Initially, the first measurement was made at the naturally dried condition of the soil. Then water was added to the soil to make about 3% moisture content increment for each trial. It was assumed to complete the calibration at gravimetric moisture content up to 40%. But the calibration terminated after the 10<sup>th</sup> trial at about 30% to 33% of moisture content because the soil started to form many big clods, which was difficult to mix the soil thoroughly and hard to insert the moisture probe into the mold.

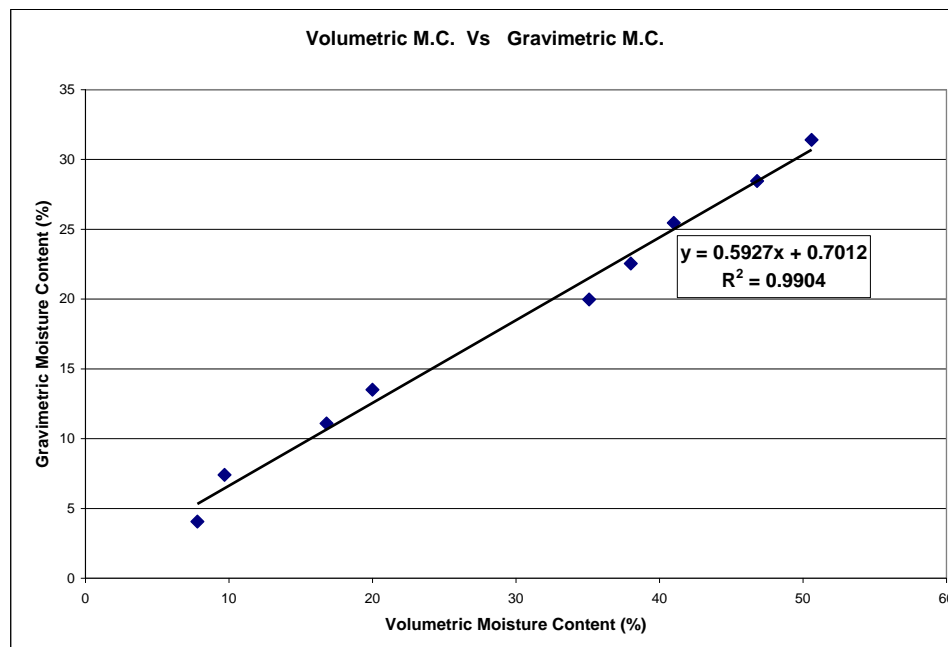
Figure B-4: The relationship between Gravimetric and Volumetric moisture content of the soil obtained from the site calibration.
