Durability of Bridge Decks

**Final Report
TRC-9210**

***Planning and Research Division
Arkansas State Highway and Transportation Department
in cooperation with
Federal Highway Administration***

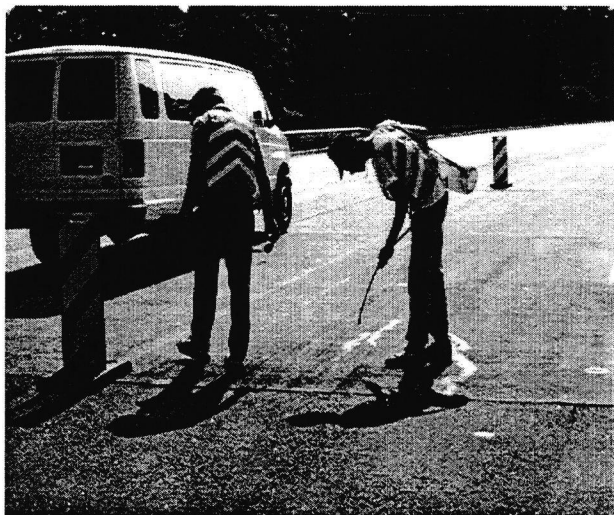
Fig. 3A
searching for cracks

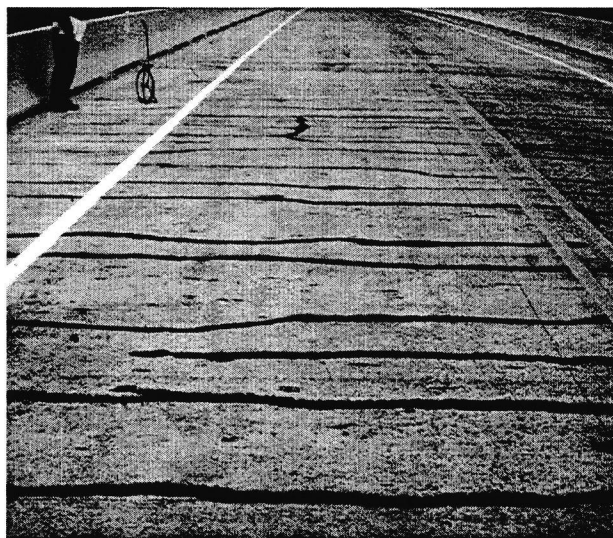
Fig. 3B
cracks sprayed with water

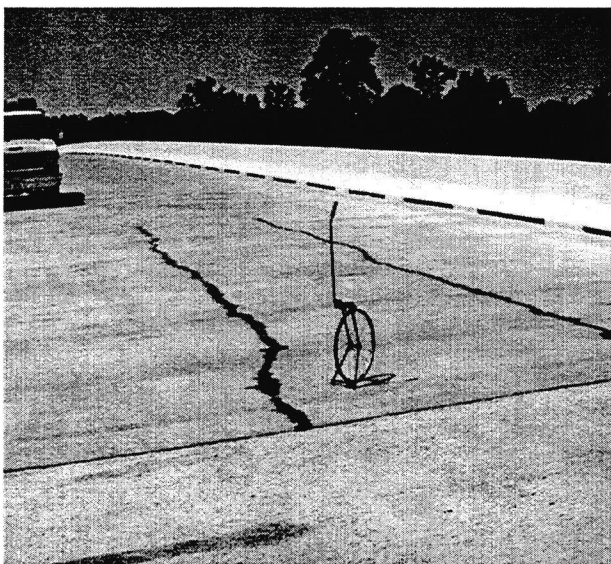
Fig. 3C
Measuring wheel

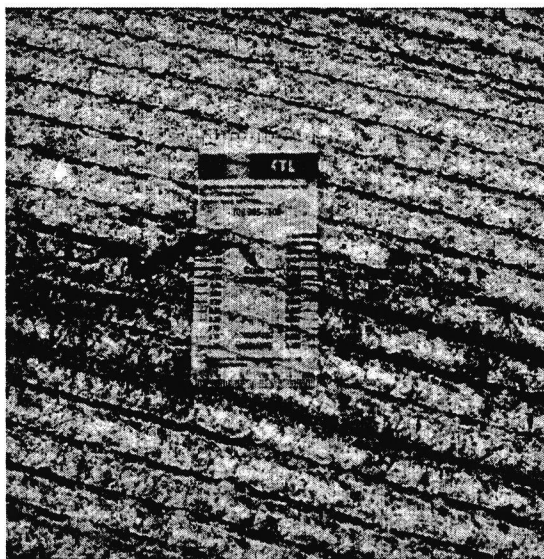
Fig 3D
Crack Comparator Card

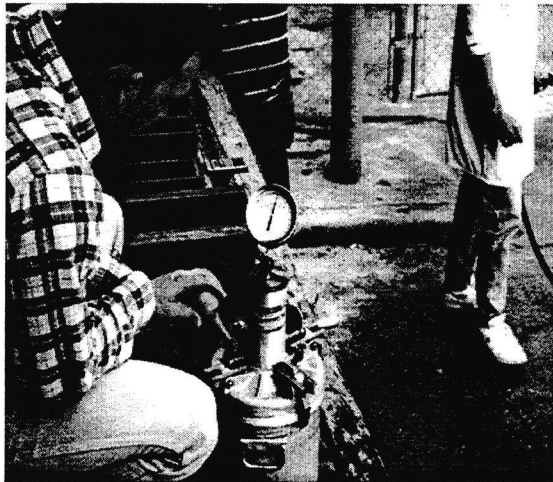
Fig 3E
Performing an Air Content Test

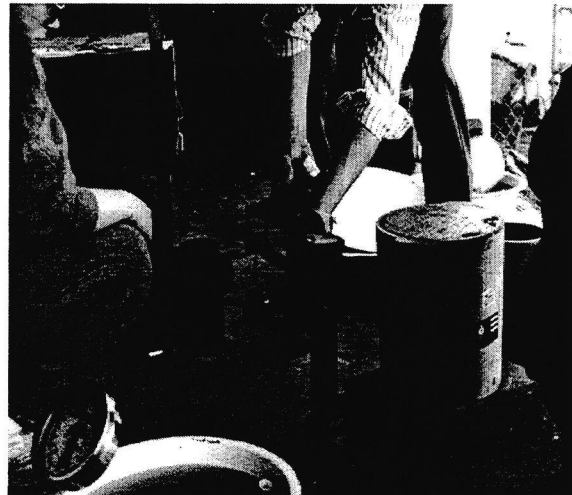
Fig. 3F
Performing a Unit Weight Test

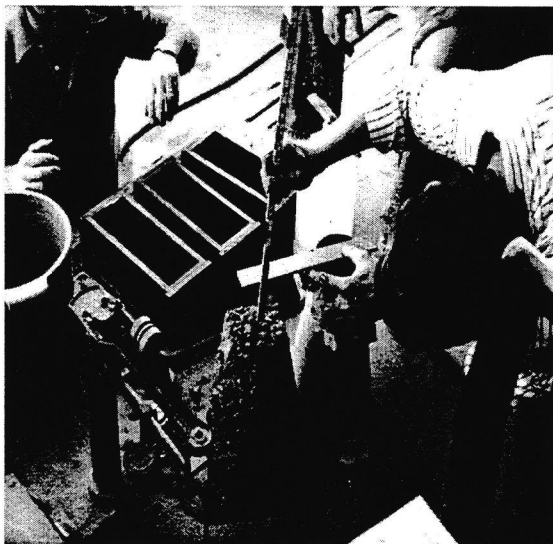
Fig 3G
Slump Test

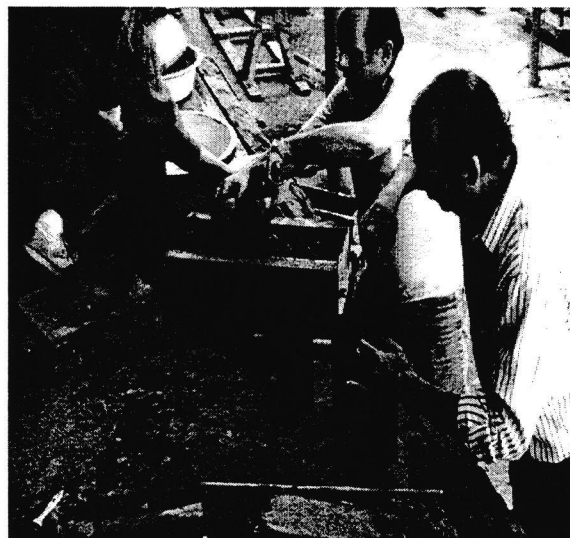
Fig. 3H
Preparing Shrinkage Test
Samples and Test Cylinders

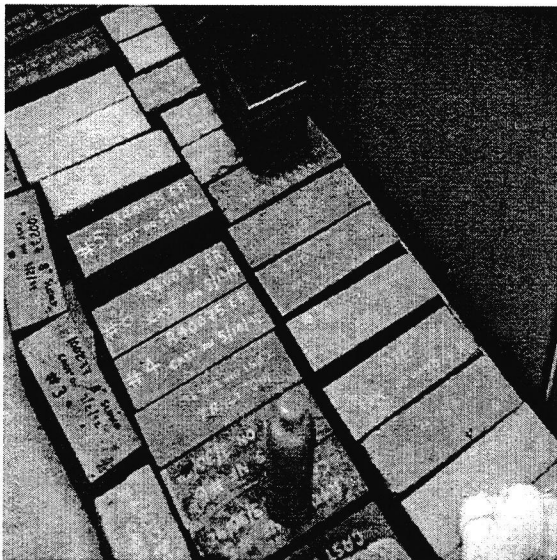
Fig 3I
Shrinkage samples

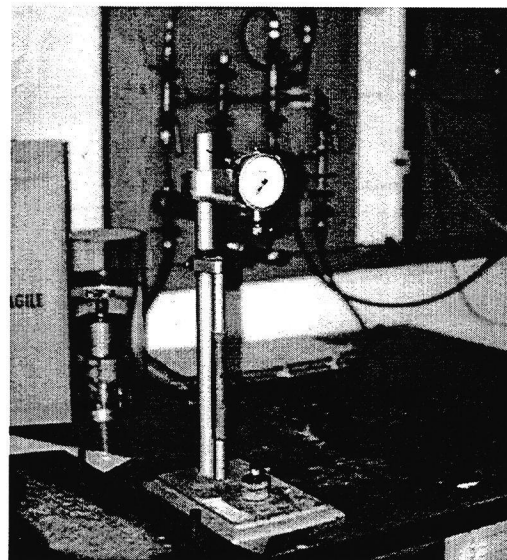
Fig. 3J
Shrinkage measuring device

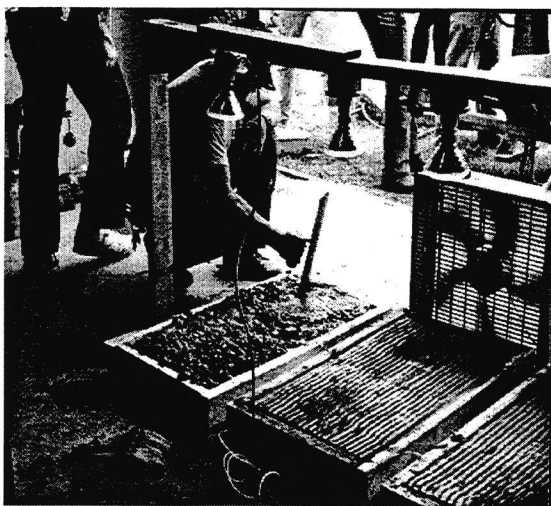
Fig. 3K
preparing Kraai test slabs

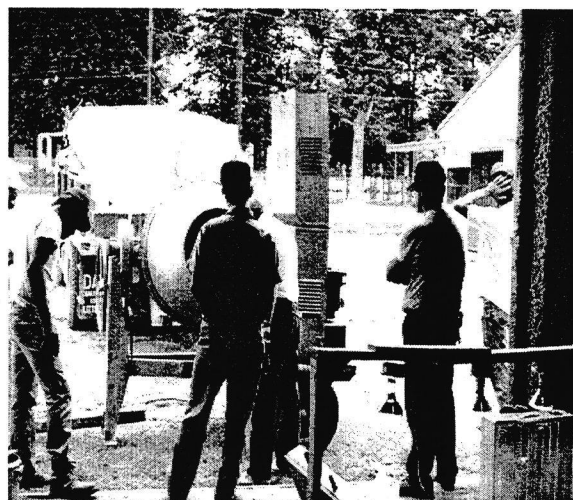
Fig. 3L
mixing concrete for "mega-mix"

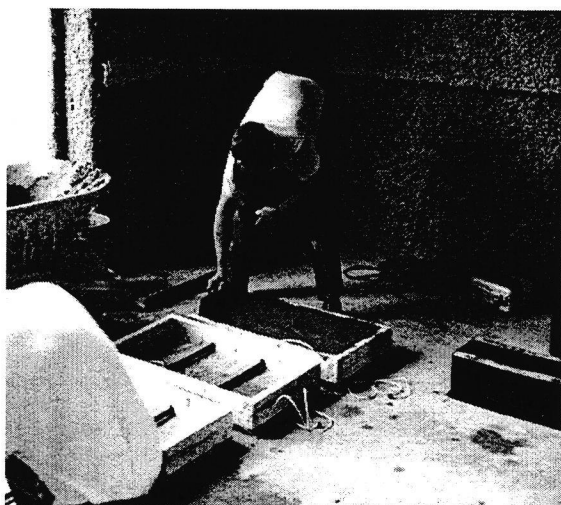
Fig. 3M
finishing a Kraii test slab

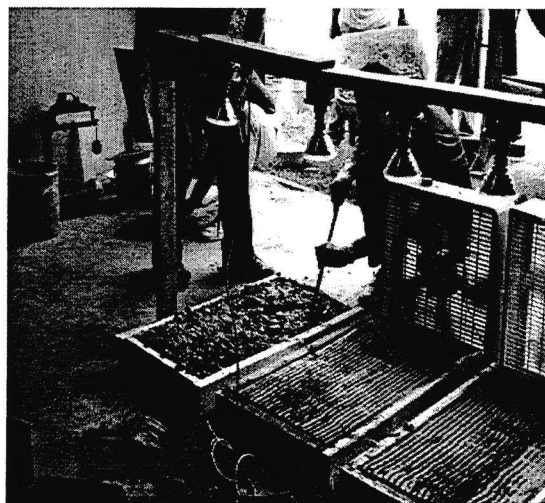
Fig 3N
tined Kraii test slabs

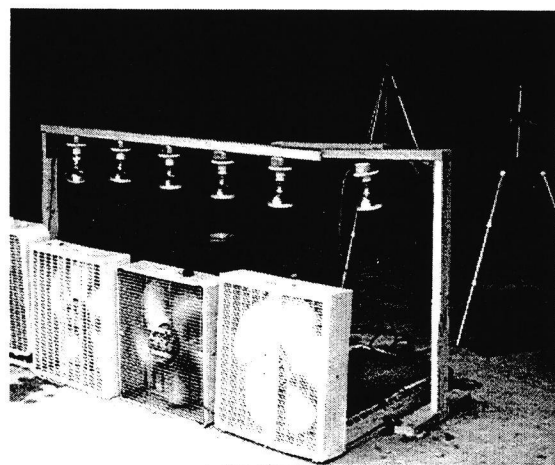
Fig. 3O
"mega-mix" test setup

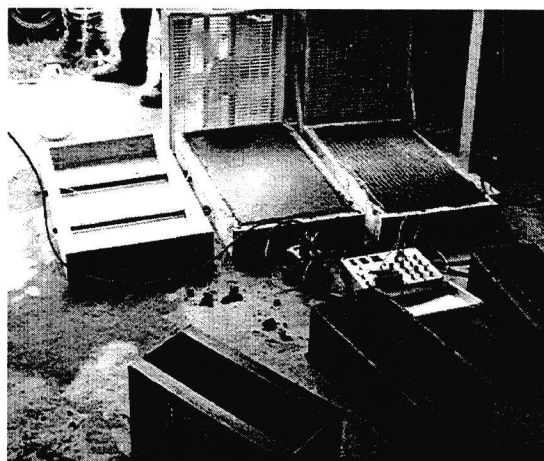
Fig. 3P
test slabs, beam molds, and temperature
measuring device

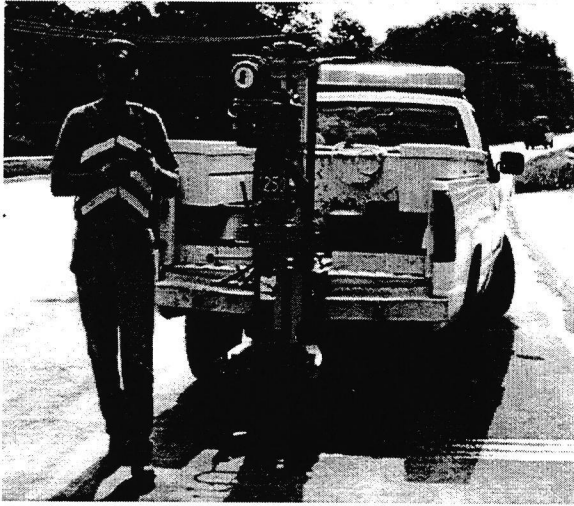
Fig. 4A
Coring the bridge deck

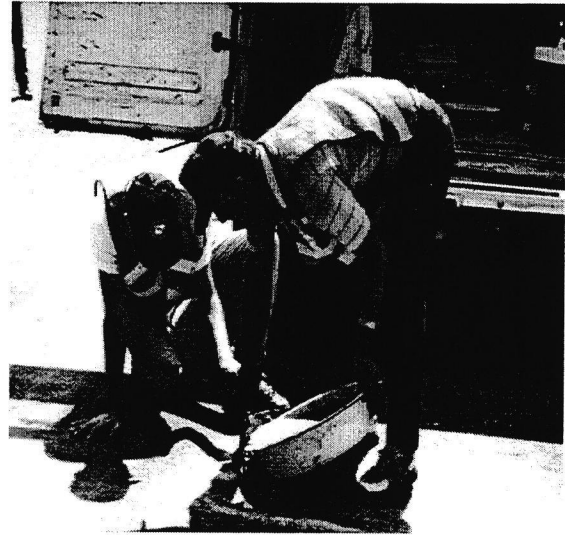
Fig. 4B
Patching the deck

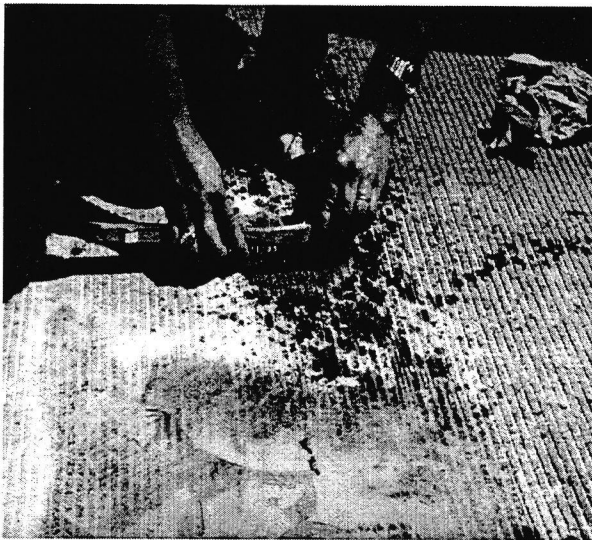
Fig. 4C
"Tining" the patch

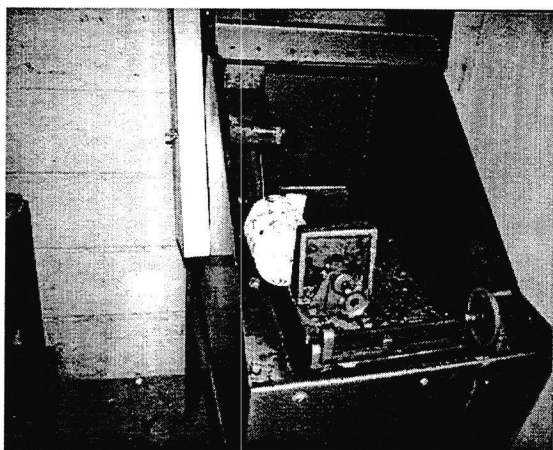
Fig 4E
Saw Unit

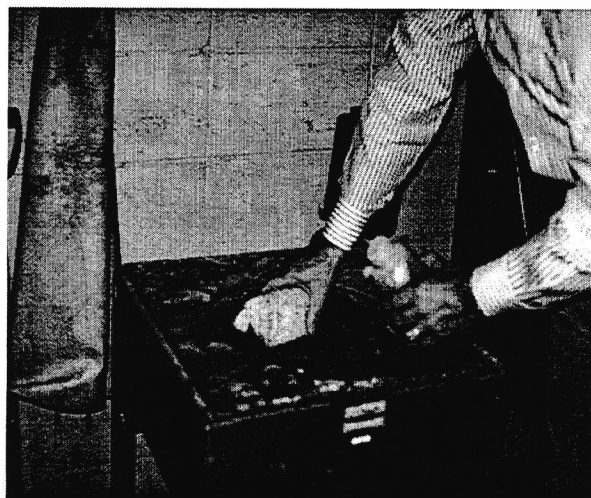
Fig. 4F
Lapidary Unit

After the samples had been cut, the polishing process was the next task to occur. A lapidary unit (Fig. 4F) was purchased for this task. The samples were polished to remove any marks left

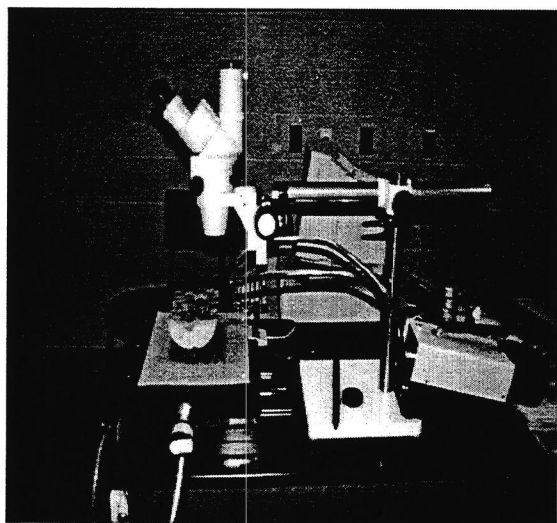
Fig. 4G
Petrographic Apparatus

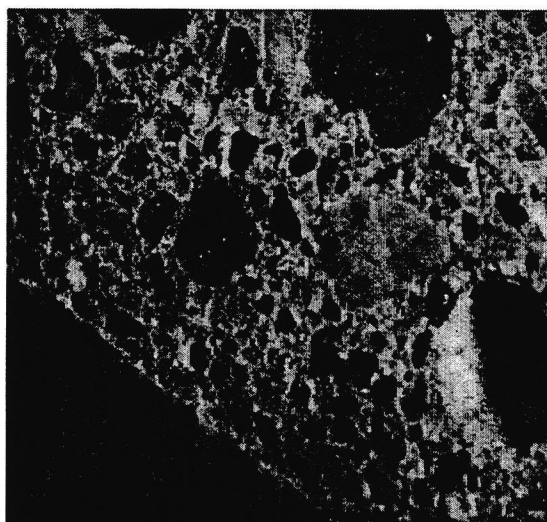
Fig. 4H
Sample under the microscope

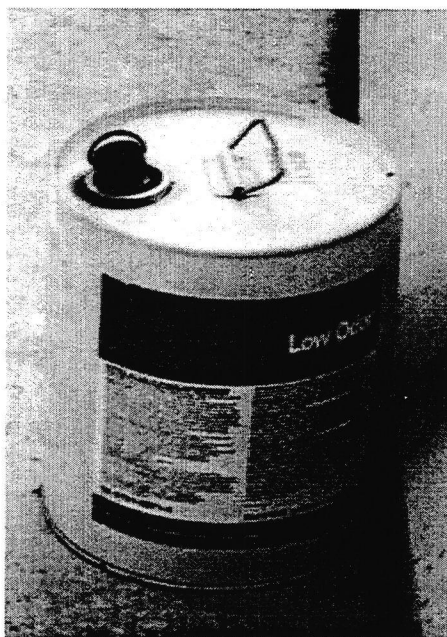
Fig 5A
3M 5741 Sealer

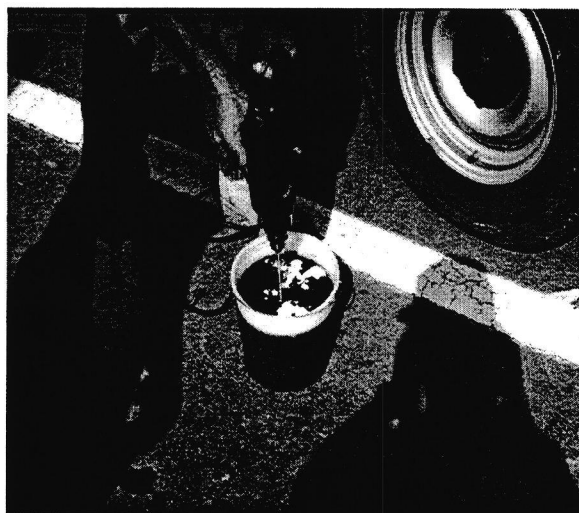
Fig. 5C
Mixing dye into the sealer

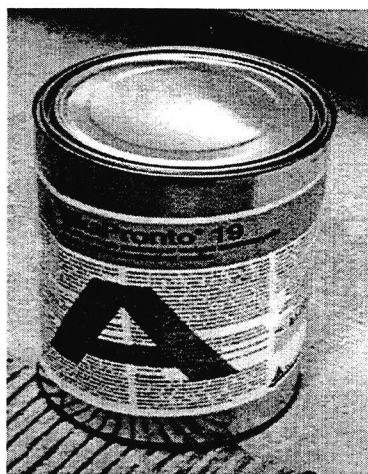
Fig. 5B
Sika Pronto 19 Sealer

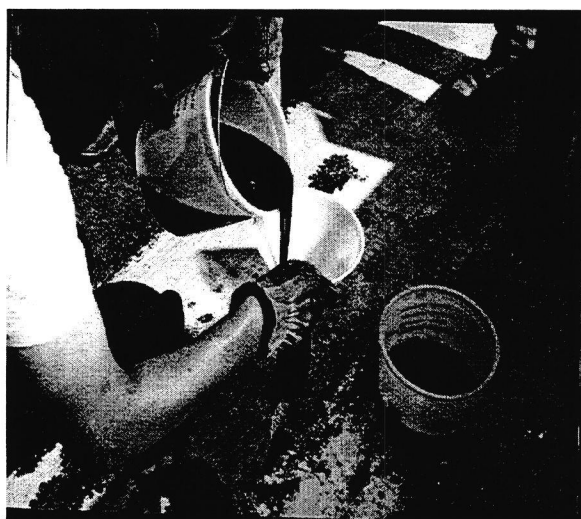
Fig 5D
Pouring the sealer into application
containers

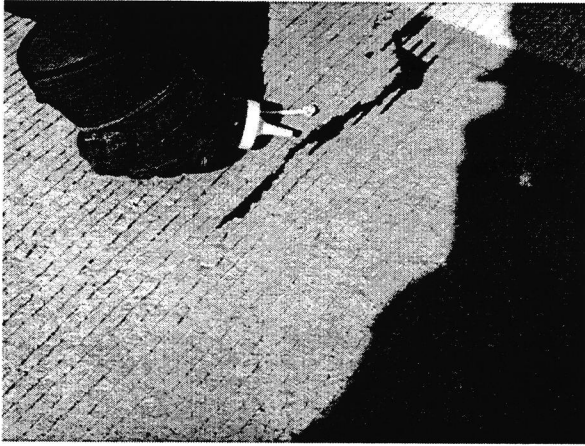
Fig. 5E
Applying the sealer

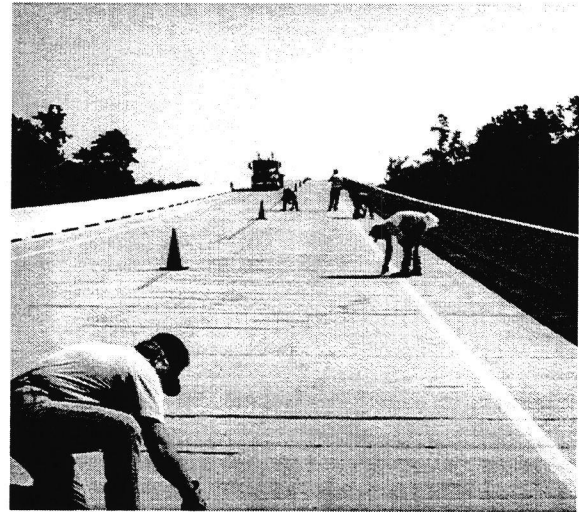
Fig. 5G
Sealer Application

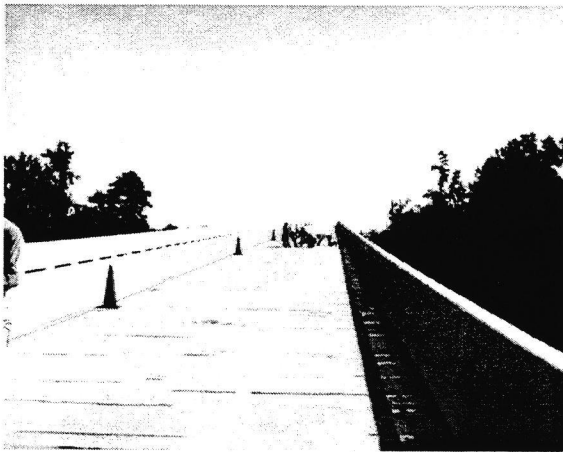
Fig. 5F
Sealer application

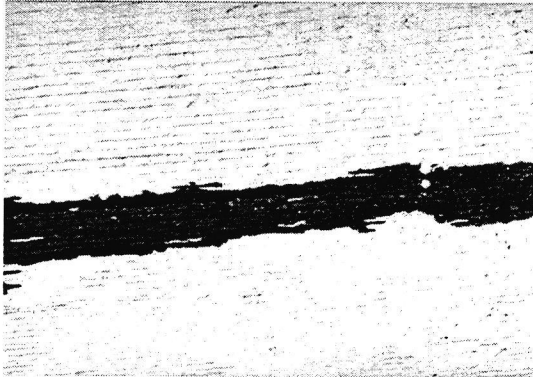
Fig. 5I
Close-up of sealer applied to a crack

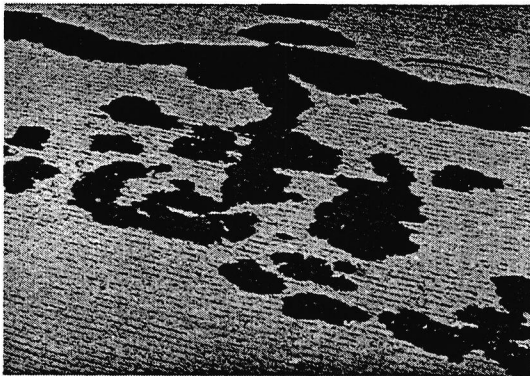
Fig. 5J
Close-up of sealer

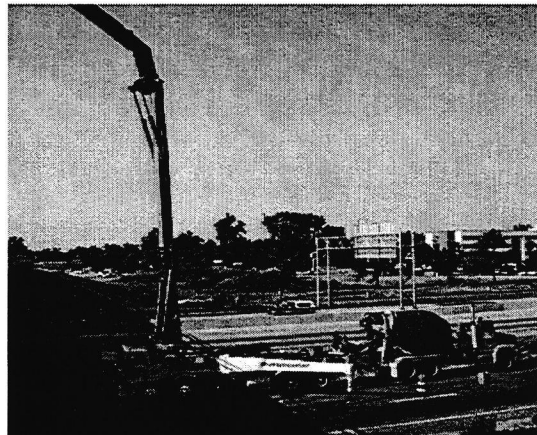
Fig 6C
Pump set-up

fiber distribution. The only adverse effect was the balling during the tining process. This did not appear to be an item that would be detrimental to the bridge deck. In fact, this problem was considered to be extremely minor. The environmental conditions during the concrete pours were such that cracking would most likely occur. This was apparent during the final evaluation. Each fiber appeared to reduce the amount of cracking which occurred in each section. Since the purpose of this phase was to determine the effectiveness of the fibers in concrete, these results were positive toward developing a solution of the premature bridge deck cracking. Pictures of the fibers and this application procedure can be seen in Figures 6A - 6H.

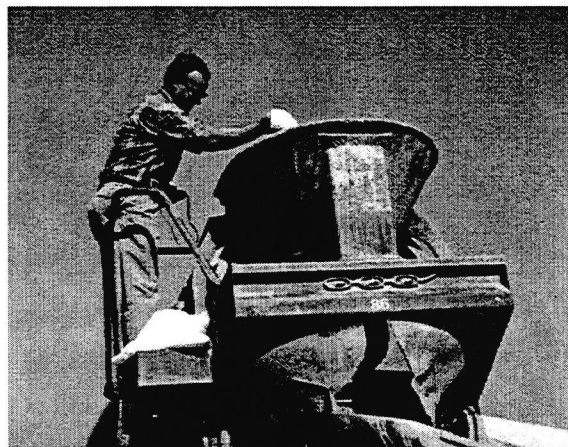
Fig. 6D
Adding fibers to the mixer
