TRC0107

**Evaluation of Monitoring and  
Remediation Measures for  
Slope Failures**

Final Report

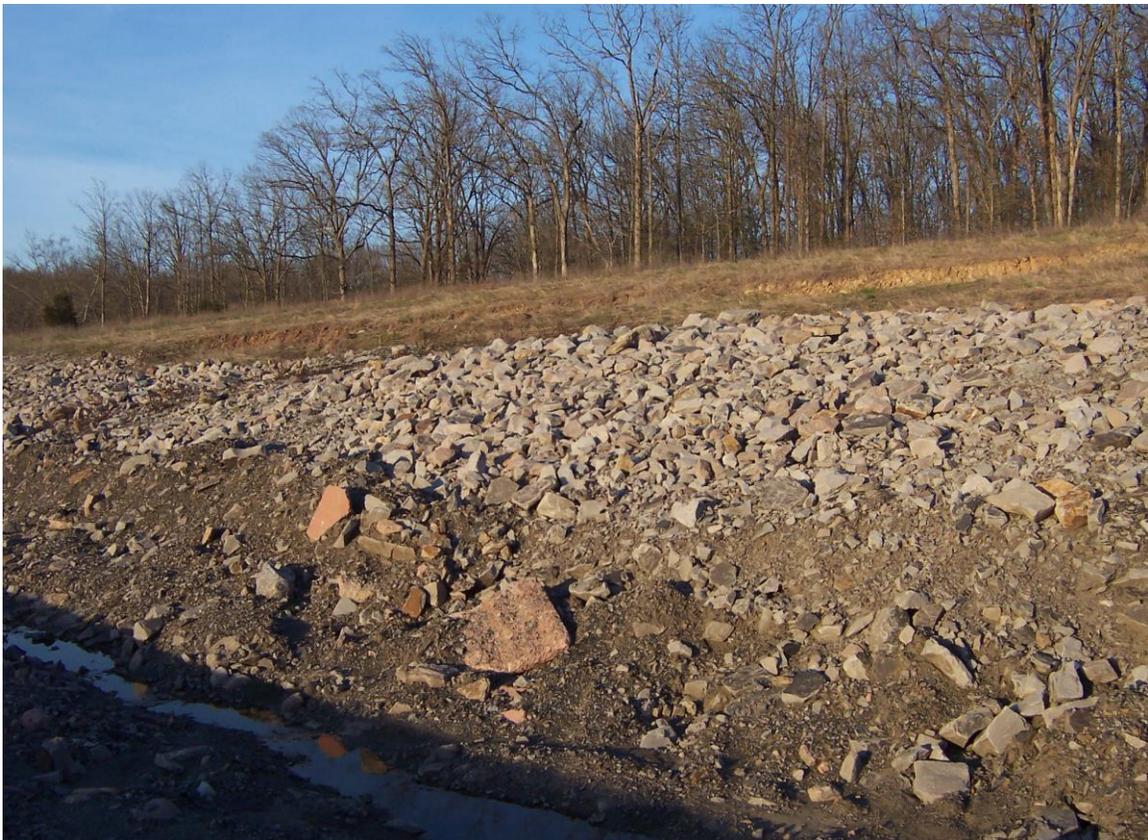
Figure 1.1: Failed slope was replaced by rock at MM46 on I-540

Figure 1.1 portrays a failure at mile marker 46 on I-540 that has been repaired three times using the rock replacement strategy while the failure depicted in Figure 1.2 was clearly related to water issues and until those issues are corrected the replacement strategy will not be effective. Alternative repair strategies are available, but their effectiveness must be monitored. The AHTD needs cost effective and reliable methods of slope remediation, but they also need an economical mechanism to monitor the effectiveness of any slope repair.

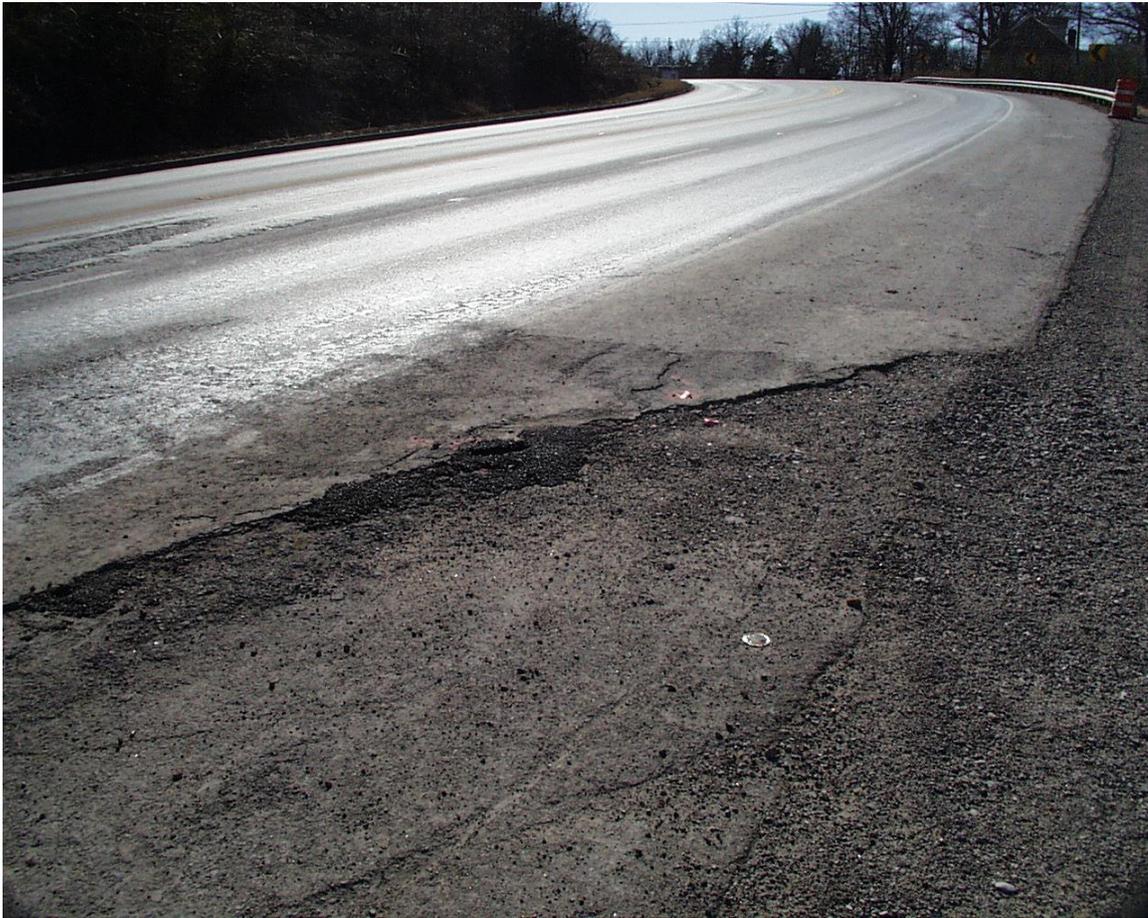
Figure 1.2: Surface cracks on Highway 167, Batesville.

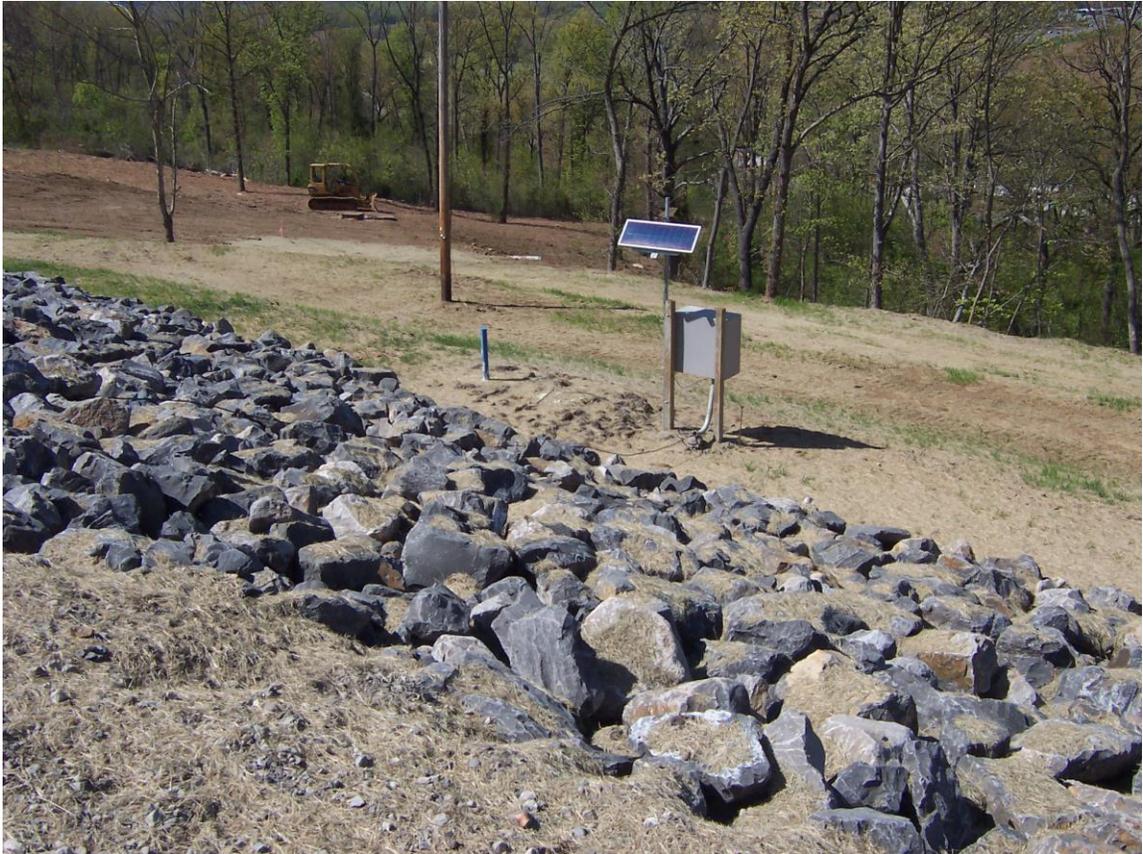
Figure 3.20: Batesville TDR monitoring station
