**The Structural Evaluation of Precast  
Concrete Slab Panels in Bridge  
Superstructures,  
Phase II**

Final Report

**December 2005**

**Sponsored by the  
Arkansas State Highway and  
Transportation Department**

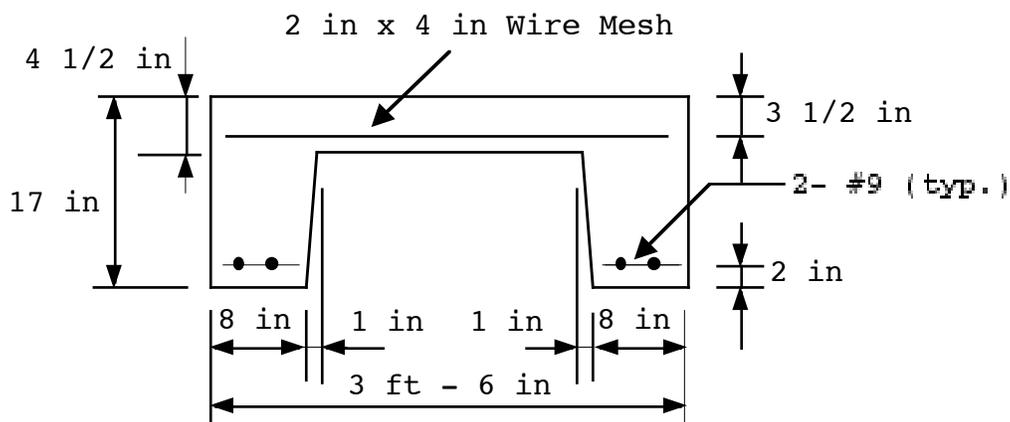
In the 1952 AHTD bridge details, a typical beam cross-section consists of two No. 9, Grade 40 longitudinal reinforcing bars in each stem, however lacks any shear reinforcement. Secondly, longitudinal reinforcement anchorage is developed only through embedment length since the longitudinal reinforcing bars do not have hooked ends. These beams were designed for a maximum H15 AASHTO loading. Both a detailed cross-section and elevation view of a single interior beam section are shown in Figures 1.2 and 1.3 respectively. Because the beams were fabricated without shear reinforcement, the shear strength is fully dependent upon the concrete compressive strength.

**Figure 1.2: Cross-Sectional View of Interior Channel Beam**

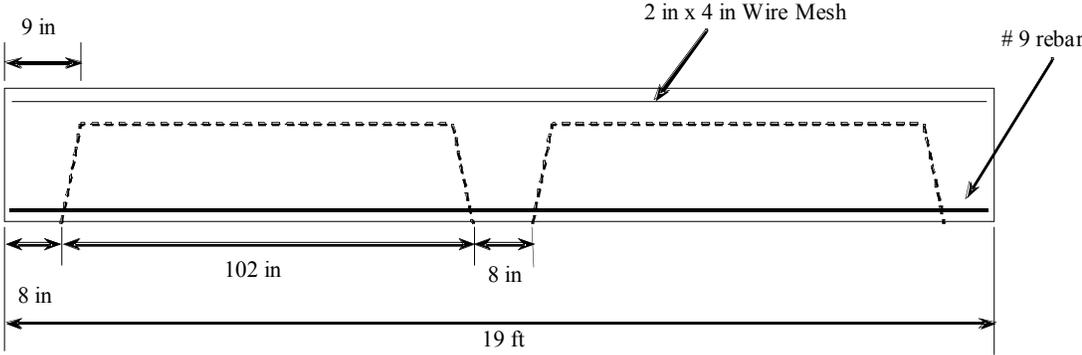
**Figure 1.3: Elevation View of Interior Channel Beam**

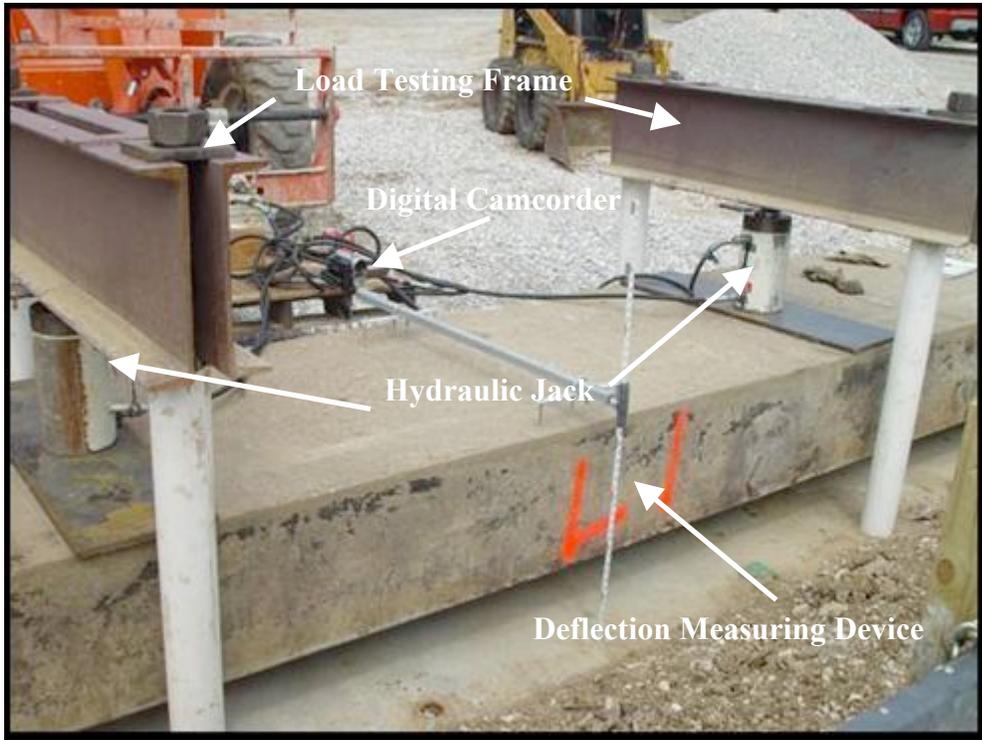
The load testing consisted of applying equal point loads,  $P$ , approximately 5.5-ft from either end of the beam. The concentrated force,  $P$ , was applied by two, 200-kip reversible hydraulic jacks linked in parallel. This loading configuration resulted in a linearly varying moment and constant shear in the end regions, and a mid-span of constant maximum moment and zero shear. The loading, bending moment, and shear diagrams are presented in Figure 2.5.

**Figure 2.4: Loading Configuration**

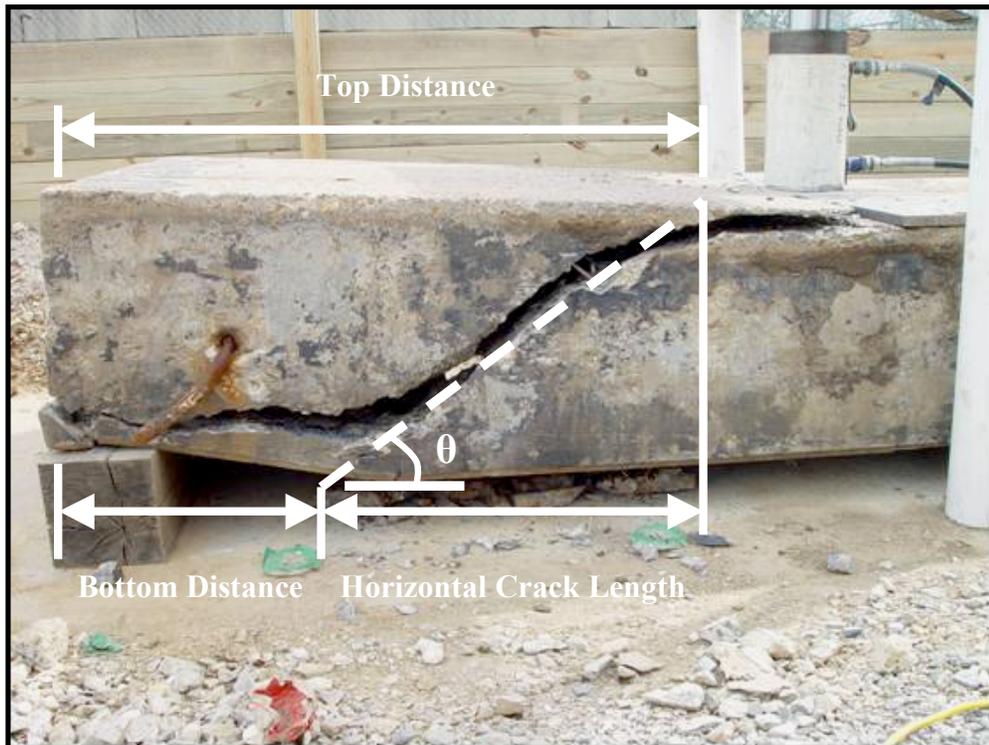
**Figure 2.8: Typical Shear Crack Measurement**

The horizontal crack length, as shown in Figure 2.8, was determined by subtracting the crack distance at the top of the beam from the bottom distance. This data was used to estimate the horizontal shear crack length measured from the crack origin on the tension face to the compression face of the beam. Table 2.8 lists the horizontal crack lengths for the twenty-nine samples. The probability of a shear crack propagating through the entire depth of the beam in a 12-in horizontal length is approximately 6%.

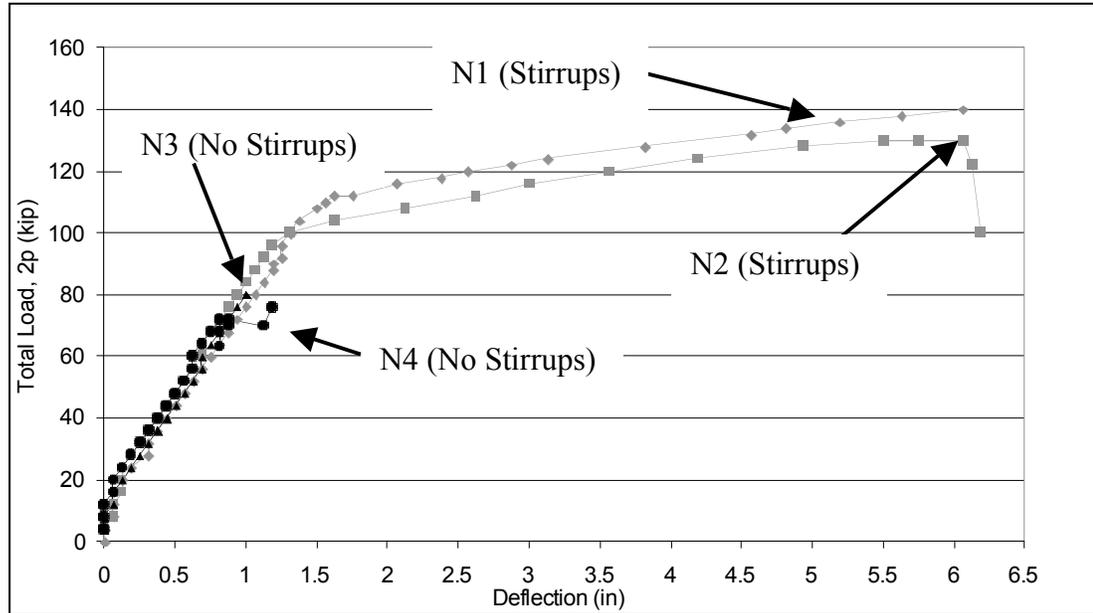
**Figure 2.13: Load versus Deflection Curves for New Beams**

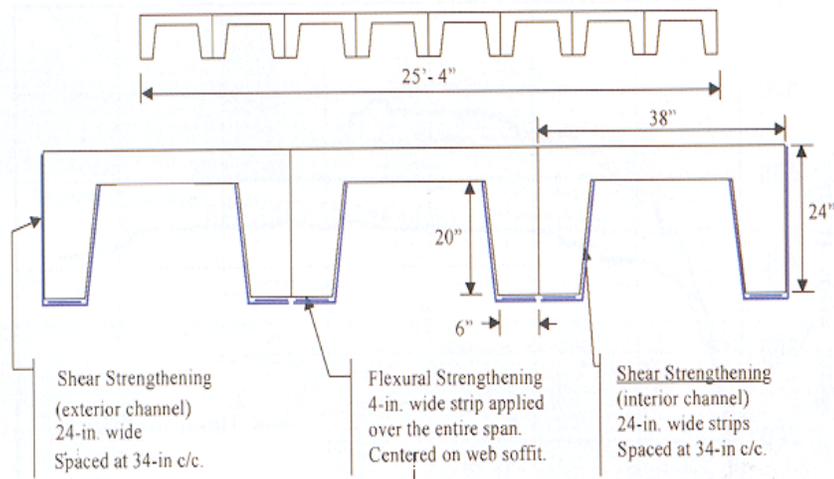
Three bridges in Boone County, Missouri, were retrofitted. The bridges were constructed between 1970 and 1976 using single-span, simply supported precast reinforced concrete channel sections [Alkhrdaji, 2002]. A 15-ton load rating was established in 1979 for the bridges. Replacement of the sections was not an option due to the high costs associated with bridge replacement. Therefore, it was determined instead to use carbon fiber reinforced polymer (CFRP) composites as a solution to this strengthening problem. A CFRP composite was used along the beam sides to provide shear strength and along the stem bases for flexural strength. Details of this strengthening method are shown in Figure 3.1. Load tests showed smaller mid-span deflections after strengthening. In addition, the retrofitted members experienced reduced internal stresses indicating improved beam stiffness.

**Figure 3.1: Details of CFRP Strengthening of Channel Sections [Alkhrdaji, 2002]**

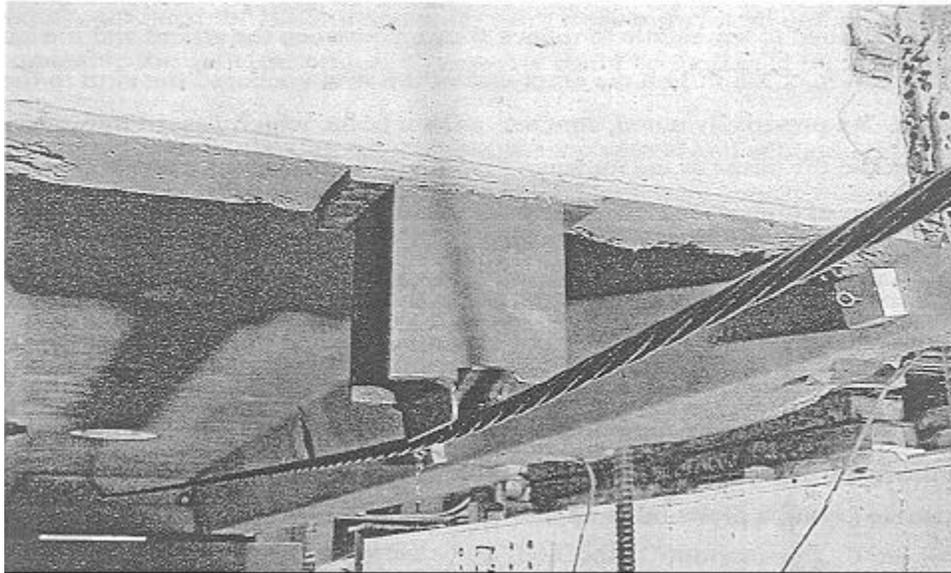
Load tests were conducted on a model bridge retrofitted with this post-tensioning method. Stretching the post-tensioning strand beneath the strut produces tension in the tendon that induces an upward force on the precast section. The magnitude of the upward force depends on the amount of tension in the strand, height of the strand, and length of the beam. Therefore, a moment can be applied equal and opposite to the moment produced from the beam self weight. This eliminates the effect of dead load, which allows for an increase in the live load capacity.

**Figure 3.2: Strut Installed on Mid-Span Diaphragm [Klaiber et al, 2001]**

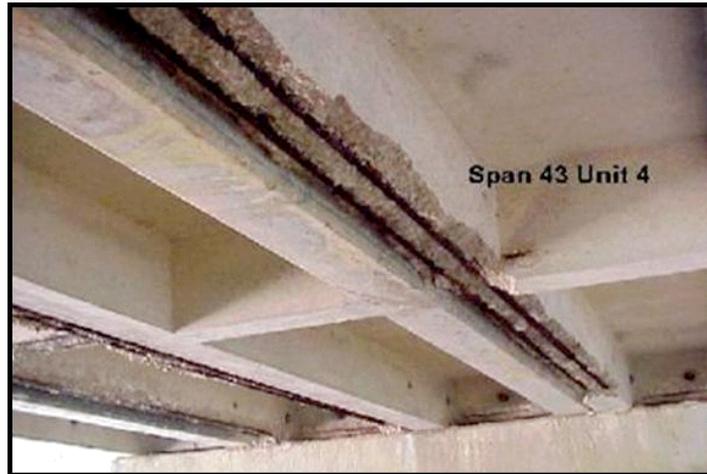
**Figure 4.1: Deterioration of Jenkins' Ferry Bridge**

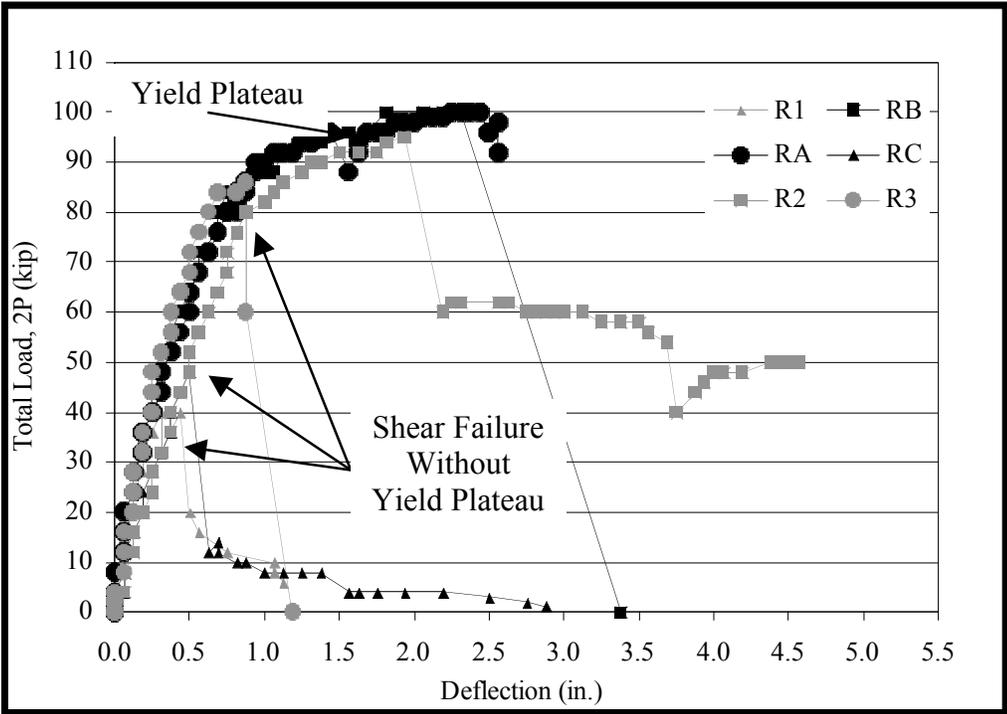
**Figure 4.2: Load vs. Deflection Curves (Poor Condition Beams)**

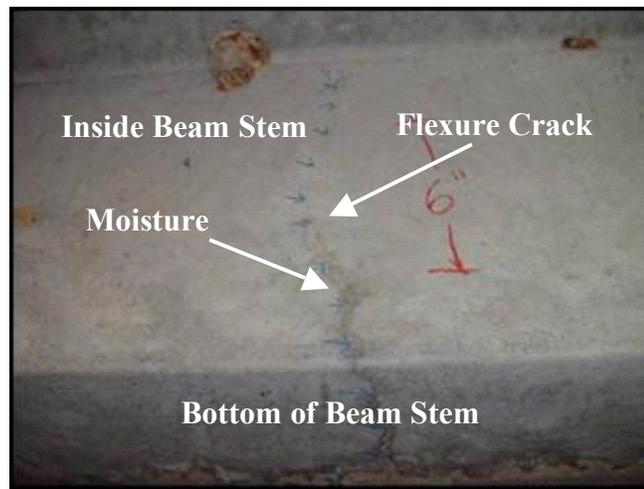
2004]. Typical flexure cracks begin at the stem base and propagate up the beam stem. Flexure cracks provide access for moisture and oxygen to the reinforcing steel. Figure 5.1 shows a flexure crack on the inside portion of the beam stem. The darkness surrounding the flexure crack is moisture seeping from inside the beam stem.

**Figure 5.1: Flexure Crack in Mid-Span Region of Beam**

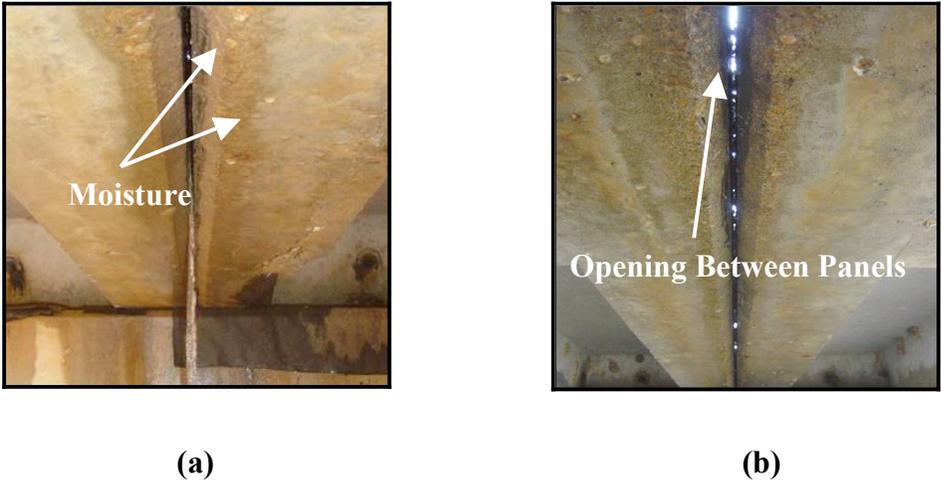
during the 0.38in. rainfall resulted in the entire stem base being completely saturated. Besides moisture at the stem base, moisture was observed exiting flexure cracks on the inside portion of the beam stem.

**Figure 5.2: Moisture at Beam Stem Base**

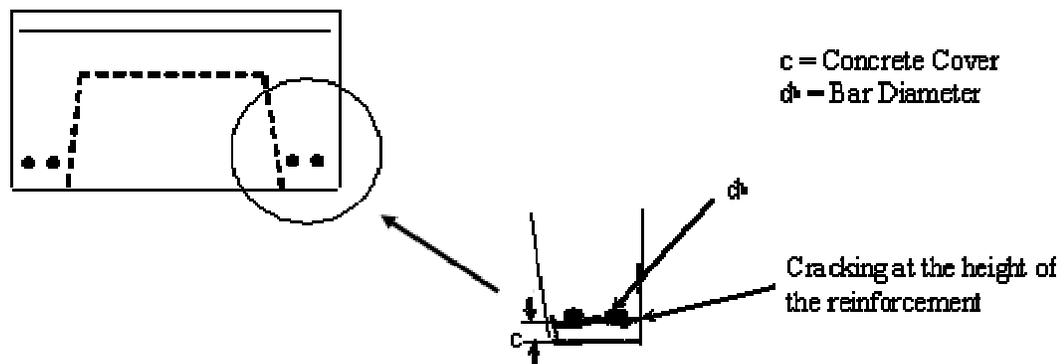
The concrete cover ( $c$ ) to bar diameter ( $d_b$ ) ratio is an indicator for potential longitudinal concrete cracking and spalling, Figure 5.4 [Emmons, 1993]. Concrete begins cracking when the corrosion level reaches 4% for a  $c/d_b$  ratio of 7. As the  $c/d_b$  is lowered to 3, cracking begins at only 1% corrosion.

**Figure 5.4: Concrete Cover to Reinforcing Bar Diameter Ratio**

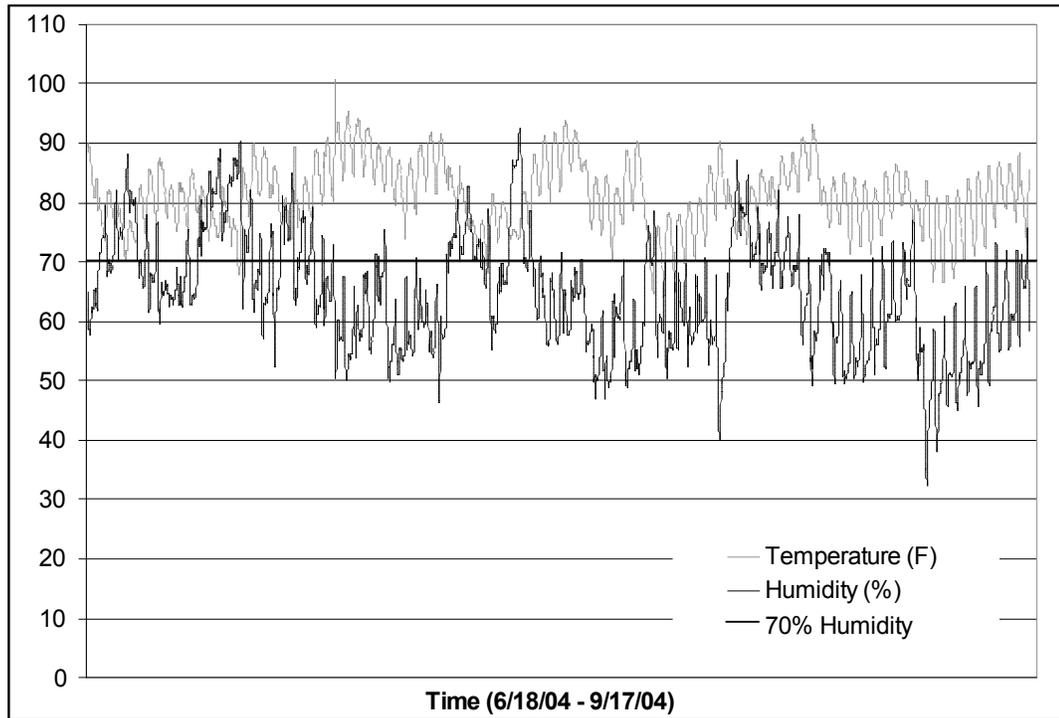
Relative humidity at both sites was consistently above 70%. Results from the humidity data collection are shown in Figures 5.15 and 5.16 for Danville, AR, and Lakeway, AR, respectively. As a result of humidity levels exceeding 70%, data indicates that adequate moisture is available for active reinforcing steel corrosion. Therefore, the combination of humidity and existing flexure cracks provides the warranted conditions for reinforcing steel corrosion.

**Figure 5.15: Danville PCB Bridge Temperature and Humidity Data**

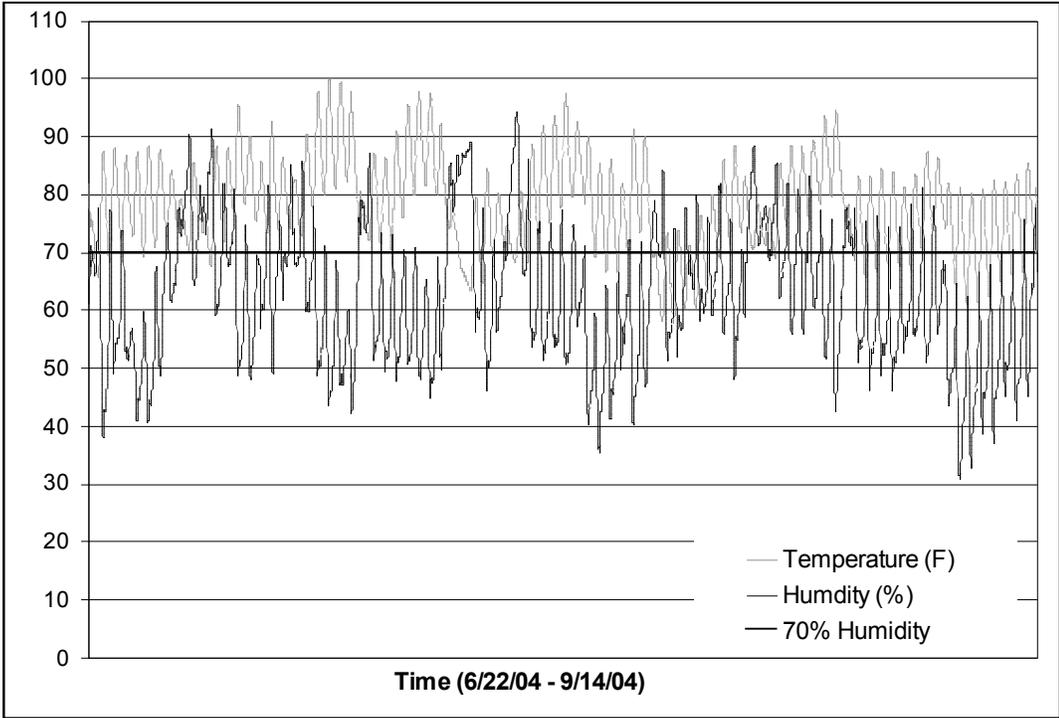
**Figure 5.16: Lakeway PCB Bridge Temperature and Humidity Data**

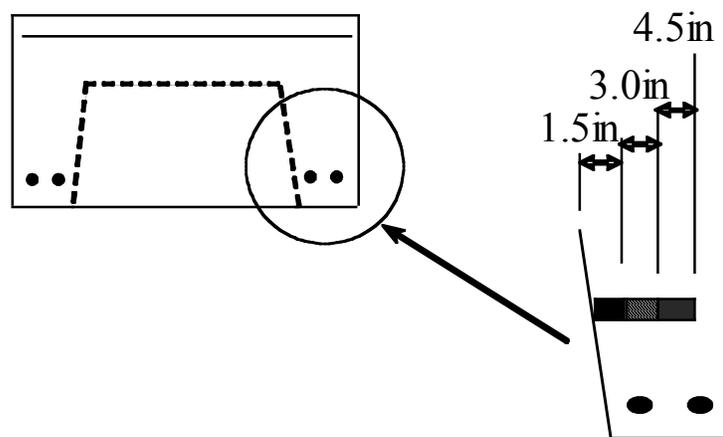
inside reinforcing steel bar. A 20-gram sample was taken at 1.5-in increments to a total depth of 4.5-in, Figure 5.17, using a 3/4-in drill bit attached to a hammer drill. The samples were collected and sealed in small plastic containers. They were then tested at the UA laboratory for moisture content.

**Figure 5.17: Moisture Content Determination**

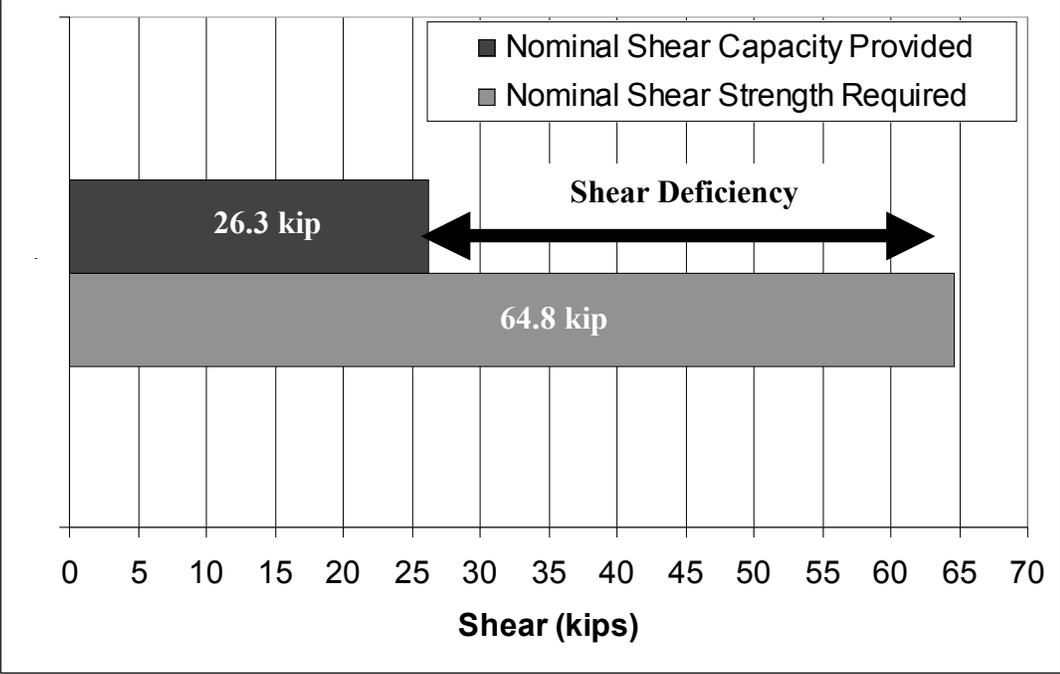
Figure 6.5: Shear Strength Deficiency

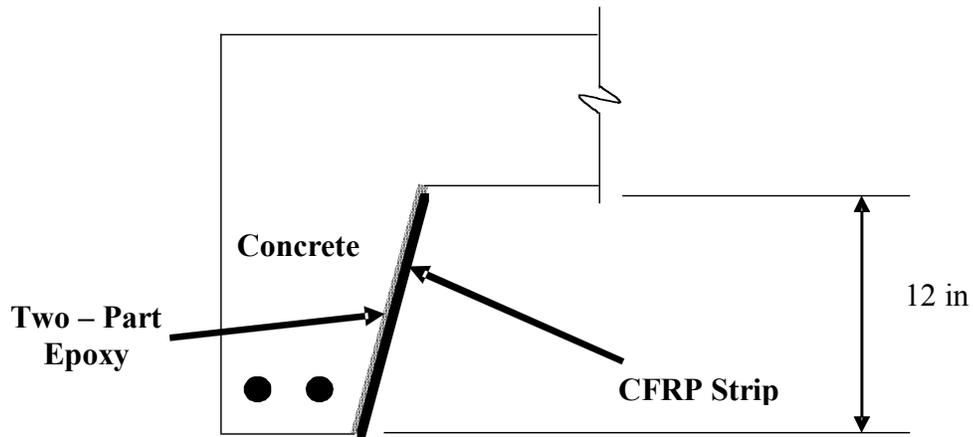
**Figure 6.7: CFRP Strengthening Retrofit (Three Component System)**

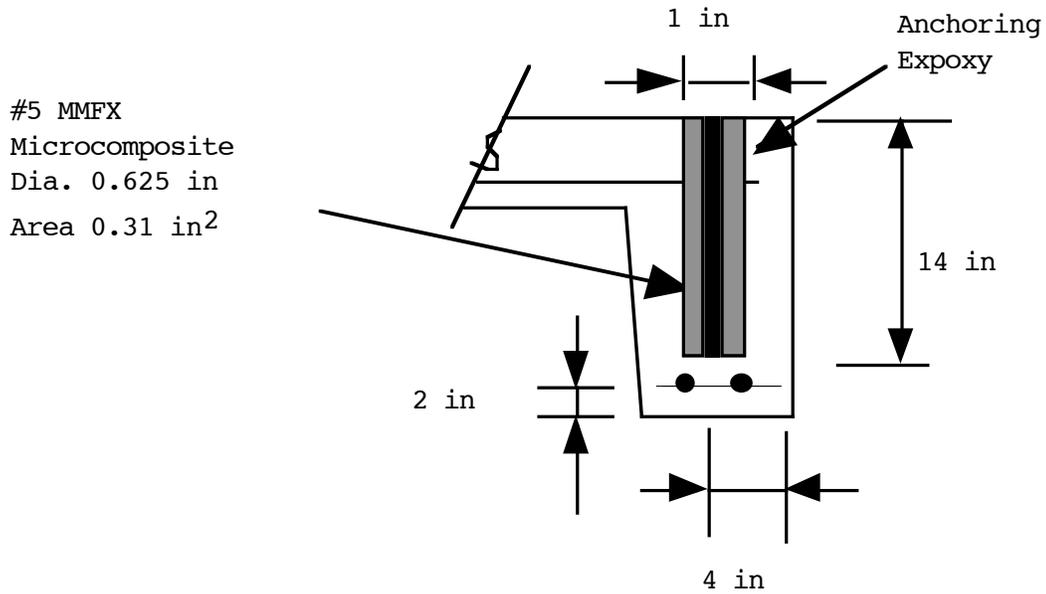
**Figure 6.10: Enlarged Schematic of MMFX Shear Bar Retrofit**

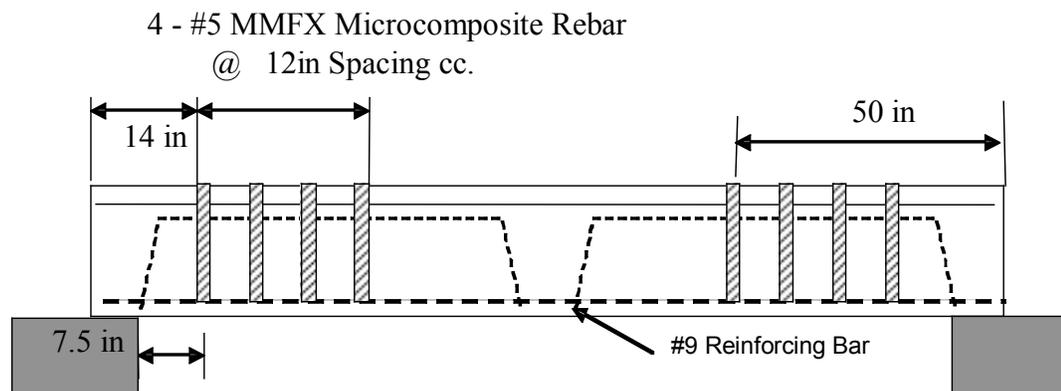
93.0-kip. Arrangement of the embedded shear bars is illustrated in Figure 6.11. The first bar is located 14-in. from the beam end. Shear bars were discontinued 50-in. from the beam end at a point in which required shear strength is adequately provided for by the concrete.

**Figure 6.11: MMFX Shear Bar Placement along Length of Beam**

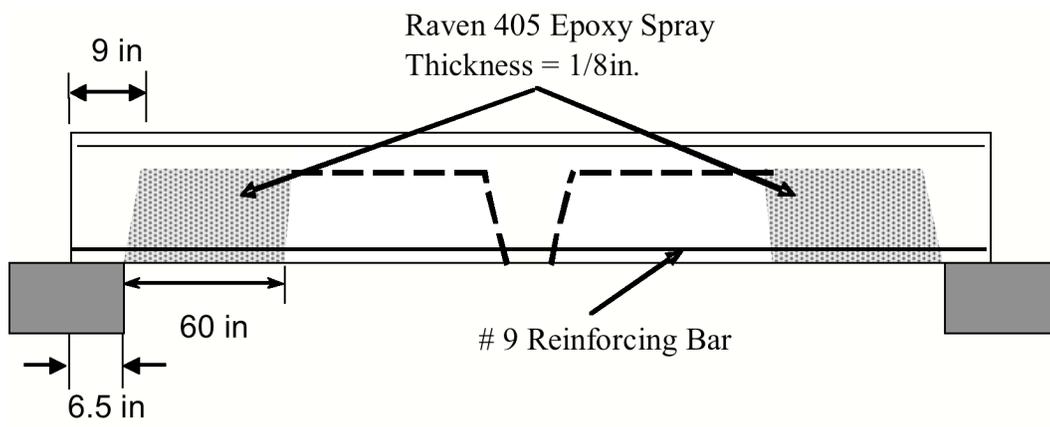
Research has shown that an epoxy thickness of 0.25 inches increases the load capacity of concrete members over 40% [Harries and Young, 2003]. Further, an epoxy thickness of 0.125-in has demonstrated improved bending stiffness. From strength curves of the epoxy material used in the project, the epoxy thickness was selected to be 0.125-in and was applied along the inside portion of the channel stems to replicate field application. The 60-in end segments of each stem was sprayed with the epoxy coating. Figure 6.12 illustrates this retrofit method.

**Figure 6.12: Side View of Beam with Sprayed Epoxy Retrofit**

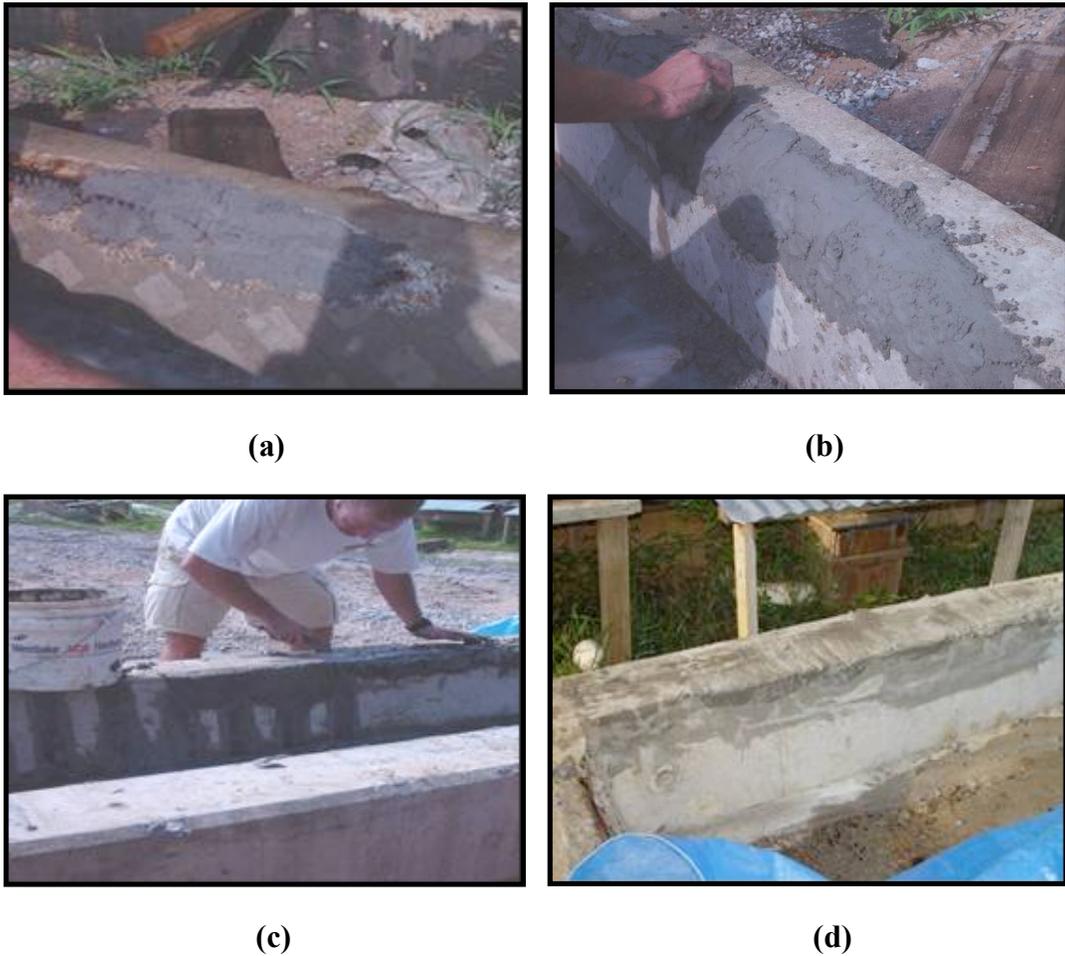
material: (a) priming, (b) application of a single layer of mortar, (c) finishing, (d) and finally the repaired surface.

**Figure 7.3: Concrete Patch Repair Procedure**

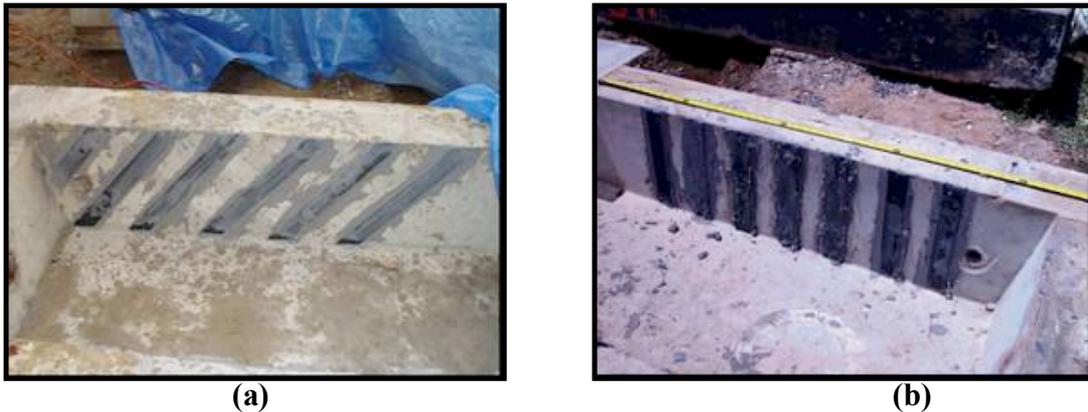
recommendation. After seven days, the epoxy reached its final design strength. Beams retrofitted with the diagonal and vertical retrofits are shown in Figure 7.6 (a, b), respectively.

**Figure 7.6: CFRP Vertical and Diagonal Retrofitted Beams**

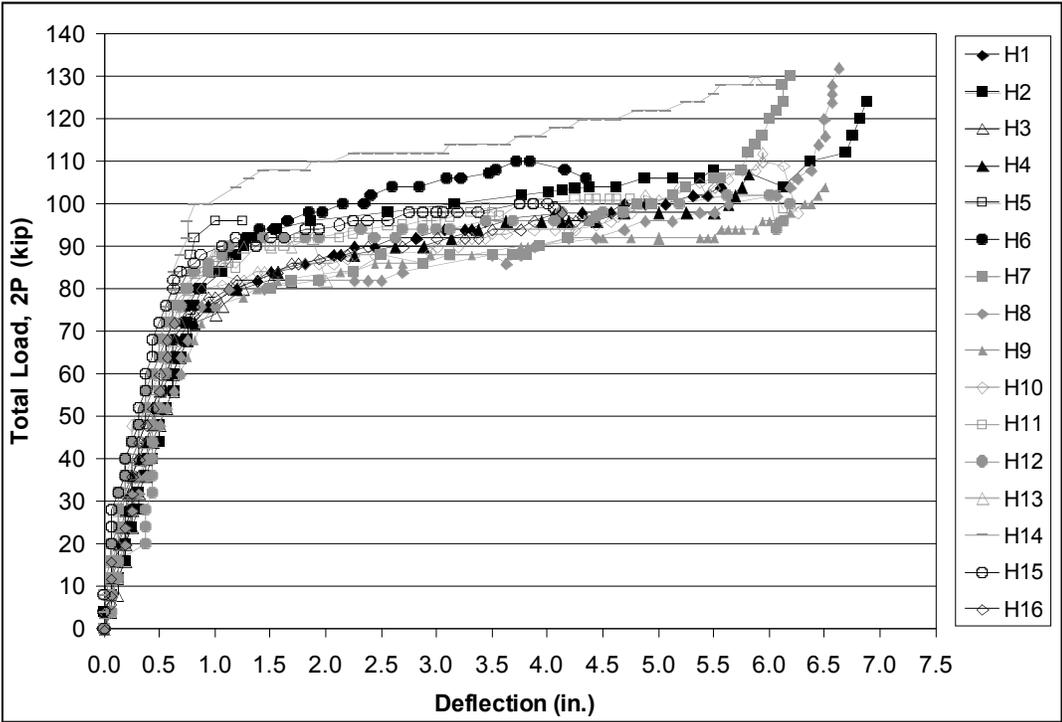
**Figure 8.2: Load versus Deflection Curves**

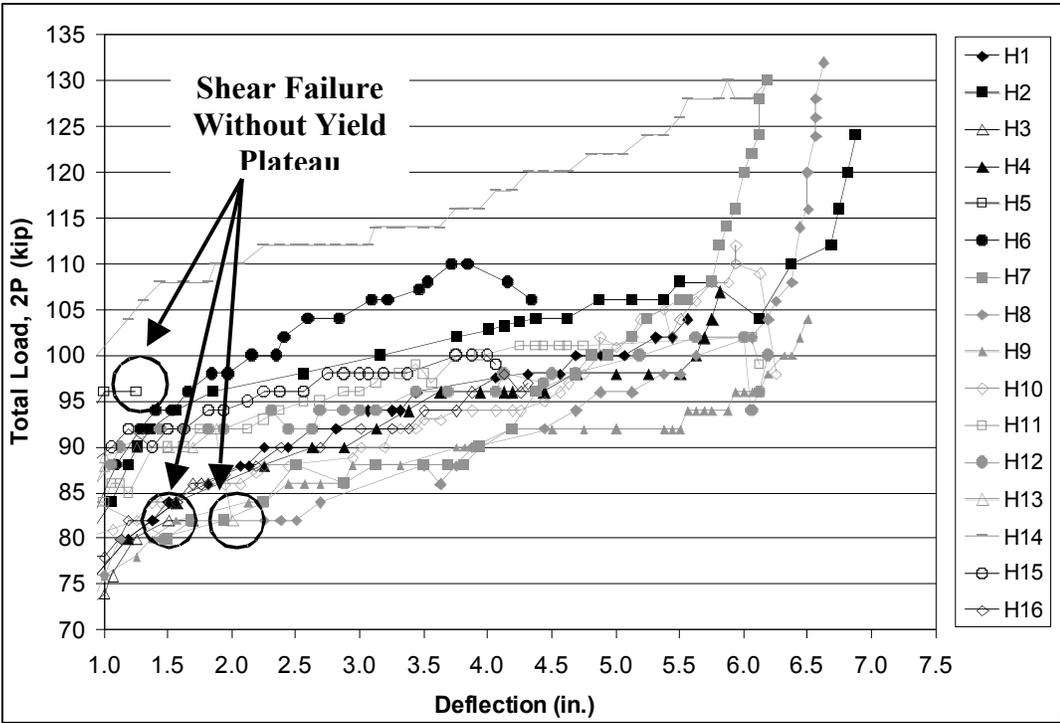
**Figure 8.3: Enlarged View of Load versus Deflection Curves**

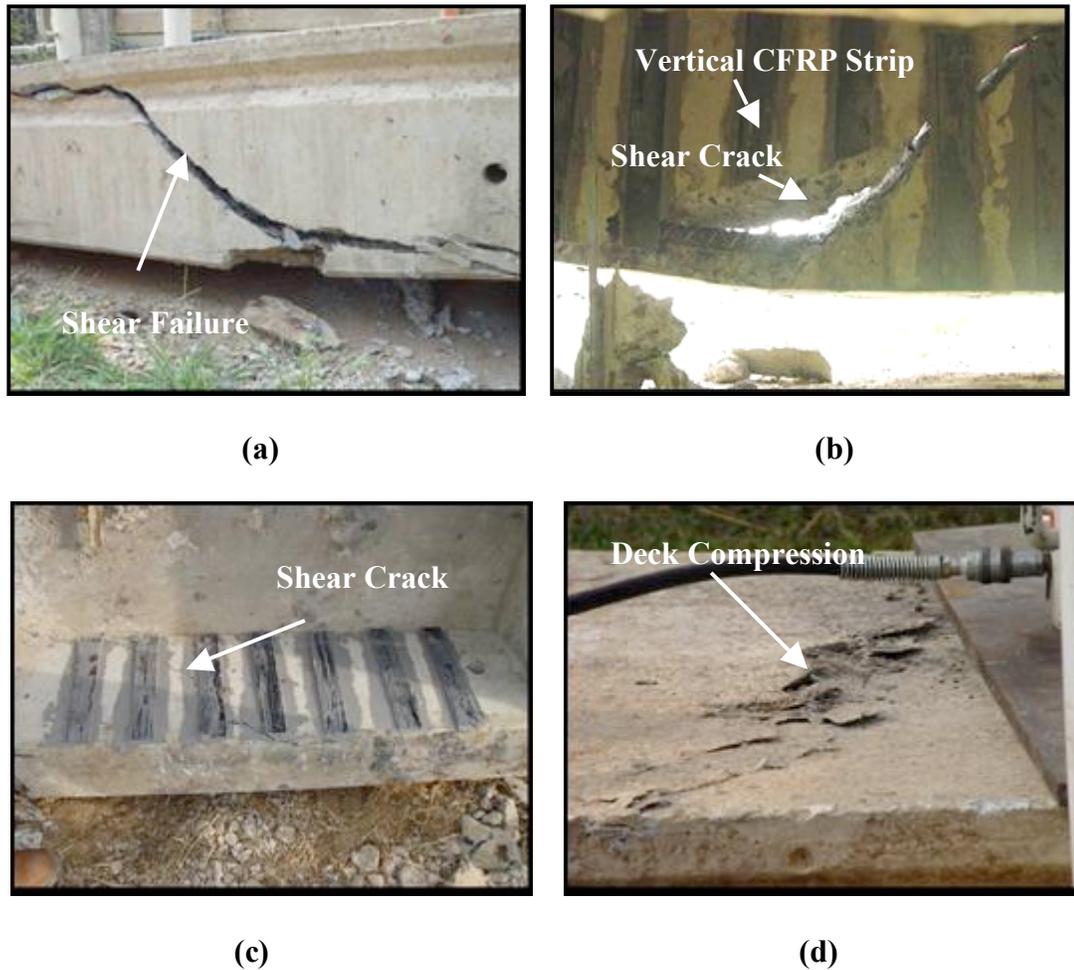
in flexure as a result of concrete crushing in the compression zone between the two load applicators. This failure is shown in Figure 8.4 (d). Beam H4 reached a maximum 2P load of 107-kip.

**Figure 8.4: Vertical CFRP Retrofitted Beams at Failure**

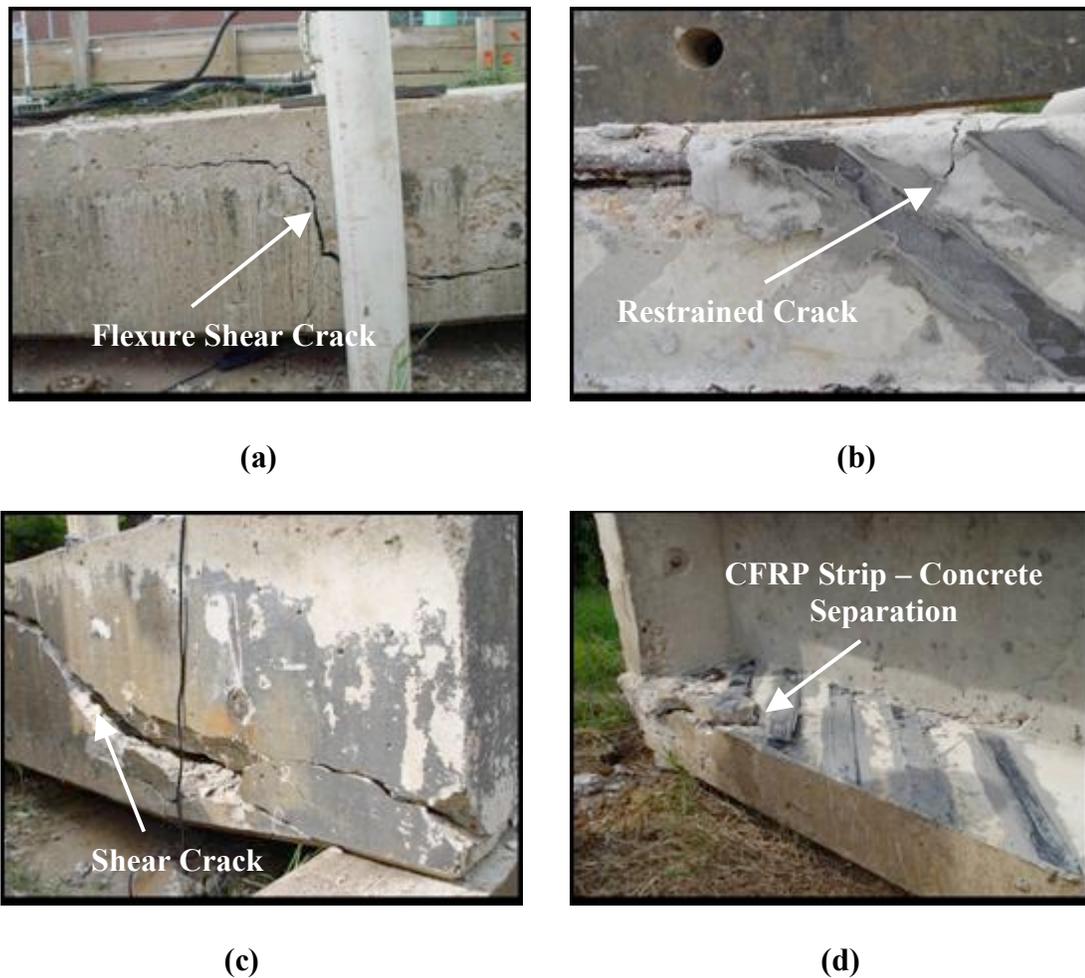
**Figure 8.5: Diagonal CFRP Retrofitted Beams at Failure**

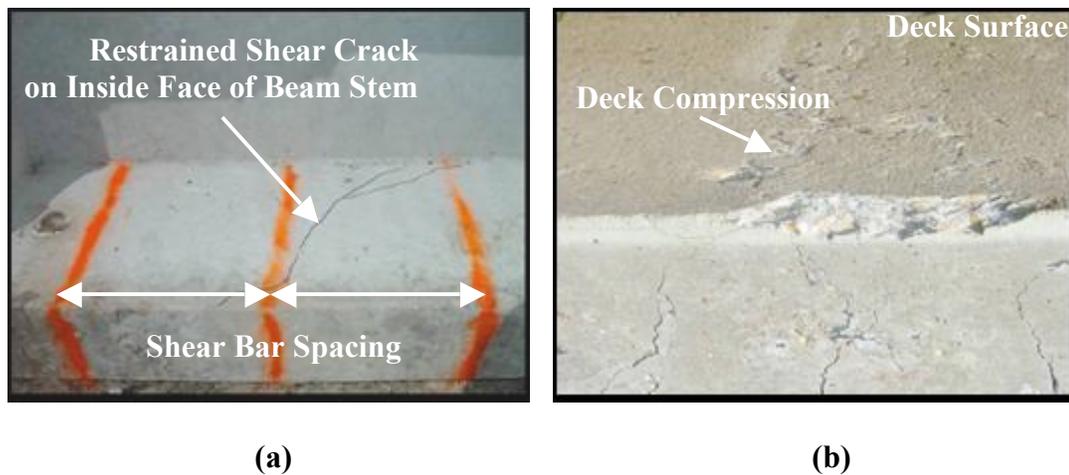
**Figure 8.6: Shear Bar Retrofitted Beams at Failure**

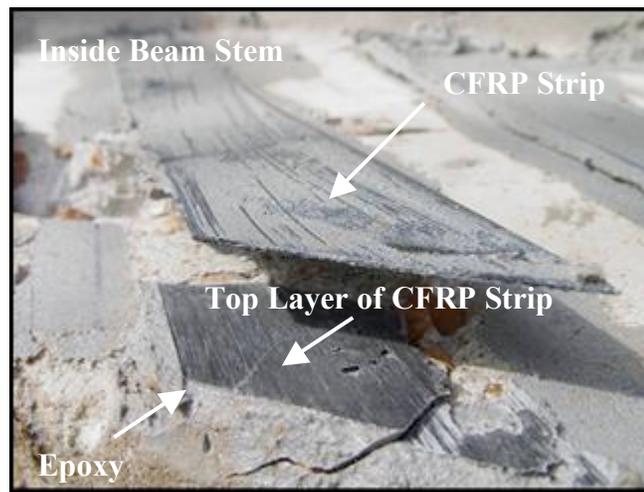
**Figure 8.11: CFRP Shear Failure**

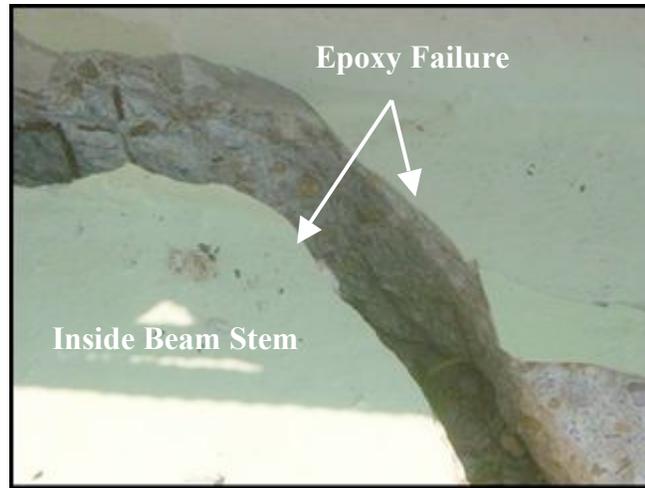
**Figure 8.12: Epoxy Failure**

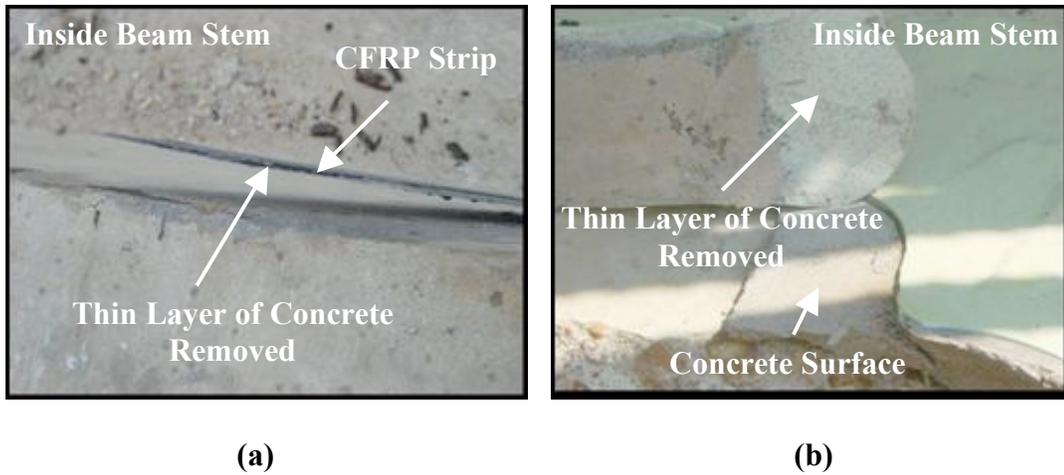
**Figure 8.13: Concrete Bond Failure**

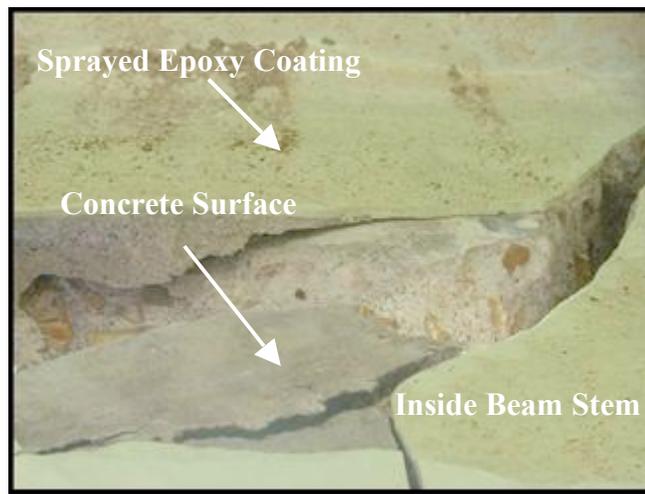
**Figure 8.14: Epoxy-Concrete Separation**

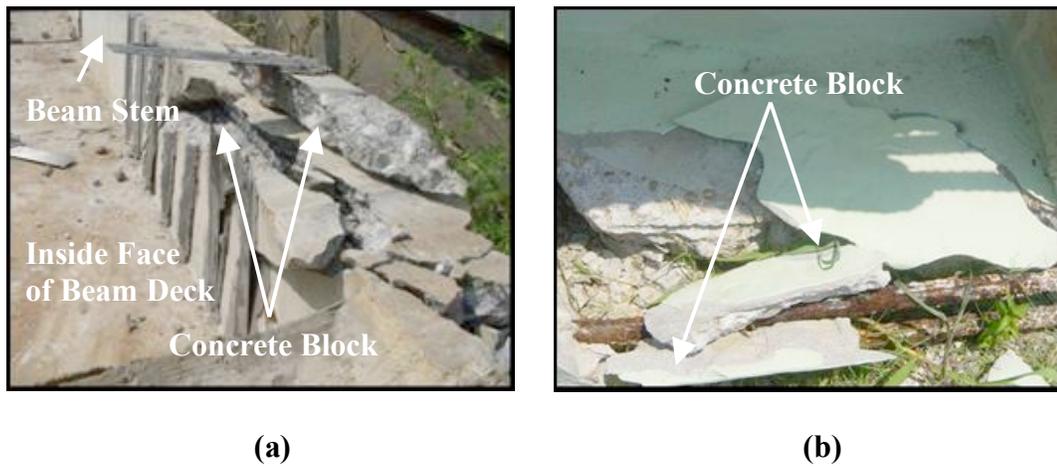
**Figure 8.15: Concrete Block Failure**

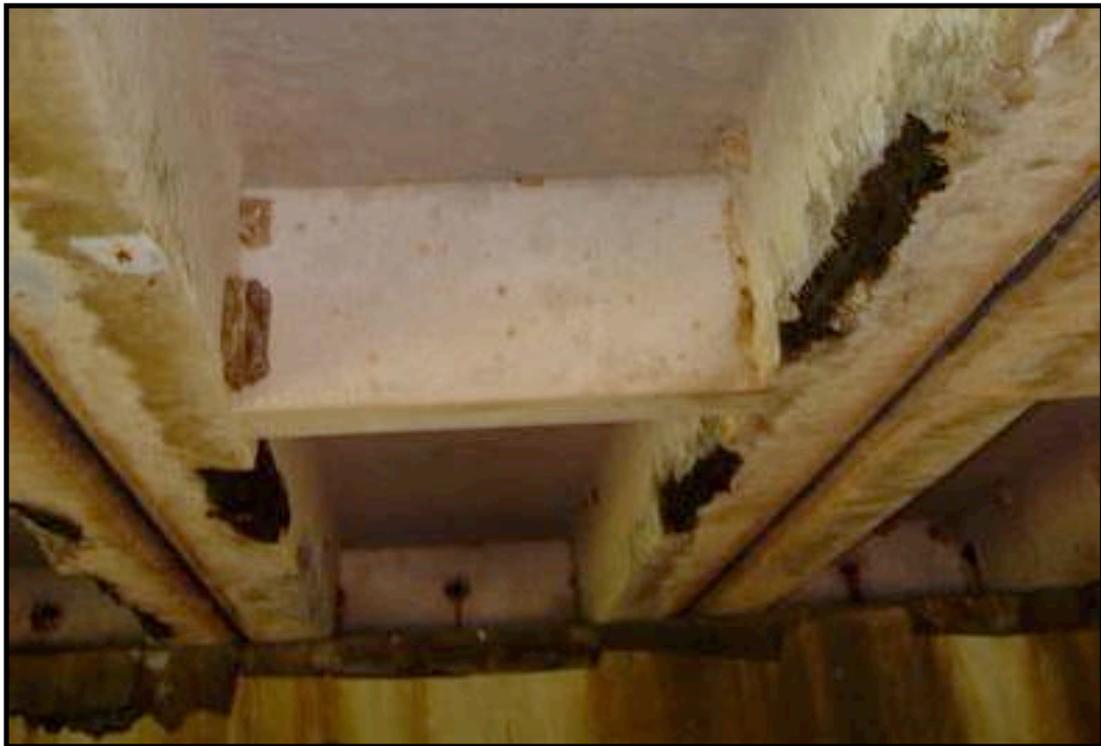
**Figure 10.4: Deteriorated Bridge Beam**

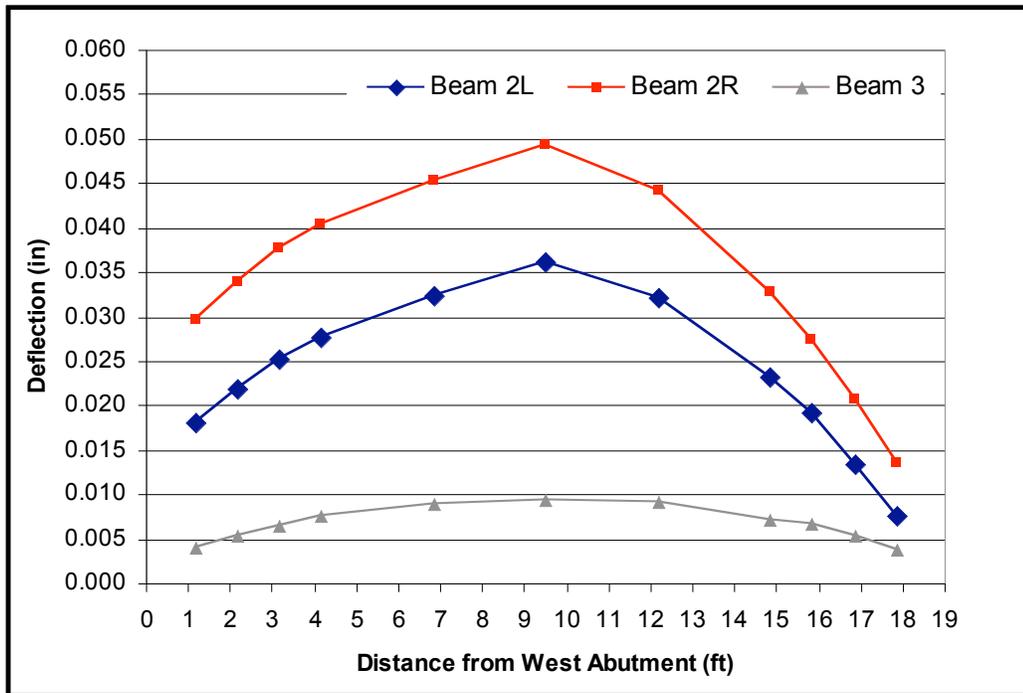
Figure 10.14: Mid-Span Deflection vs. Longitudinal Position for Span 4 [1]

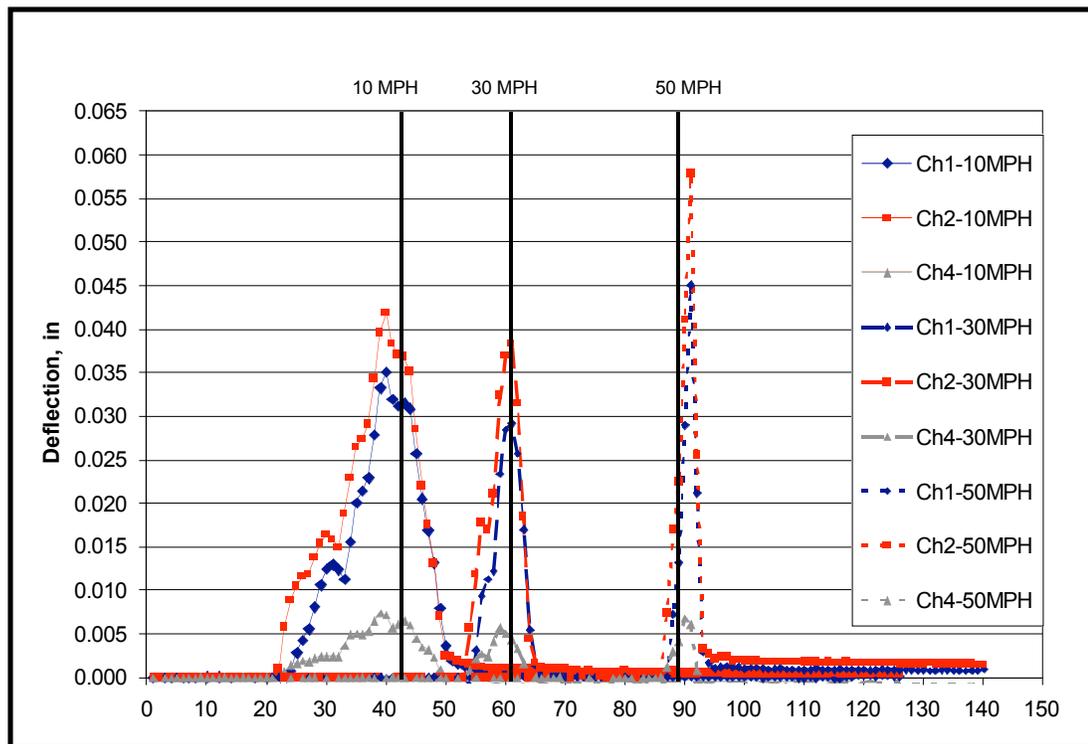
**Figure 10.23: Deflection Measurements for Truck Velocities Before Retrofit [1]**
