**Comparison of Texturing Methods  
Used for  
Highway Construction and Maintenance**

Final Report

Arkansas State Highway & Transportation Department

September 2016

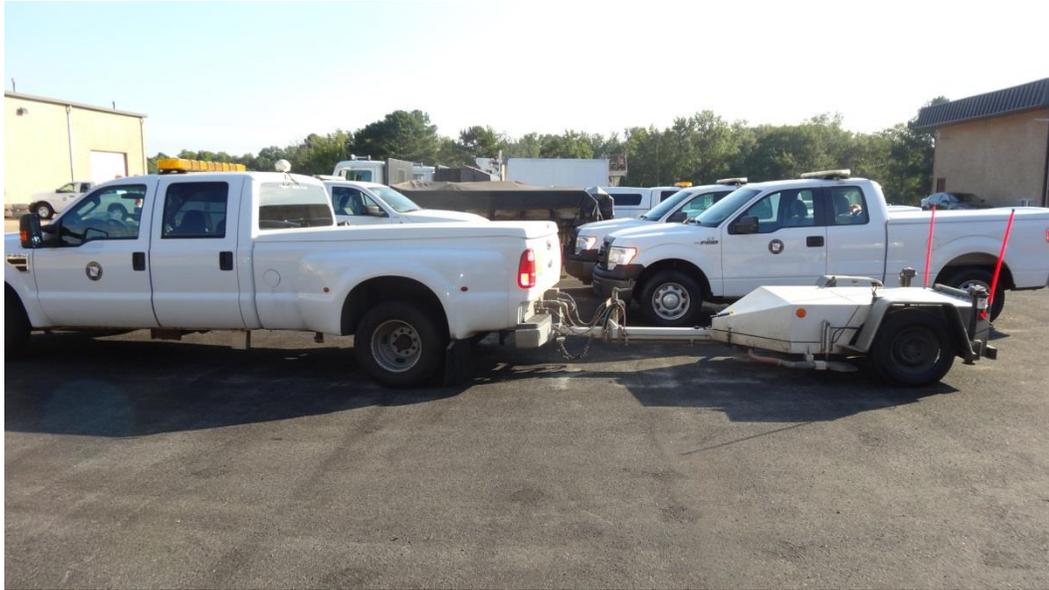
**Figure 1**

Currently there are five methods that the Department utilizes to test texture and skid resistance of pavement surfaces. The Department already utilizes a locked wheel tester “skid truck” (Figure 1) to measure surface resistance during wet conditions. Other options for testing surface texture are a Circular Texture Meter (CTM) (Figure 2), a Dynamic Friction Tester (DFT) (Figure 3), the “Sand patch” (Figure 4) test and an Outflow Meter (Figure 5). Both a CTM and DFT are available for Department use through the Friction, Texture, and Profile Measurement Equipment Loan Program with Federal Highway Administration.

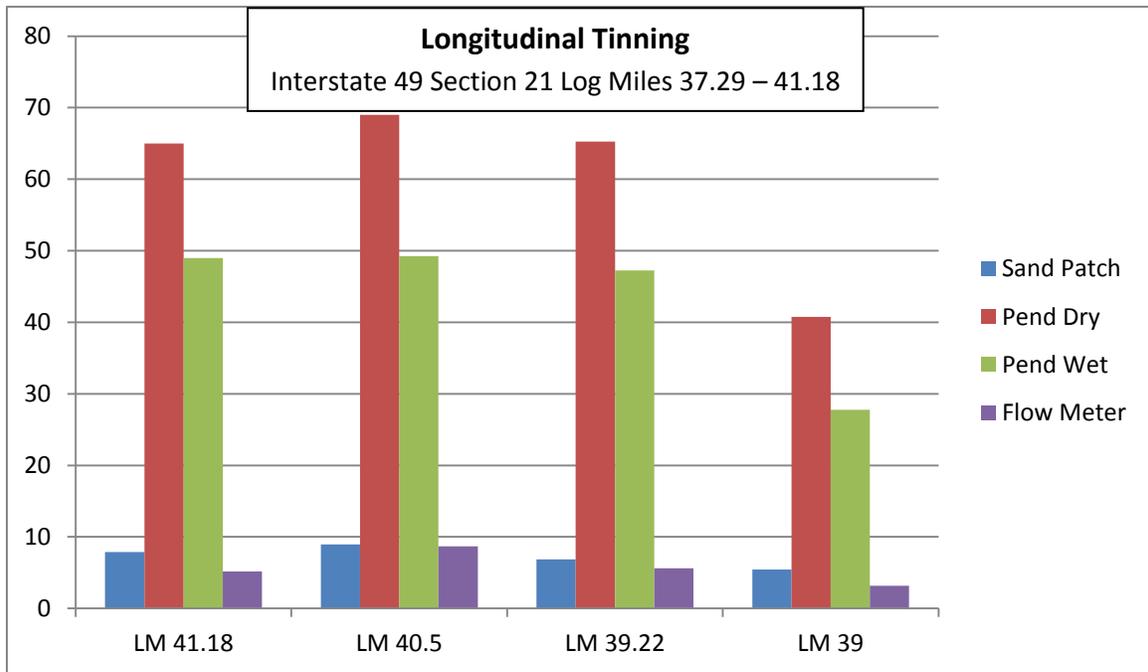
**Figure 6**

AHTD's District 3 has one site. This site is Interstate 49 Section 21 log mile 41.18 – 37.29 and it is longitudinal tinning. There is also a fabric interlayer at log

mile 40.50. Four sites with four tests of each were completed at this site. The data collected for this site is shown in Figure 6.

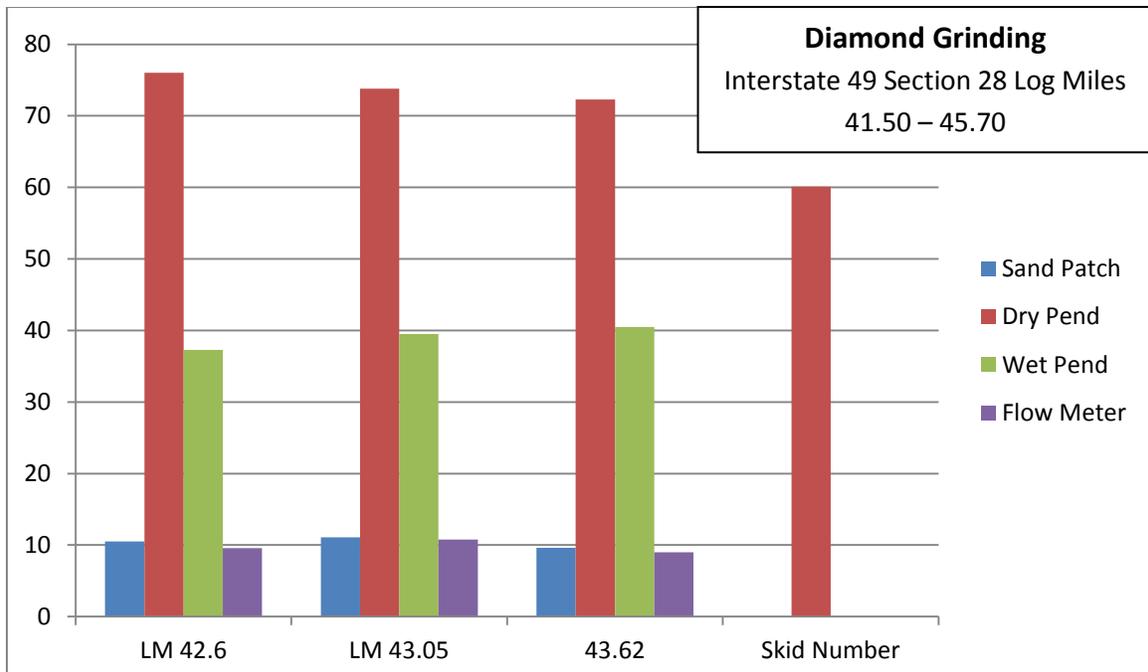
**Figure 7**

One location in District four. It is the diamond ground site on Interstate 49 Section 28 Log mile 41.50 – 45.70. There were three test sites with four tests completed at each site. The data collected for this site is shown in Figure 7.

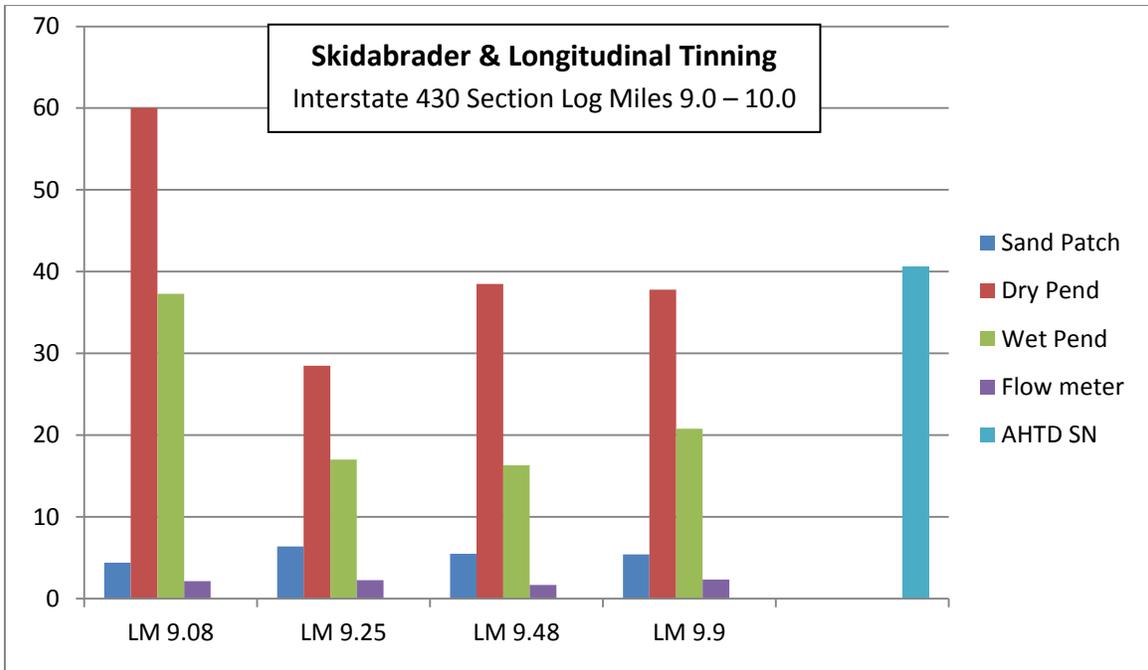
**Figure 8**

Three locations in District six. The first site is longitudinal tinning and skidabrader. It is on Interstate 430 section 21 log mile 9.0 – 10.0 (Figure 8). There is also skidabrador on Interstate 440 Section 1 Log mile 7.43 -8.43 (Figure 9). The cold milling is on Highway 5 Section 7 Log mile 16.4 – 17.9 (Figure 10).

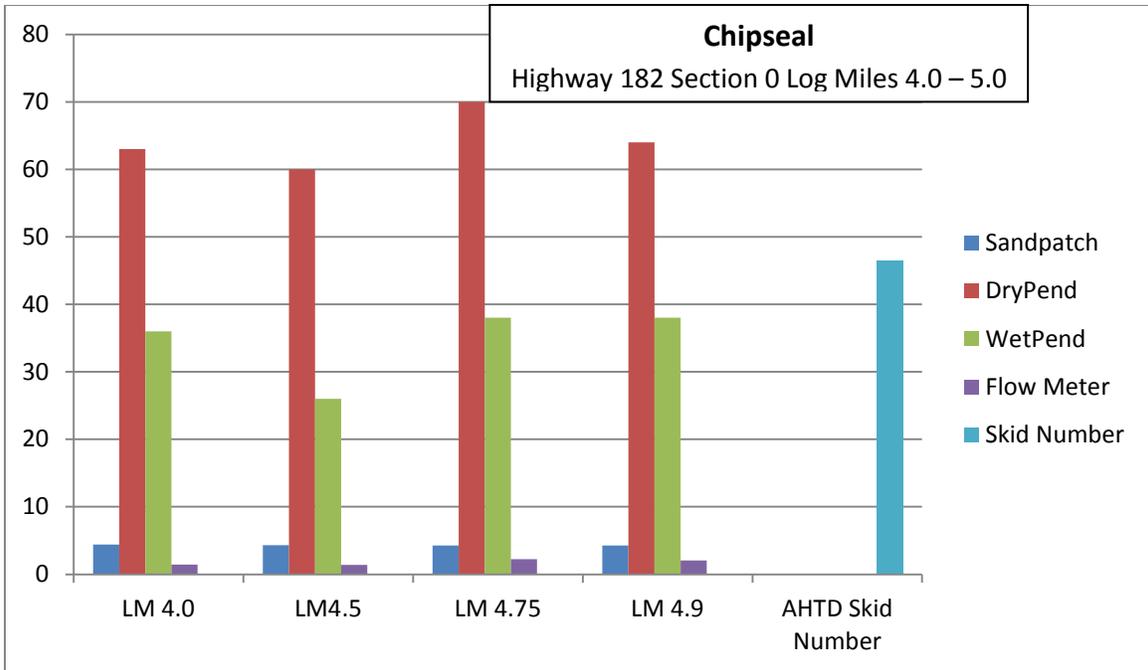
**Figure 11**

There are two locations in District seven. The first site is Highway 182 Section 0 log miles 4.0 – 5.0 and it consists of a chip seal (Figure 11). The other site is Interstate 30 Section 14 log mile 54.0 – 56.0 (Figure 12) and is an ultra-thin bonded wearing course.

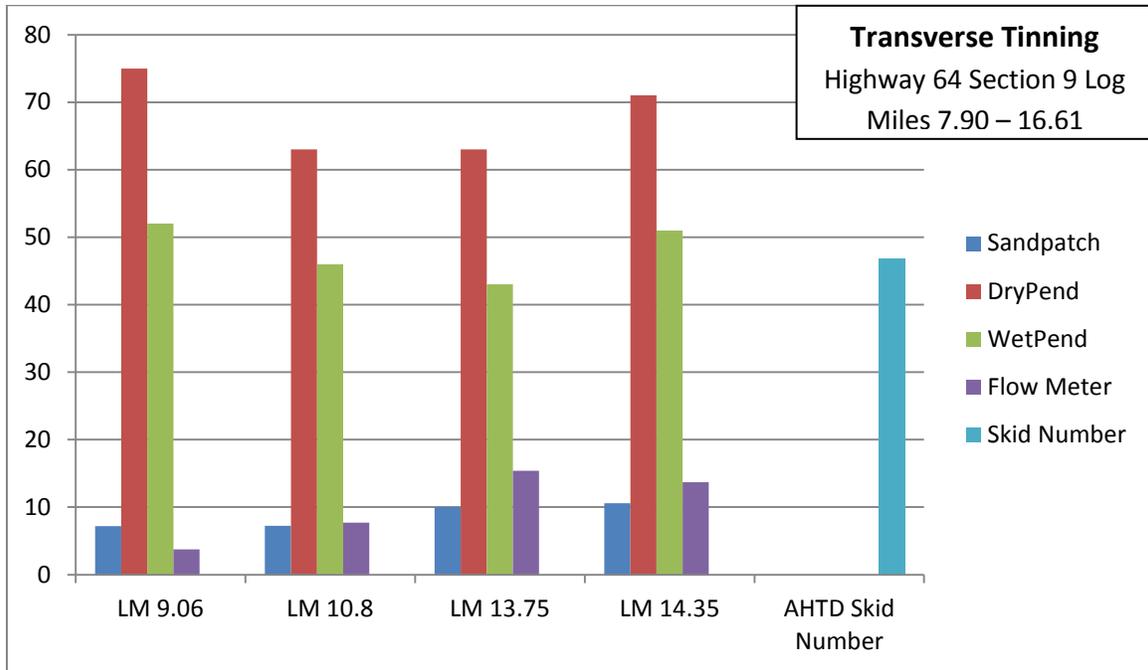
**Figure 13**

District 8 has one site that is transverse tinning. This site is on Highway 64 section 9 from log mile 7.90 to log mile 16.61 (Figure 13).

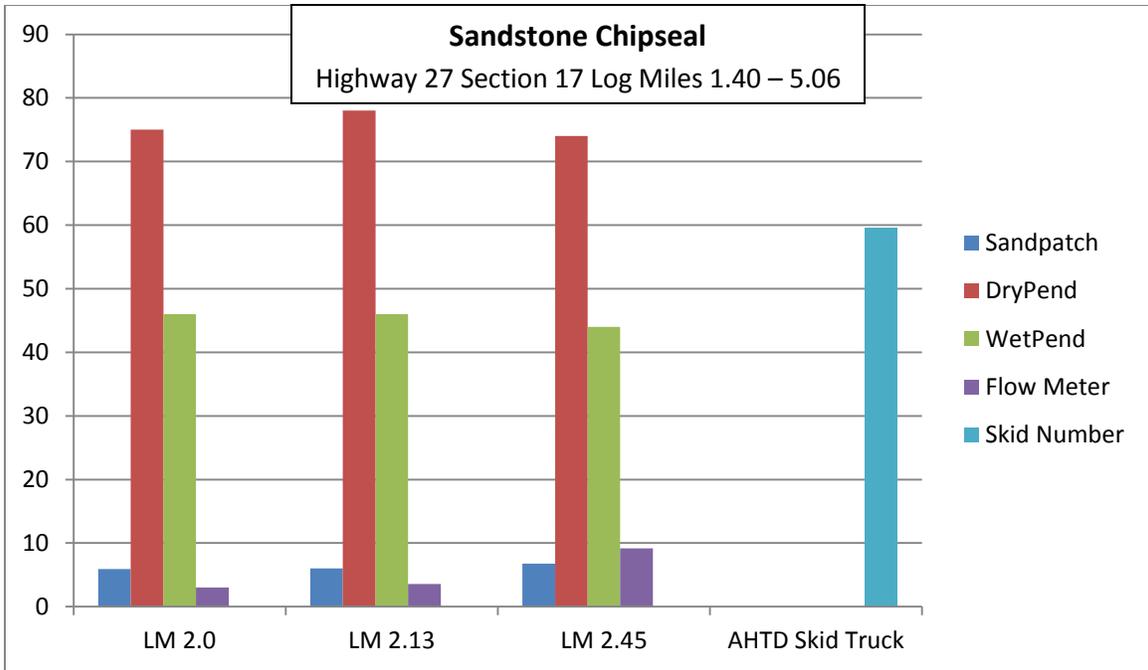
**Figure 14**

There are four locations in District nine. Three sites that have a sand stone chipseal are Highway 27 Section 17 log mile 1.40 – 5.06 (Figure 14), Highway 74 Section 5 Log mile 1.35 – 1.45 (Figure 15), and Highway 201 Section 1 Log mile 4.62 – 5.12 (Figure 16). The other location in District 9 is a light-weight chert chipseal that is on Highway 72 Section 3 Log mile 3.48 – 3.61 (Figure 17).

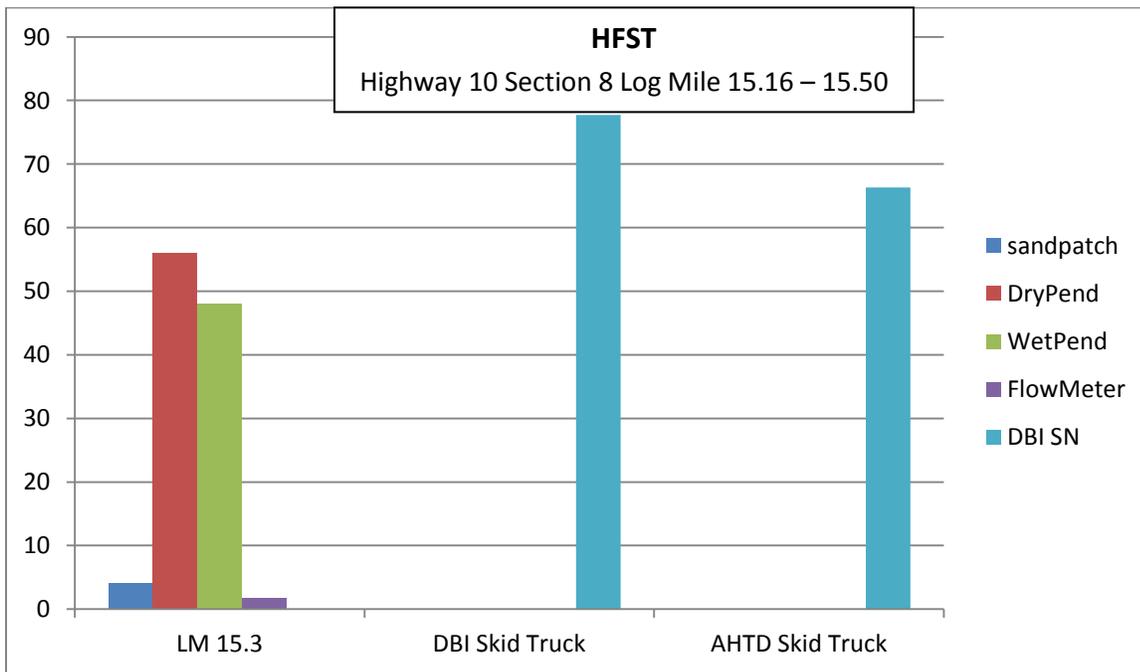
**Figure 18**

There is High Friction Surface Treatment (HFST) on Highway 10 Section 8 Log mile 15.16 – 15.50 (Figure 18) and 16.0 – 16.07 (Figure 19). Highway 5 Section 7 also has HFST at log mile 6.65 – 6.87 (Figure 20). HFST was also placed on Highway 5 Section 6 at log miles 0.00 – 0.2 (Figure 21) and 3.0 – 3.20 (Figure 22). Highway 270 Section 6 Log mile 6.64 – 6.80 (Figure 23) is the next site the HFST was placed. Highway 7 Section 9 log mile 1.62 – 1.83 (Figure 24) also has HFST. Two more HFST sites in District 6 are on Highway 67 Section 9 at log miles 6.03 -6.11 (Figure 25) and 6.37 – 6.47 (Figure 26). The final HFST in District 6 is Highway 5 Section 12 log mile 6.70 – 7.30 (Figure 27).

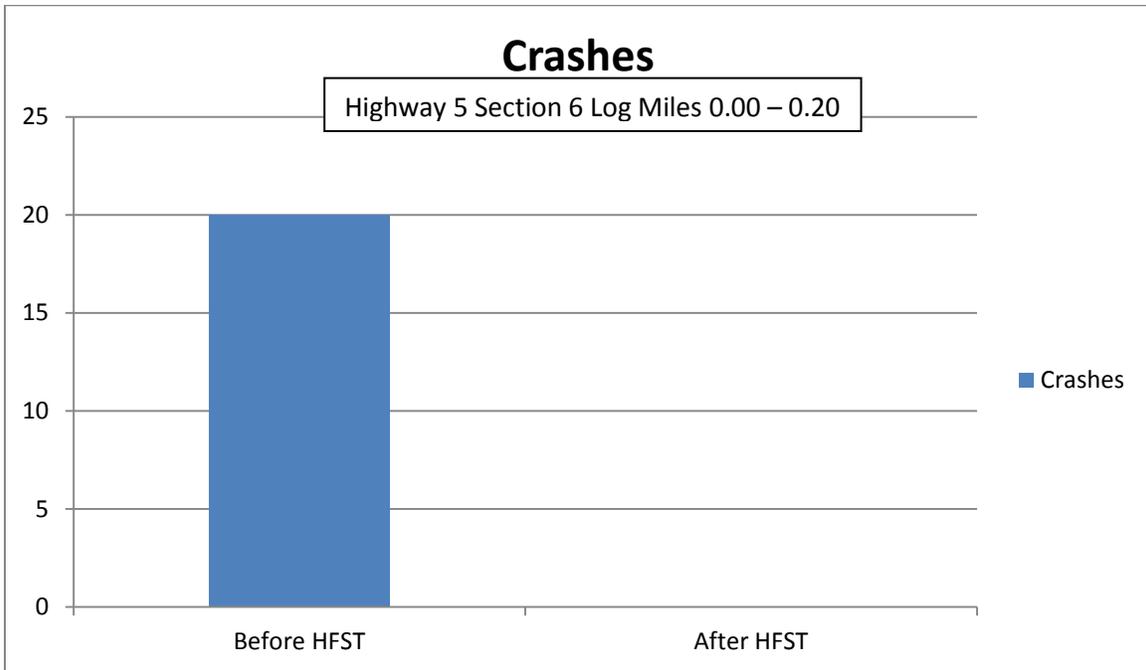
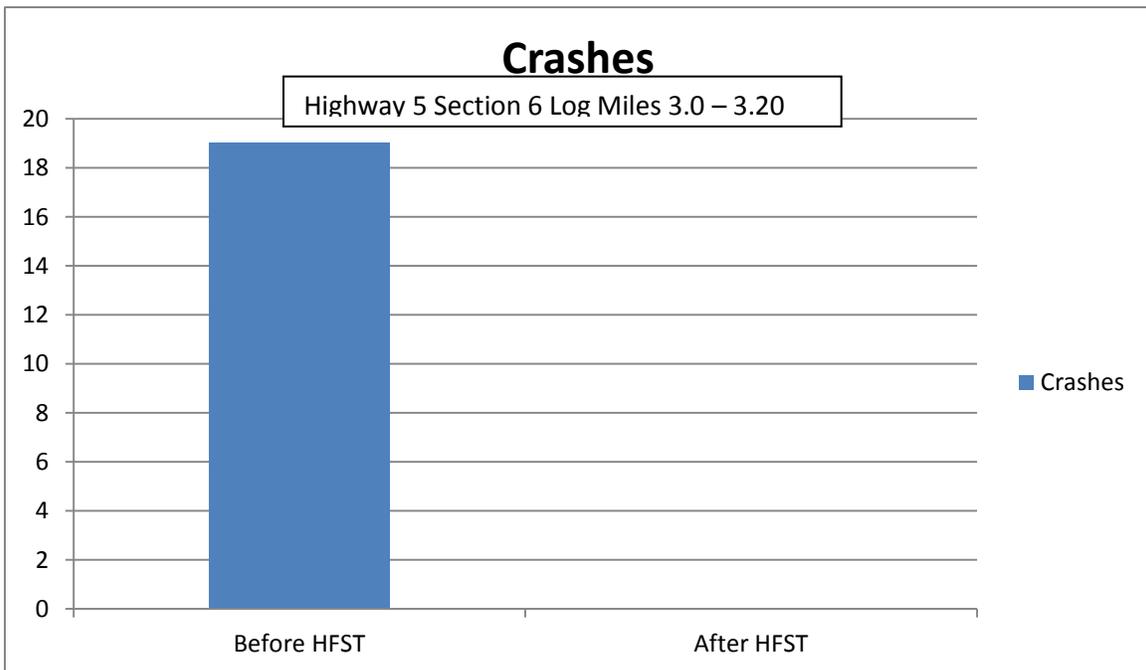
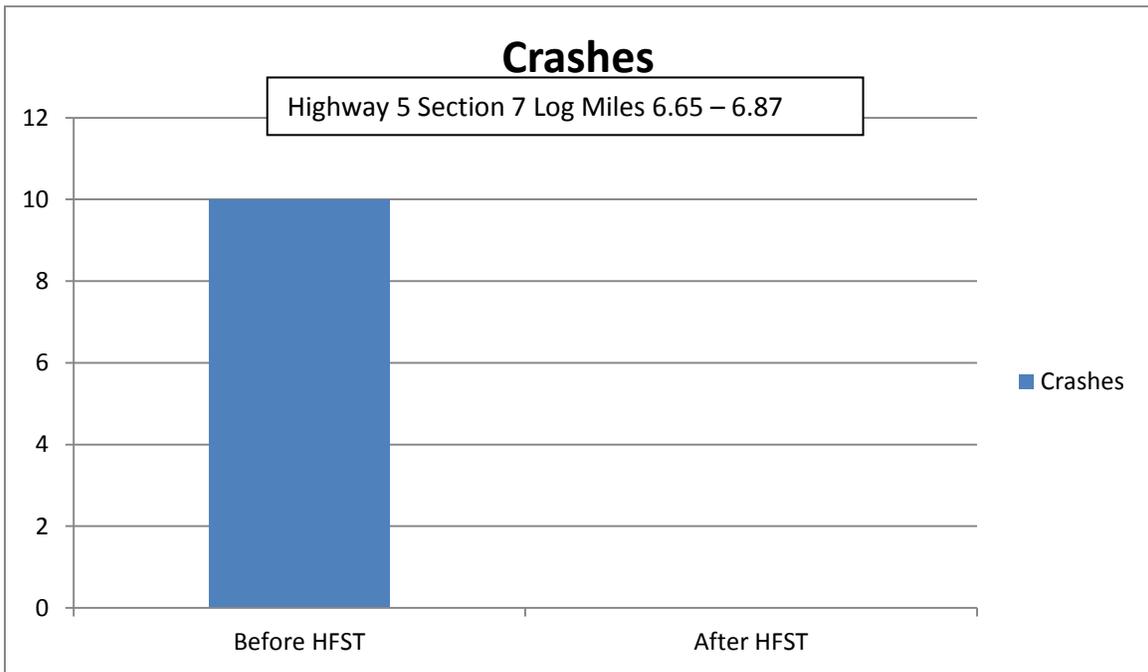
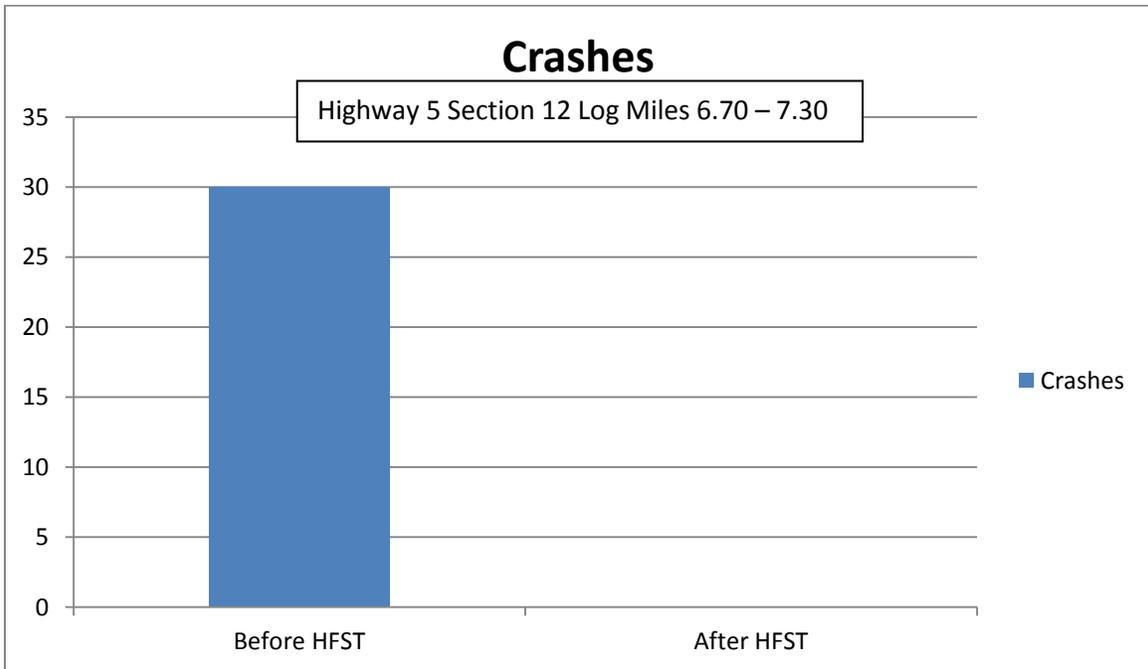
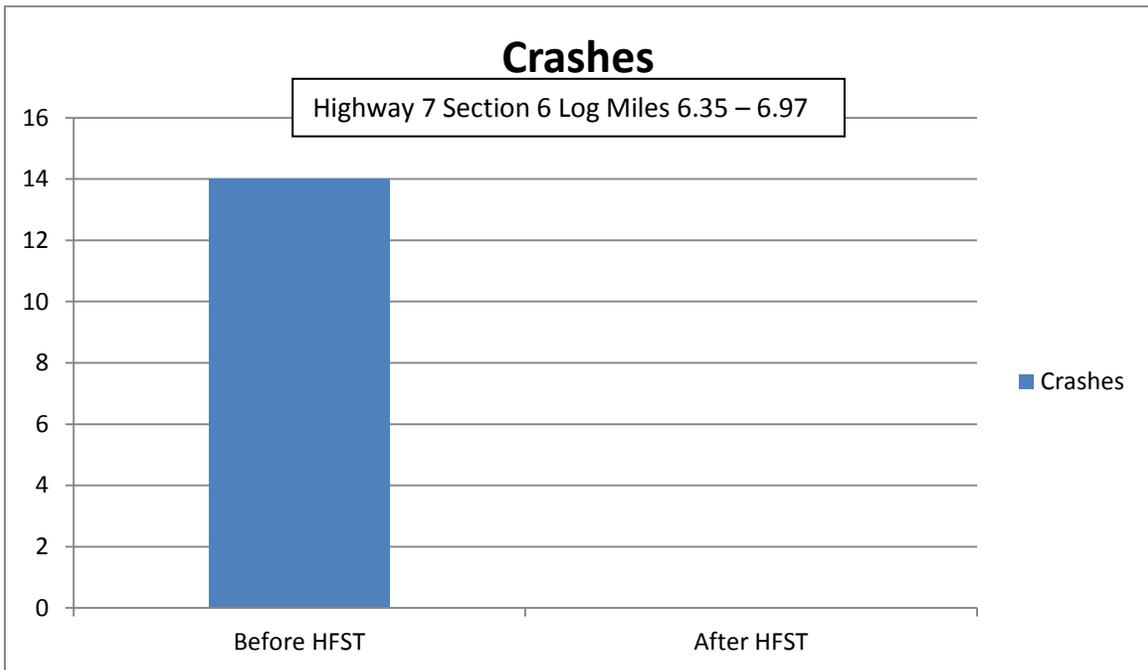
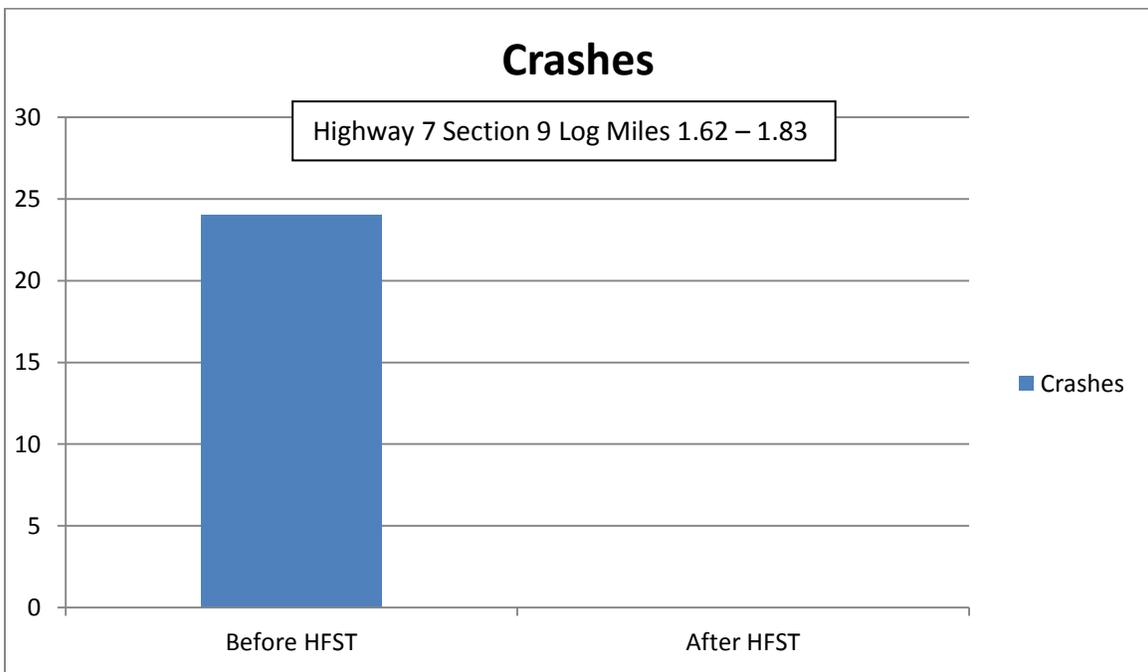
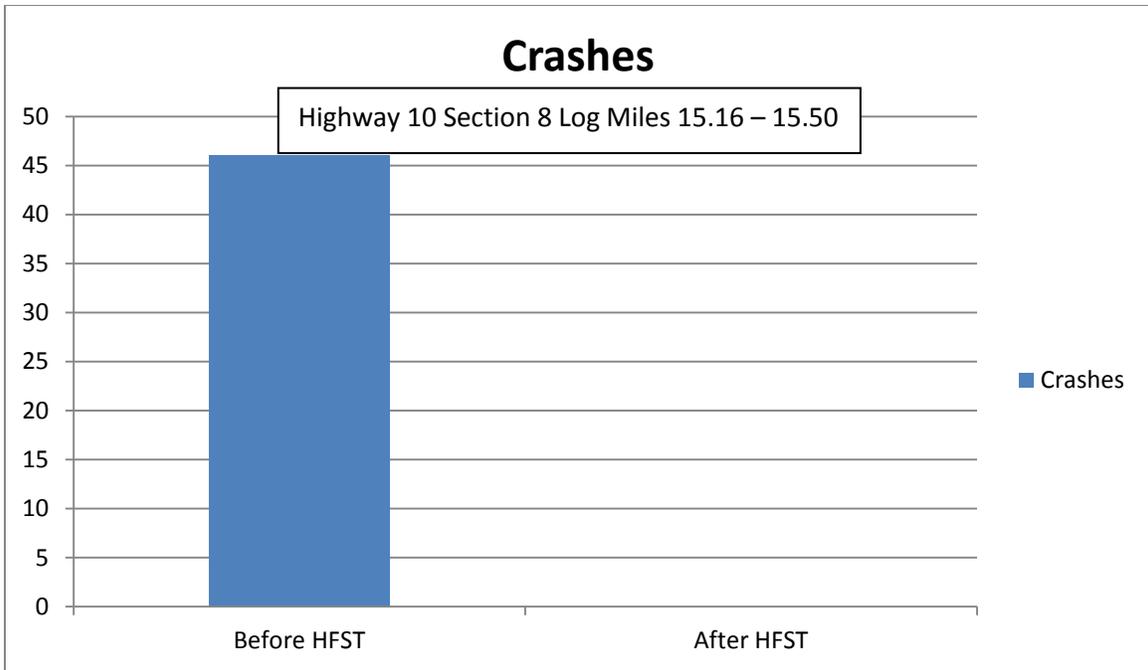
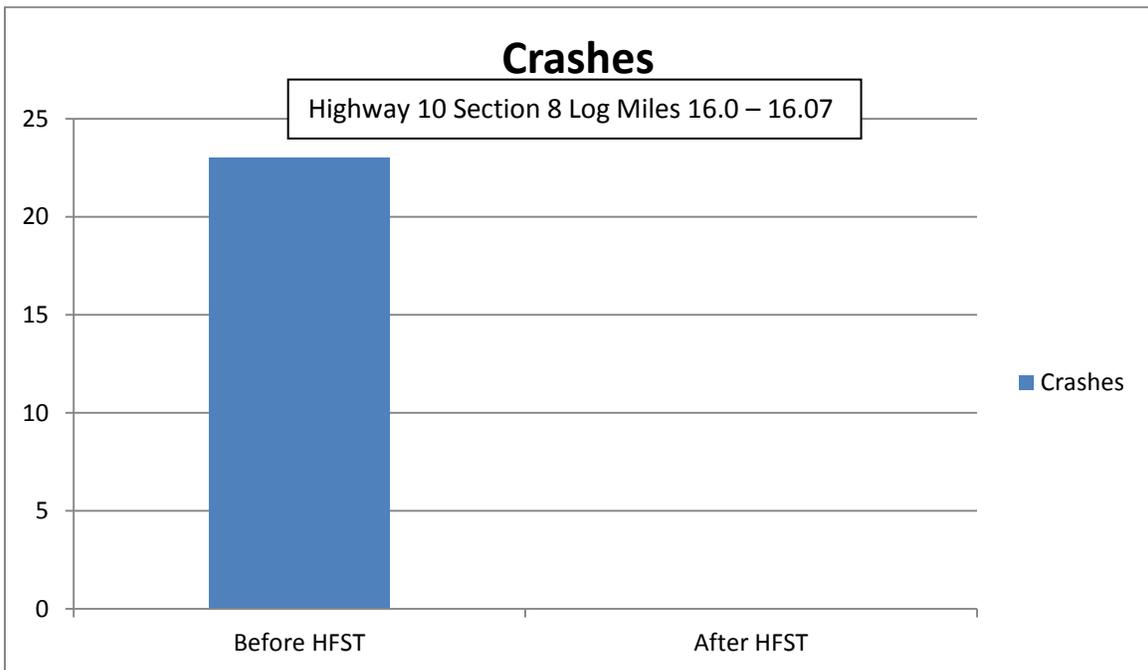
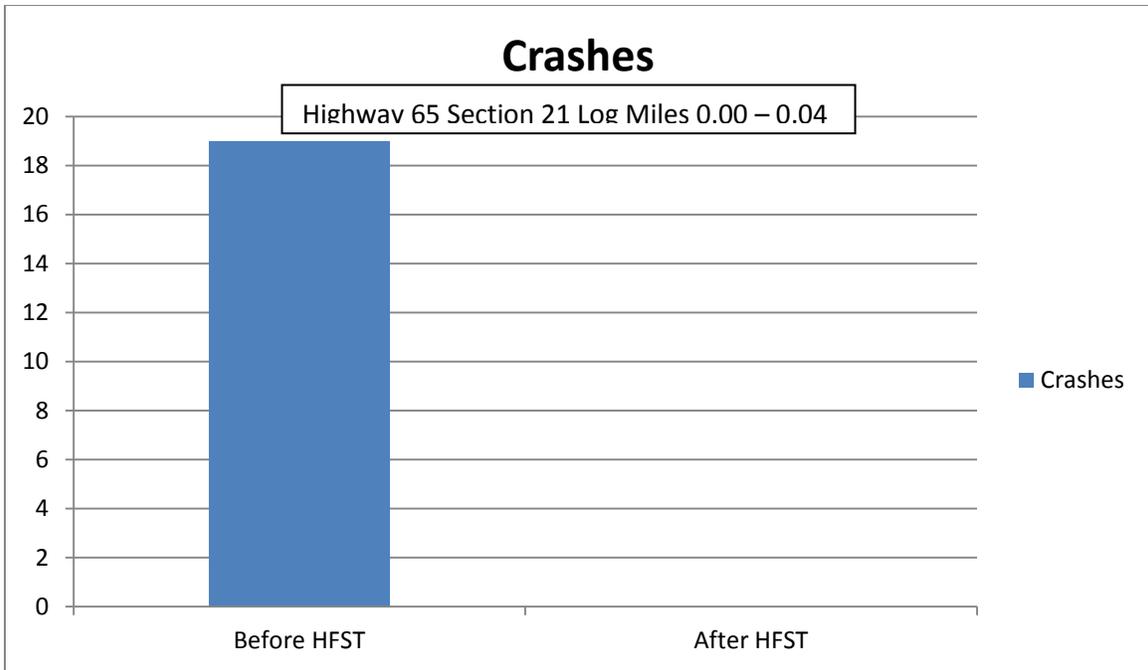
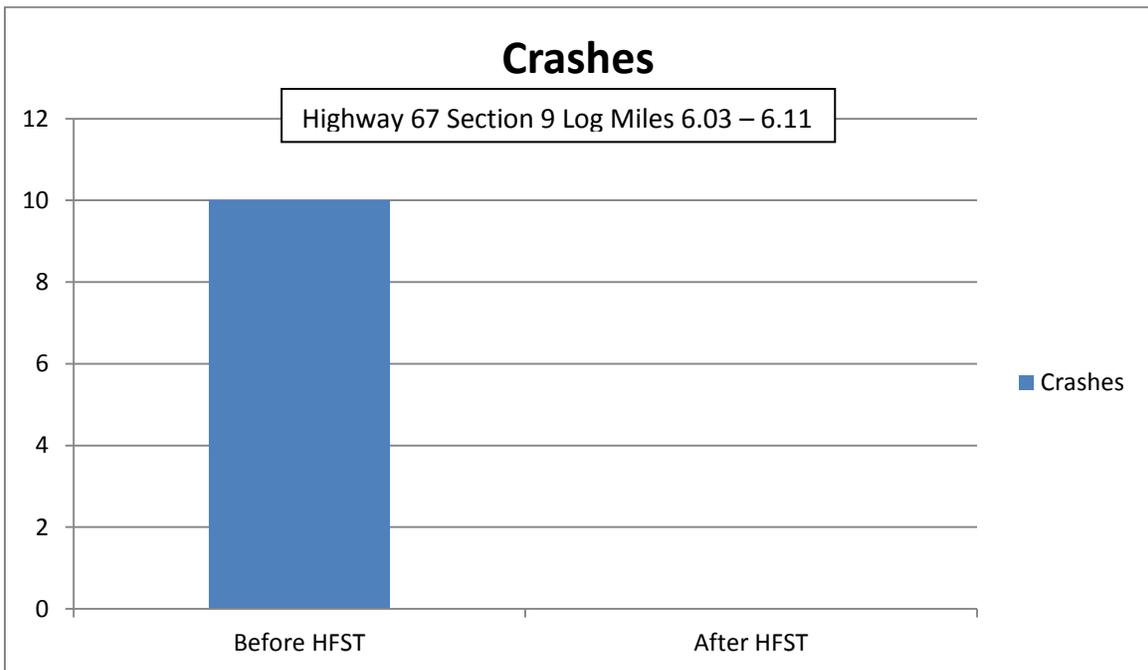
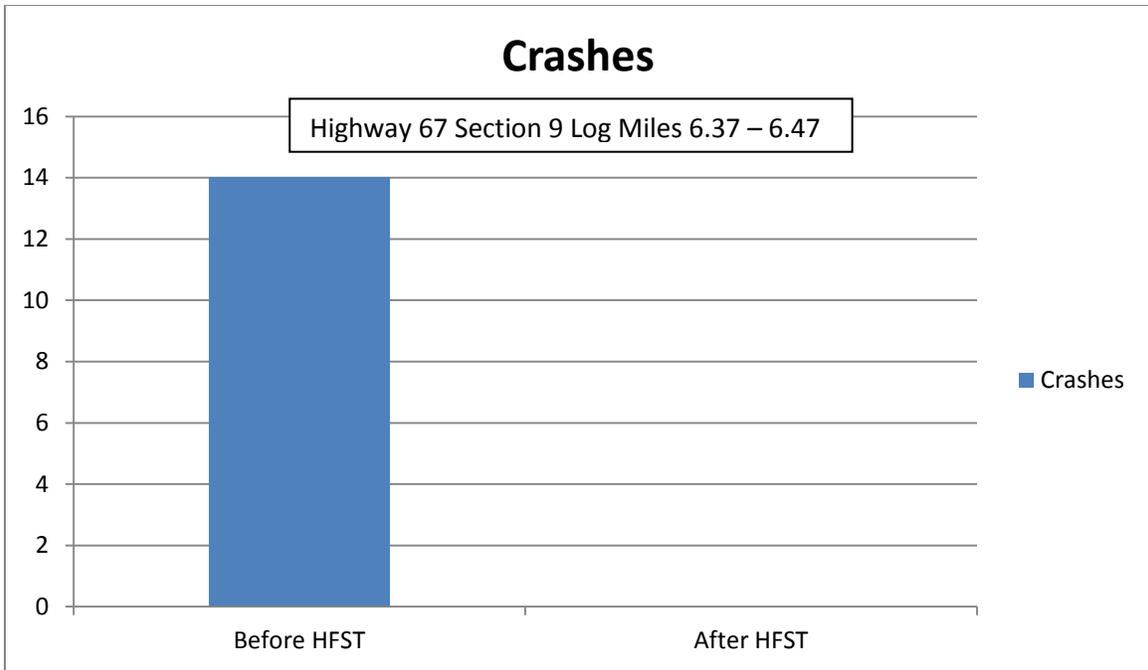
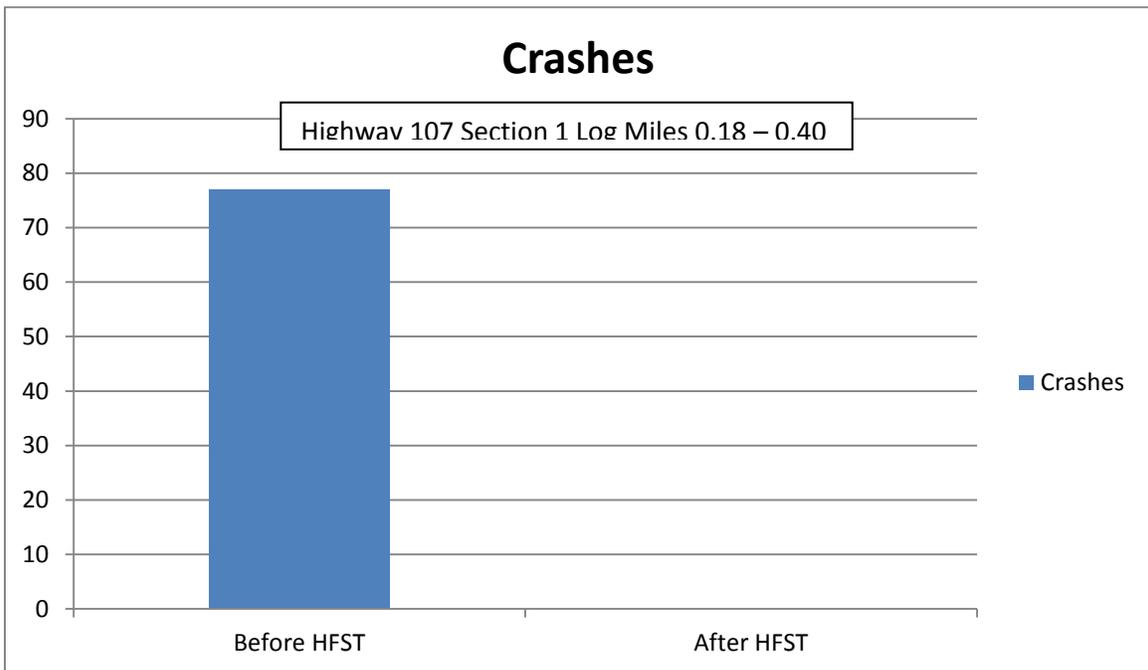
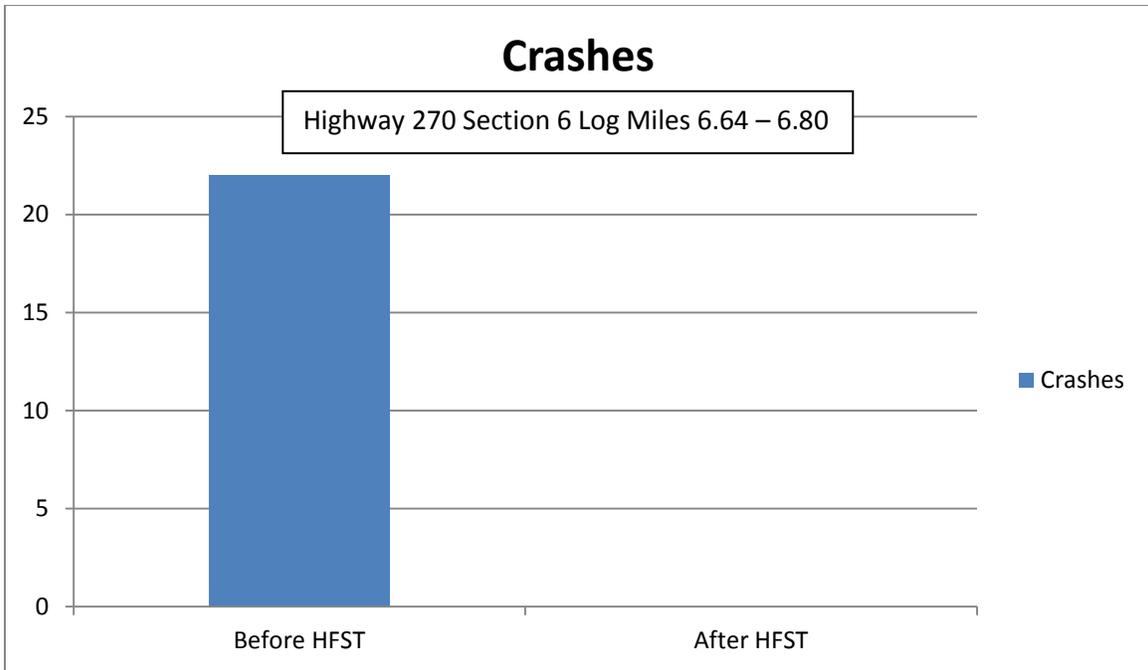
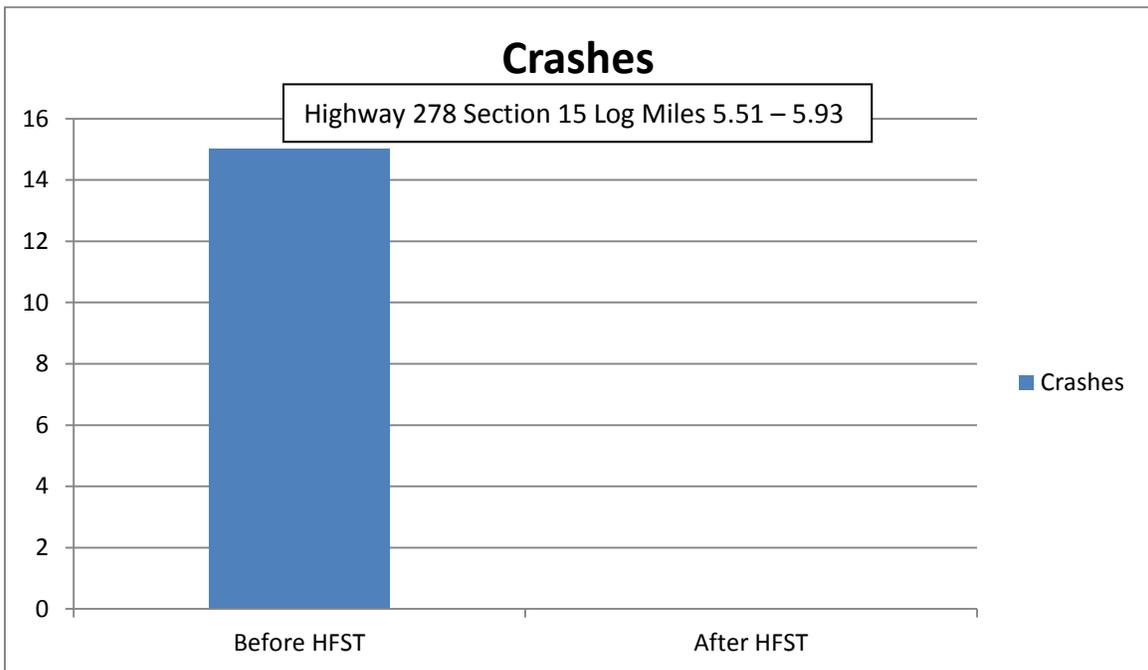
At the time of this report only the crash data before the HFST was placed was available. The crash data for one year after the HFST sites were laid will be available early 2017. Once the crash data is obtained it will be added to this report. The following charts (Figures 28 – 41) contain the crash data from 2010 through 2014, which is before the HFST was applied.
