**Comparison of Texturing Methods  
Used for  
Highway Construction and Maintenance**

Final Report

Arkansas State Highway & Transportation Department

September 2016

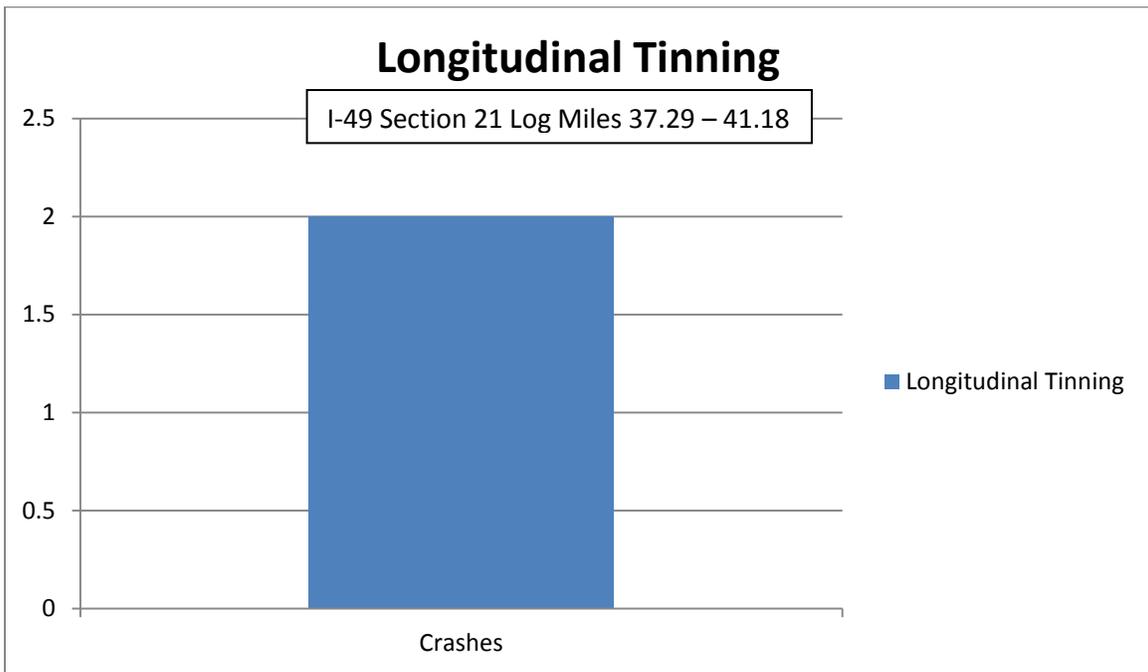
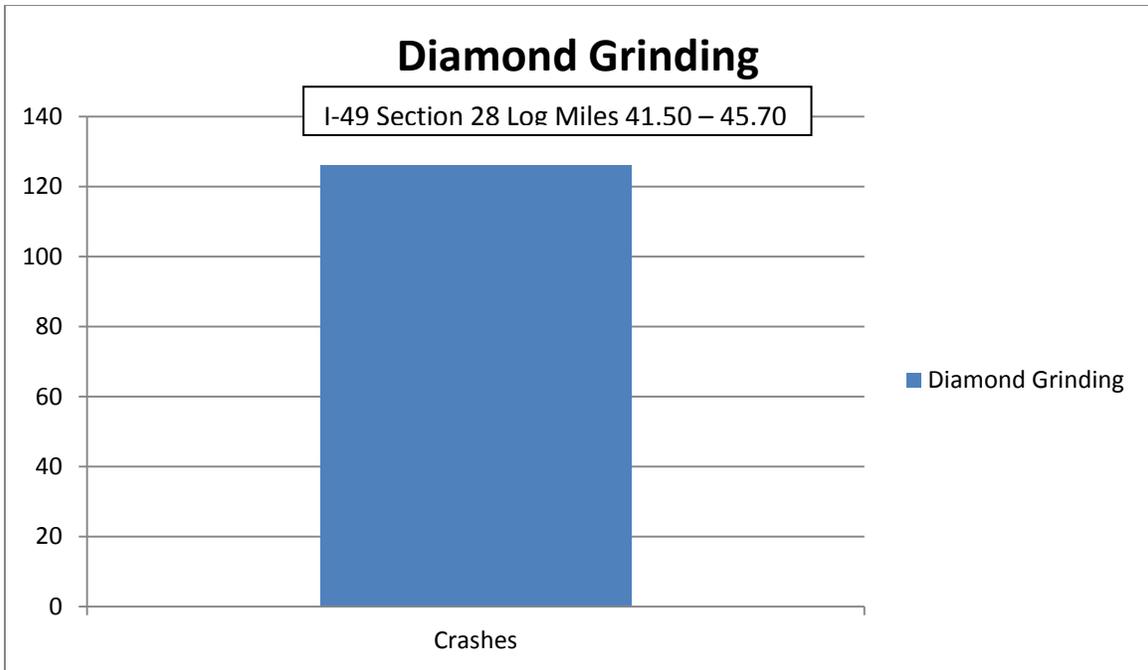
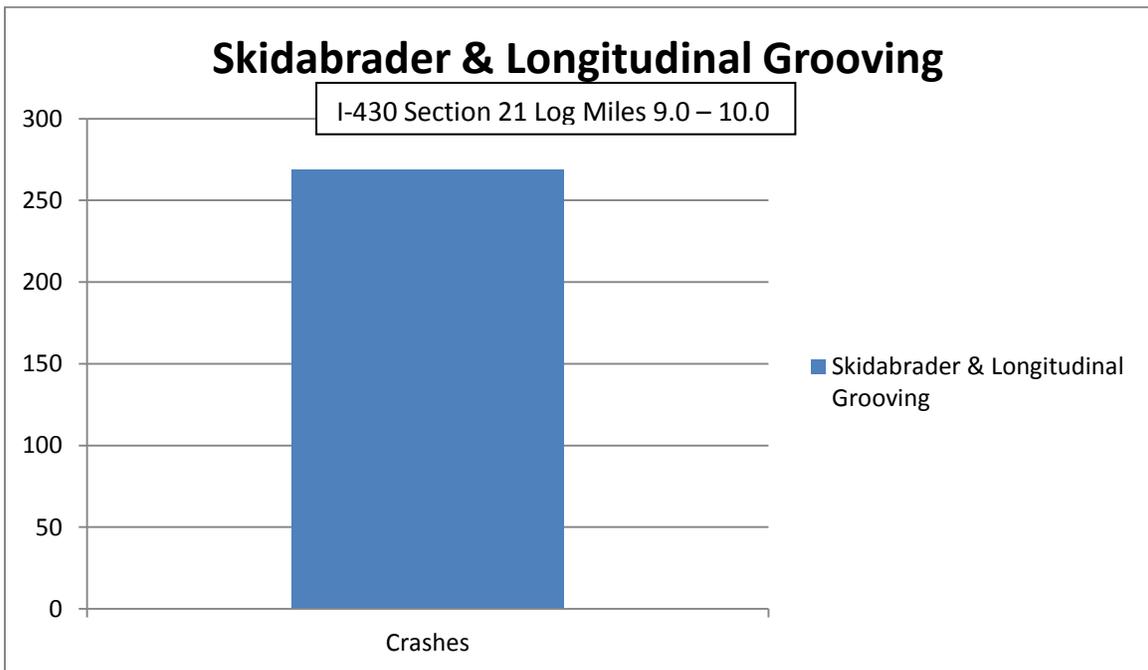
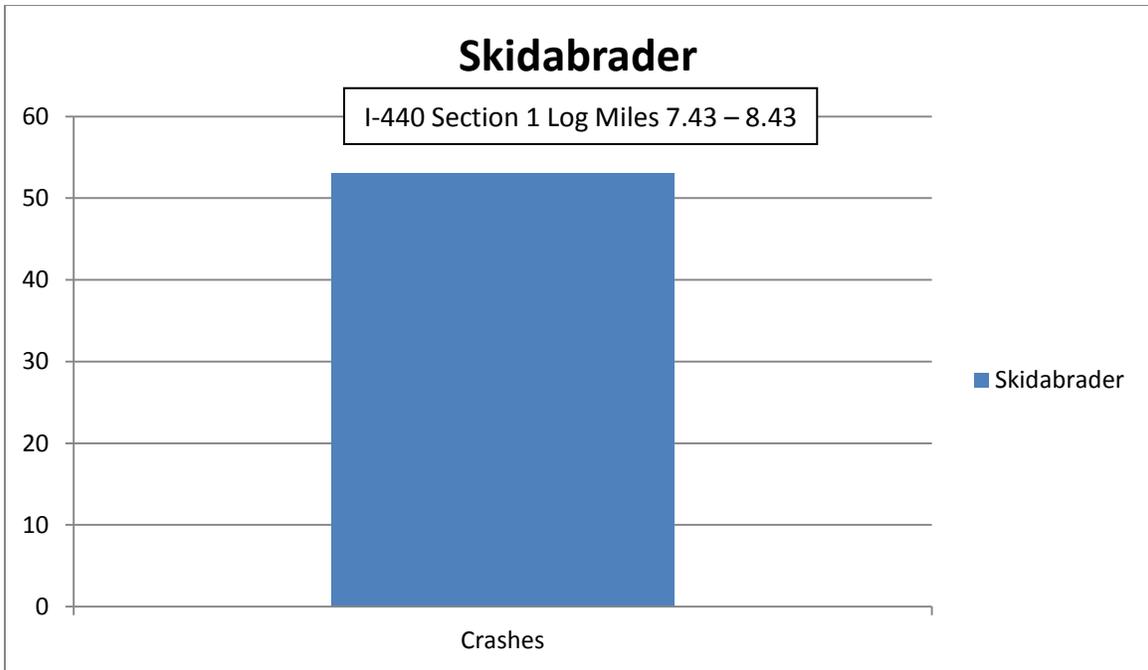
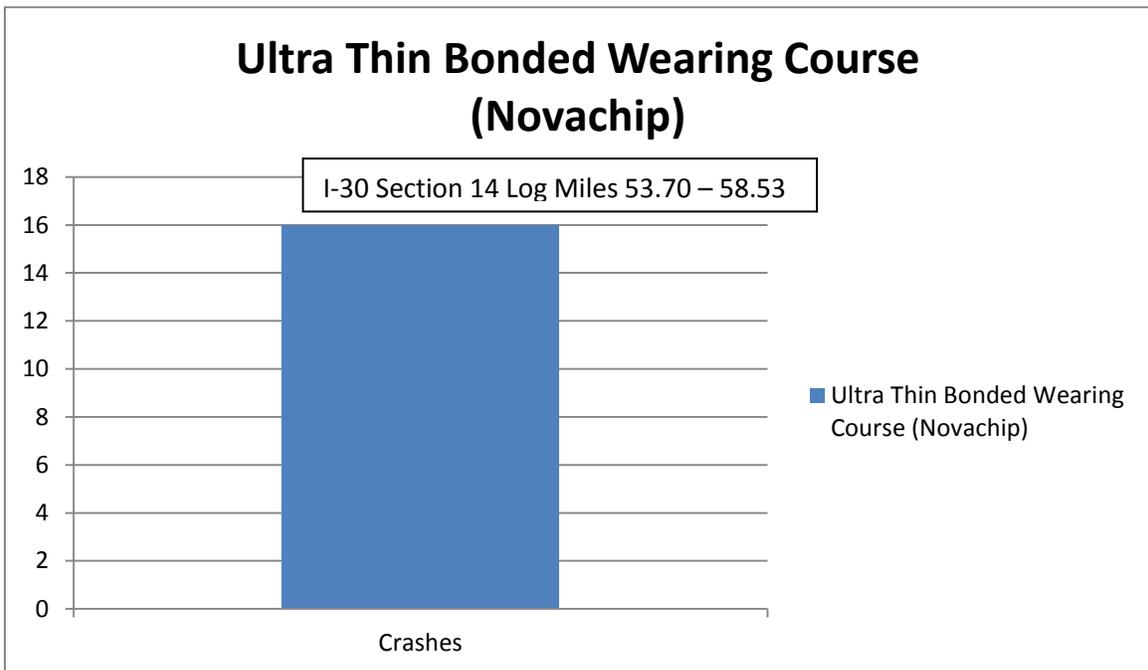
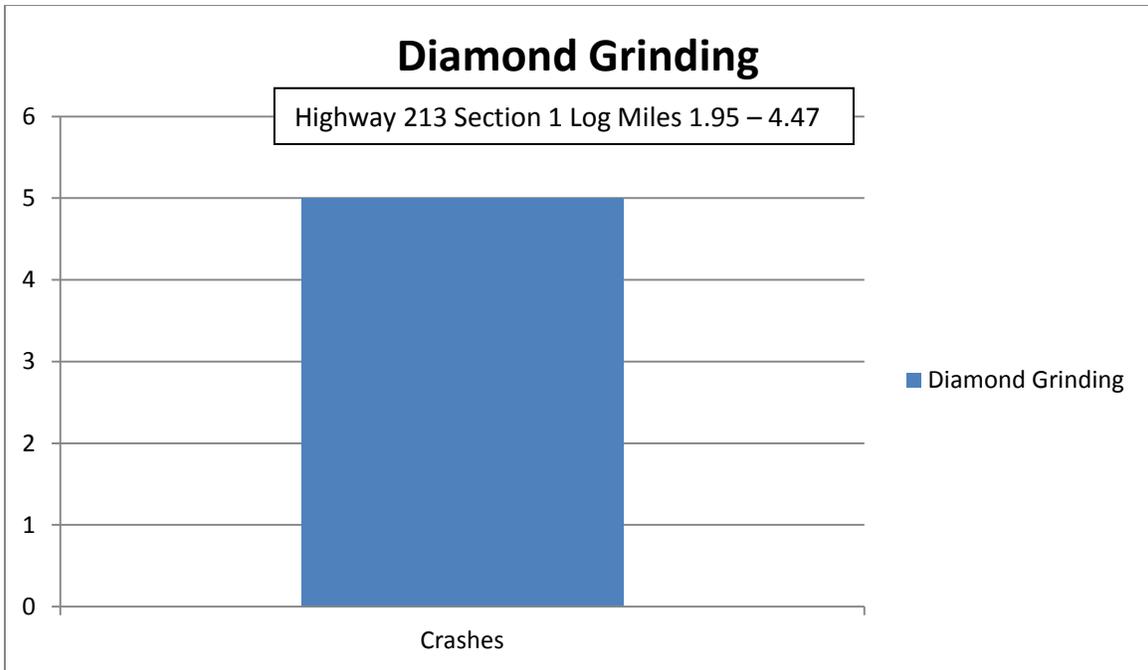
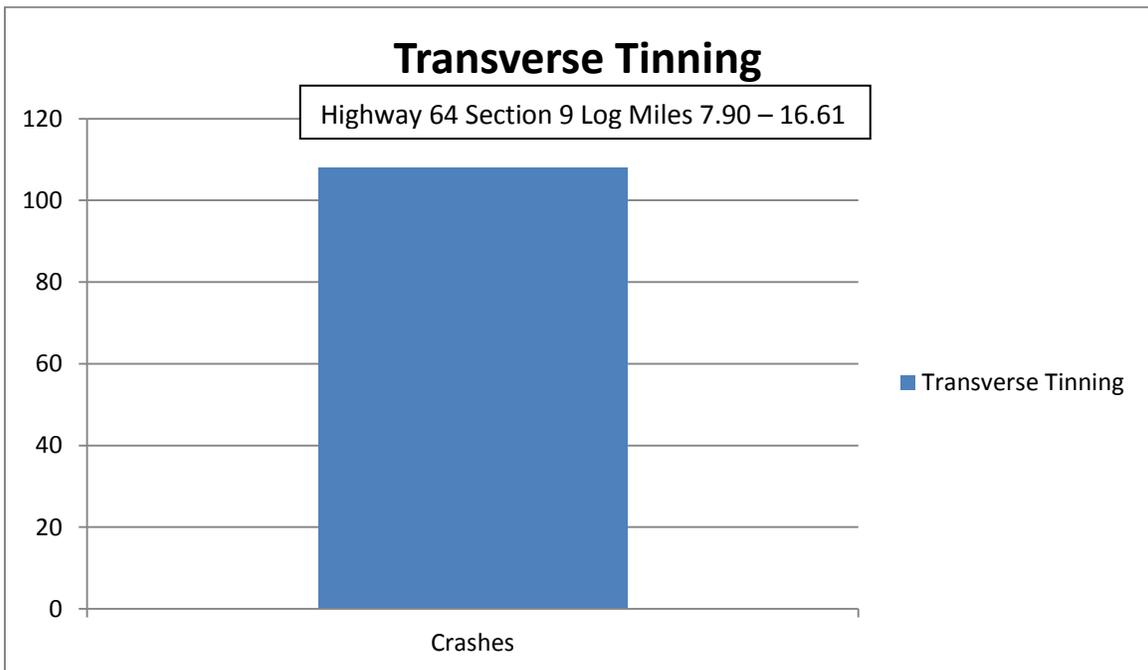
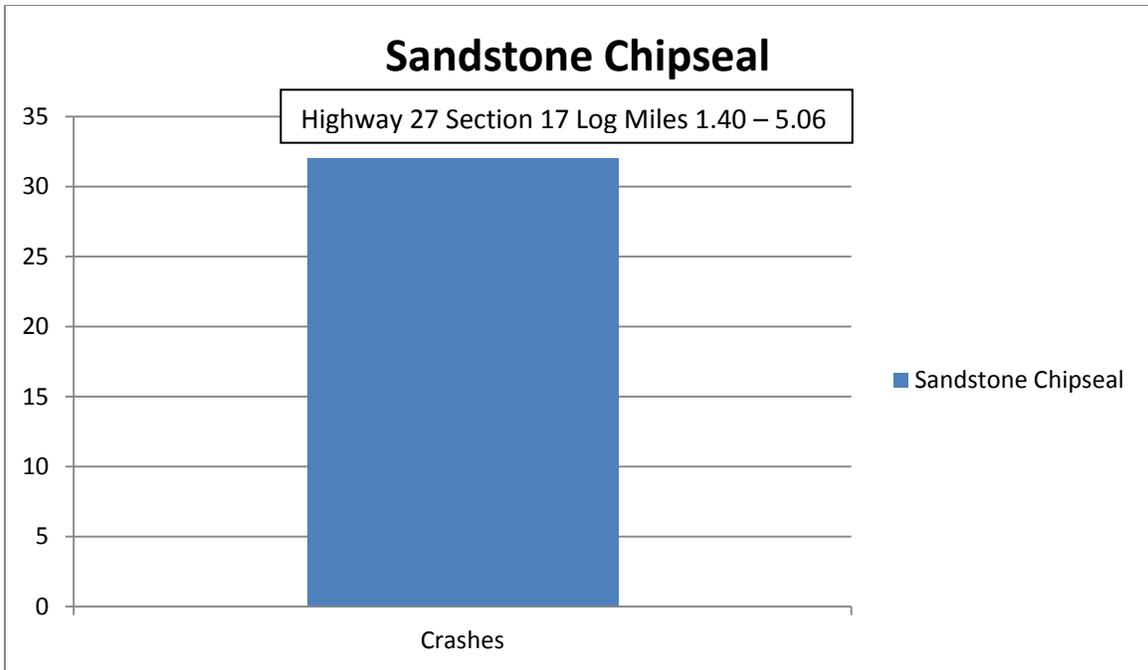
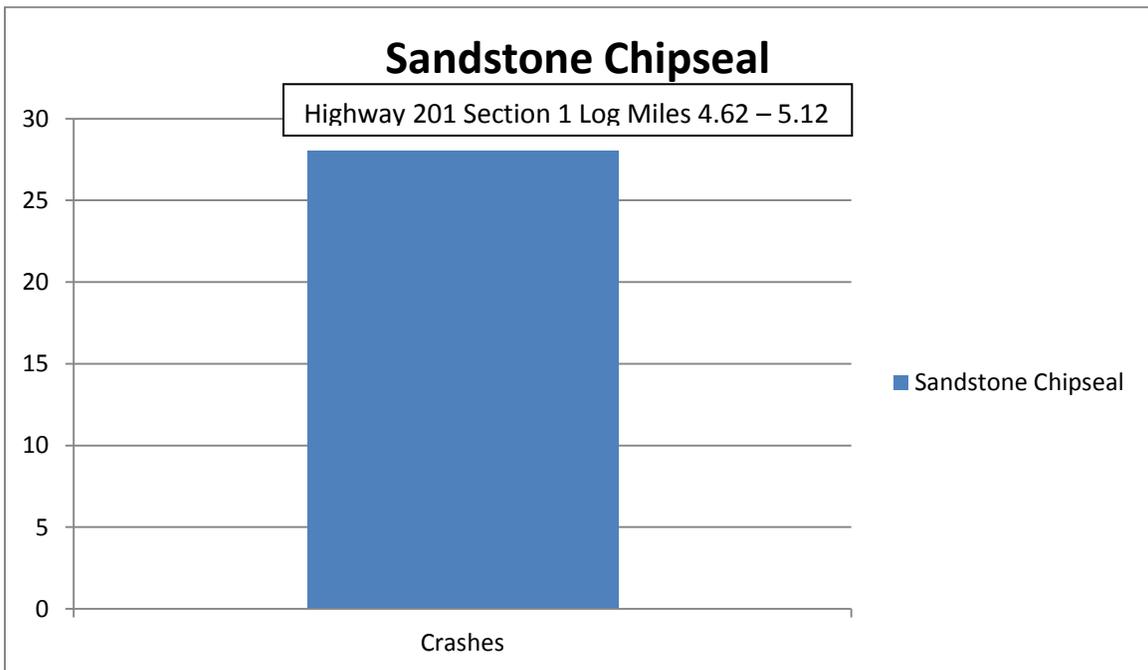
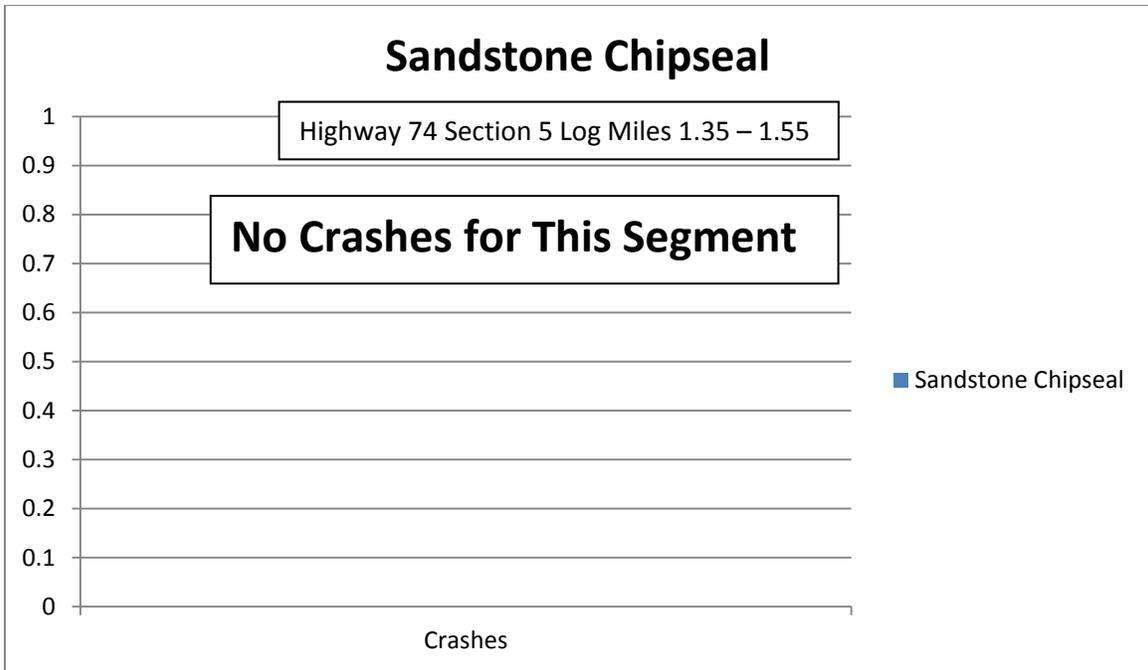
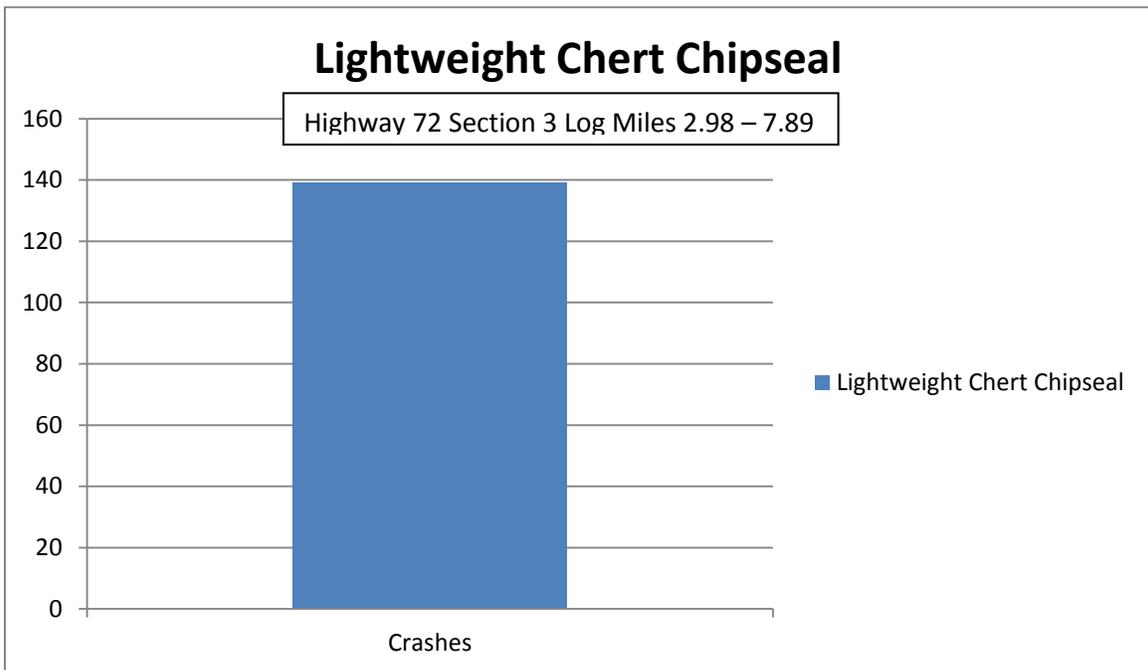
The following charts (Figures 42 – 52) are of crashes that happened on each existing location from 2010 through 2014.

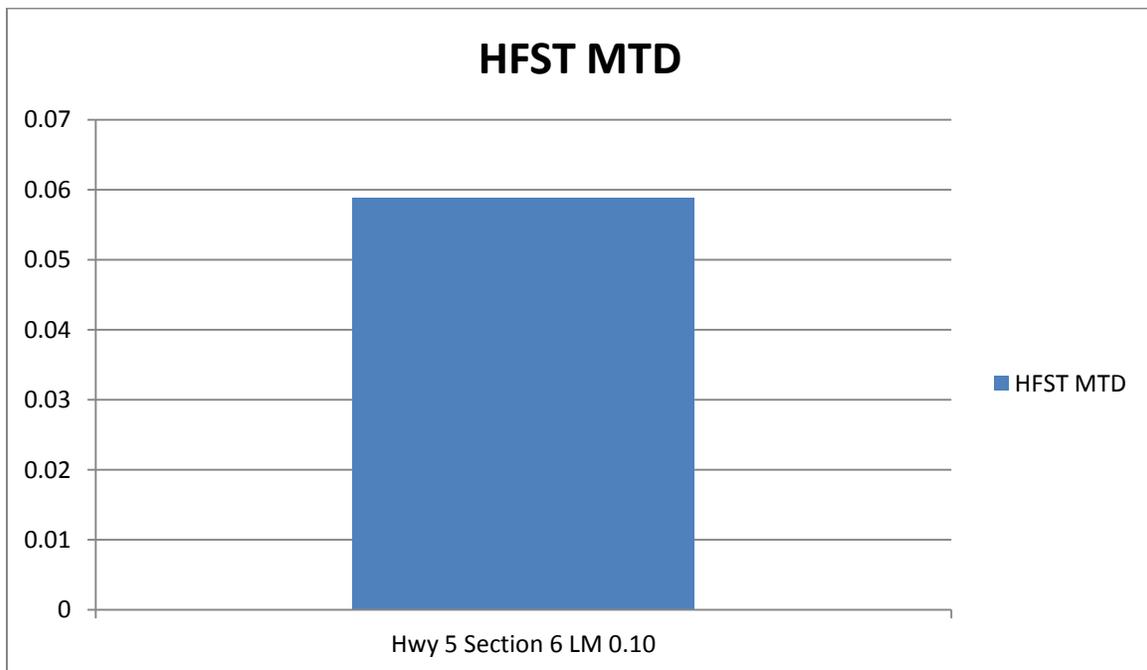
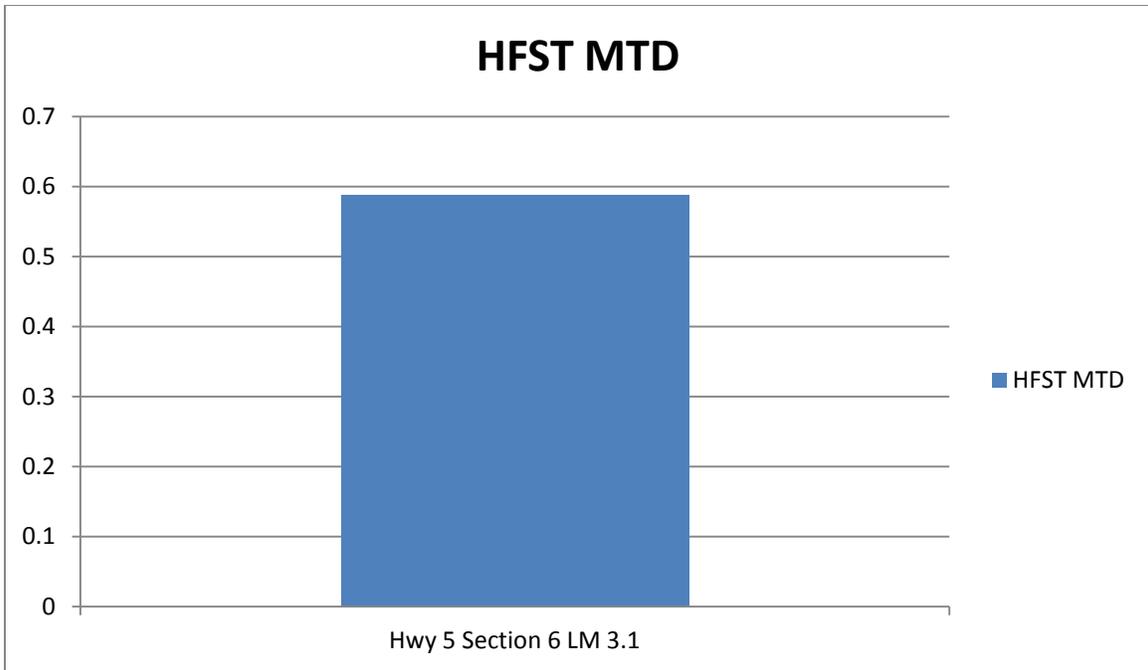
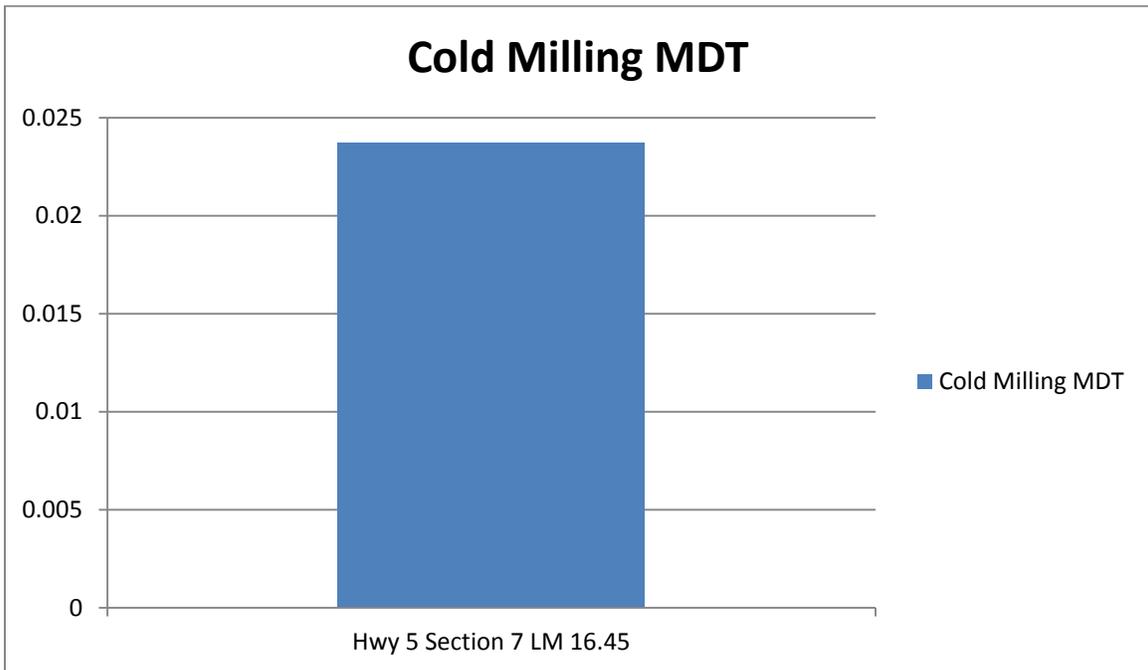
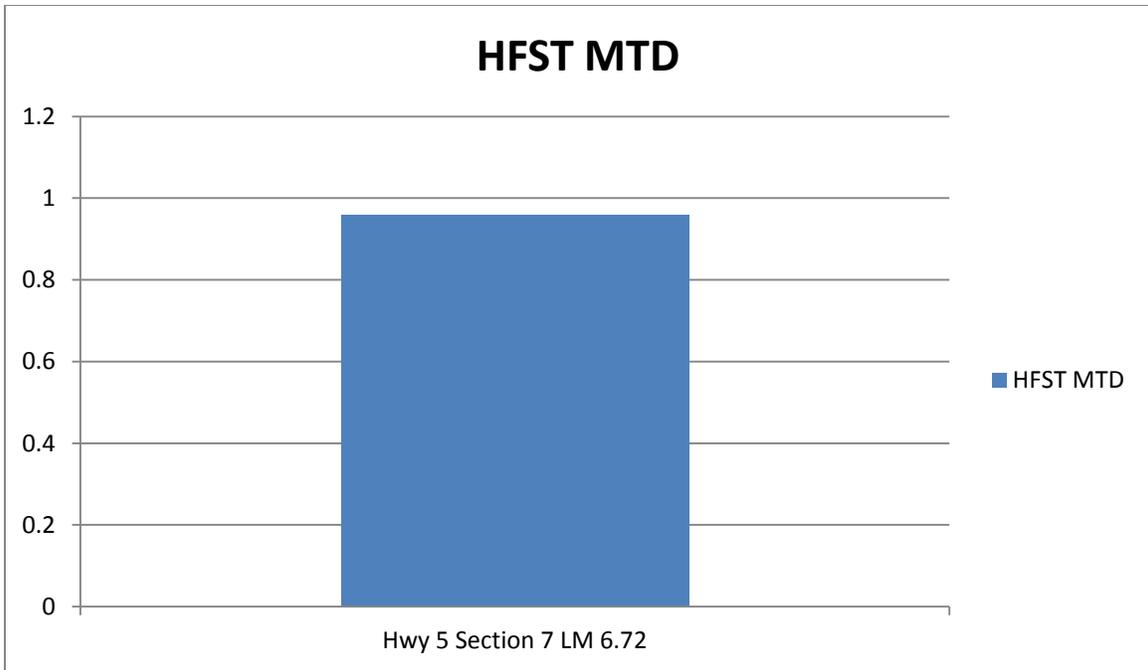
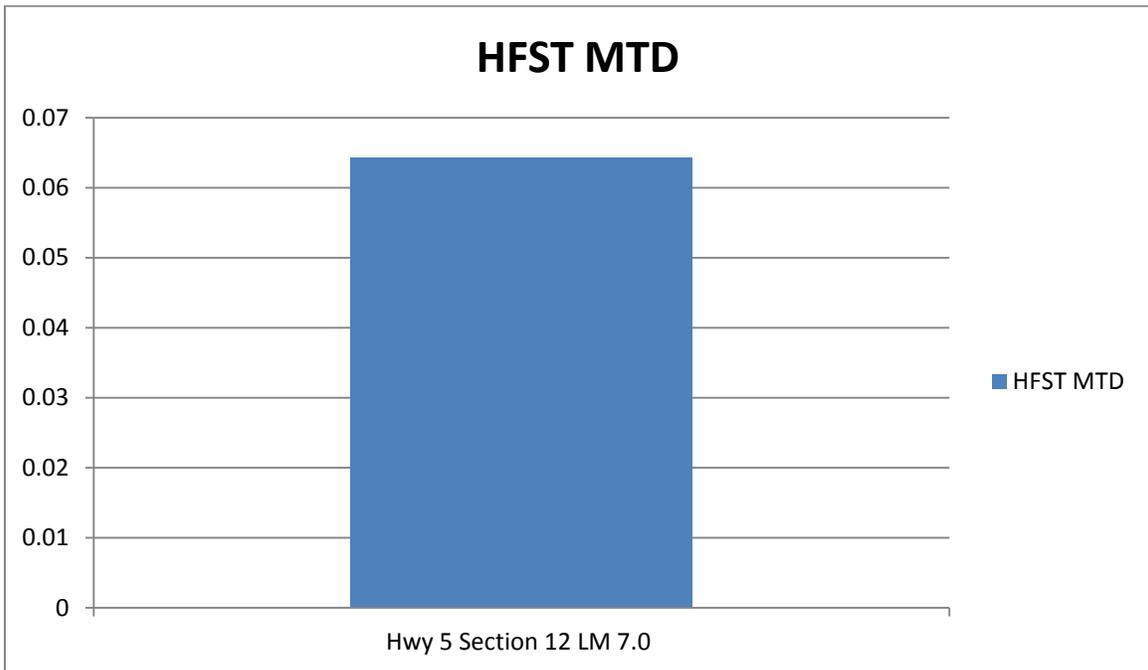
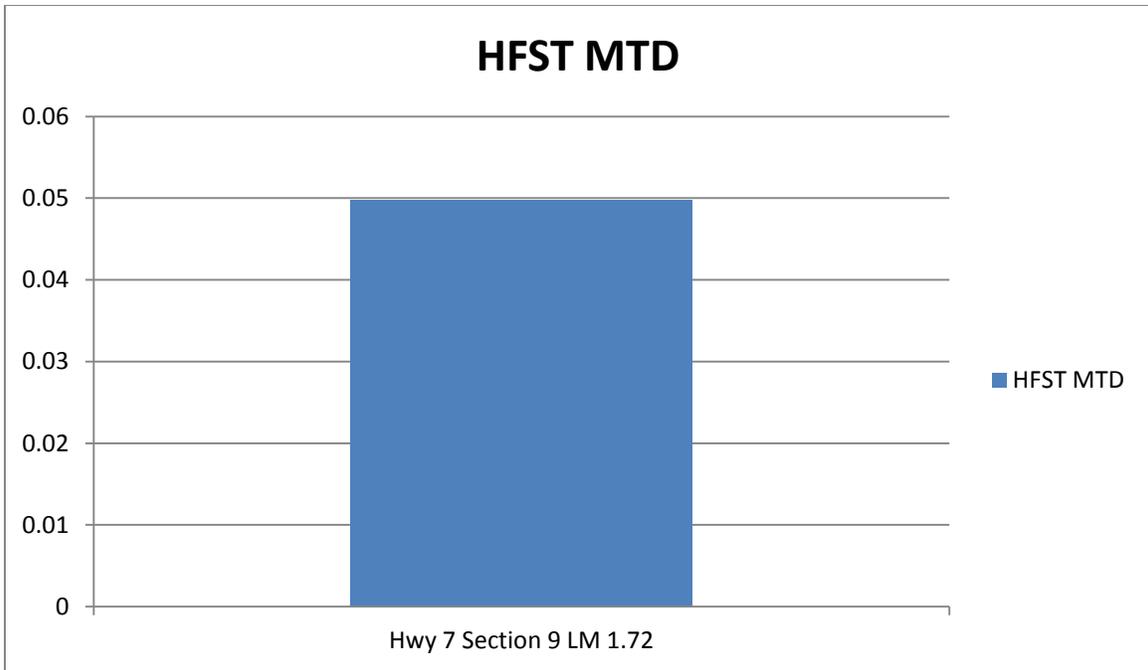
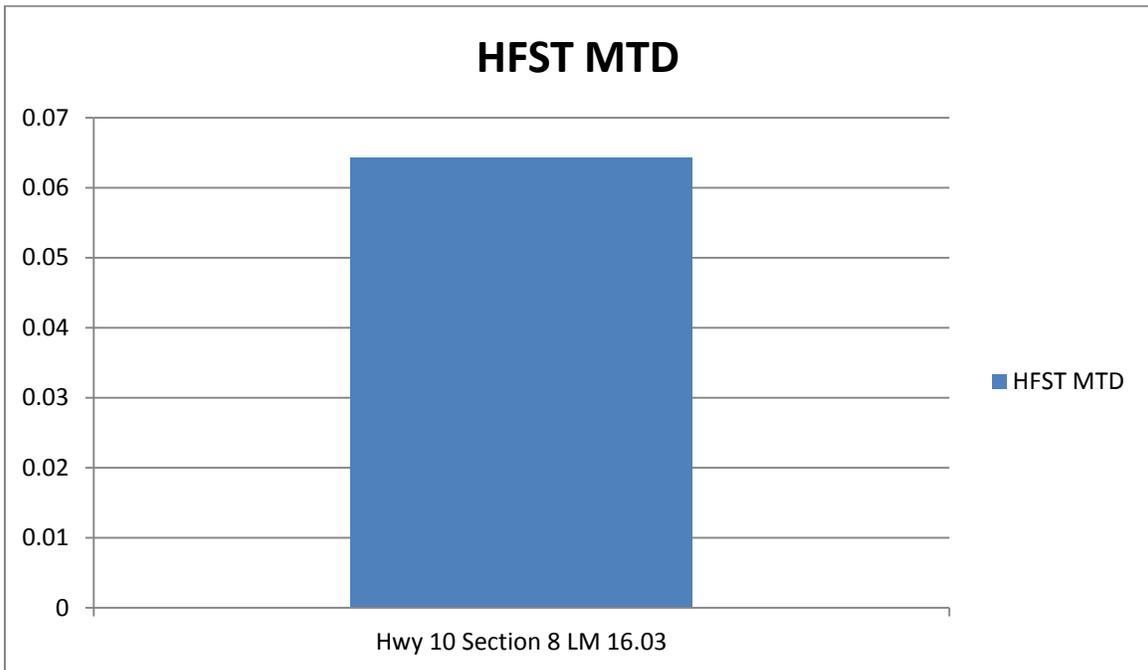
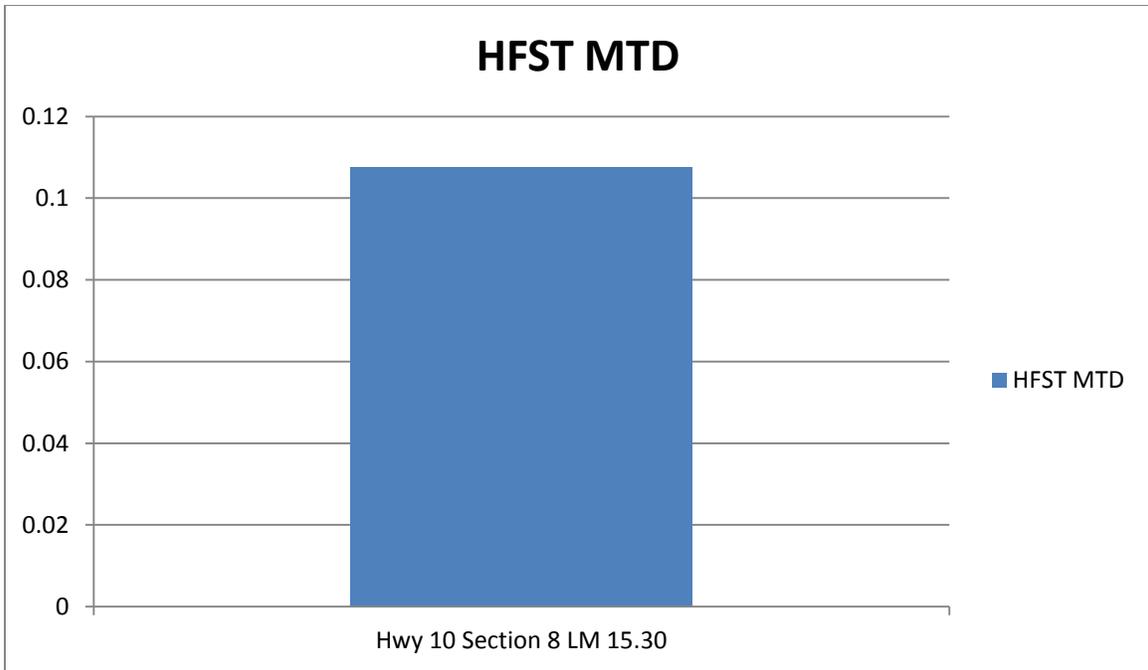
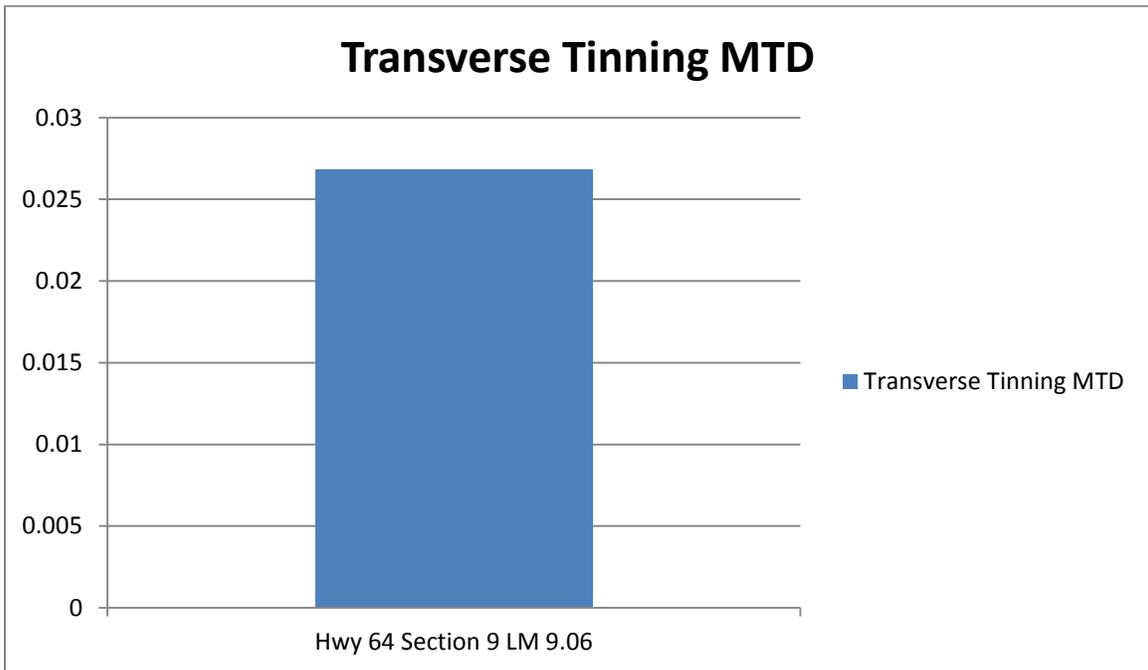
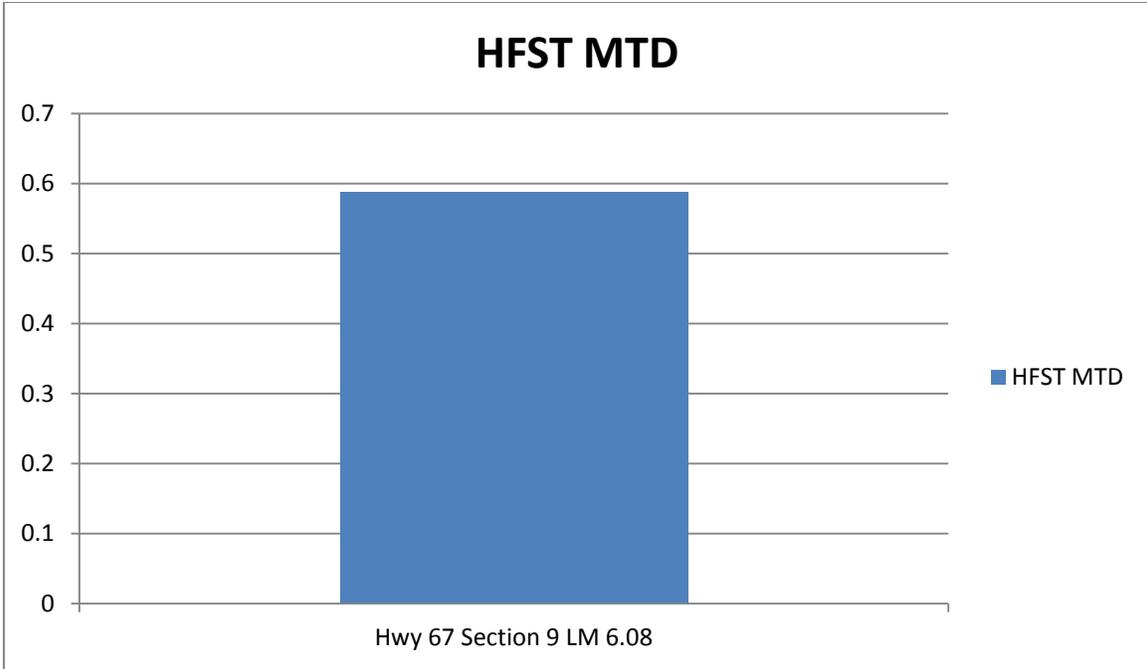
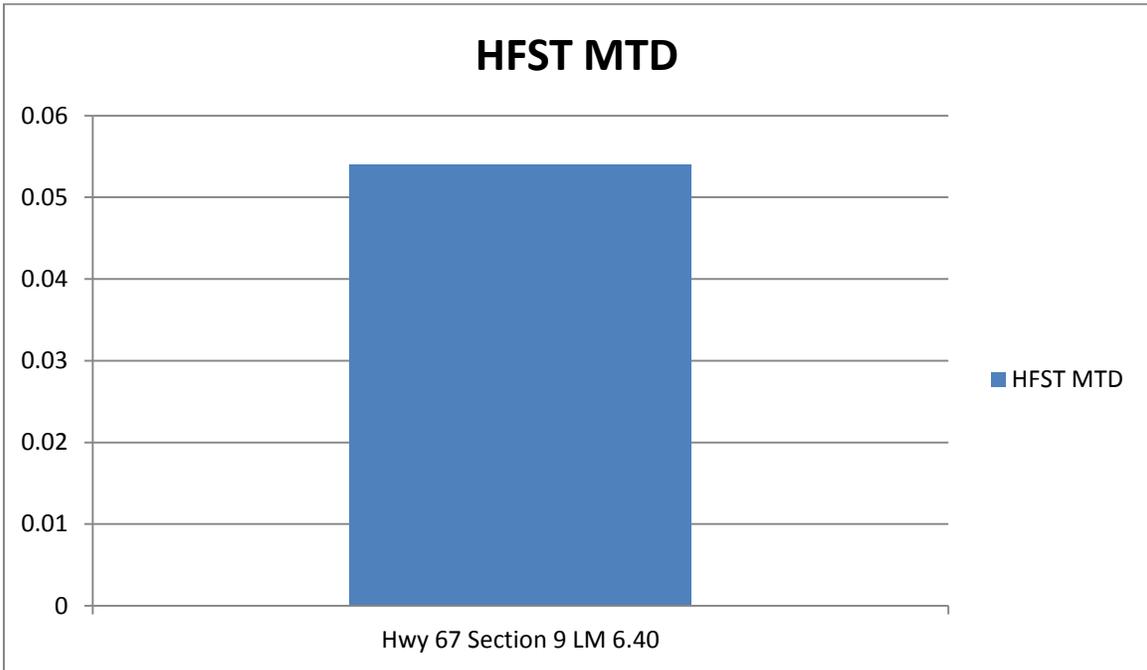
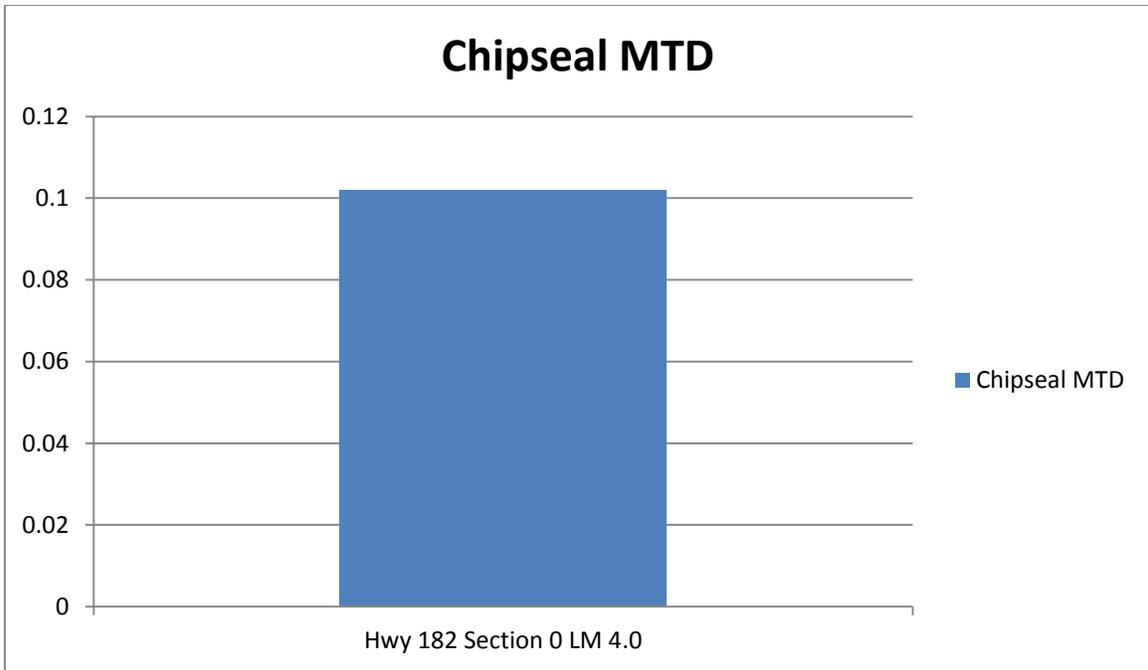
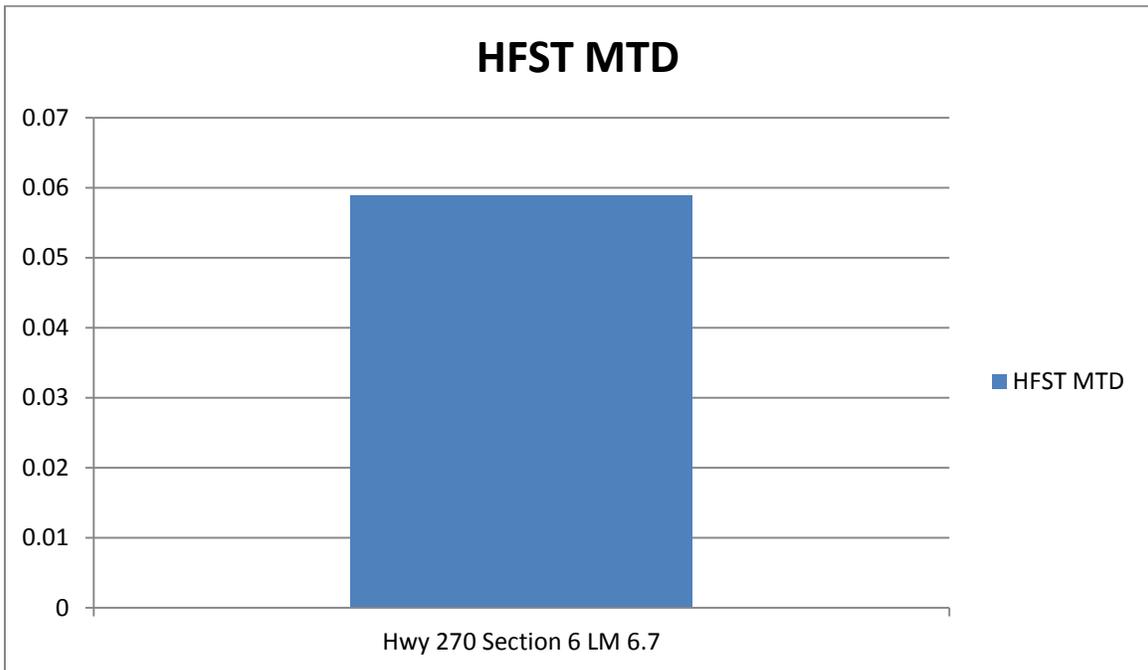
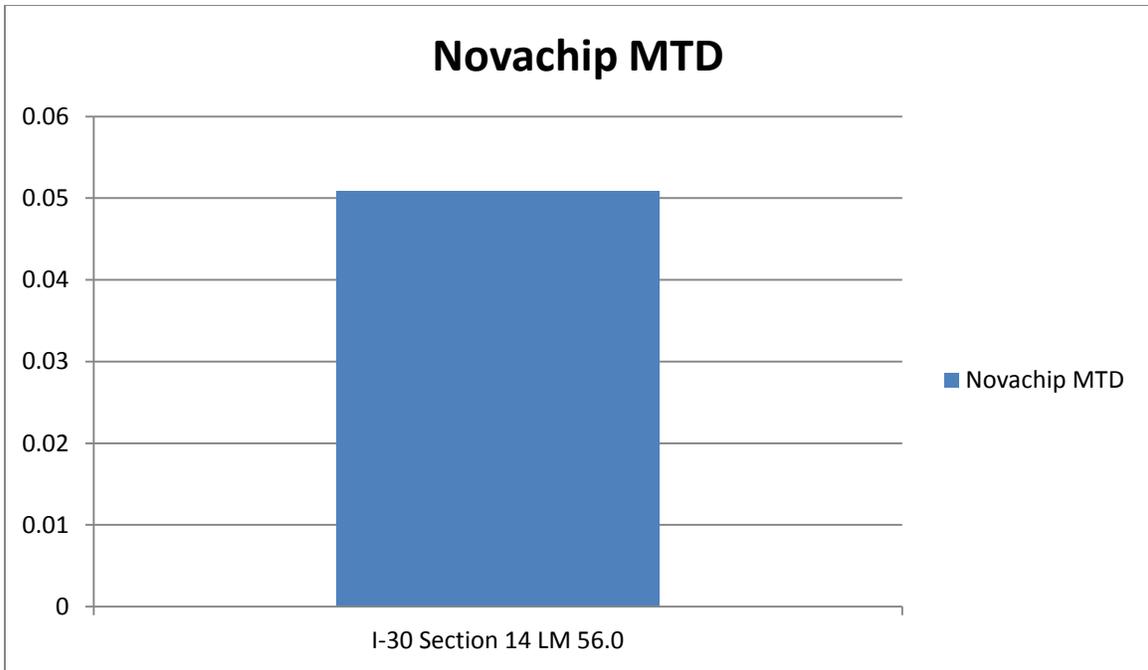
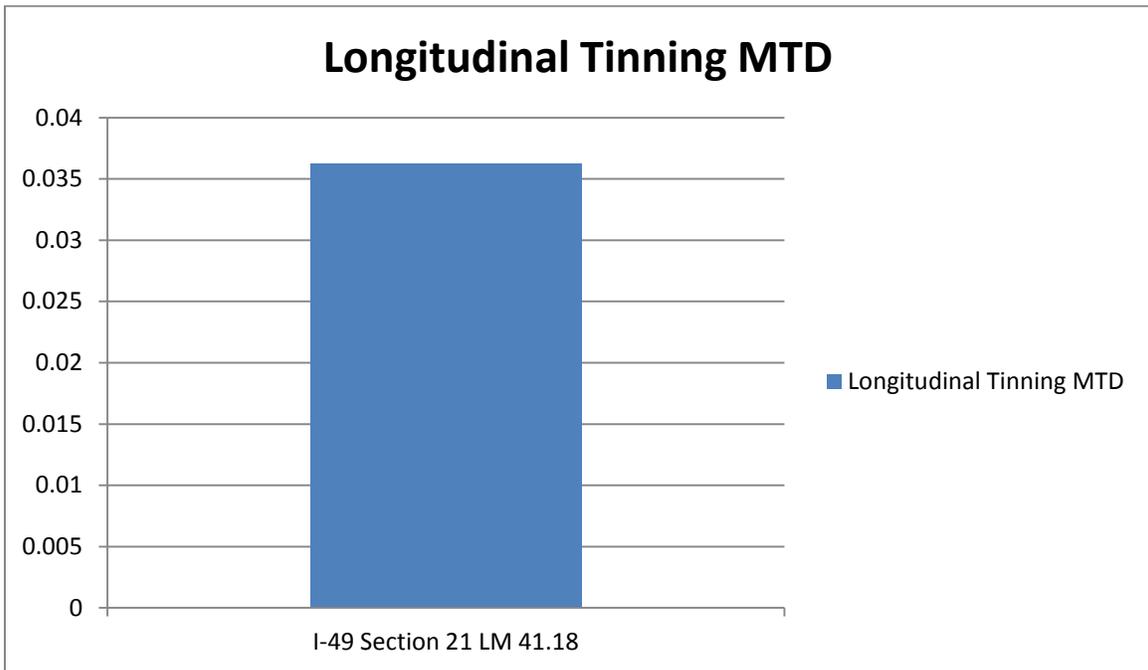
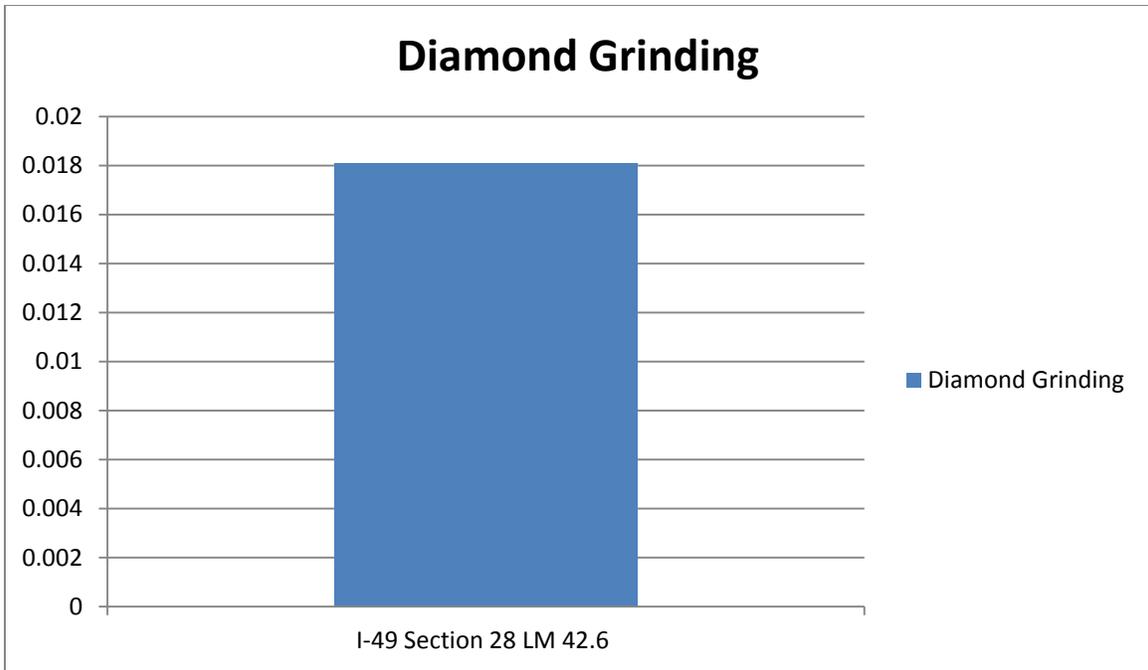
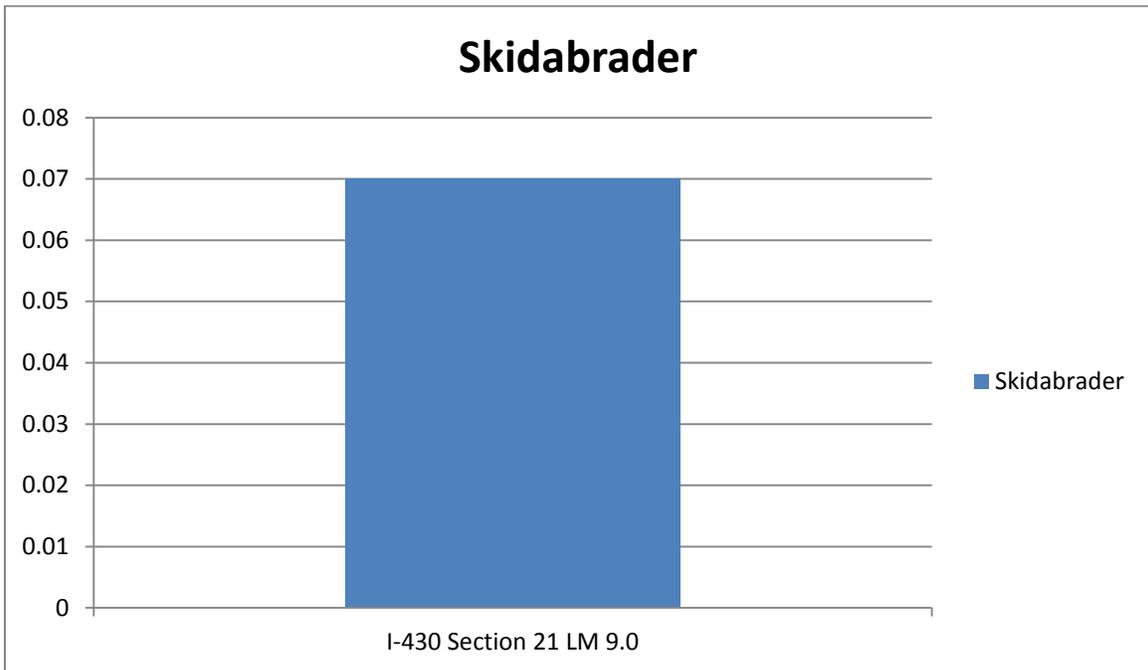
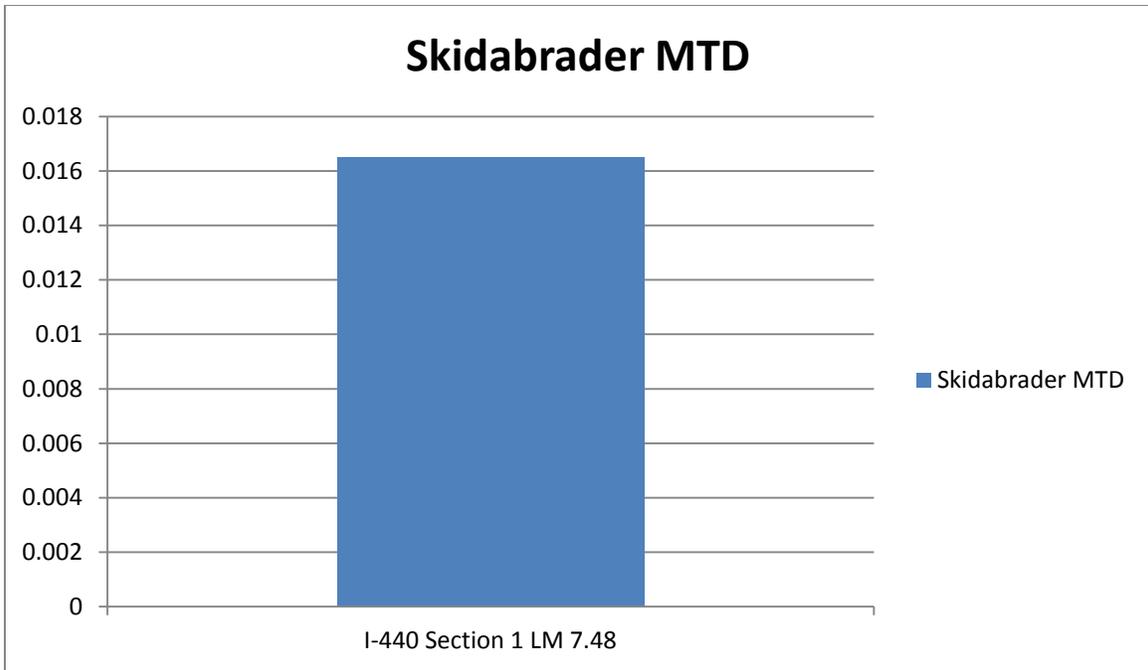
Micro texture is the pavement's texture with a wavelength (distances from bumps to dips) of less than 0.5 mm and the macro texture is the pavement's texture where the wavelength is between 0.5 mm to 50 mm. The sand patch test and the CTM are ways to measure the micro and macro textures. The sand patch test uses a volumetric approach of measuring the pavement micro/macro texture. In the sandpatch test a known amount of material is spread evenly over the pavement surface to form a circle. This fills the surface voids with material. Then, the diameter of the circle is measured on four axes and the value averaged. The Mean Texture Depth (MTD) is then calculated with the known value. The MTD is shown for each location in the following graphs (Figures 53 – 70).

The HFST also had the highest skid numbers and best MTD numbers out of all of the treatments.
