BRIDGE DECK SURFACE DURABILITY SURVEY

Sam I. Thornton and Larry G. Pleimann

1986

7. Author(s) Sam I. Thornton and Larry G. Pleimann		8. Performing Organization Report No.	
9. Performing Organization Name and Address Department of Civil Engineering University of Arkansas Fayetteville, Arkansas 72701		10. Work Unit No. (TRAIS)	11. Contract or Grant No. HRP

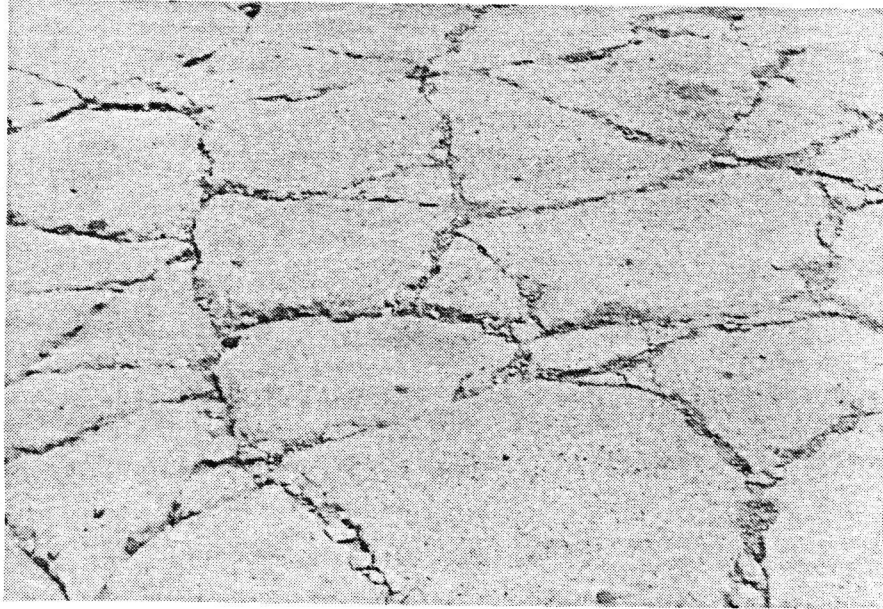
"Cracking (Figure 1.1) is characteristic of concrete because of concrete's low tensile strength and the relatively large volume changes in response to changes in humidity and temperature" (NCHRP Synthesis #57). The effect of cracking upon the durability of a deck depends upon the origin of the crack. Cracks due to shrinkage or settlement of the falsework are usually fine and do not adversely affect the durability of a deck, while map or pattern cracking due to reactive aggregates can result in the complete disintegration of the deck (NCHRP Synthesis #57).

Figure 1.1 Cracking

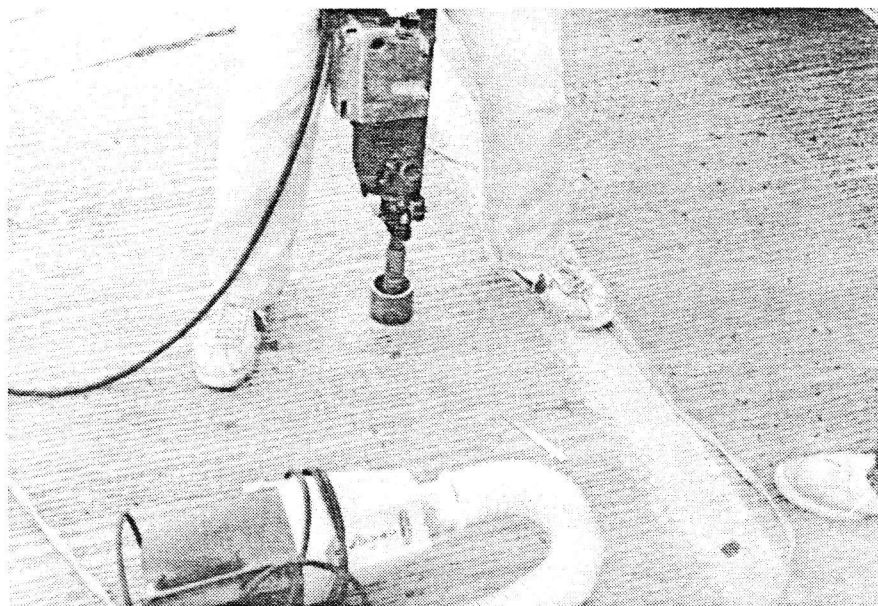
Figure 3.2 Pulverizing Concrete

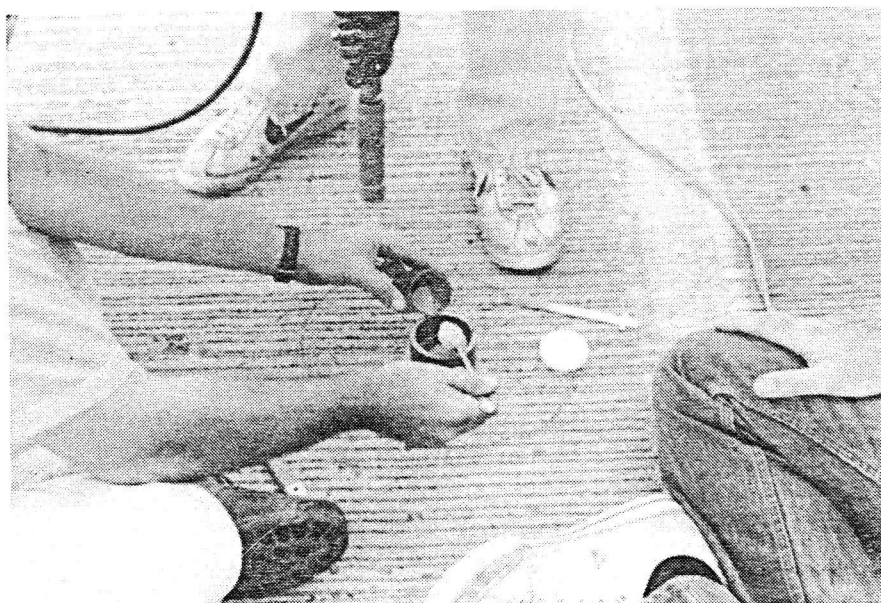
Figure 3.3 Collecting Sample

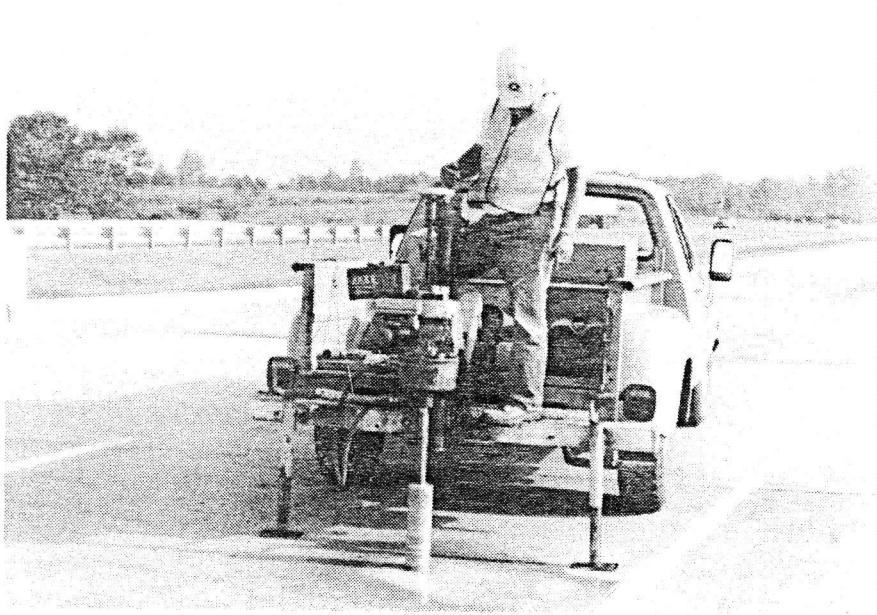
Using a coring truck (Figure 3.4), two core samples were taken from each bridge. The cores are approximately four inches in diameter and six to ten inches in height (Figure 3.5). The cores were usually taken from both ends of the bridge. On long bridges, the samples were taken approximately 100 feet apart. The samples usually came from the inside wheel path. The cores were visually examined in the laboratory for cover, type of surface, consolida-

Figure 3.4 Coring Truck
