TRC9705

Settlement of Bridge End Embankments

Prepared by the
Research Section
of the
Arkansas Highway and Transportation Department

SEPTEMBER 2011

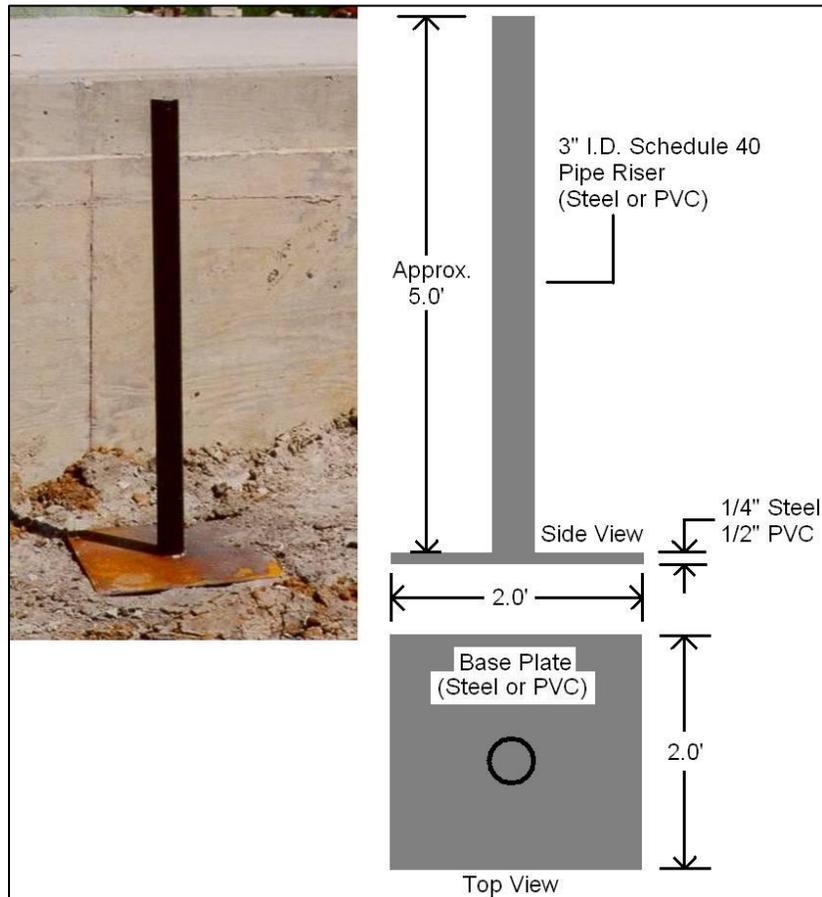
Figure 2. Settlement plate dimensions.

Settlement plates were installed in the abutment excavations for all four bridges included in this project. These excavations were then backfilled with either compacted fill or flowable fill. The settlement plates were either constructed of steel or PVC plastic. The plates and risers were constructed out of steel at the DeRoche Bayou Bridge and the Raymar Road Bridge. For these two bridges the base measured 2.0'x2.0'x0.25" and the riser was a Schedule 40 5.0'x3" I.D. pipe. The plates and risers for the Chicot Road Bridge and the Crow Creek Bridge were constructed out of PVC. For these, the base measured 2.0'x2.0'x0.5" and the riser was a Schedule 40 5.0'x3" I.D. pipe. The dimensions for the settlement plates and risers can be seen in Figure 2 along with a photograph of a steel settlement plate setup. Once the fill was completed, either flowable or compacted earth, the risers were cut off near the fill surface.

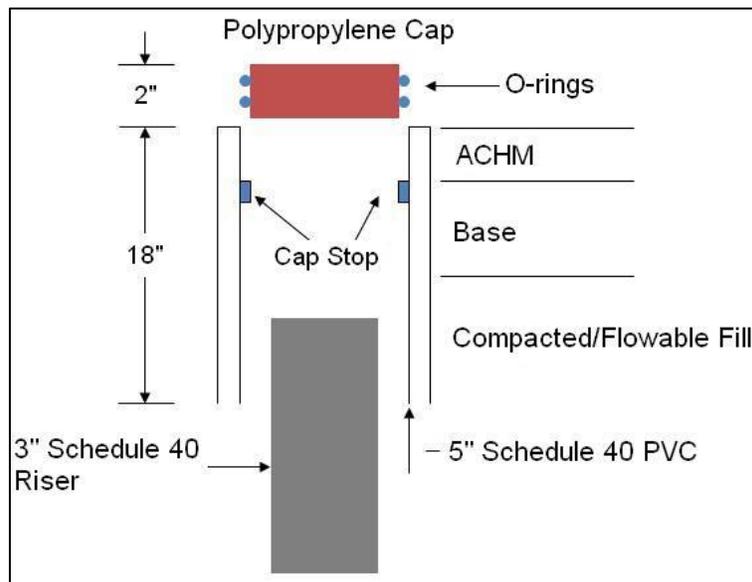
Figure 3. Access tube components.

Once the final road surface was in place, AHTD personnel went back and installed access tubes by coring through the pavement. The access tubes consisted of 18" long piece of 5" diameter Schedule 40 PVC pipe. Around the insides of the tubes, stops were placed in order to keep the cap from being pushed further down into the tube by traffic or other loads. The caps were made by Research personnel and consist of a polypropylene body with two O-ring seals. Long pieces of polypropylene were milled down to the inner diameter of the 5" PVC pipes and then cut into 2" thick segments. Two grooves were then milled into the body of the cap for the O-rings. Finally, a threaded cap was installed into the caps to be used for extracting the caps from the access tubes. A diagram of the access tube can be seen in Figure 3 and an uninstalled cap can be seen in Figure 4.

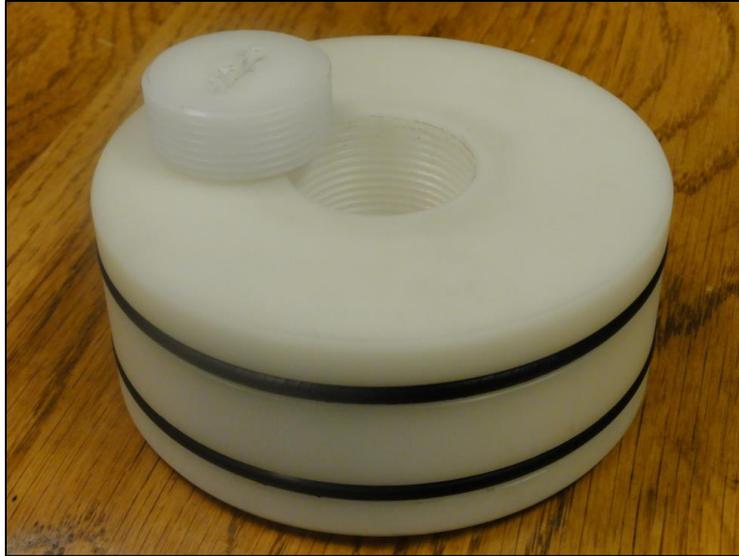
Figure 4. Access tube cap.

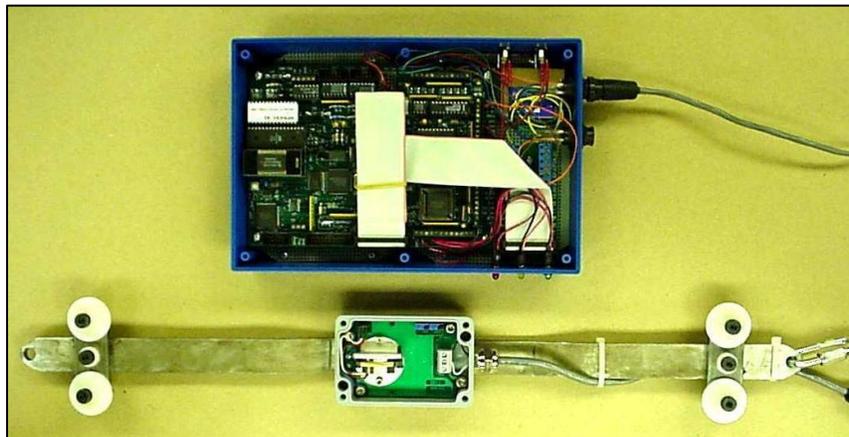
Figure 5. Horizontal inclinometer setup, data logger (upper) and inclinometer sensor (lower).

Along with the settlement plates, horizontal inclinometers were installed in the abutment excavations on the Chicot Road Bridge and the Crow Creek Bridge. An inclinometer and data acquisition system was built in-house for this project and can be seen in Figure 5. The inclinometers were used in these two bridges for several reasons. The inclinometer setup allowed for data acquisition by one person and did not require traffic control for taking settlement measurements. These were also non-destructive to the pavement surface.

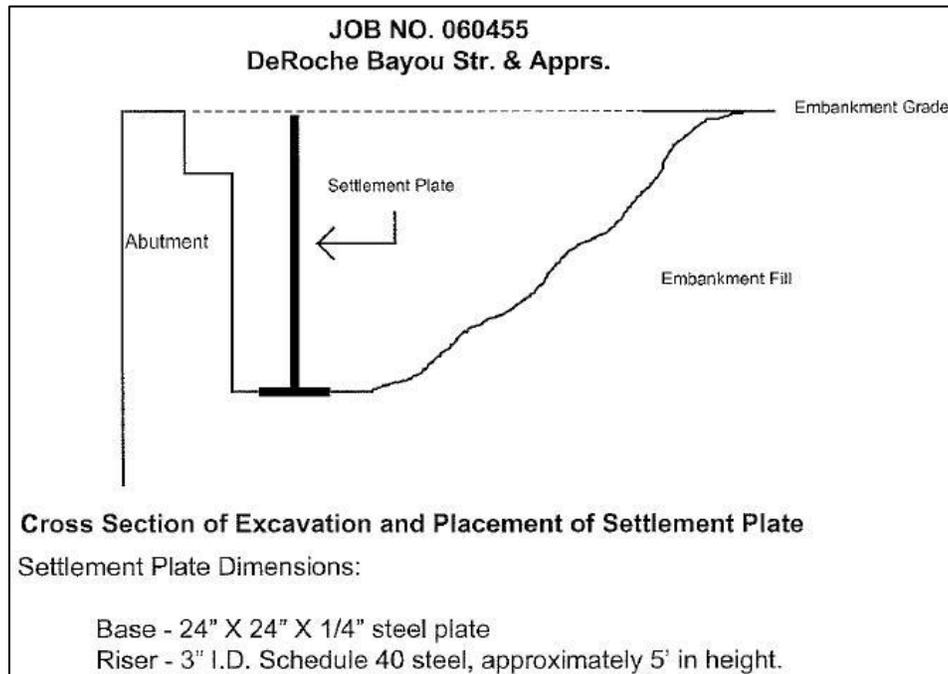
Figure 6. DeRoche Bayou general settlement plate locations.

The DeRoche Bayou Bridge was constructed during May-June 1999 as part of Job 060455. The bridge runs in an east-west direction. The east embankment was the control embankment and was constructed with the standard compacted fill. The west embankment was the test embankment and was constructed using flowable fill. The settlement plate general locations can be seen in Figure 6.

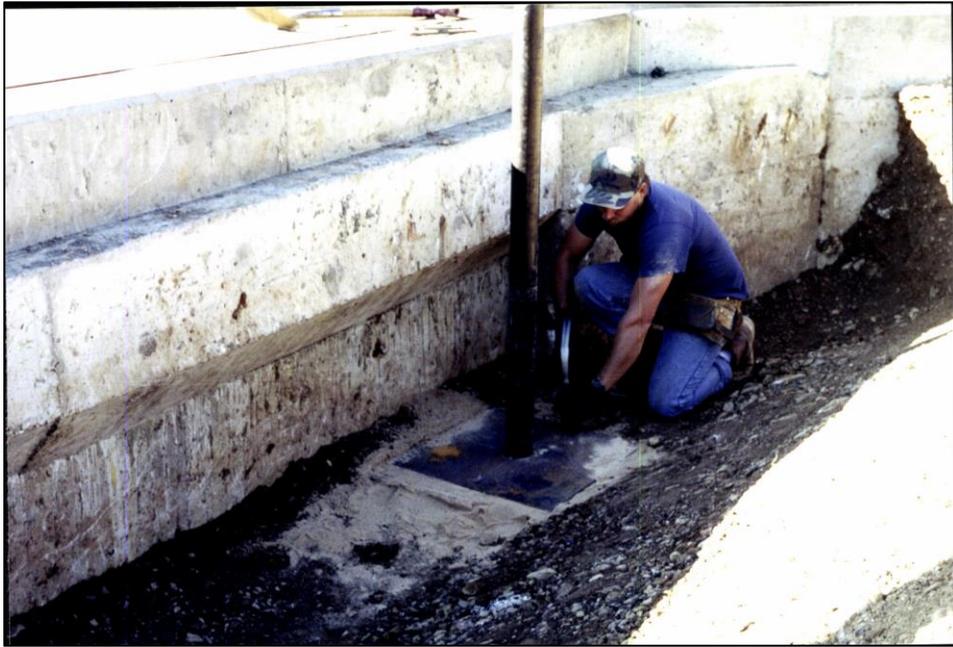
Figure 7. The settlement plates were bedded on sand and staked with rebar.

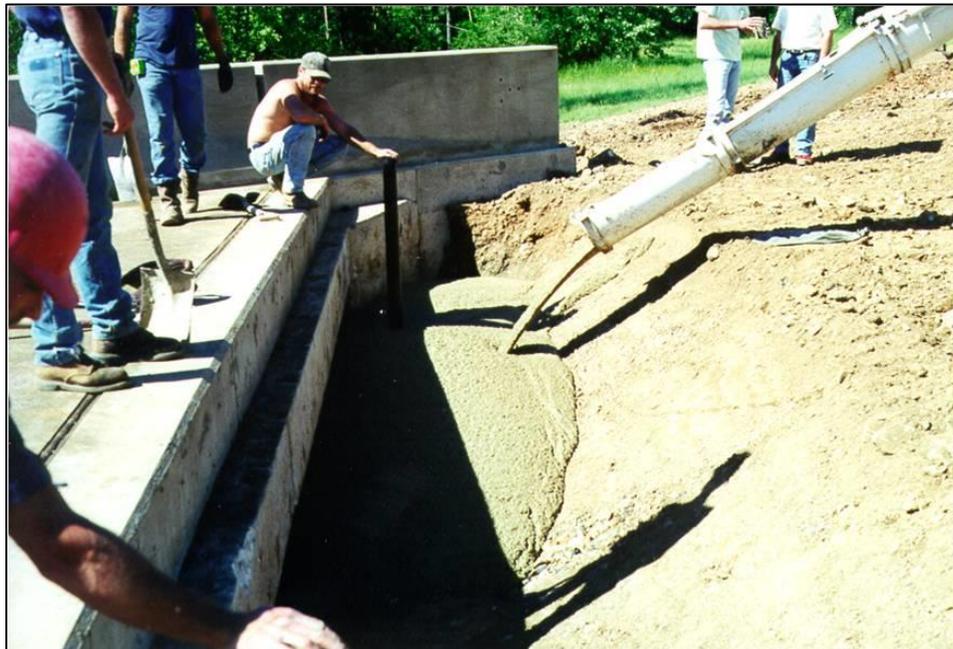
Figure 8. Flowable fill filling the embankment trench at the west embankment of the DeRoche Bayou Bridge.

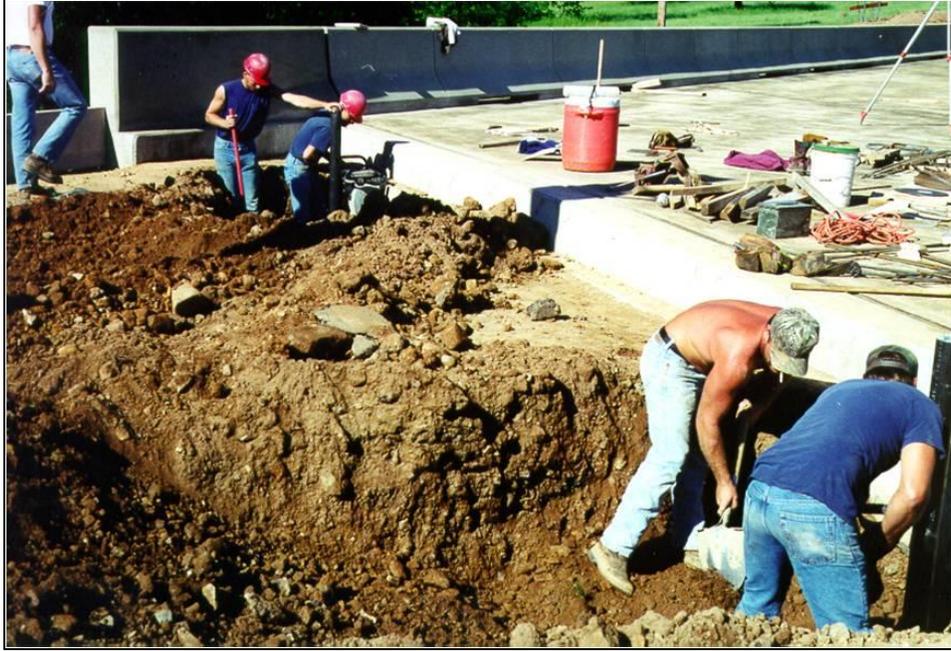
Figure 9. Compacted fill at east embankment of the DeRoche Bayou Bridge.

earth fill was dug out to install the settlement plates then re-compacted after the settlement plates and risers were in place, as shown in Figure 9.

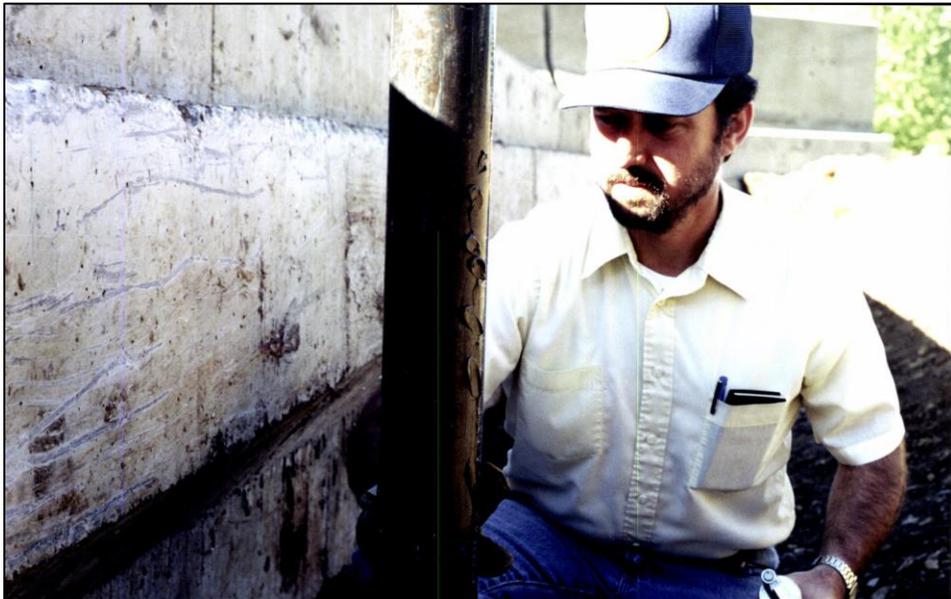
Figure 10. The grease used to keep the steel risers from sticking to the surrounding medium can be seen.

To keep the concrete and compacted earth from sticking to the steel and allowing a smooth rise and/or fall with settlement, the risers were well-greased before the compacted fill was placed and before the flowable fill was poured. The copious amounts of grease can be seen in Figure 10.

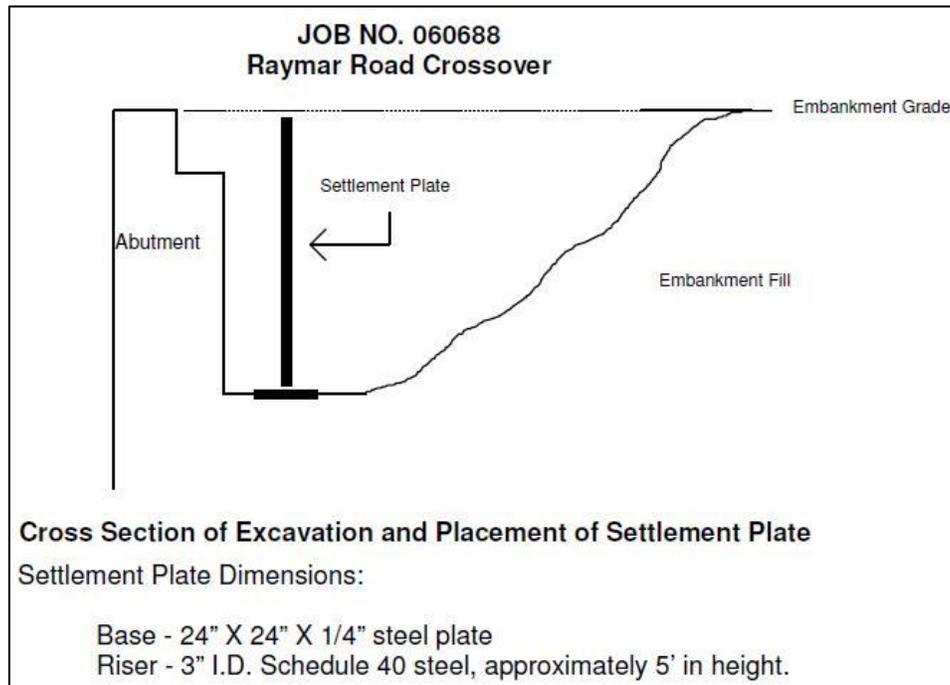
Figure 11. Raymar Road general settlement plate locations.

The Raymar Road Bridge over Interstate 30 was constructed in April-May 1999 as part of Job 060688. The bridge runs in a north-south direction. The south embankment was the control embankment and was constructed with the standard compacted fill. The north embankment was the test embankment and was constructed using flowable fill. The general locations for the settlement plates can be seen in Figure 11.

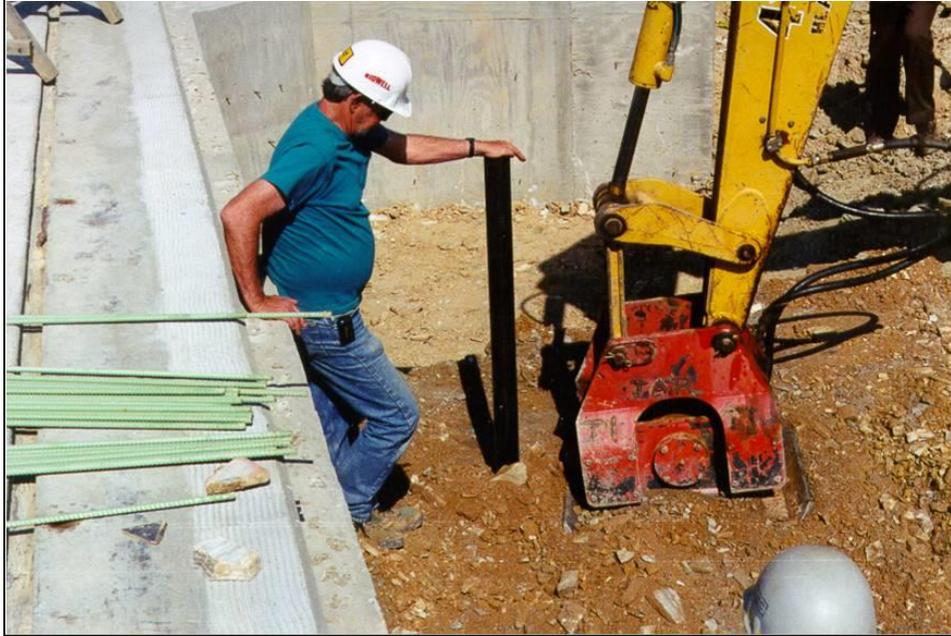
Figure 12. Compacting the earth around a steel riser at Raymar Road.

As with the DeRoche Bayou Bridge, the exact locations of the settlement plate risers were recorded so that they could be located after the road surface was placed. This bridge was chosen to be the medium embankment height bridge for the study, with an embankment height of approximately 22-foot. The compacted earth embankment was constructed first following the same method used in the DeRoche Bayou Bridge. Equipment can be seen compacting the earth around the settlement plate and riser in Figure 12.

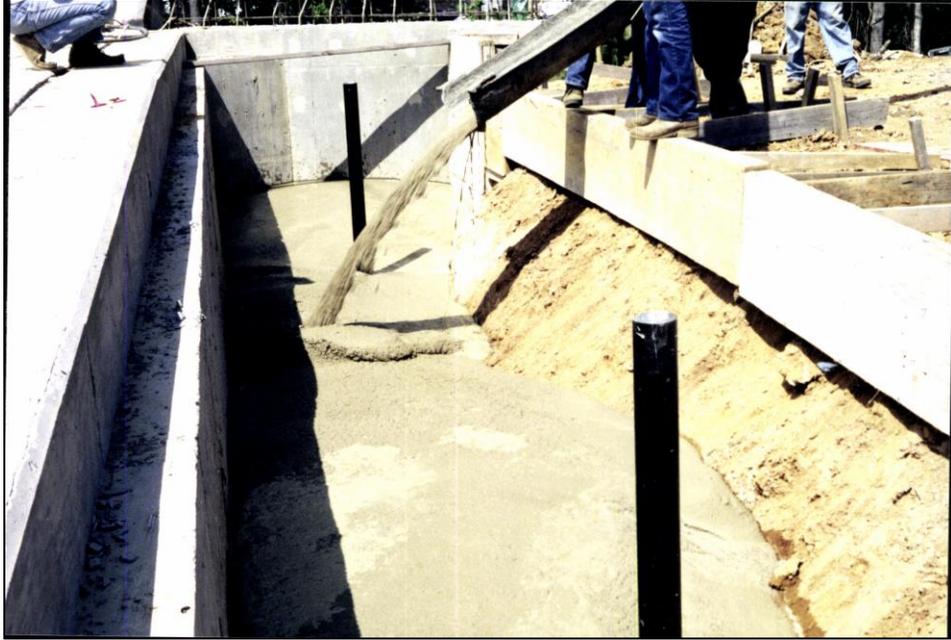
Figure 13. Flowable fill being added to the north embankment of the Raymar Road Bridge.

Unlike the DeRoche Bayou site, the flowable fill on the north embankment of this bridge required forms. The trench on this embankment for the flowable fill appeared to be 6-foot deep by approximately 3-foot wide running the width of the bridge. The in-place forms and the placement of the settlement plate risers can be seen in Figure 13, also showing the flowable fill being added. This bridge end required approximately 45 cubic yards of flowable fill concrete. Figure 14 shows the flowable fill concrete after it had started to cure. The risers at this bridge location were greased as well.

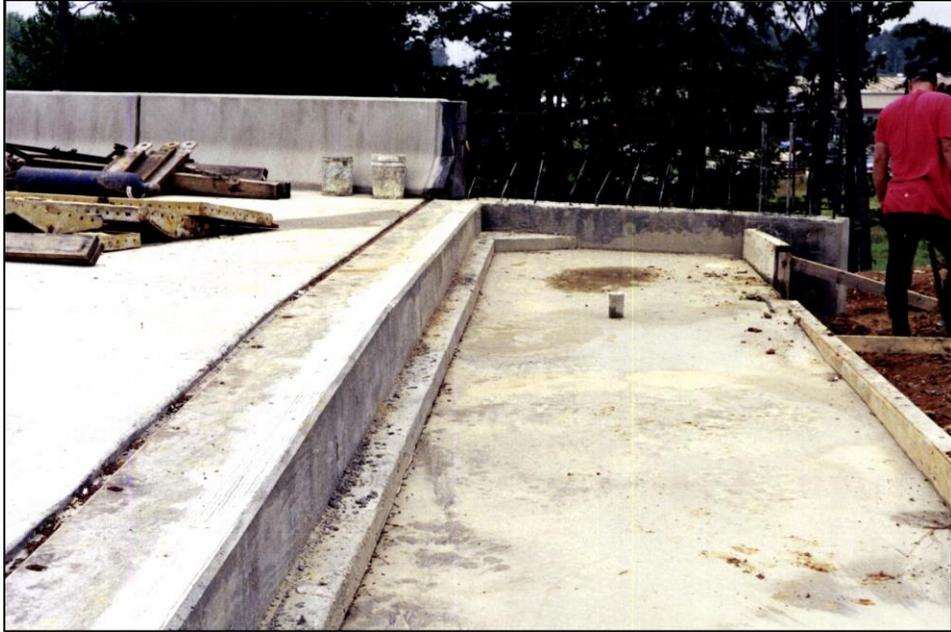
Figure 14. The flowable fill after it had started to cure.

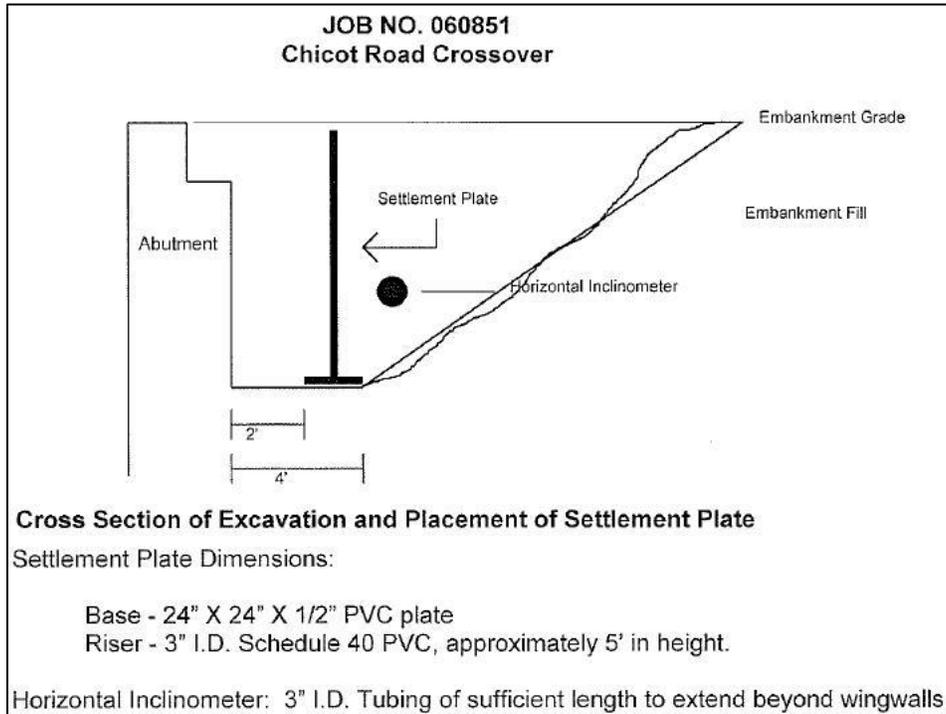
Figure 15. Chicot Road general settlement plates and horizontal inclinometer locations.

The Chicot Road Bridge over Interstate 30 was constructed in 1999 as part of Job 060851. The bridge runs in a north-south direction. The south embankment was the control embankment and was constructed with the standard compacted fill. The north embankment was the test embankment and was constructed using flowable fill. The settlement plate and horizontal inclinometer general locations can be seen in Figure 15.

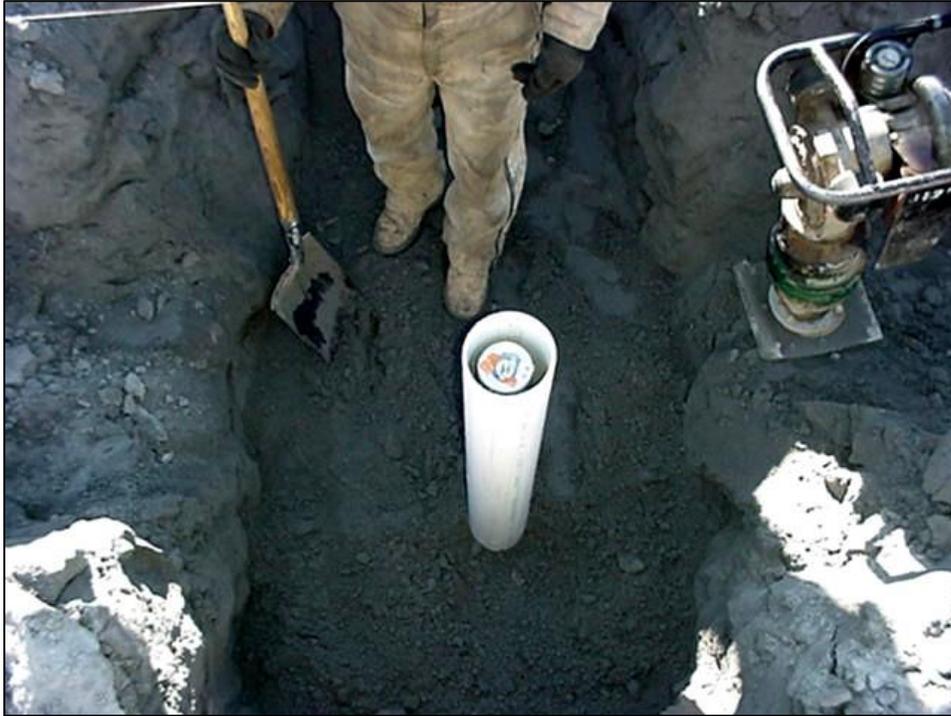
Figure 16. PVC riser in the compacted fill embankment at Chicot Road.

around the riser and capped. The theory behind this was that even if the compacted earth attached itself to the outer PVC pipe, the inner pipe (riser) could still move freely with the settlement of the abutment. A photo of a PVC riser in the compacted embankment can be seen in Figure 16.

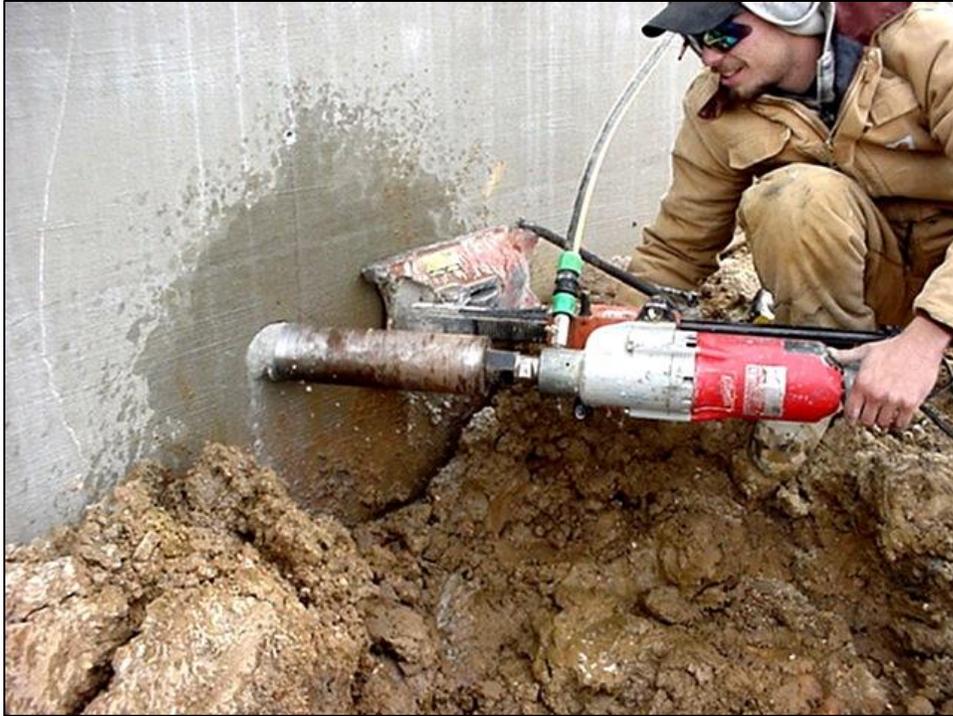
Figure 17. Drilling through a wingwall for horizontal inclinometer installation.

For the installation of the horizontal inclinometers on each end of the bridge, holes had to be drilled through the wingwalls in order to have an exit point for the inclinometer tube. A worker can be seen drilling a hole in one of the wingwalls in Figure 17 and the finished tube can be seen extending through the wall in Figure 18. Figure 19 shows the final placement of the horizontal inclinometer tube and the settlement plates on the compacted fill end.

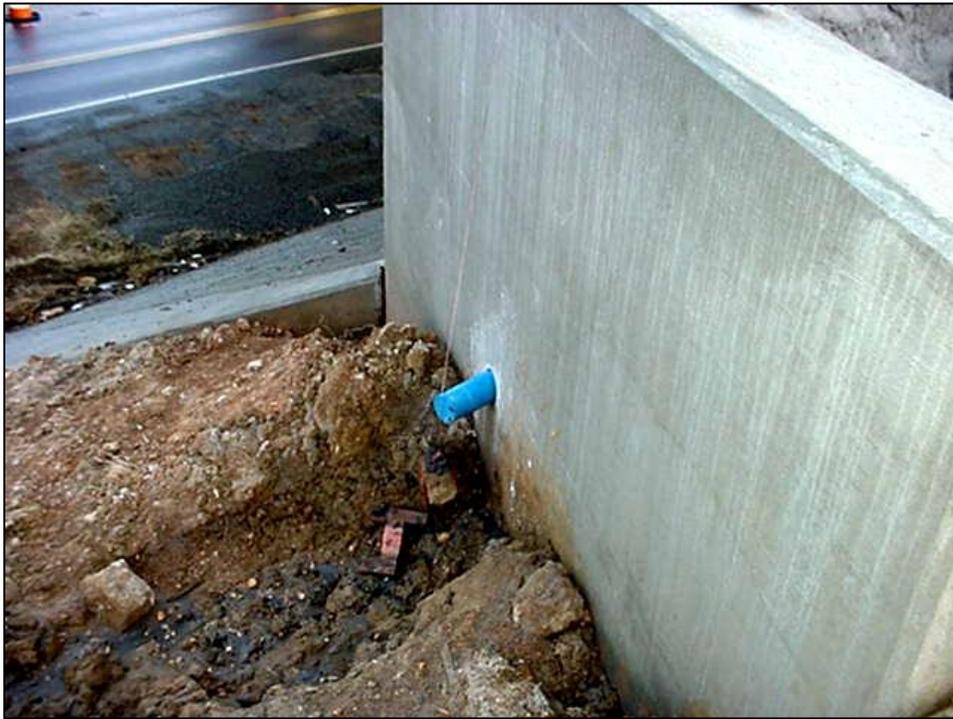
Figure 18. Horizontal inclinometer tube protruding from a wingwall.

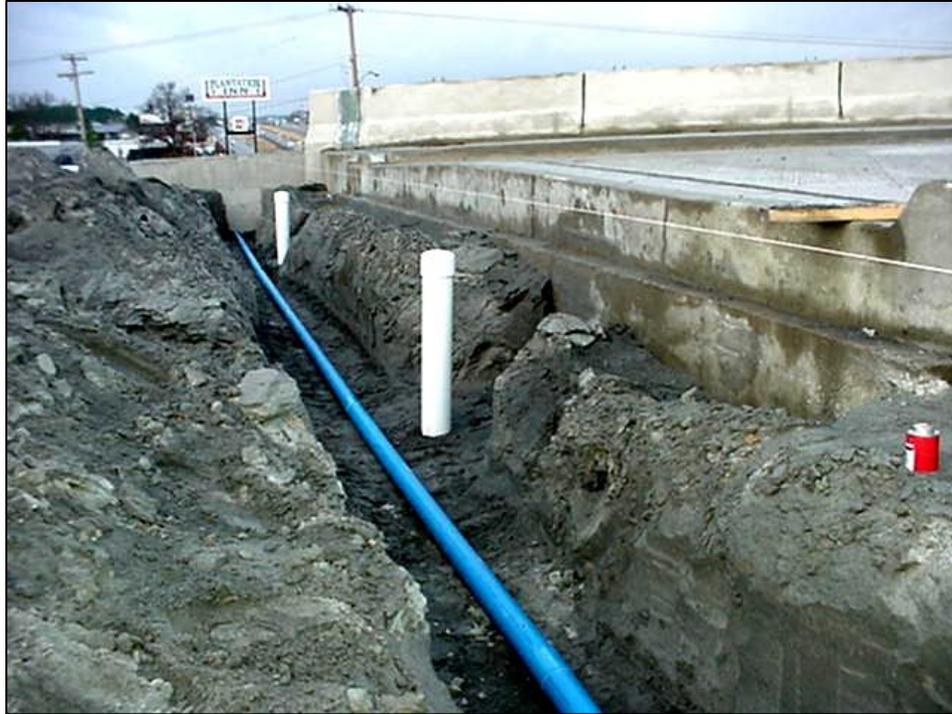
Figure 19. Installation locations at the south end of the Chicot Road Bridge.

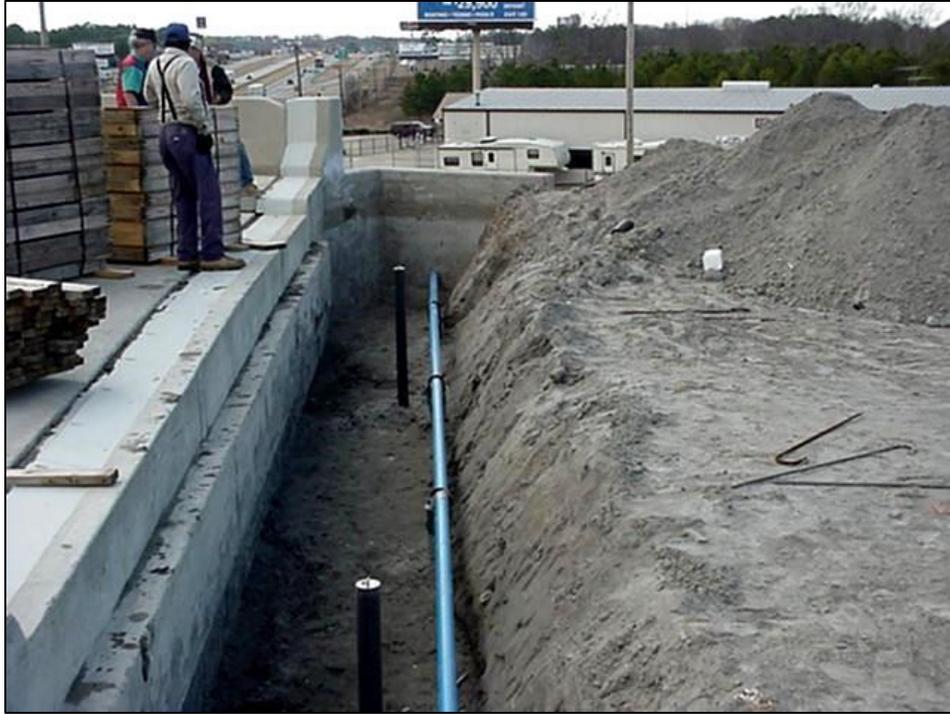
Figure 20. Installation locations at the north end of the Chicot Road Bridge.

The trench at the flowable fill end of this bridge was approximately 4-foot deep by approximately 3-foot wide running with full width of the bridge. A photo showing the installation locations for the horizontal inclinometer tube and the settlement plates with risers can be seen in Figure 20. The risers on the flowable fill embankment were greased like those in the previous bridges. The trench at the north embankment of this bridge required approximately 40 cubic yards of flowable fill concrete.

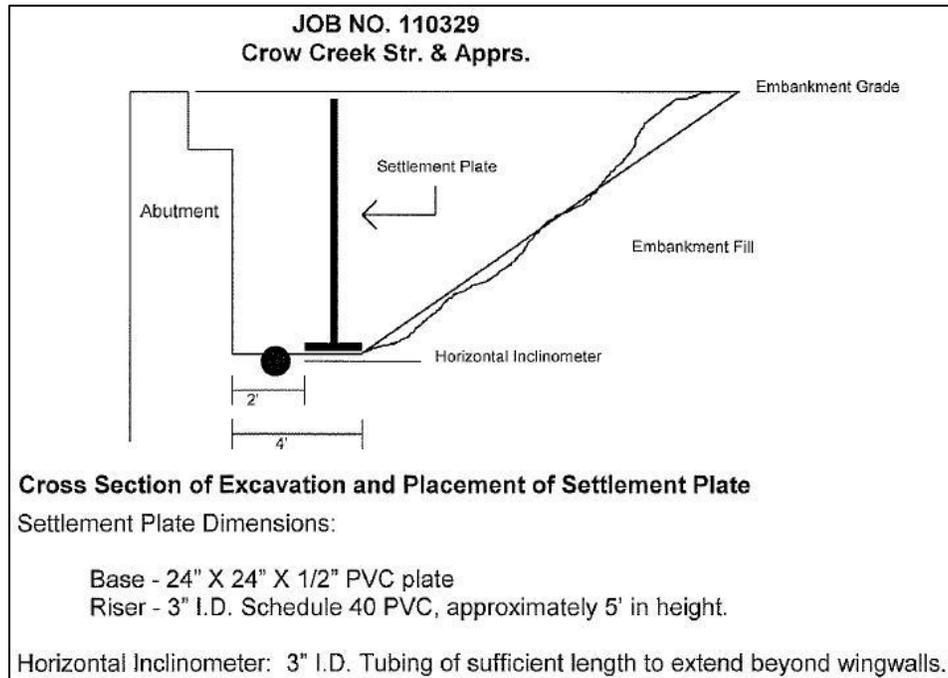
Figure 21. Crow Creek general settlement plates and horizontal inclinometer locations.

The Crow Creek Bridge was constructed in early 2000 as part of Job 110329. The bridge runs in a northeast-southwest direction. The southern embankment was the control embankment and was thus constructed with standard compacted fill. The northern embankment was the test embankment and was constructed using flowable fill concrete. These general placement locations for the settlement plates and horizontal inclinometers can be seen in Figure 21.

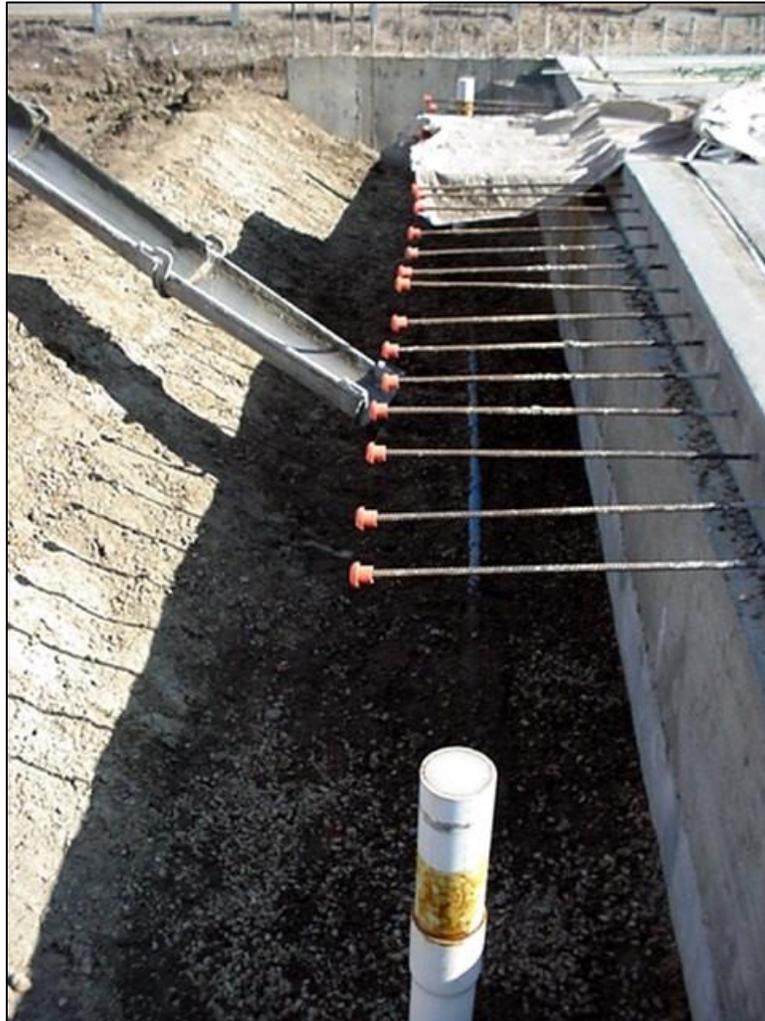
Figure 22. Final placement of the horizontal inclinometer tube and settlement plates at the southern embankment of the Crow Creek Bridge.

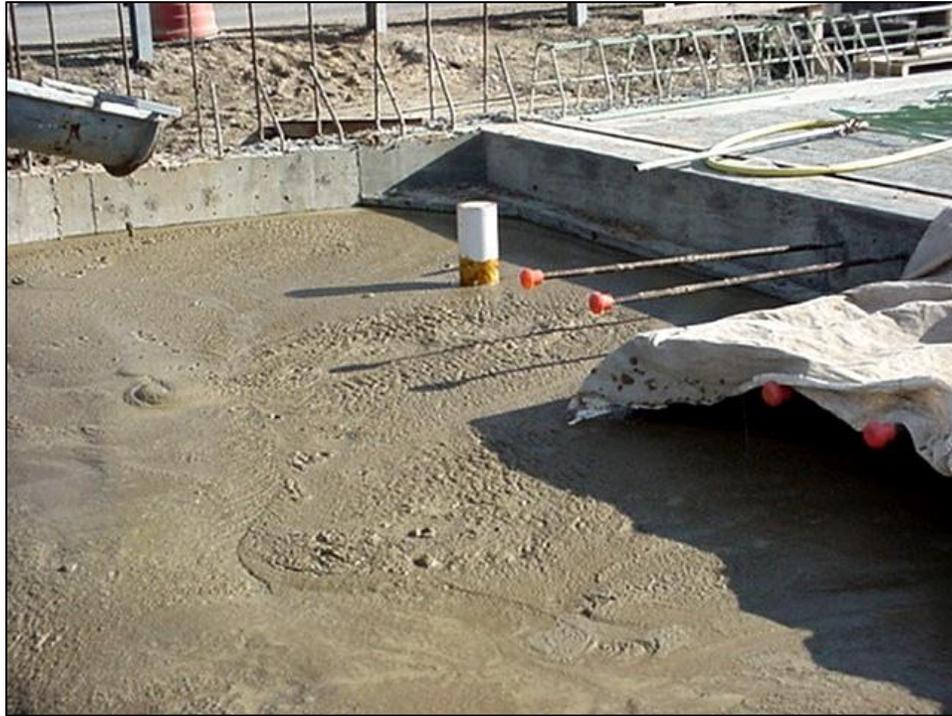
Figure 23. Flowable fill poured at the southern embankment of the Crow Creek Bridge.

Because of these approach slabs, the method of placing the risers had to be altered. As Research personnel would not be allowed to drill through the concrete slabs as they had the asphalt pavements on the other bridges, the access tubes and caps had to be cast into the concrete with the rest of the setup. Figure 23 shows the access tube and riser sleeve setup after the flowable fill was initially poured.

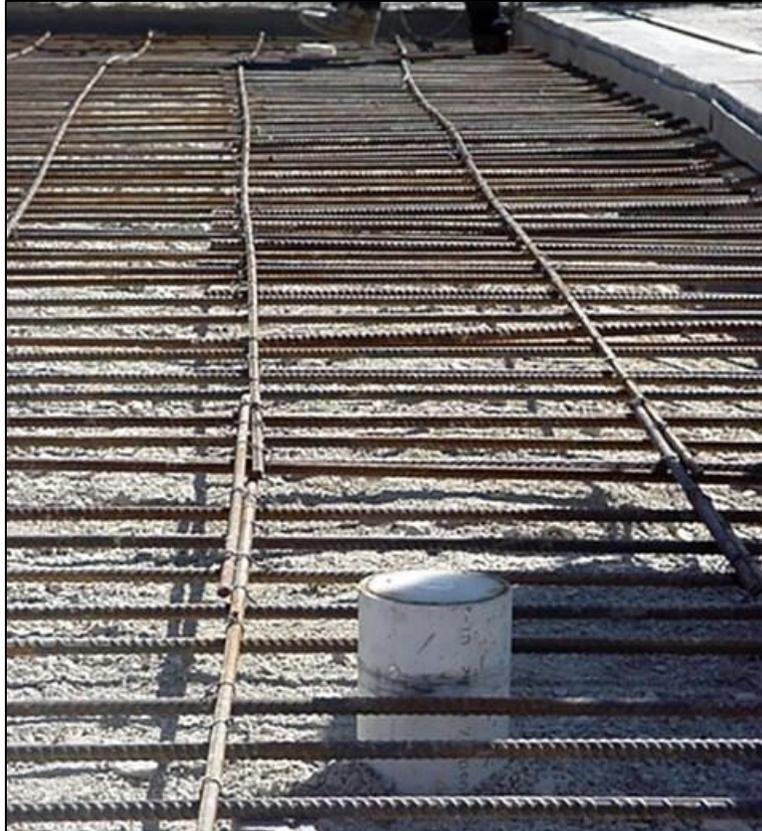
Figure 24. Capped access tubes sticking up between reinforcing members.

After the flowable fill dried and the northern embankment was compacted, gravel was positioned to level the surface and the reinforcement for the approach slabs was placed, allowing the settlement plate risers to stick up between the pieces of rebar, Figure 24. Before the concrete could be poured for the approach slabs, the settlement plate access tubes were positioned so that they would be correct at final road grade. The left image in Figure 25 shows the PVC riser positioned in the access tube, all imbedded in concrete. The right image shows the cap just before the concrete was poured. The polypropylene caps had to be thoroughly greased to keep the concrete from firmly attaching to them.

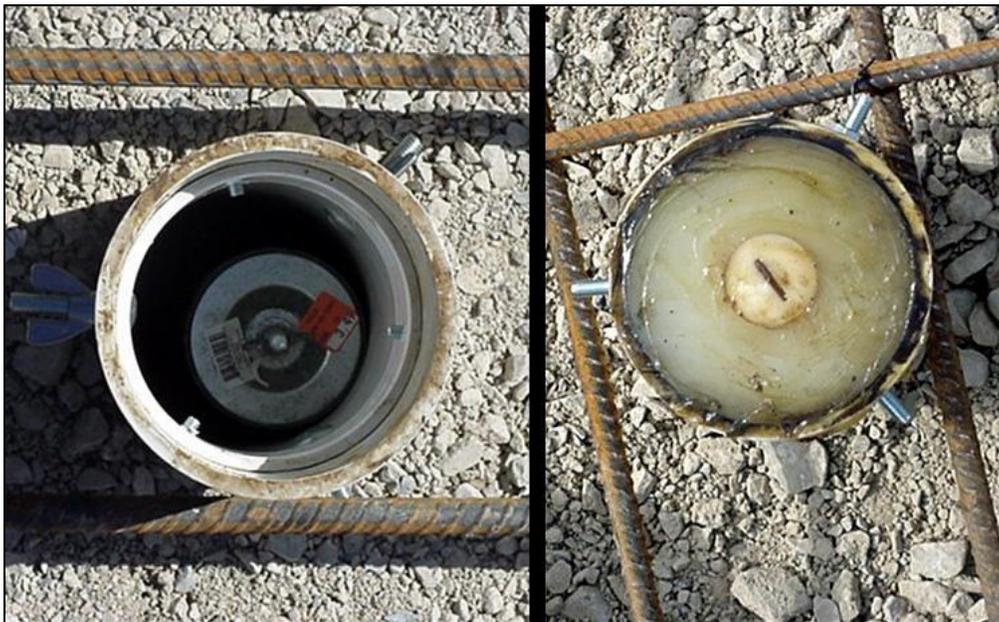
Figure 25. PVC riser in the access tube (left) and a greasy polypropylene cap (right).

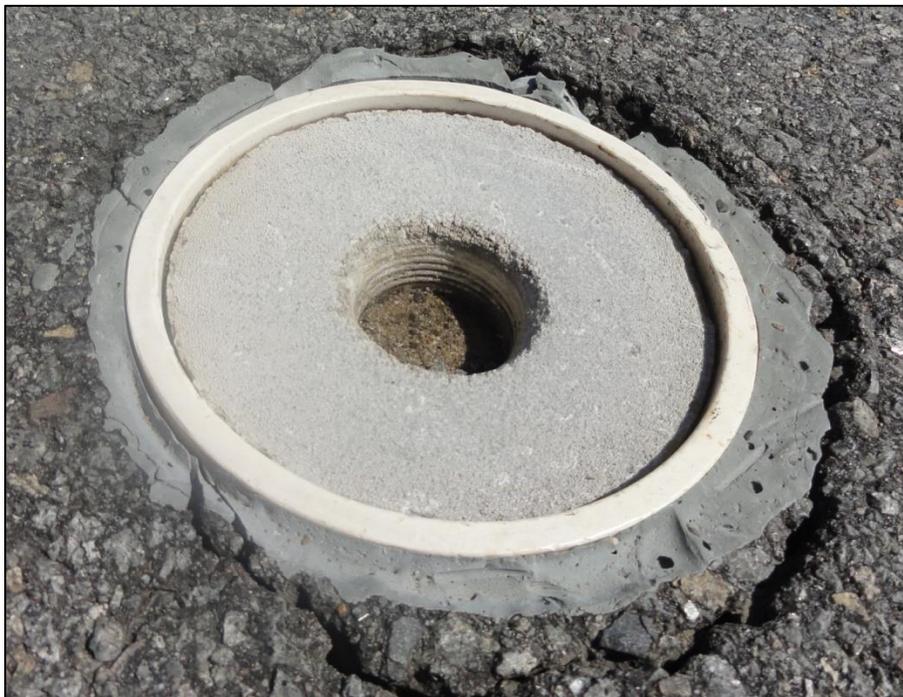
Figure 26. Dilapidated cap after ten years of neglect.

In 2011, Research personnel went back to the bridge end locations to see if the settlement plates were still accessible. The polypropylene seemed to hold up well to ten years of weathering and traffic except for the threads on the removal slot, making them very difficult to remove in the intended method. For the most part, the caps had sealed in place after roughly ten years with the lack of new grease to lubricate the cap sides. It would be very difficult to remove the caps in order to take readings anymore. A very dilapidated cap can be seen in Figure 26. The settlement plate data that was collected can be seen in Appendix 9.1.

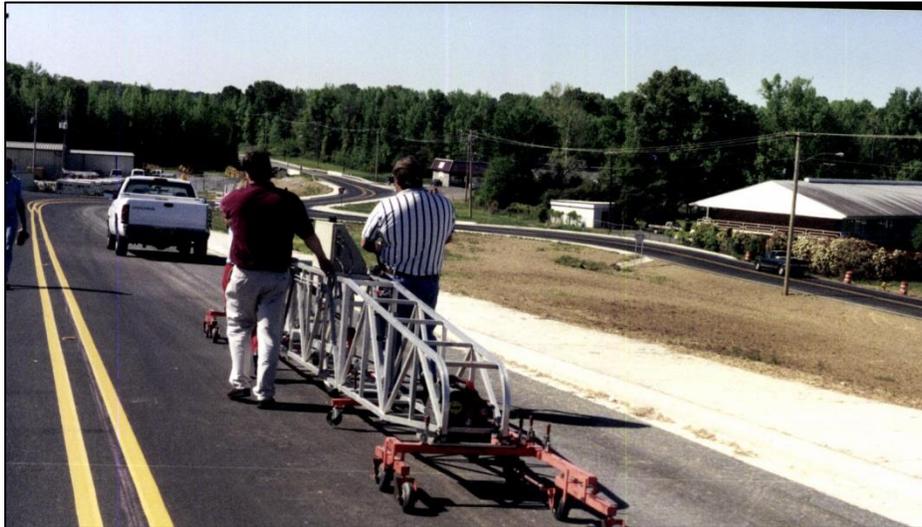
Figure 27. California profilograph at Chicot Road Bridge.

There were two different types of profilographs used to monitor this project. A California profilograph was used to get an initial profile on the Chicot Road Bridge, the Raymar Road Bridge and the Crow Creek Bridge. Research personnel can be seen taking making an original profile using the Department's California profilograph at the Chicot Road Bridge before it was opened to traffic in Figure 27.

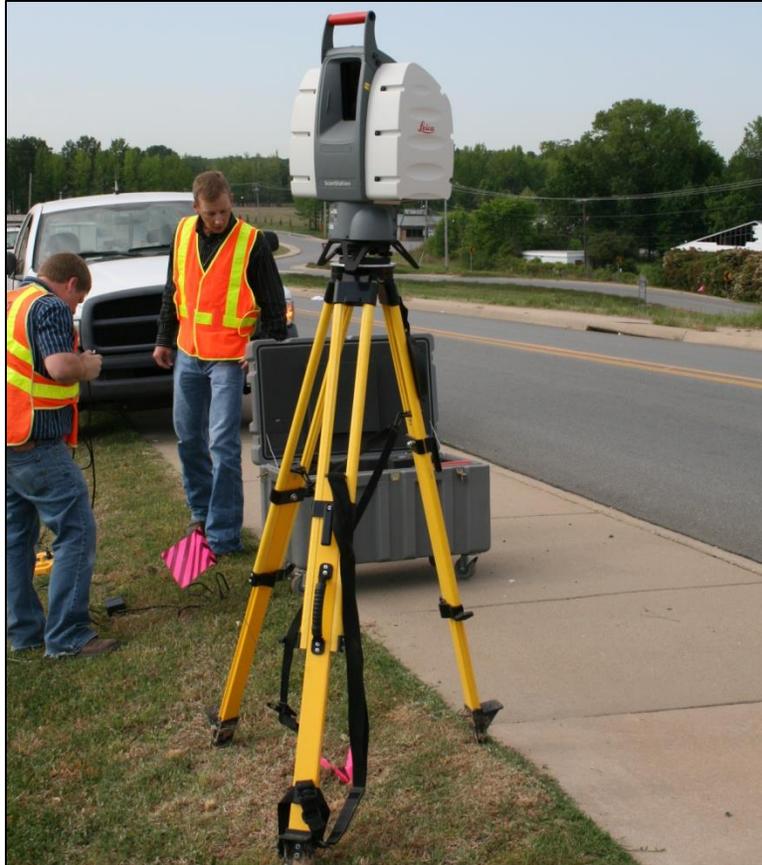
Figure 28. First laser scanner at the south end of the Chicot Road Bridge.

The Surveys Division was contacted and agreed to scan the bridge ends. In April of 2010, a survey crew took the laser scanner and mapped the bridge ends of the Chicot Road Bridge and the Raymar Road Bridge. The survey crew is shown scanning the Chicot Road Bridge ends in Figure 28.

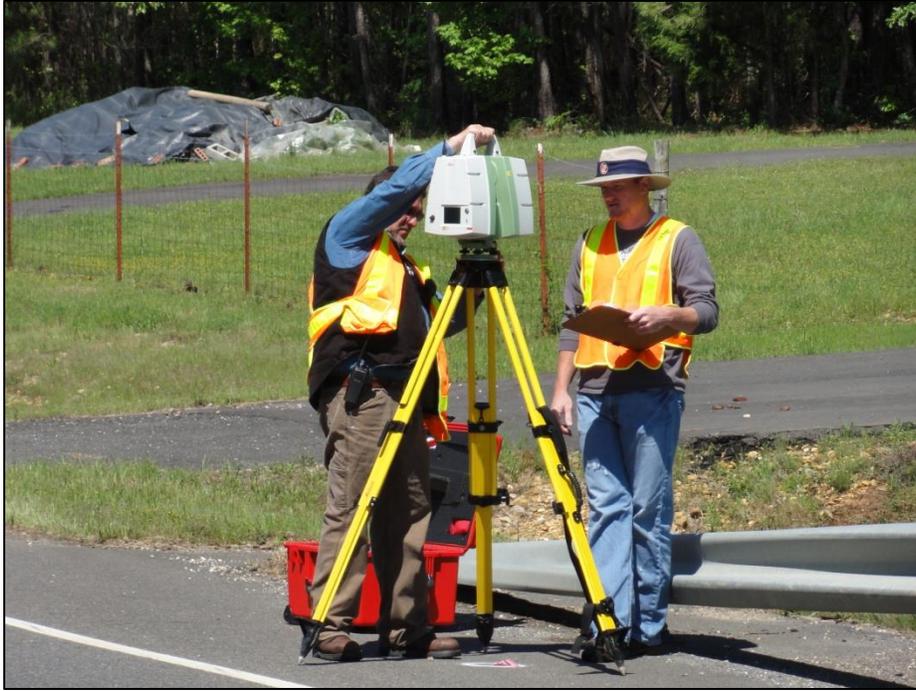
Figure 29. Survey crew using the new laser scanner at the DeRoche Bayou Bridge.

Between the first scans and early 2011, the Survey Division traded in the laser scanner for a newer, more advanced model. With this new scanner, in February and April of 2011, the survey crew re-scanned the Raymar Road and Chicot Road bridges and got first-time scans for the DeRoche Bayou Bridge and the Crow Creek Bridge. Then, in September 2011, all four bridges were scanned again. A survey crew with the new Scanstation can be seen scanning the DeRoche Bayou Bridge in Figure 29.
