APPENDIX H

HAZARDOUS MATERIALS PROCEDURES AND RESULTS

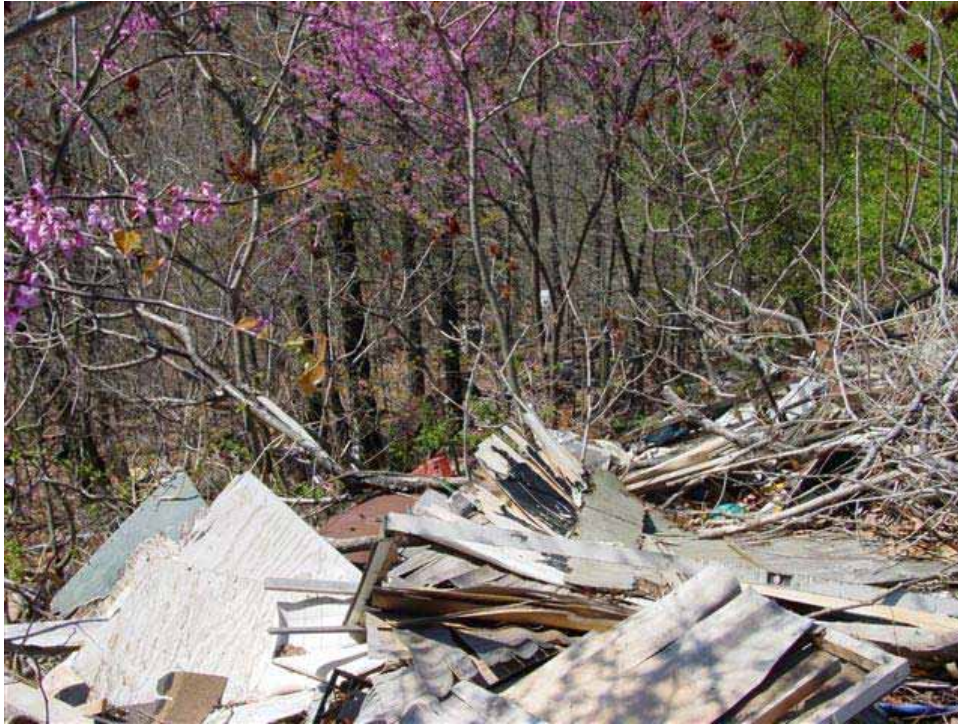
Figure H-1: Illegal dump on south side of Trapp Road.

Trapp Road Illegal Dump - An illegal dump was found at the end of Trapp Road where construction and demolition waste, tires, household waste, bricks and various plastic items were found (Figure H-1). No sealed drums or hazardous waste containers were observed at the site. No age determination could be established for this site. The site was not in ADEQ's Solid Waste-Illegal Dumps.

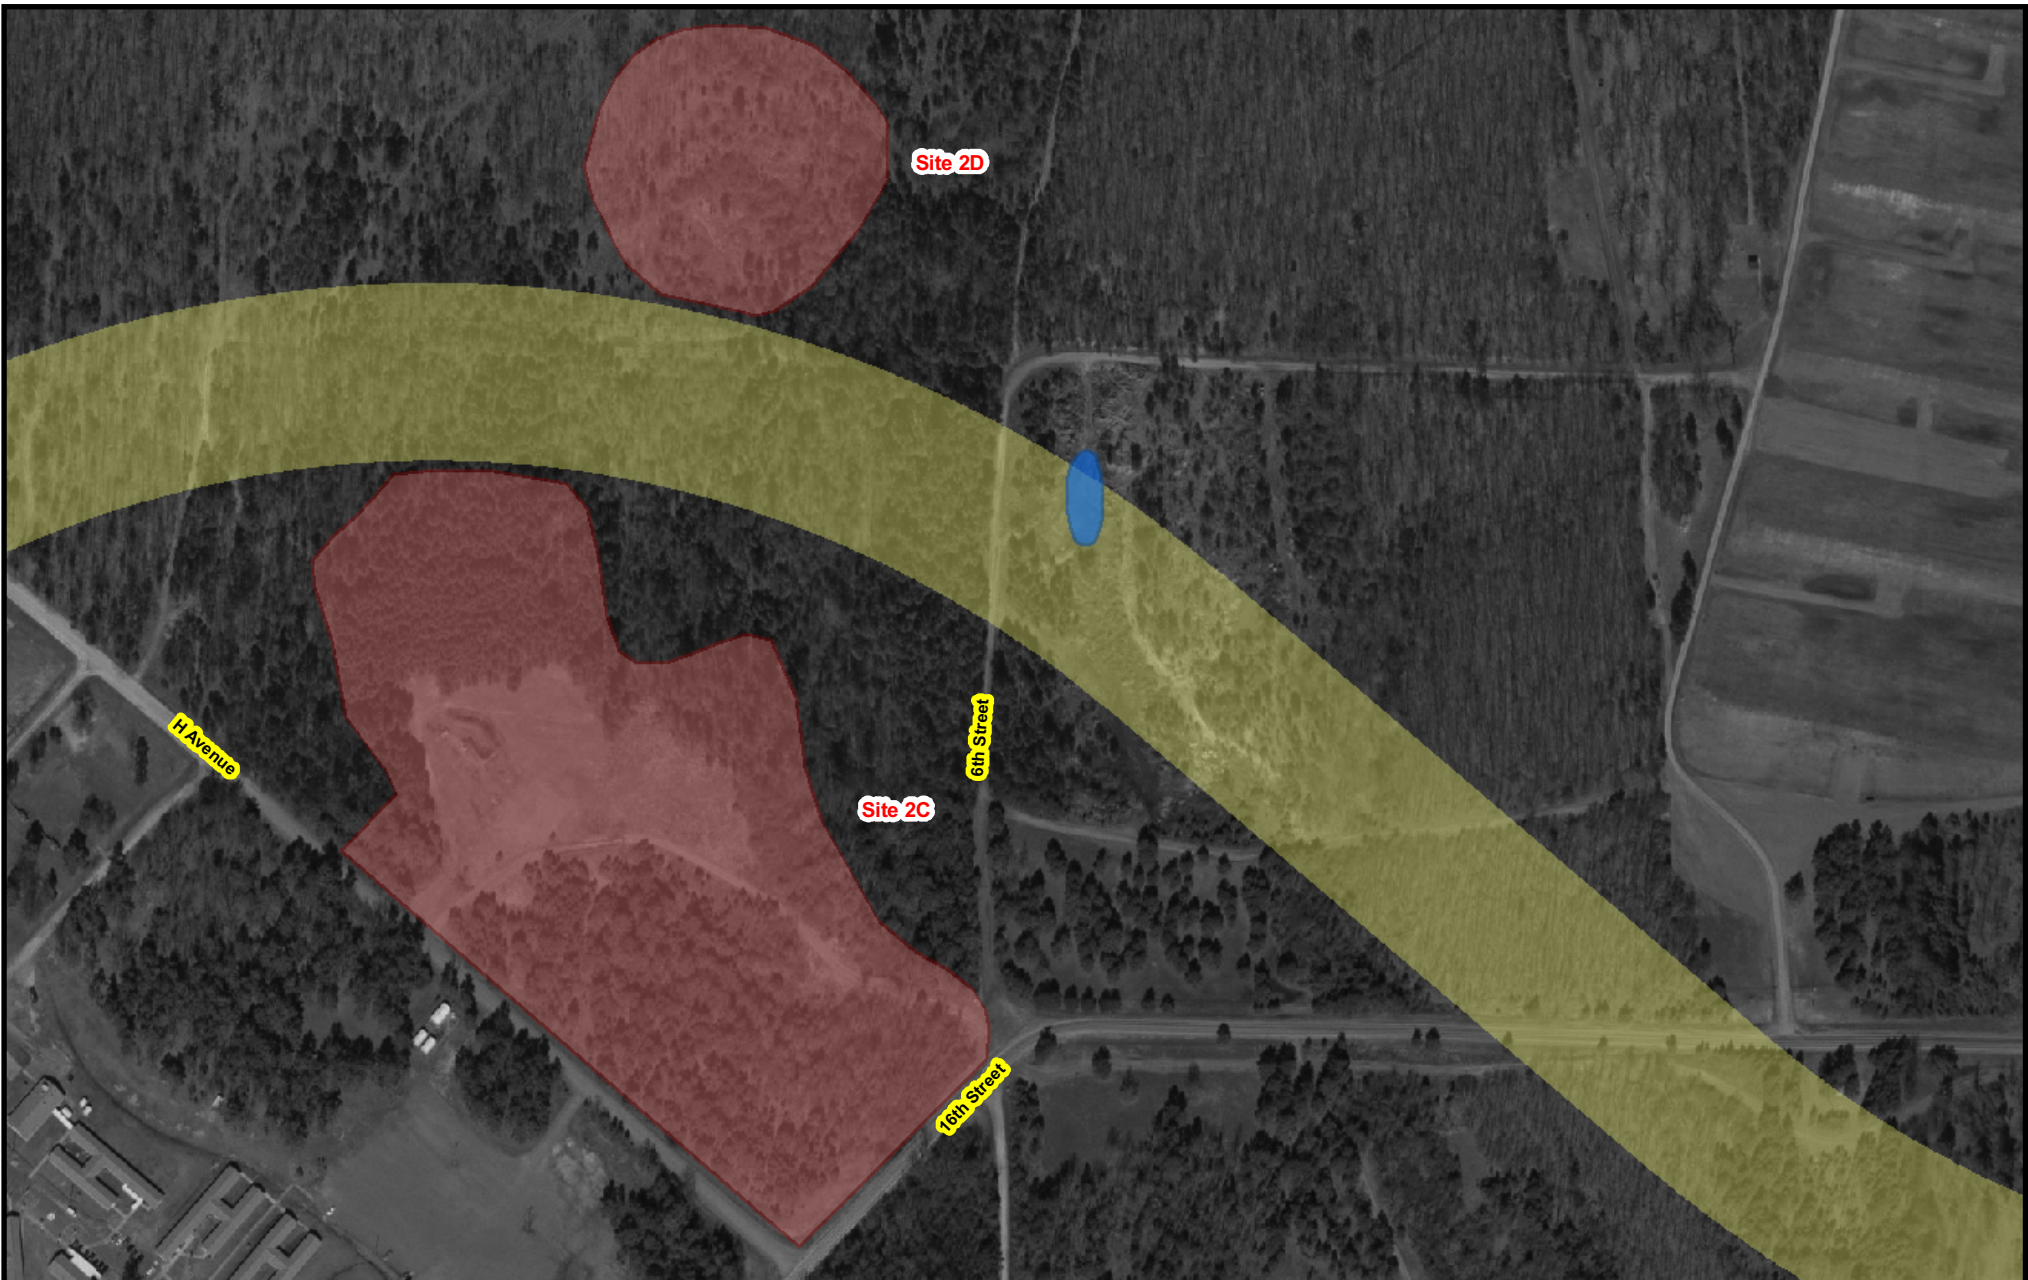
Figure H - 2
Location of Landfill Sites 2C and 2D
 North Belt Freeway

Abandoned Landfills North of Barracks Complex - A landfill which contains various unknown materials and substances was created in the early 1970s. The location of this landfill is just outside the Common Alignment, is shown on Figure 3.15-1 and Figure H-2, and is named Site 2C. The primary method of disposal in the landfill was pit and burial. The size of the landfill is approximately 17 acres and currently has a brush and small pine tree cover. This landfill has been abandoned for approximately 14 years. The materials and substances deposited in the landfill are of unknown chemical and physical properties.

However, three areas of surface contamination within the landfill were observed that indicated the probable presence of petroleum-based products. These observations indicate the probable existence of contamination; therefore, avoidance is considered the prudent and preferred action.

A small landfill, named Site 2D, is located north of Site 2C (Figure H-2). These landfills are connected by a small dirt road. The landfill is the oldest of the identified landfills in Camp Robinson. The landfill was used primarily as a disposal site for building materials; i.e. concrete blocks, steel structural supports, concrete slabs, etc. However, Camp Robinson personnel lack complete records of all the materials disposed in this landfill; therefore, avoidance again is considered the prudent action. Between Sites 2C and 2D there is an approximately 300-foot (91-meter) wide corridor that was not used for landfilling according to Camp Robinson records. To utilize this corridor, the proposed Common Alignment would need to pass between Sites 2C and 2D in a northwest/southeast direction for approximately 1,500 feet (457 meters) then turn with an acceptable curvature.

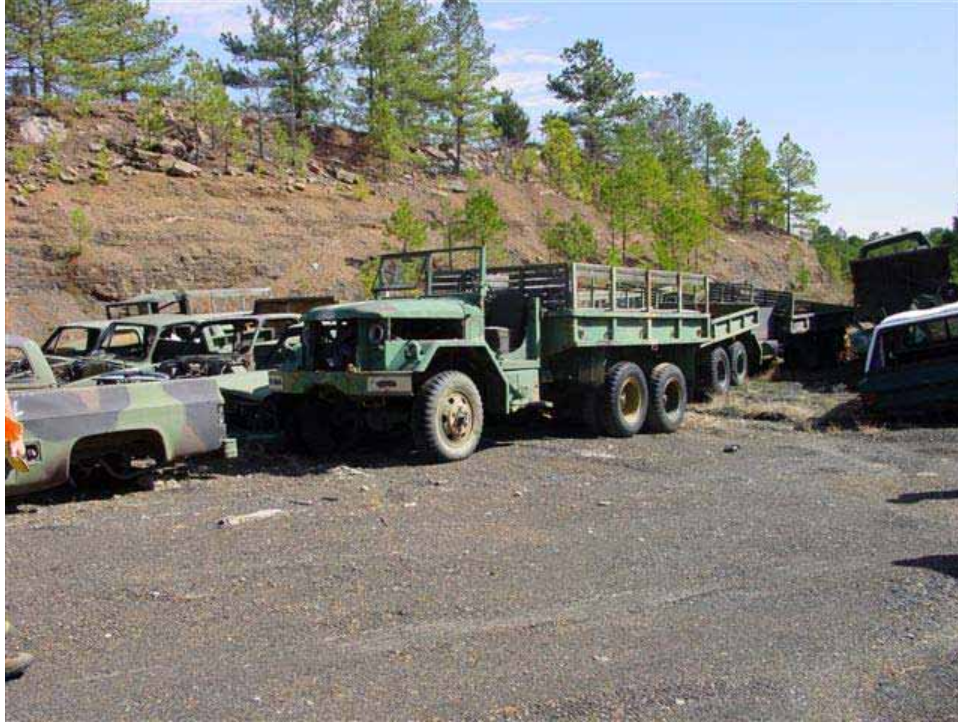
Figure H-3: Old Military Vehicle Storage Area

Vehicle Storage Area - An old military vehicle storage area is located 400 feet (122 meters) northeast of Site 2C. This site, as shown in Figure H-3, could be directly impacted by the Common Alignment. Since these vehicles are movable, any transmission fluid and/or petroleum products materials left behind can be removed and remediated as per ADEQ specifications. Avoidance is a possible option, if any significant contamination is identified during the AHTD's assessment.

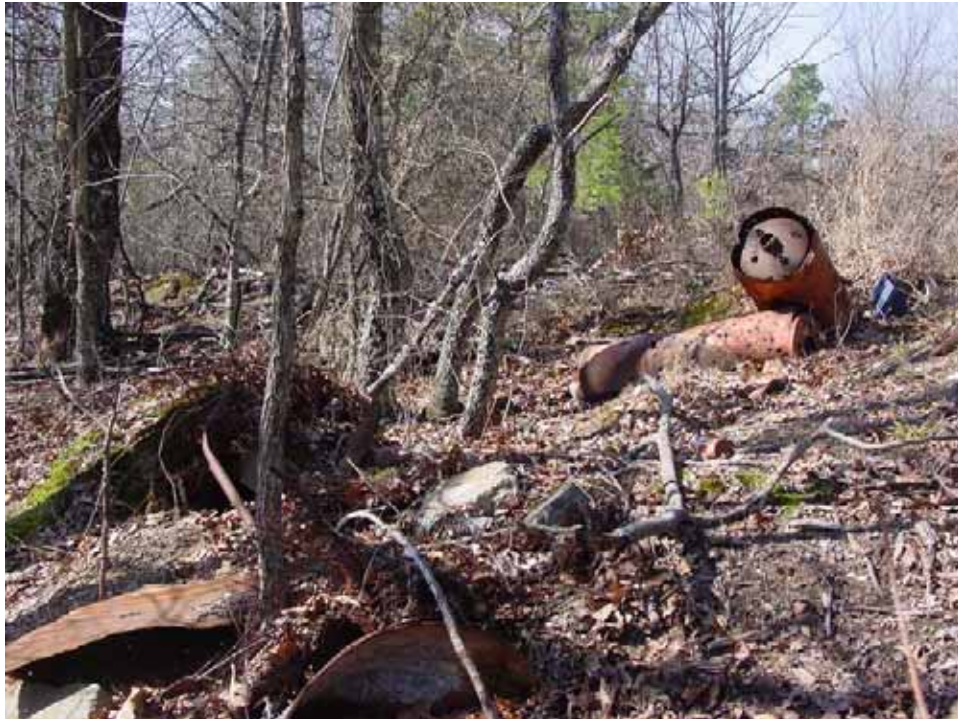
Figure H-4: Illegal Dump near Batesville Pike

Batesville Pike Illegal Dump – An illegal dump was found in an area located on an unimproved turnout east of Batesville Pike (see Figure H-4). This area was once owned by Camp Robinson, but recently the land has been acquired by private developers. This illegal dump is approximately two acres in size and consists of construction and demolition debris, household debris and various metal objects. No age determination could be established for this site. The site was not in ADEQ's Solid Waste-Illegal Dumps records. Avoidance is a possible option, if any significant contamination is identified in the AHTD's assessment.

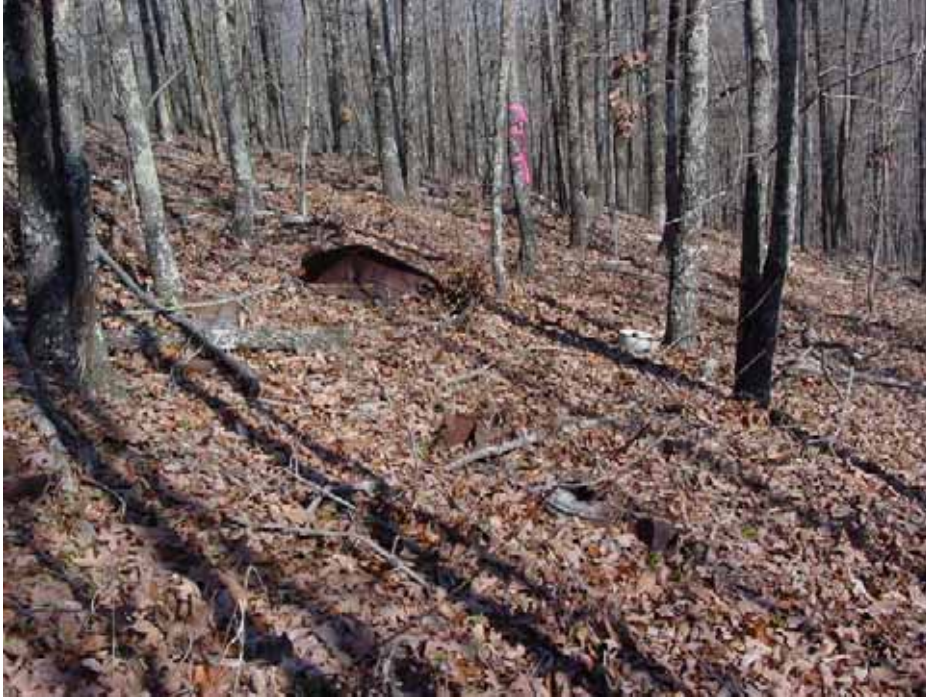
Figure H-5: Illegal dumping along Batesville Pike

Batesville Pike Illegal Dump - An illegal dump located parallel to Batesville Pike along Alignment Alternative B was found to contain old car parts, tires, and other metal household debris (figure H-5). This dump is approximately 50 feet (15 meters) wide and runs in a northeast-southwest tangent for a distance of 150 feet (46 meters) about 100 feet (30 meters) east of Batesville Pike. No sealed drums or hazardous waste containers were observed at the site. No age determination could be established for this site. The site was not in ADEQ's Solid Waste-Illegal Dumps records.

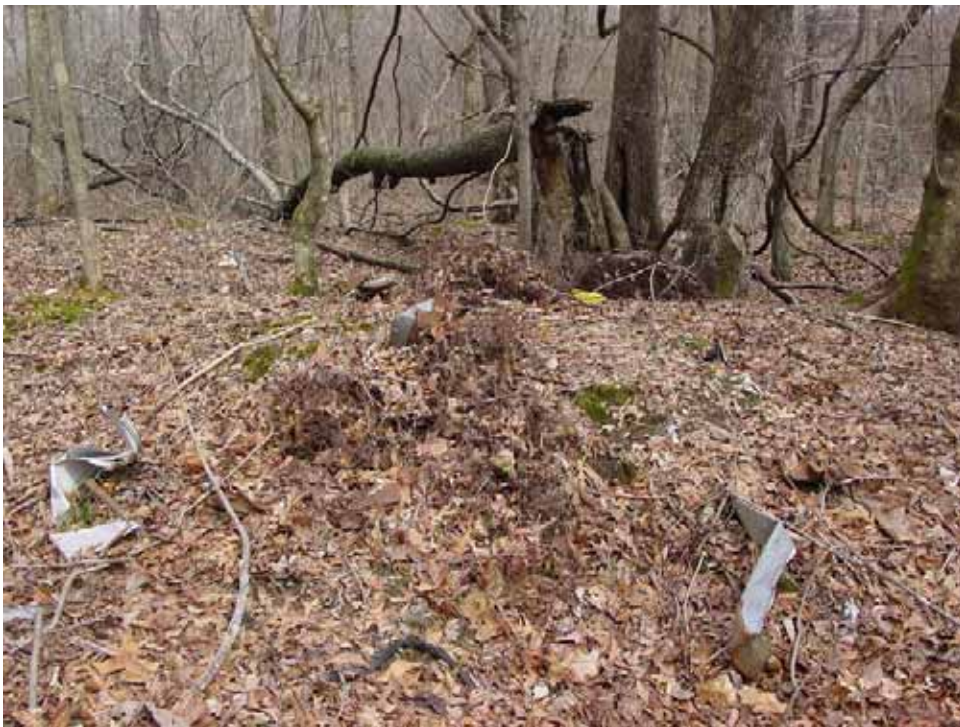
Figure H-6: Illegal landfill east of Oneida Street

Old Landfill - An old landfill is located south of Main Street and east of Oneida Street, which is within Jacksonville City limits. The site is about 120 feet (37 meters) west of the proposed centerline. The landfill is approximately 100 foot wide (30 meters) and 250 feet (76 meters) long consisting of household debris, demolition debris, cans, and other various metal objects (see Figure H-6). No recent dumping is evident, and this landfill has been abandoned for several years. The materials and substances deposited in the landfill are of unknown chemical and physical properties; therefore, avoidance is considered the prudent and preferred action.
