ARKANSAS STATE HIGHWAY AND TRANSPORTATION DEPARTMENT

INTEROFFICE MEMORANDUM

SUBJECT: Pavement Condition and Needs Study - Revised
Highway 150 from I-55 to Highway 137
Mississippi County

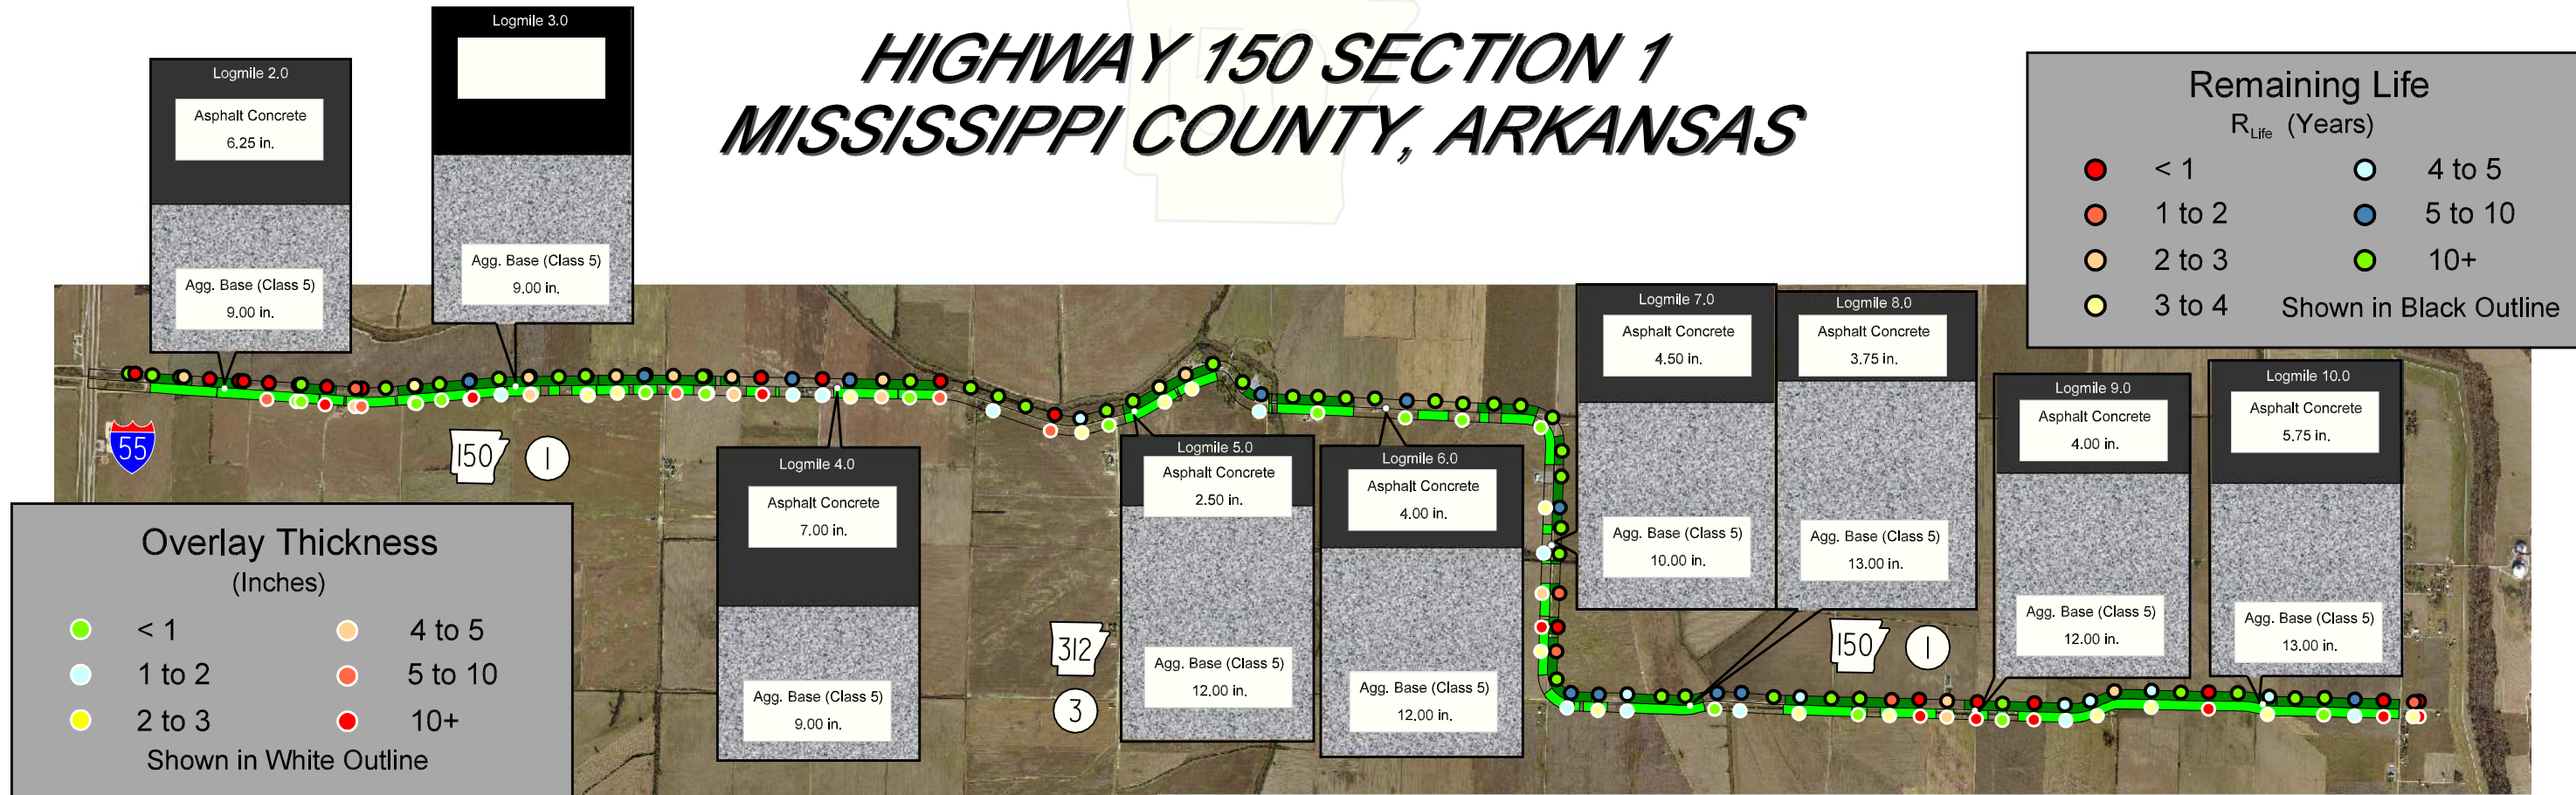
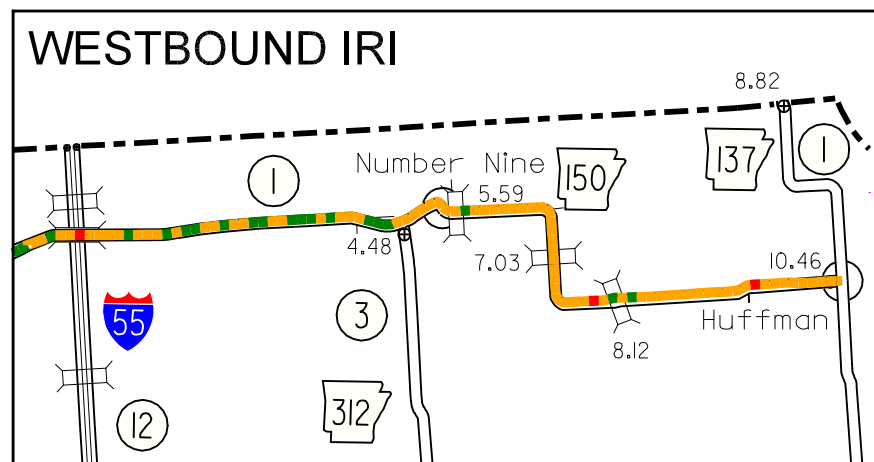
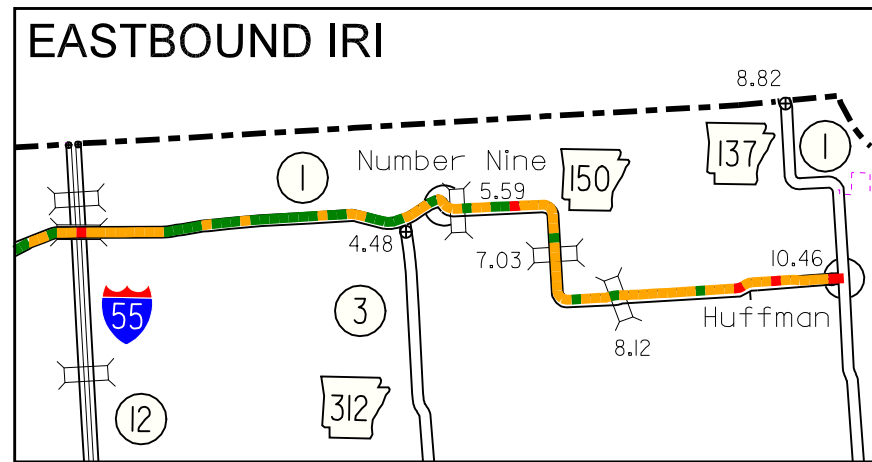
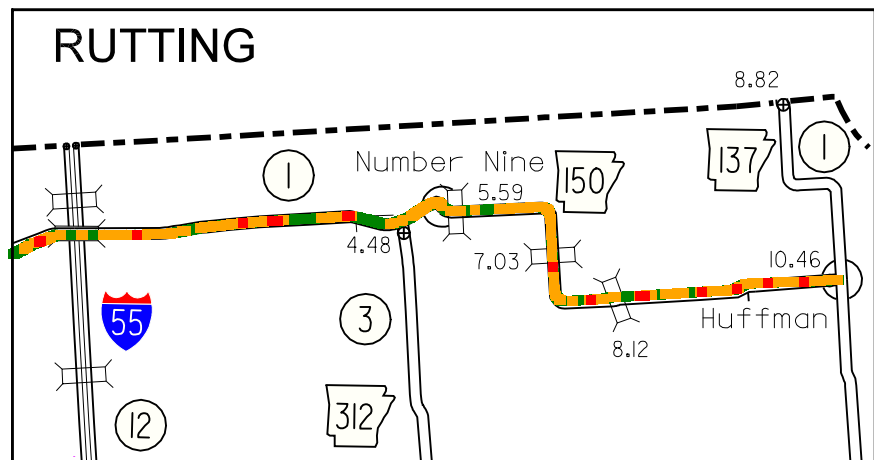
HIGHWAY 150 SECTION 1 MISSISSIPPI COUNTY, ARKANSAS

IRI		RUTTING
< 95	GOOD	< 0.25 inches
95 to 219	FAIR	0.25 to 0.5 inches
> 219	POOR	> 0.5 inches

Highway 150, Section 1 Logmile 1.52 to 10.46

R_{Life} Average _____ 9.7 Years _____

This analysis was performed using a 20 year design life, with 42,554 ESALS, on FWD data collected November 2010. The Remaining Life is an average. Overlay is shown for the 80th percentile. The pavement condition data was collected November 2010. The IRI and Rutting are shown as averages.
