TRC1002

**Evaluation of High Performance Curing  
Compounds on Freshly Poured Bridge  
Decks**

Final Report

Arkansas State Highway & Transportation Department

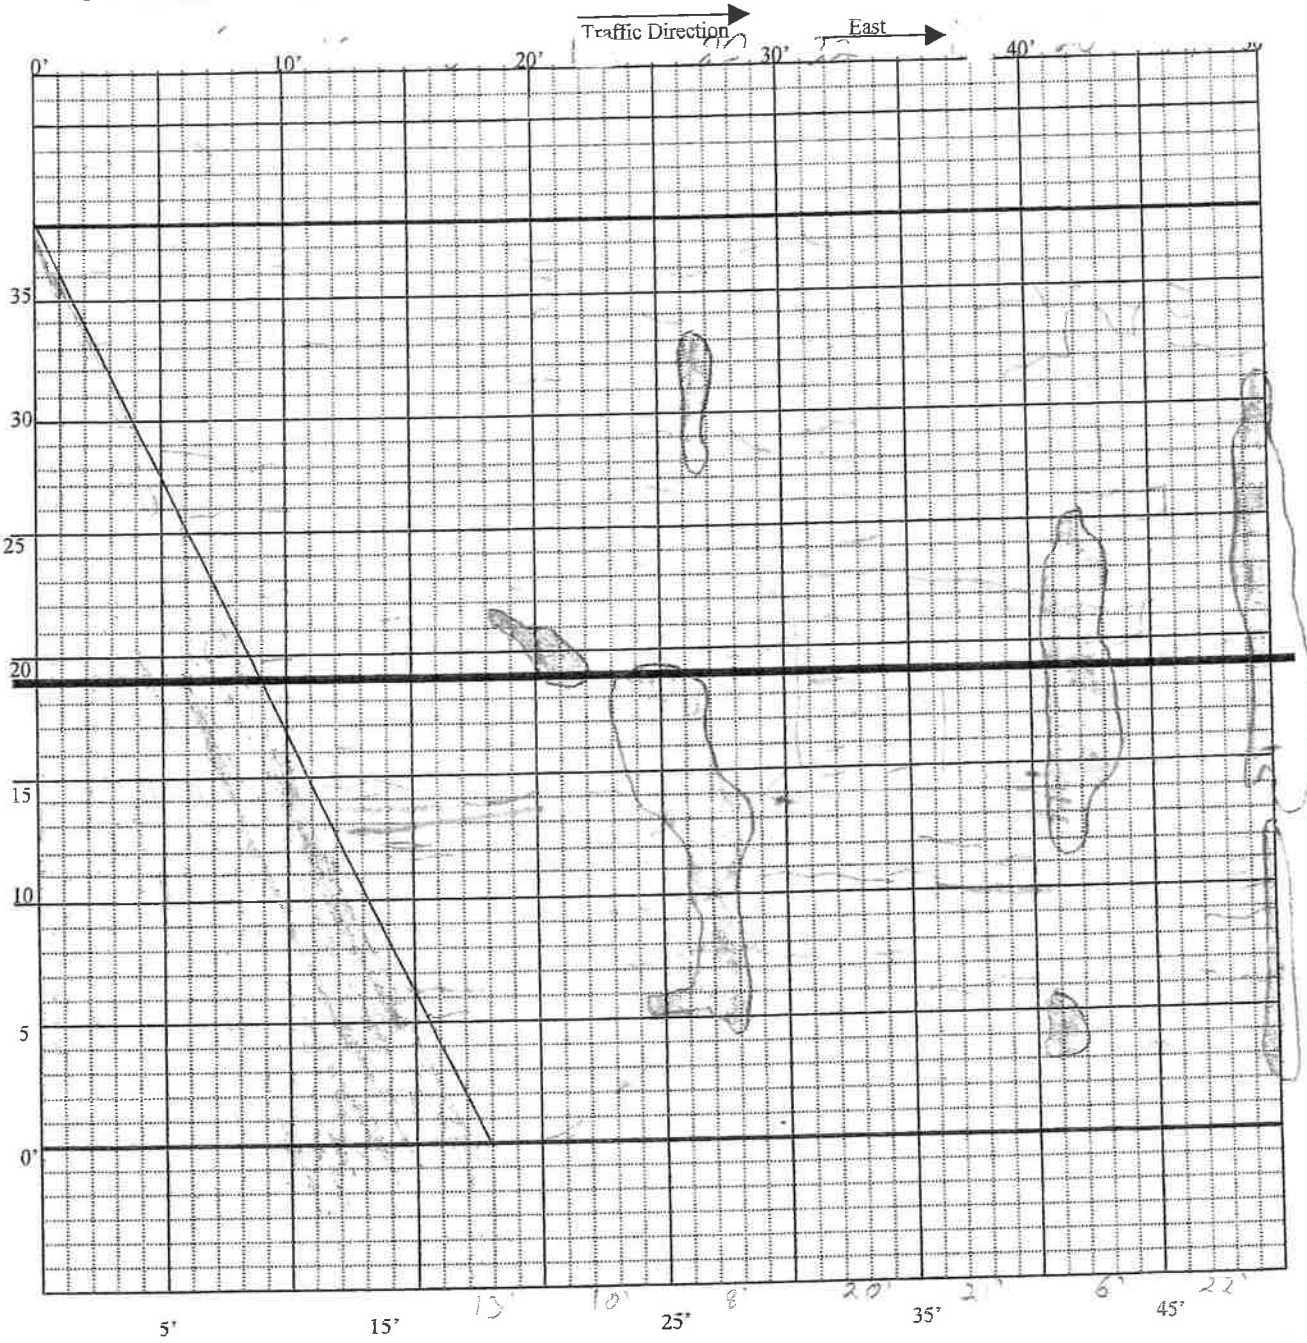
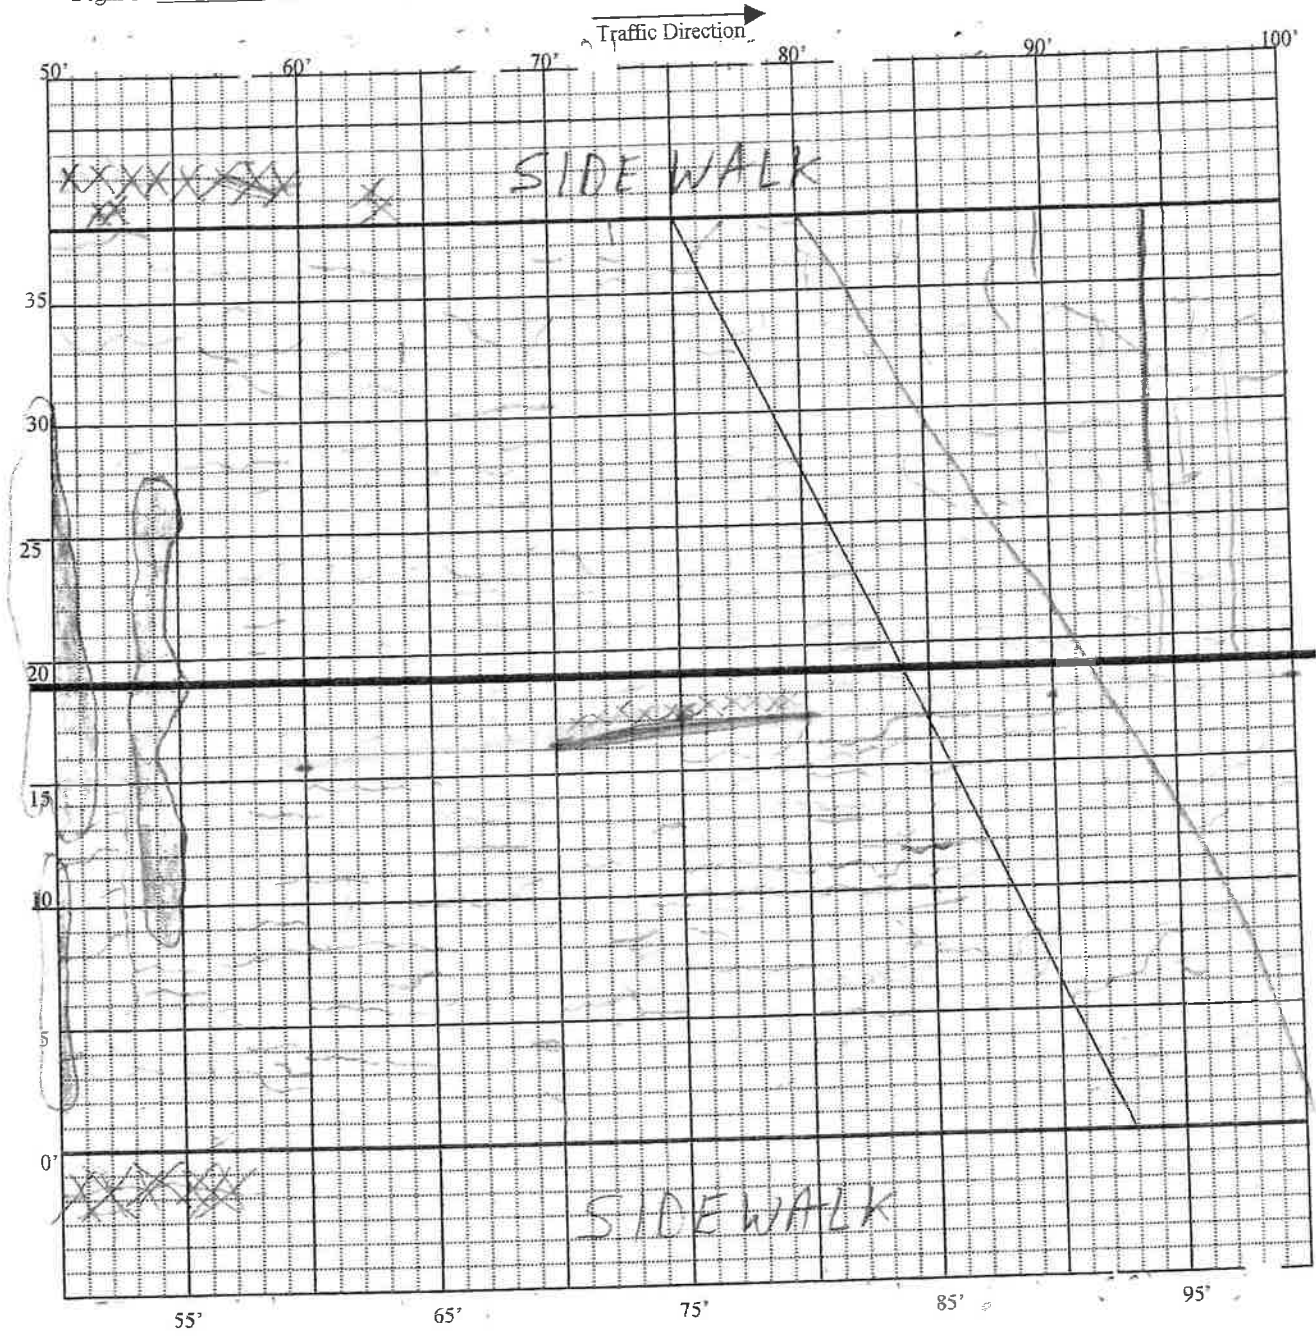
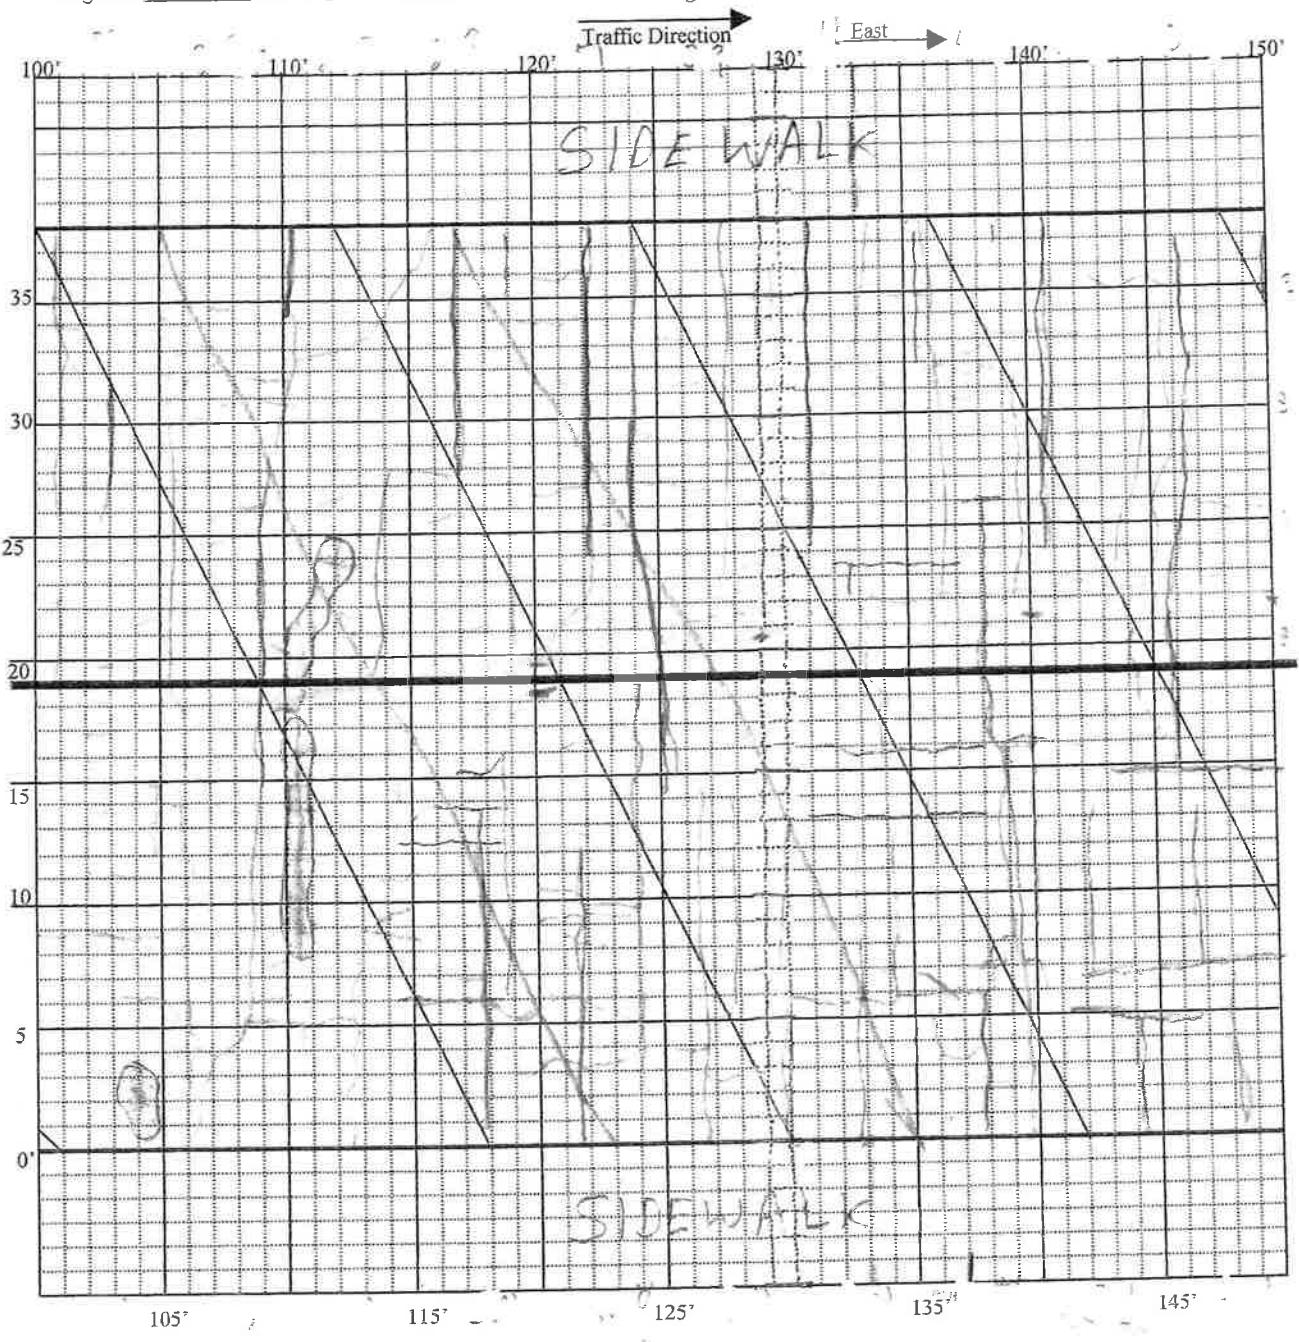
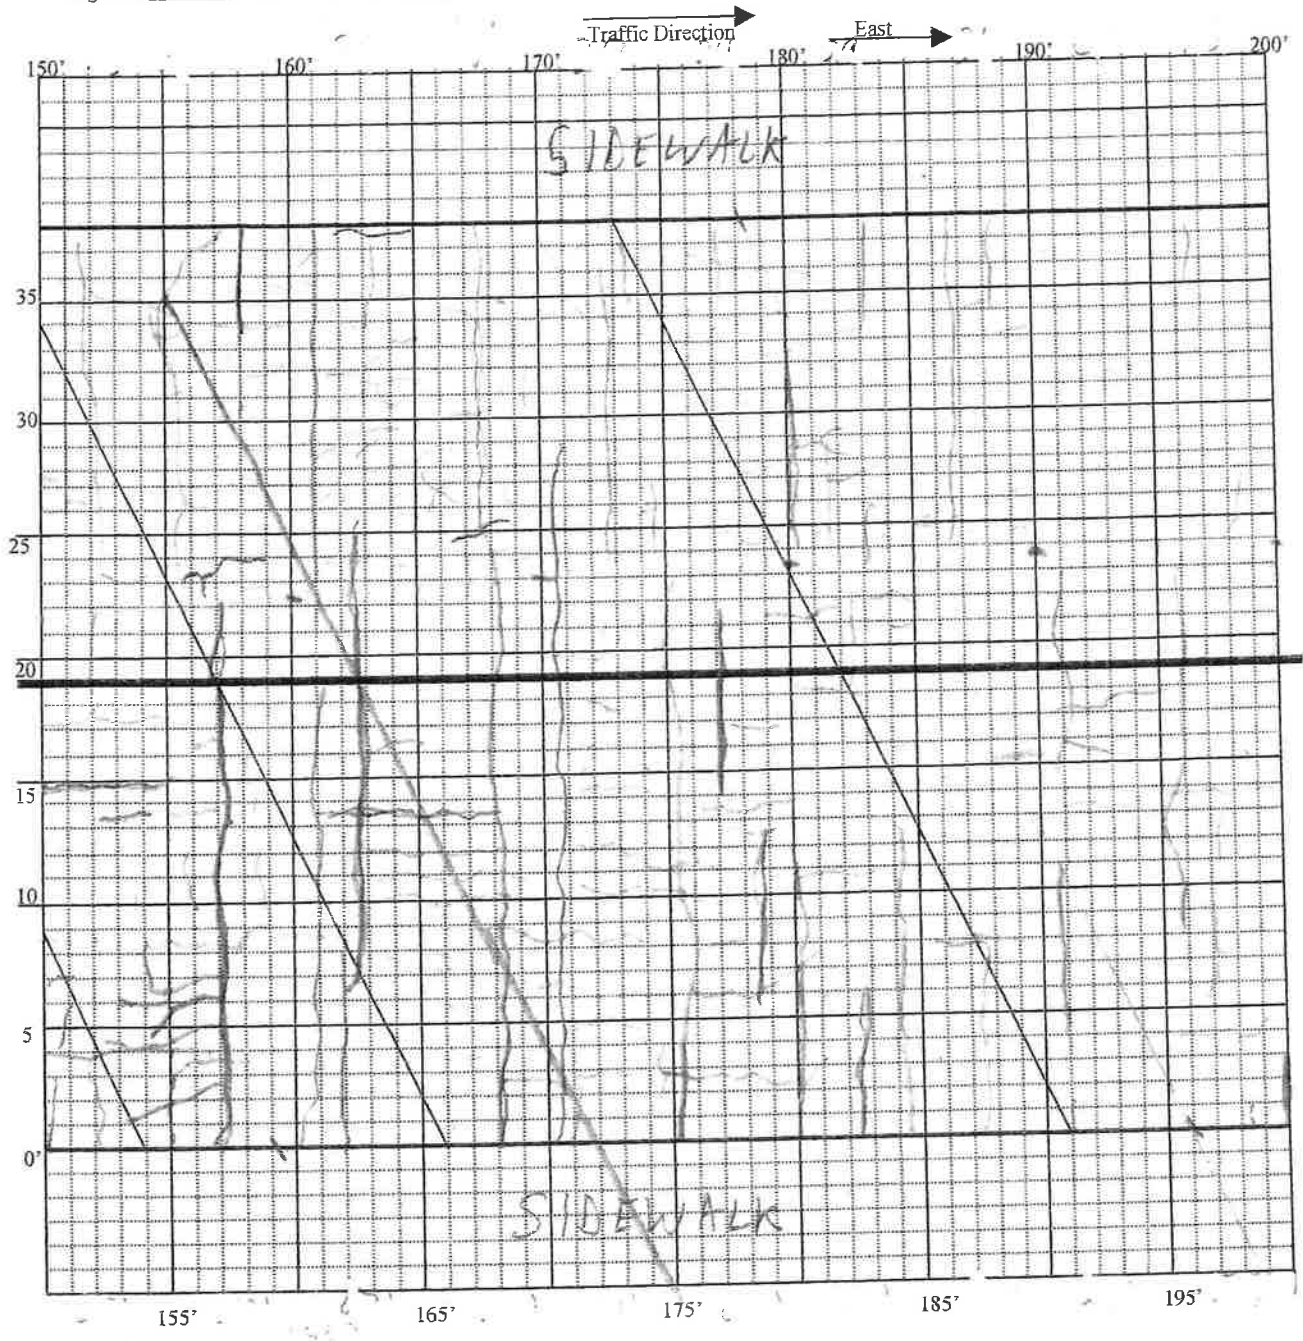
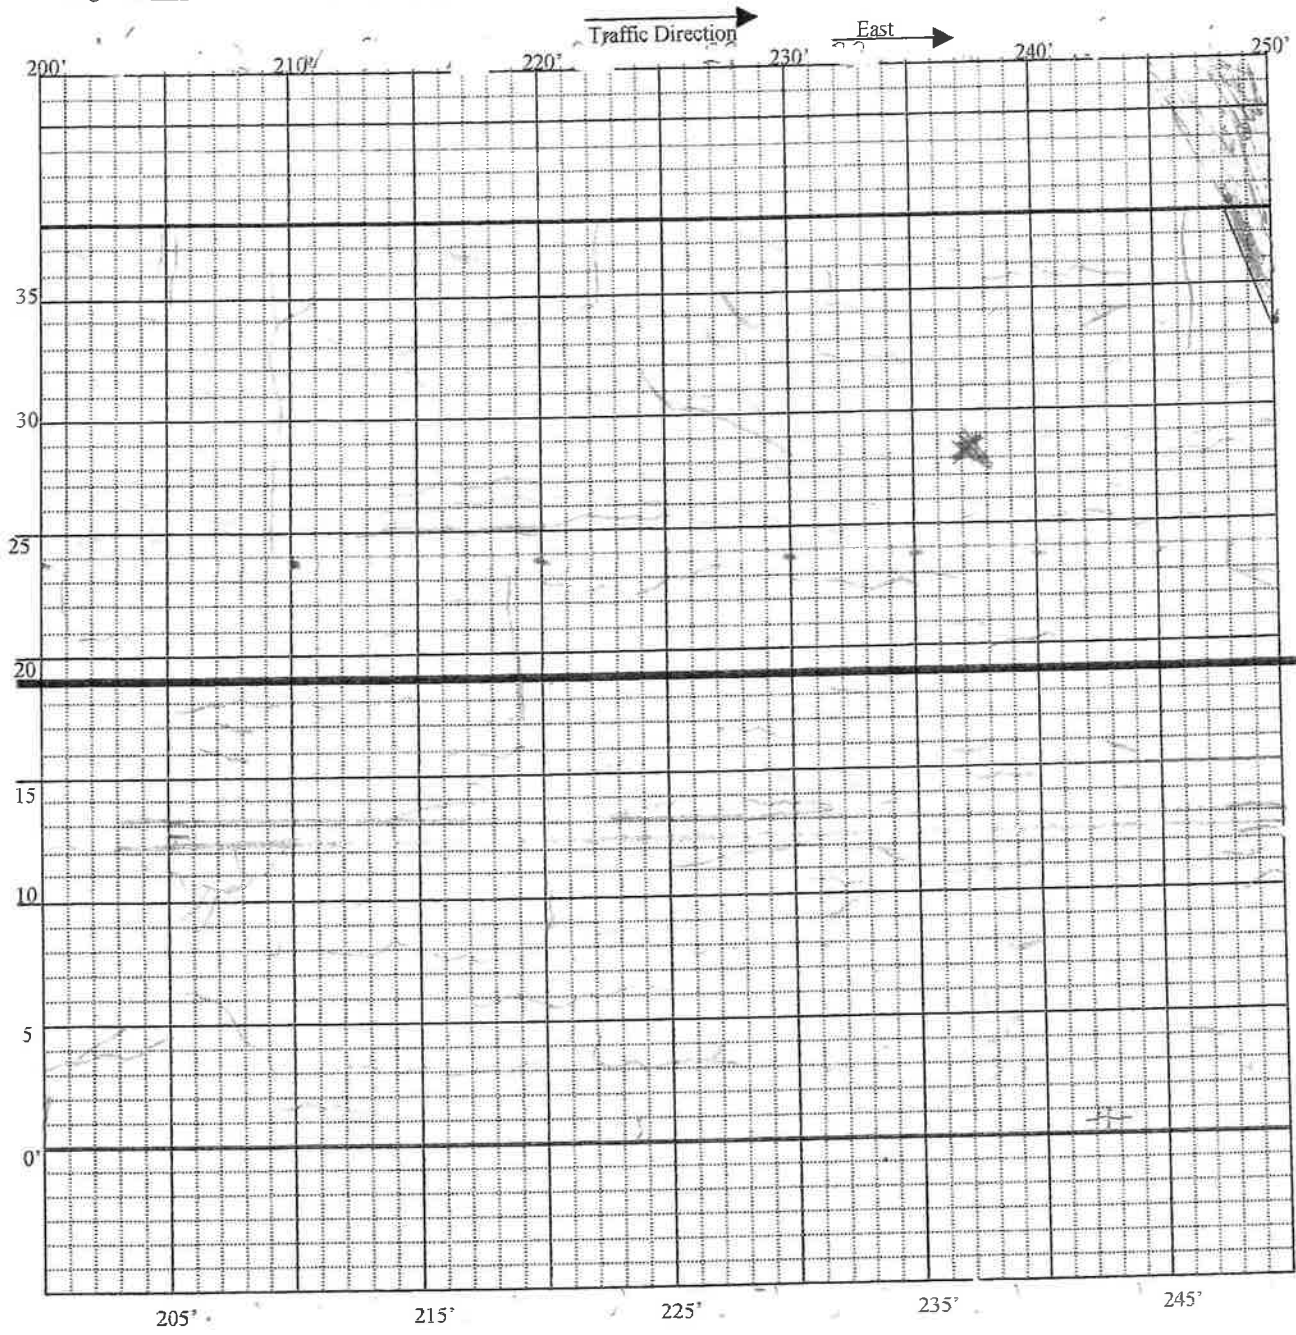
Project No. 030341

The bridge deck in Texarkana was completed on September 2, 2009. The first distress survey was completed on November 12, 2009. In the areas where ponding had occurred during the application of the HPCC, the surface of the concrete became soft and is indicated by the elongated circles in the distress survey. With the final application of the HPCC several months later, the softer areas did seem to harden. At the time of the first distress survey, there was a total crack length of 173 feet on the HPCC half of the deck and 301 feet of total crack length on the control sections. There was approximately a 43% reduction in the HPCC section when compared with the control section. Due to time constraints the distress survey was not completed a year after placement of the bridge deck. The second survey was completed in two parts. The first part was completed on February 21, 2012 and the second part was completed on March 22, 2012. The total linear feet of cracking for the HPCC half was 1,402 linear feet and the control section had 1,608 linear feet of cracking. There was a 13% reduction in cracking when comparing the HPCC to the control section.

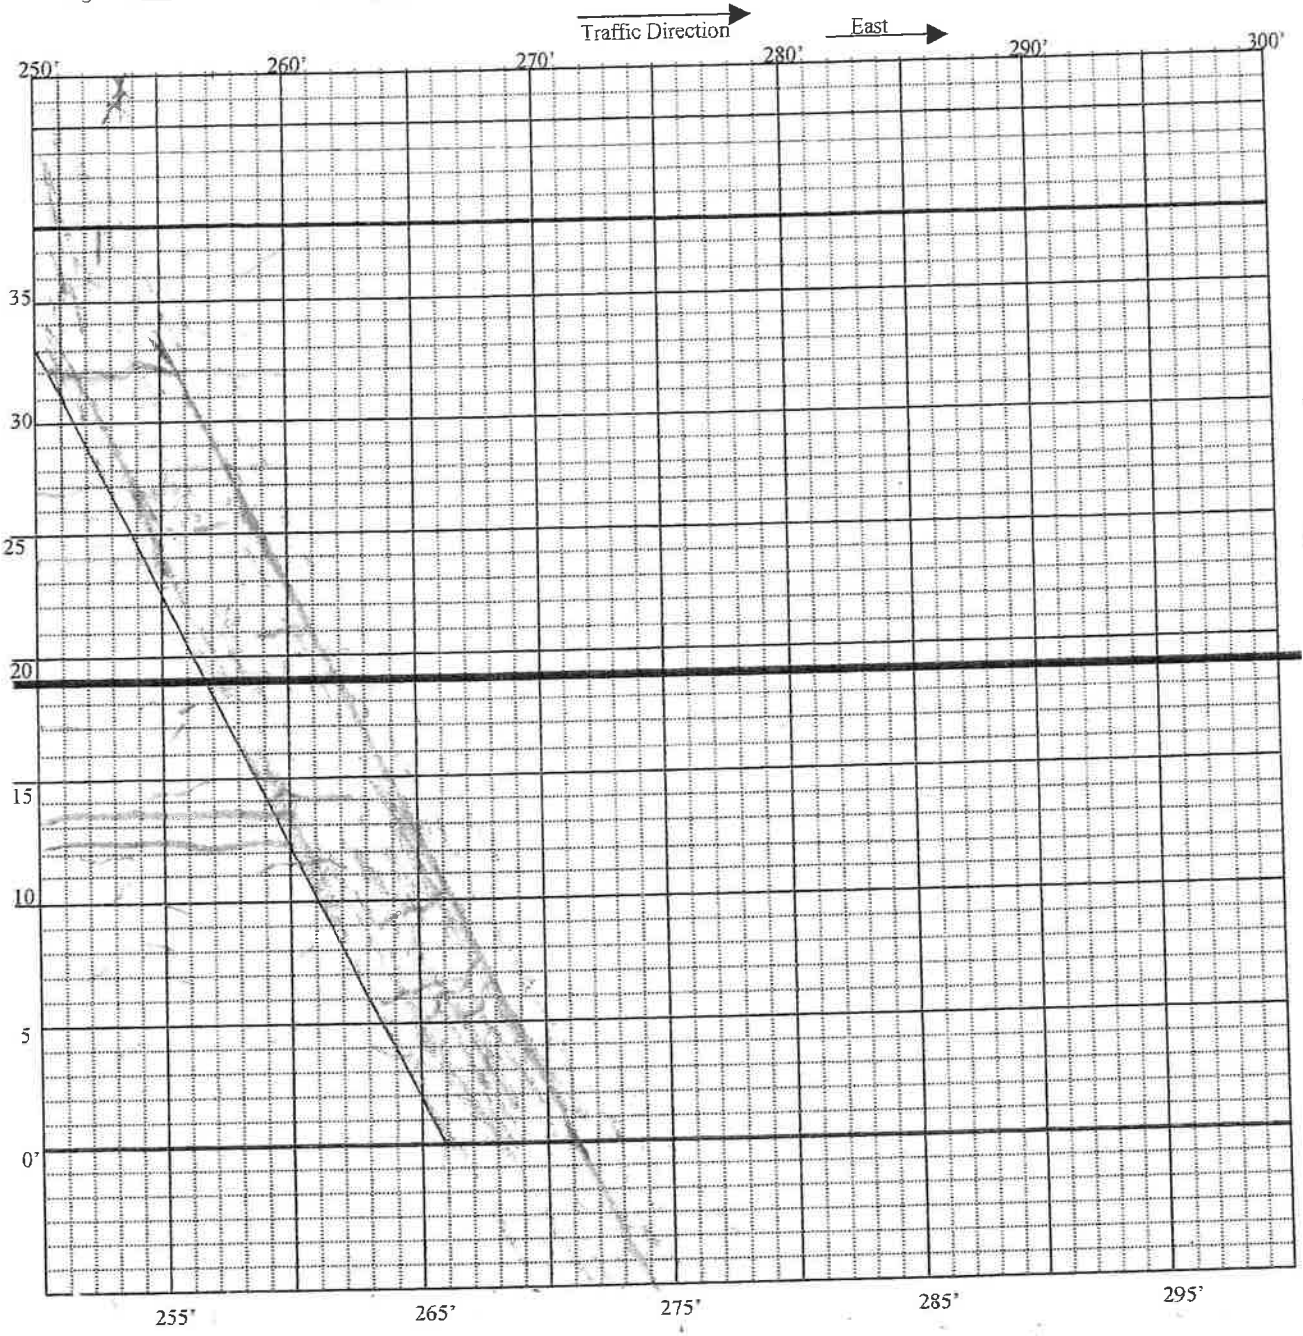
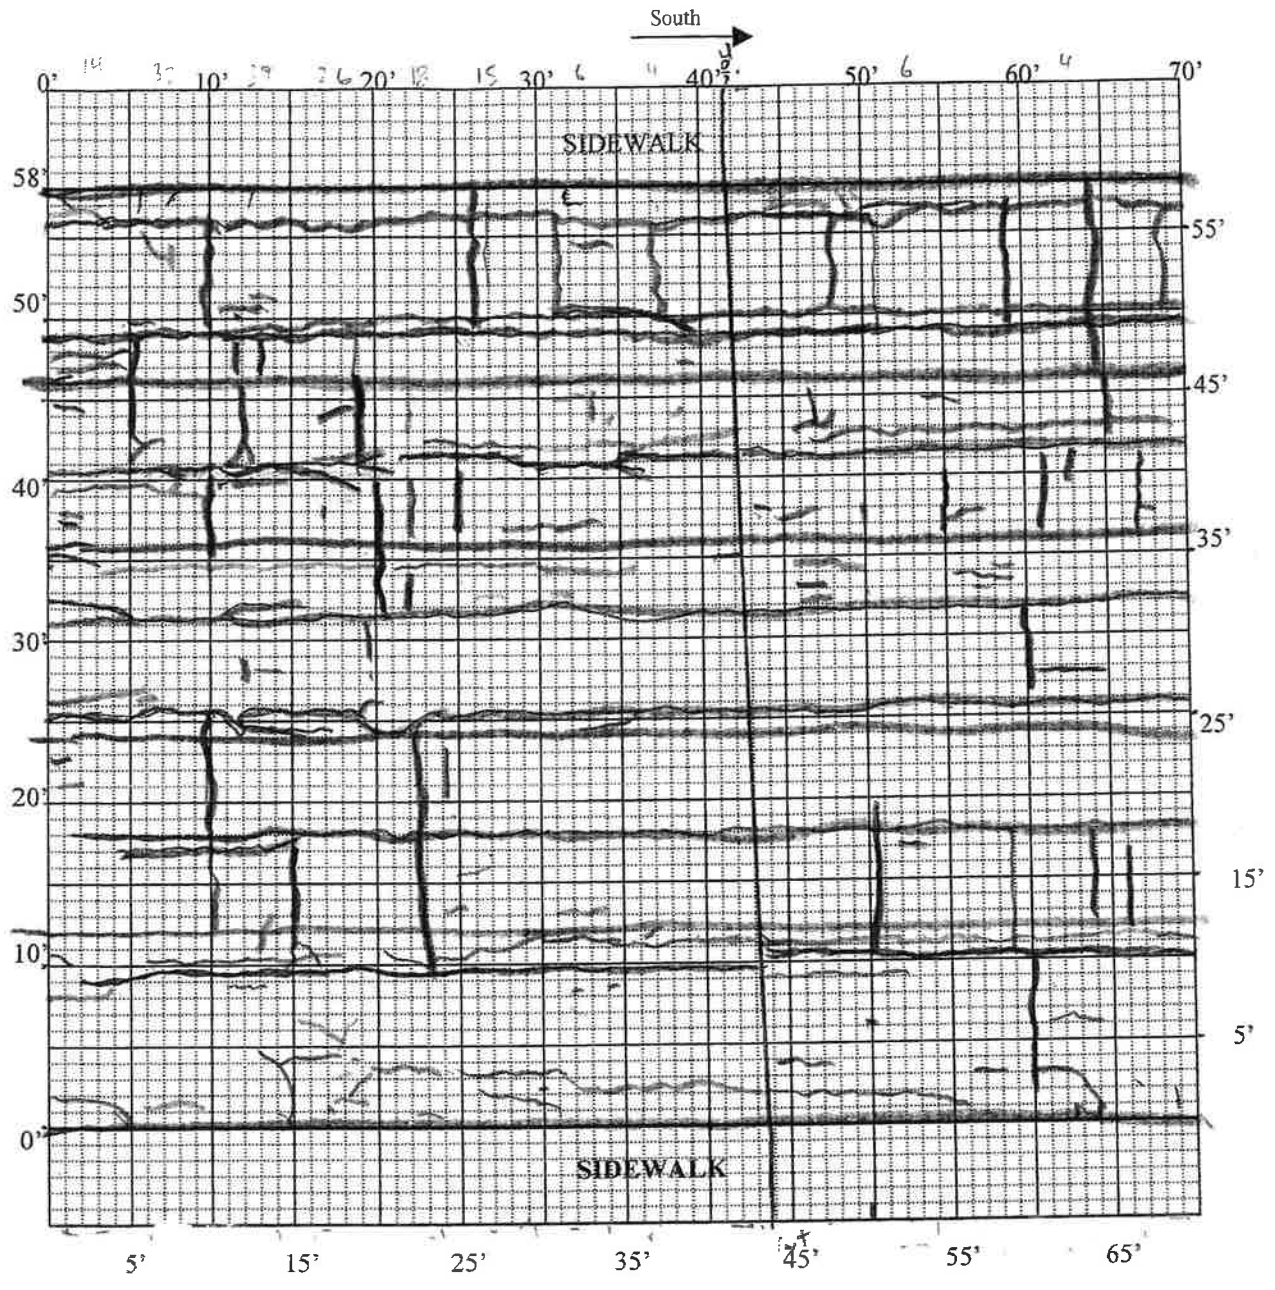
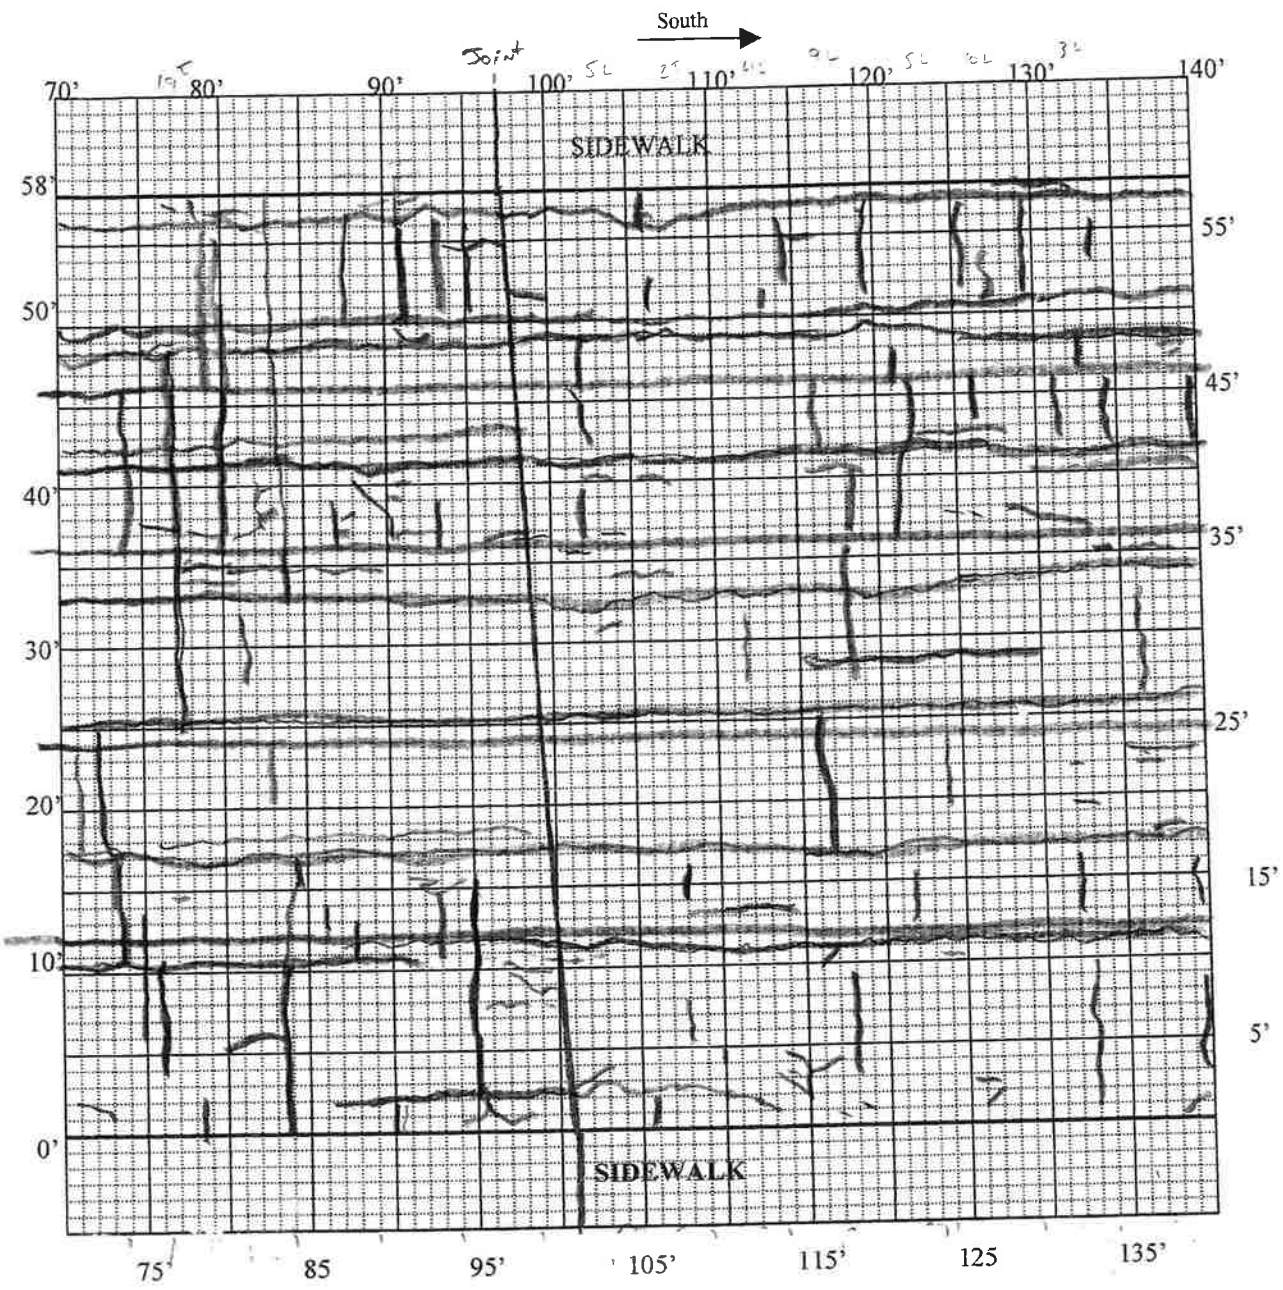
Project No. 100608 Project Name: MARS Creek Bridge Surveyor: \_\_\_\_\_  
Station \_\_\_\_\_ Route: \_\_\_\_\_ Section: \_\_\_\_\_ Location: Pocahontas Date: 2-27-12  
Begin Sta \_\_\_\_\_ End Sta \_\_\_\_\_

The bridge deck in Pocahontas was placed on March 31, 2010. Since the entire bridge deck was treated with the HPCC, there is no comparison for this bridge. The first distress survey was completed on June 16, 2010 with a total crack length of 236 linear feet. The second distress survey was completed on August 25, 2010 with a total crack length of 1,208 linear feet. The third and final distress survey was completed on February 27, 2012 at which time the bridge deck had a total crack length of 2,485 linear feet.
