TRC1002

**Evaluation of High Performance Curing  
Compounds on Freshly Poured Bridge  
Decks**

Final Report

Arkansas State Highway & Transportation Department

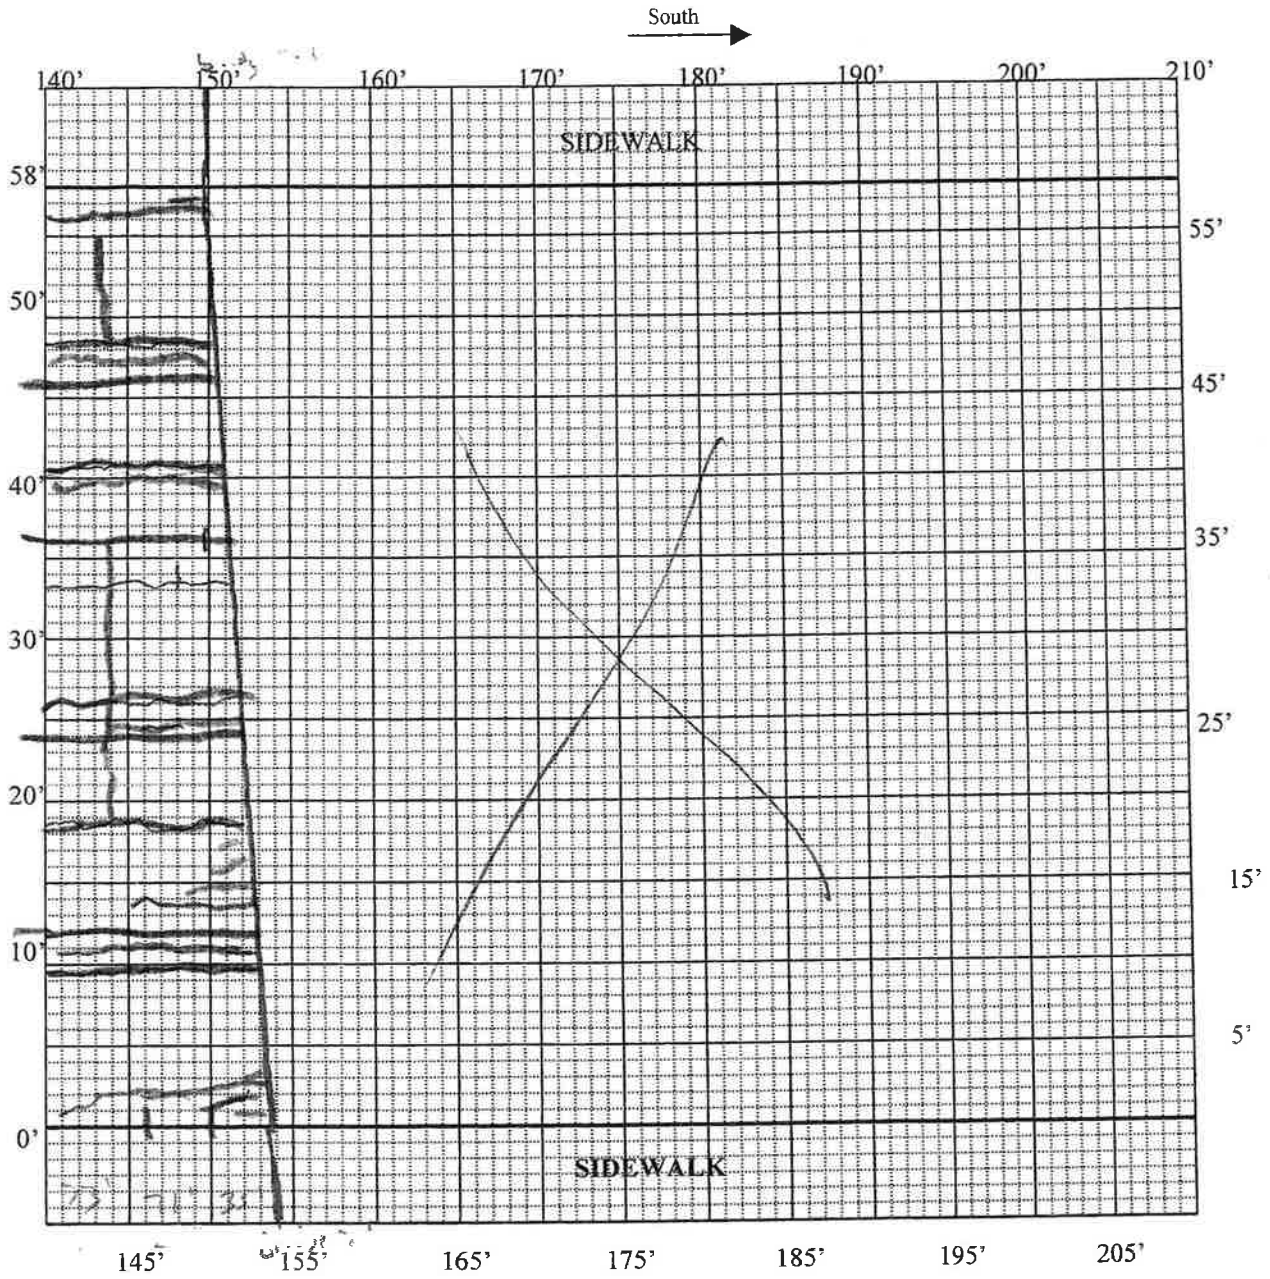
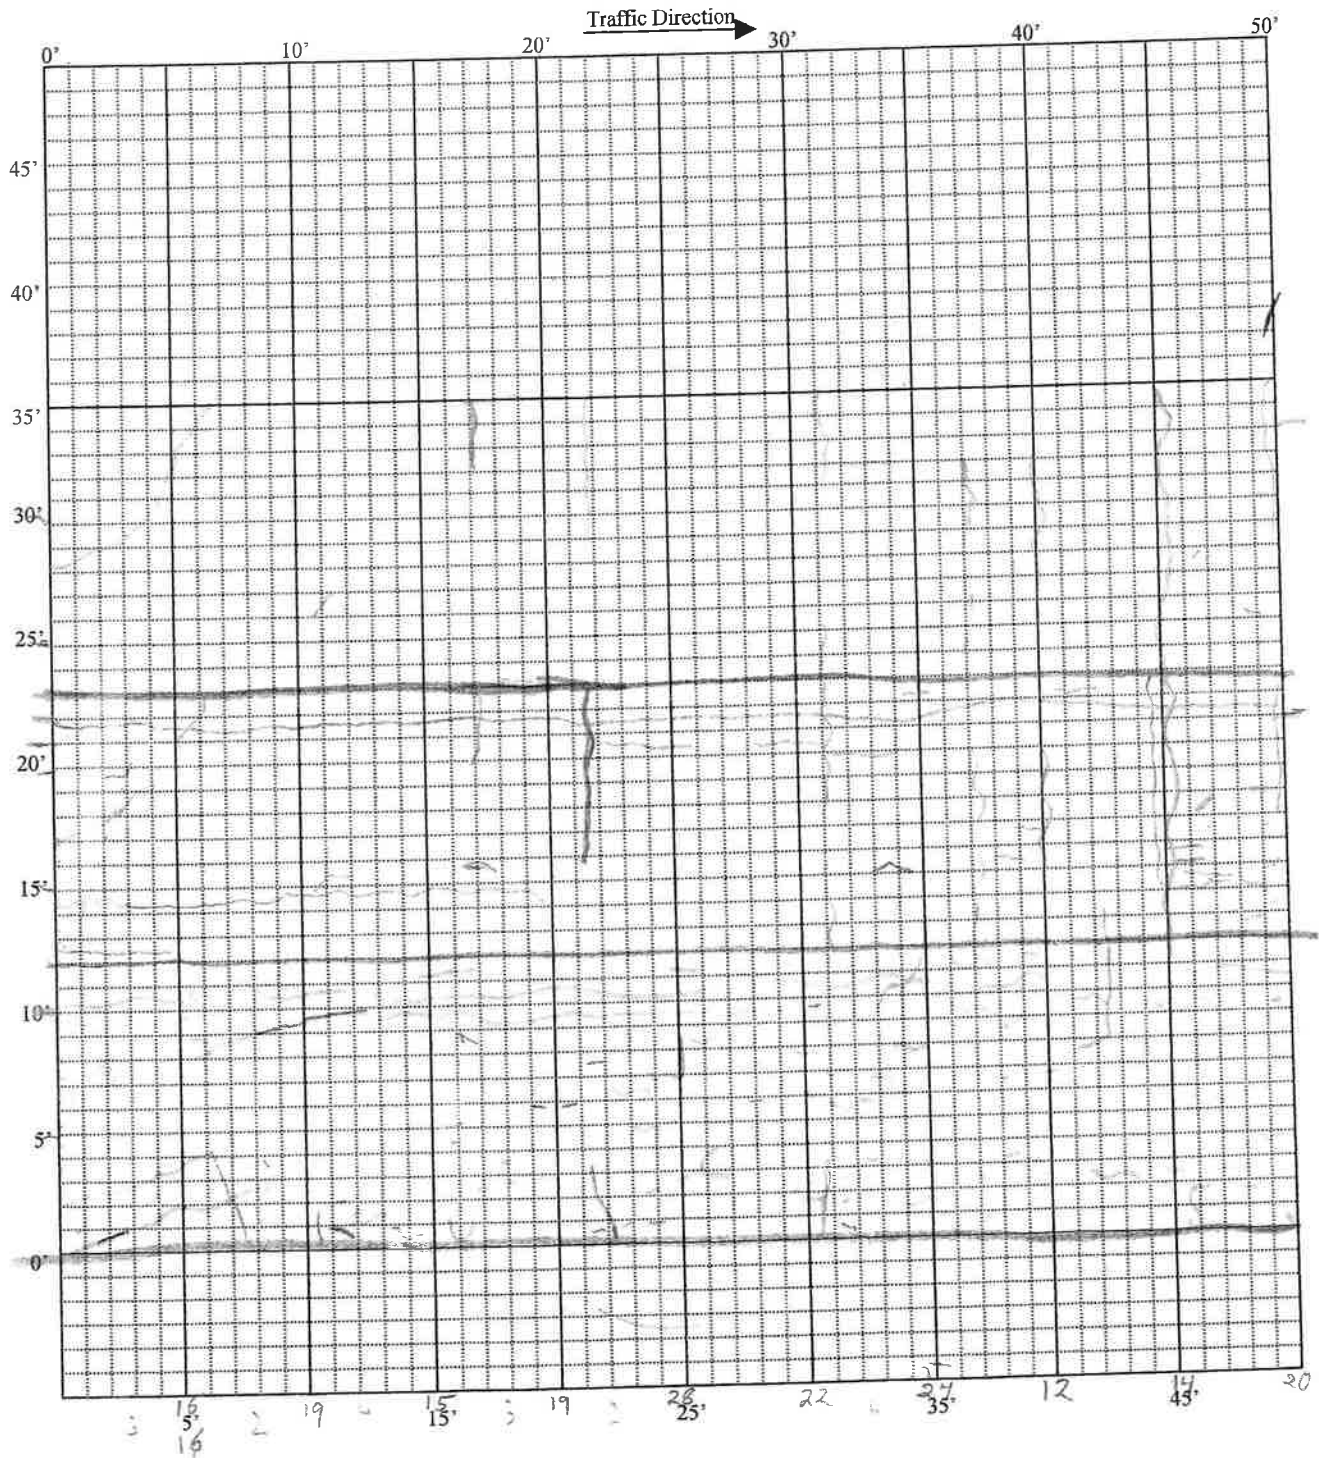
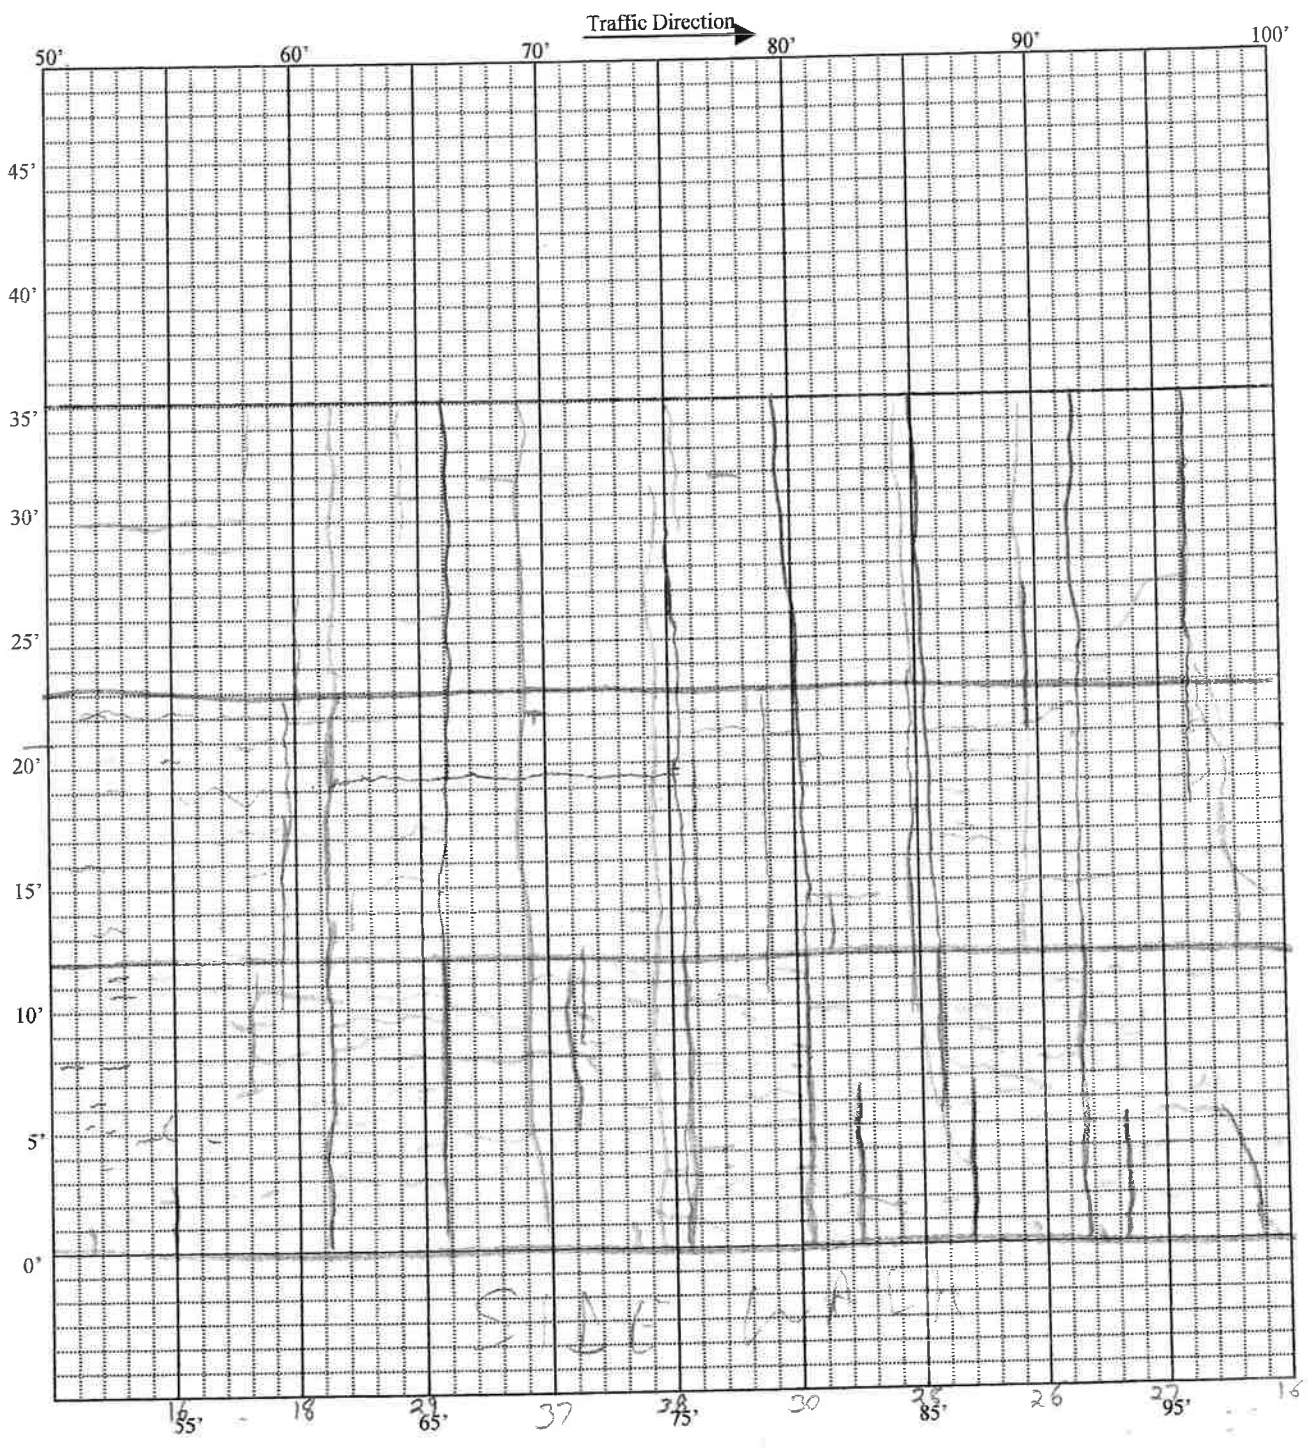
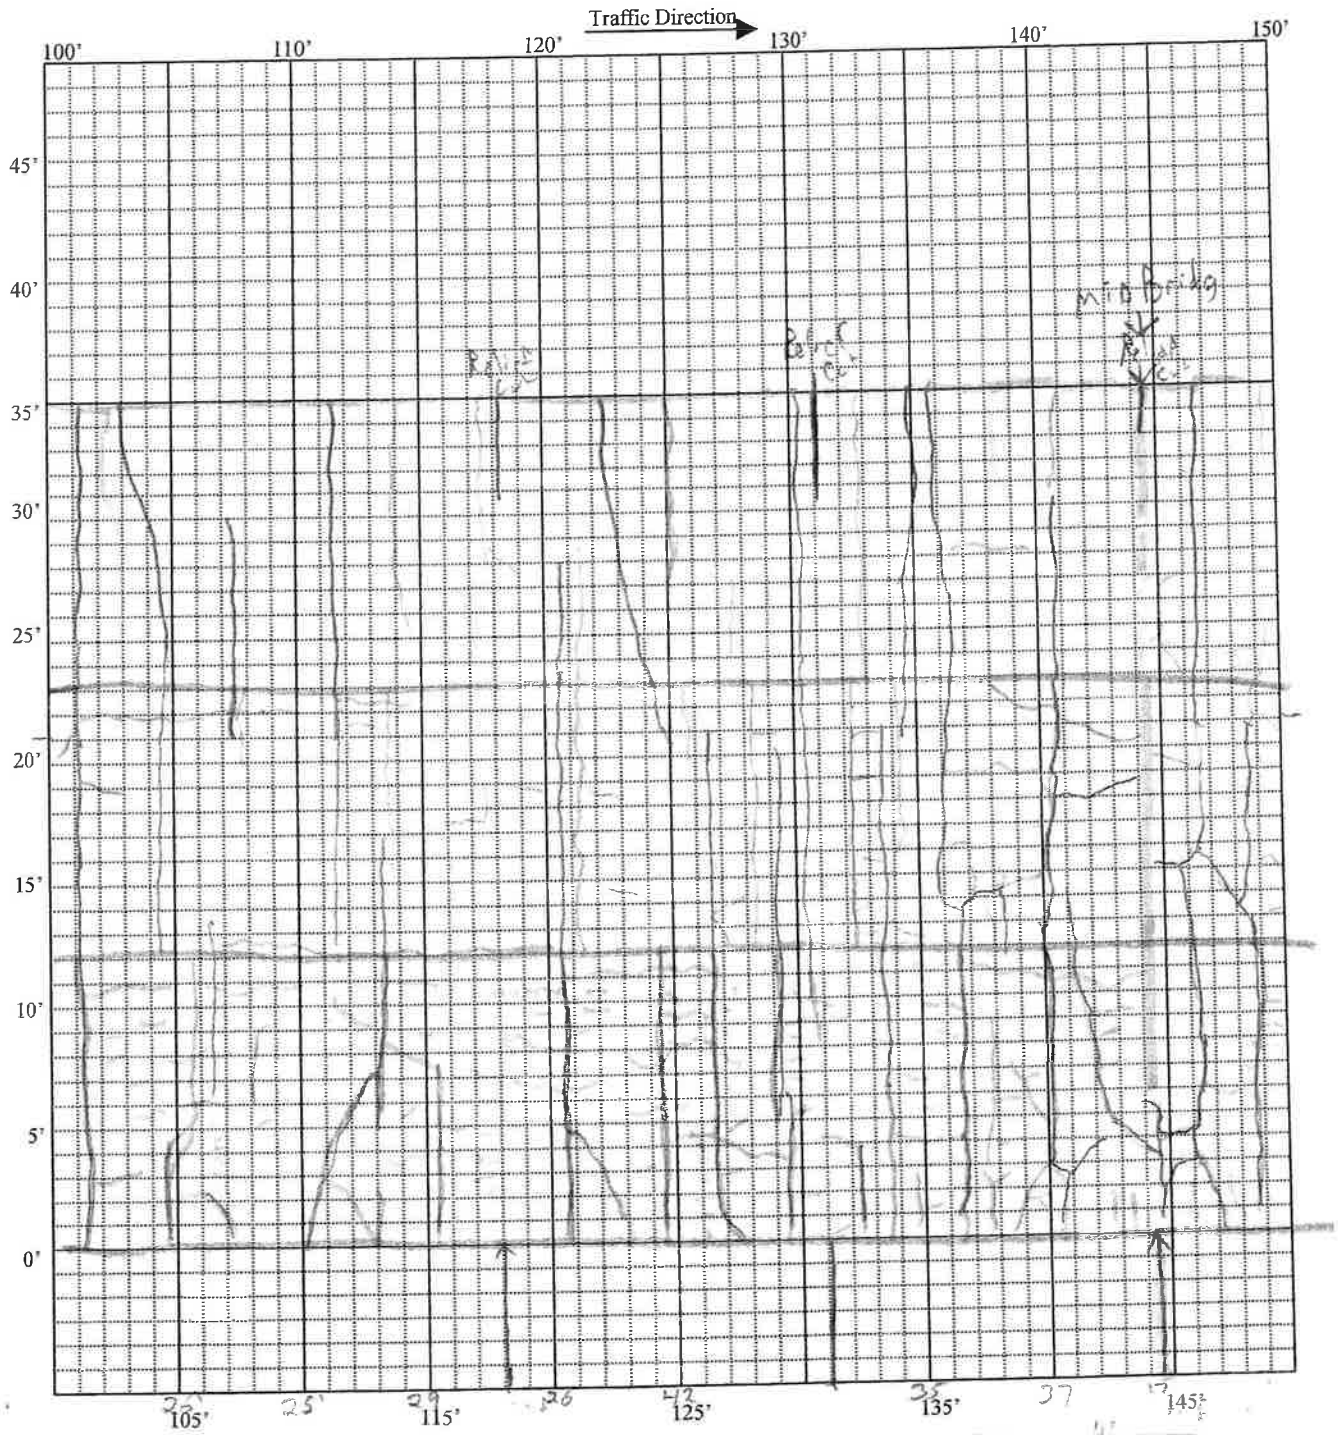
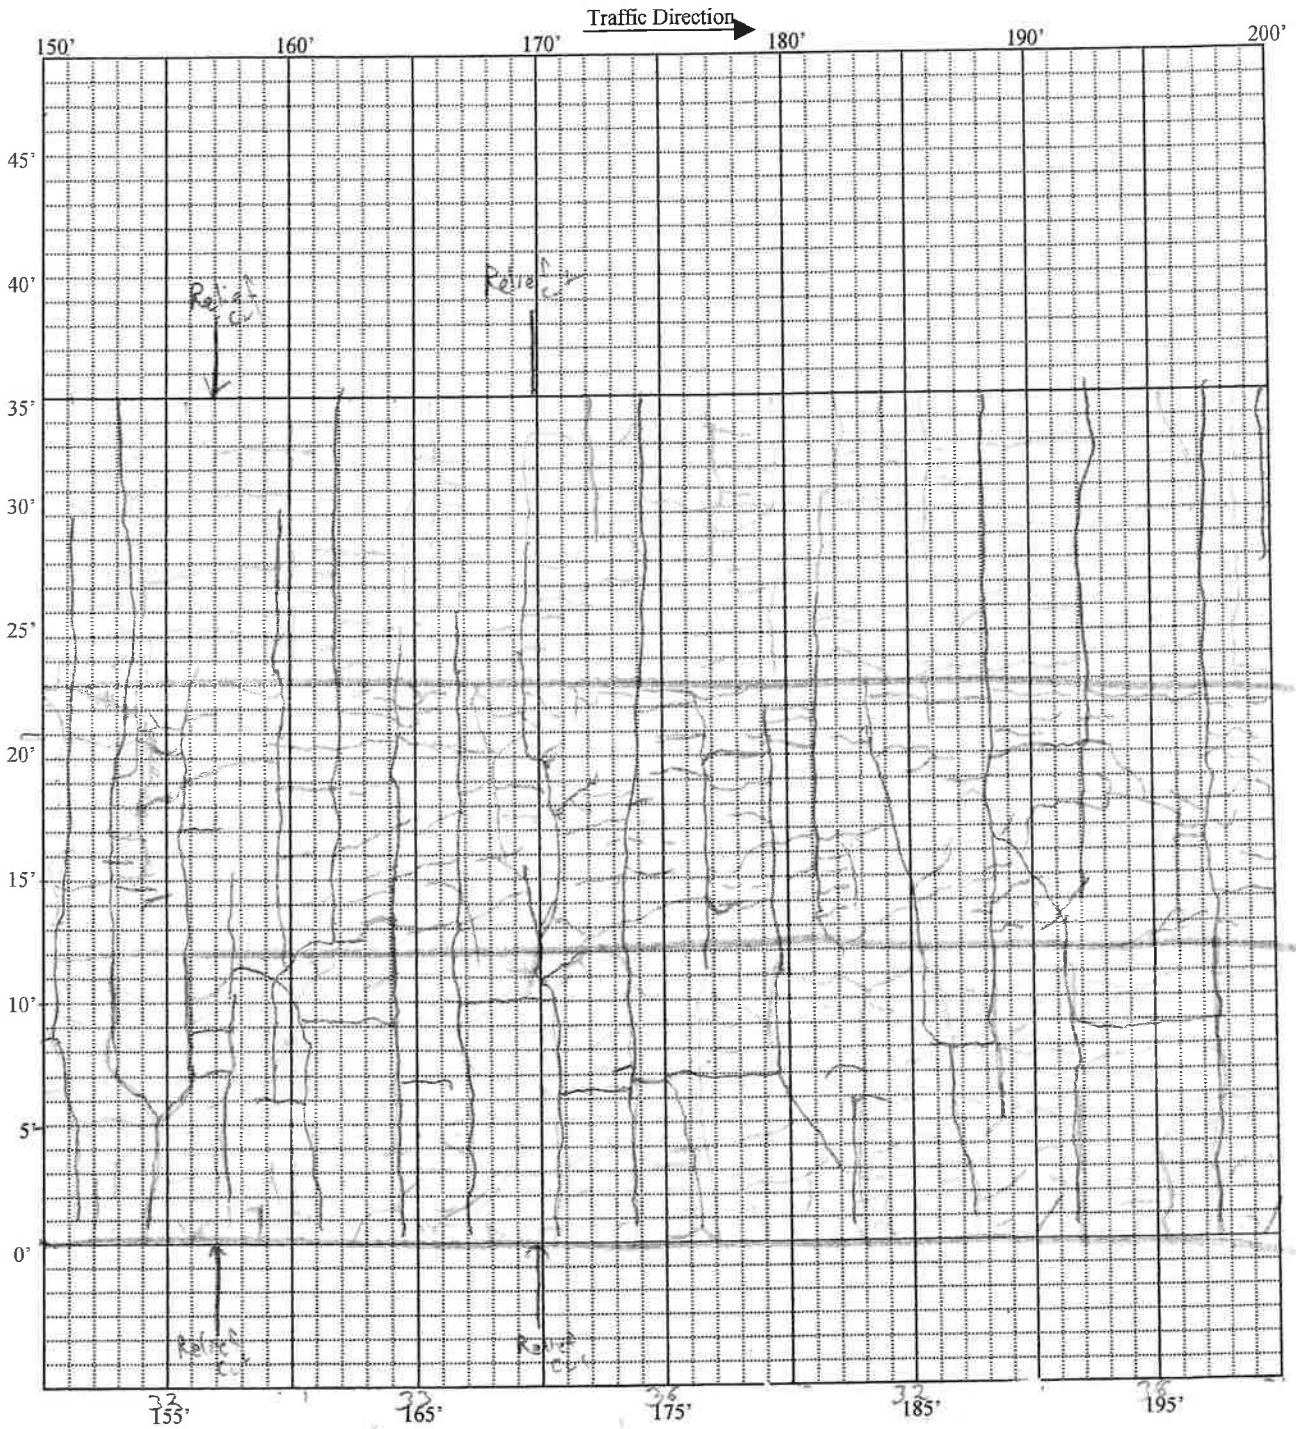
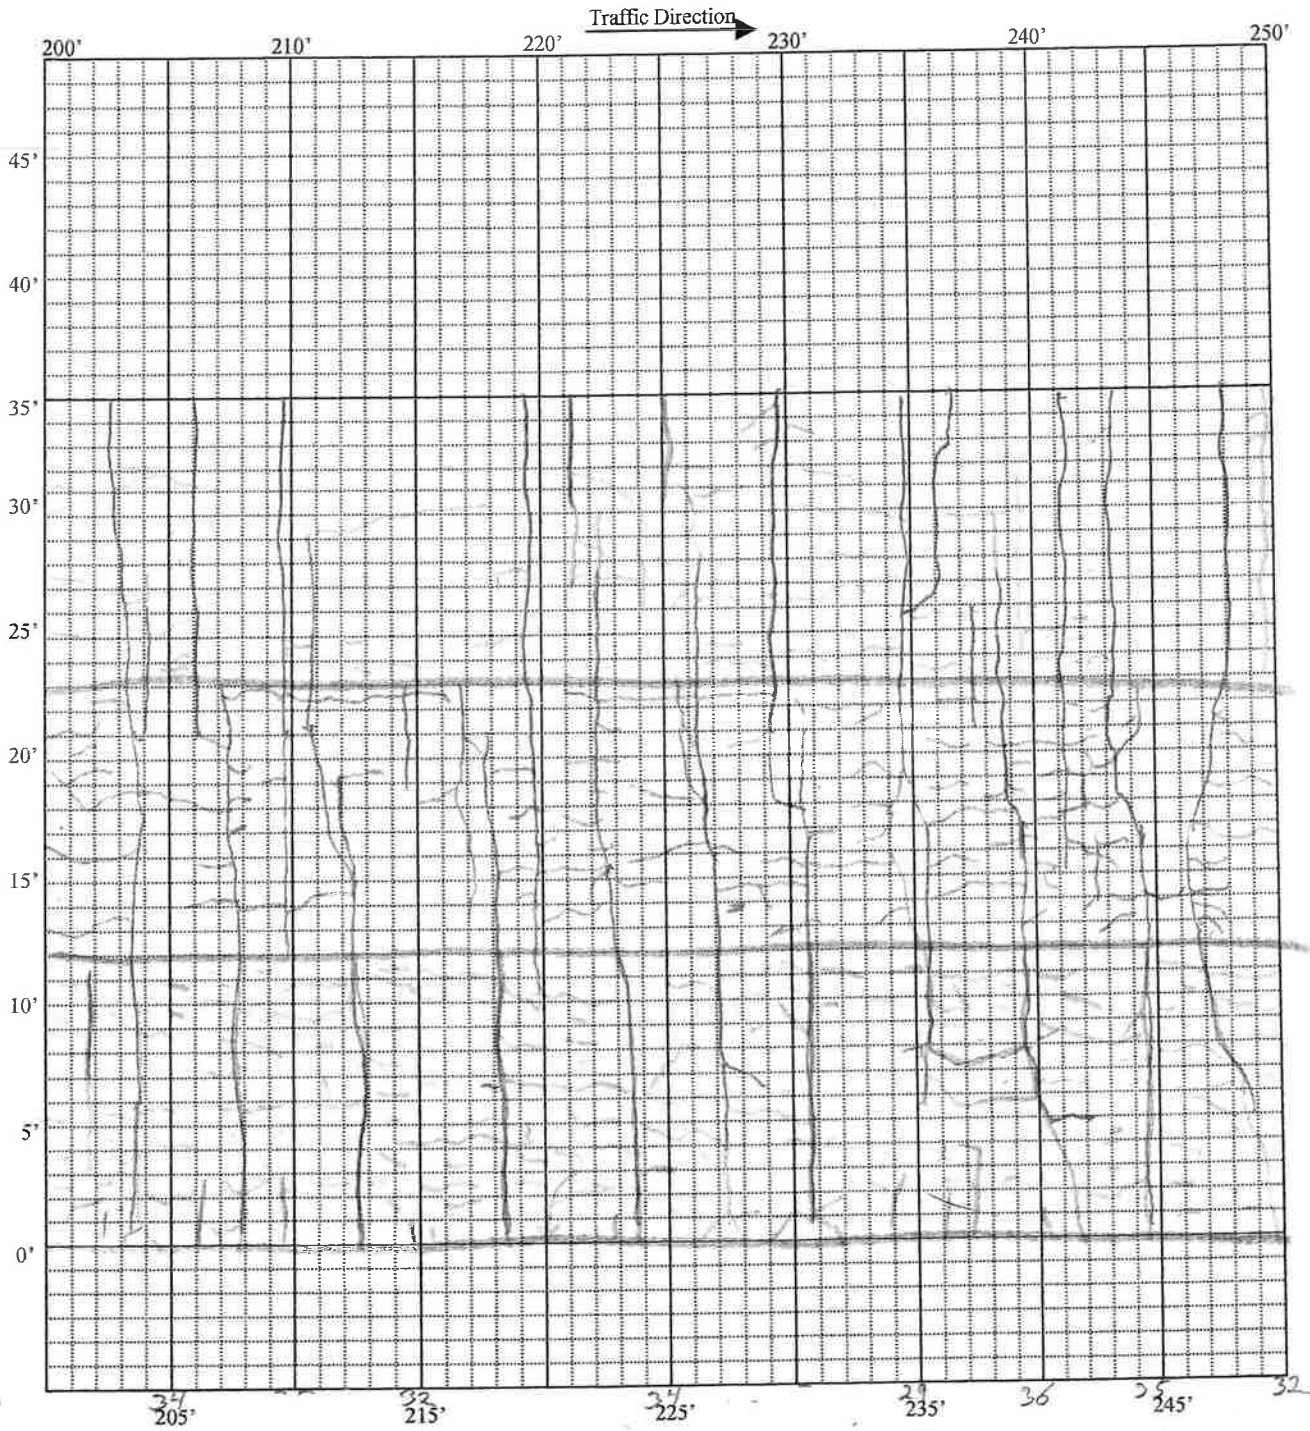
Project No. 030350 Project Name: I-30 E.B. Ramps - North (Hope) Surveyor: Greenwood, Tamara - W.H.L. 0-50

The second distress survey for job number 030350 was completed on January 14, 2010. The HPCC total crack length measured 672 feet and the total crack length for the control section was 1,190 feet. At the time of this distress survey there was approximately a 44% reduction in cracking with the HPCC when compared to the control section. The third and final distress survey was completed in two parts the first part, the westbound lanes, was surveyed on February 16, 2012 and the second part of the distress survey was completed on March 7, 2012. The HPCC section had 1,750 linear feet of cracking where the control section had 2,654 feet of linear cracking. The

reduction in cracking was approximately 34 percent when comparing the HPCC section to the control section.

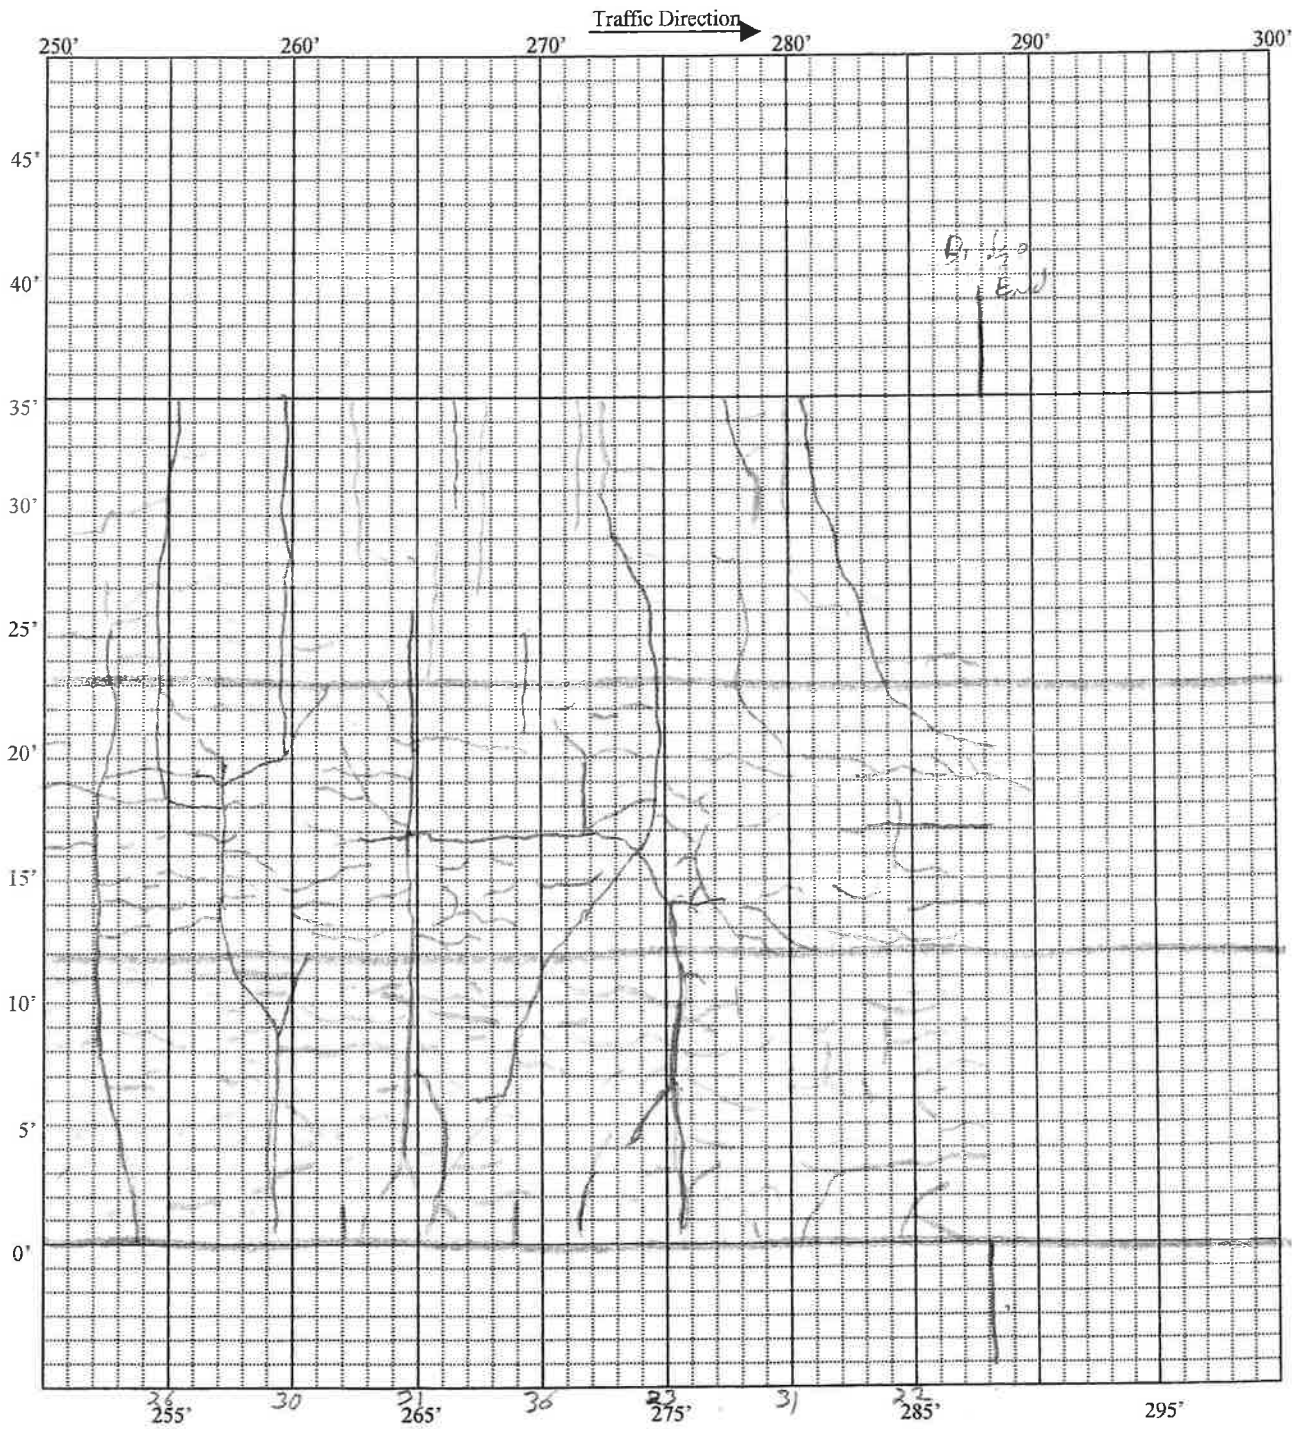
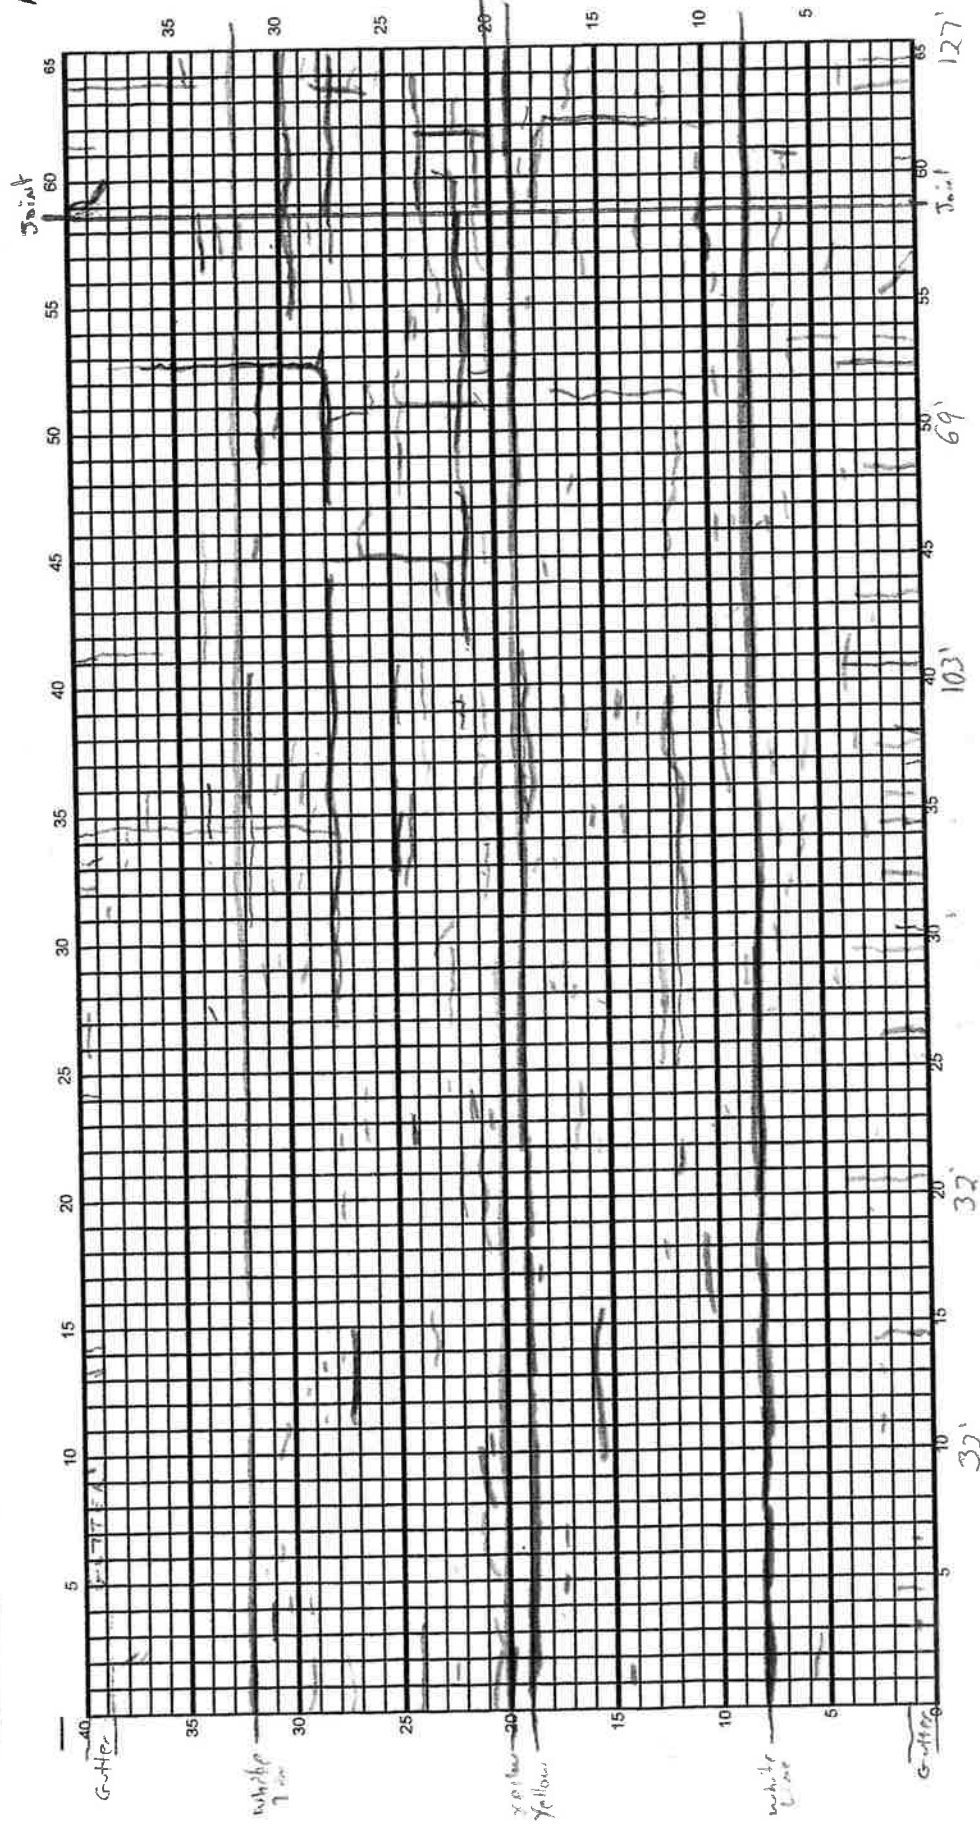
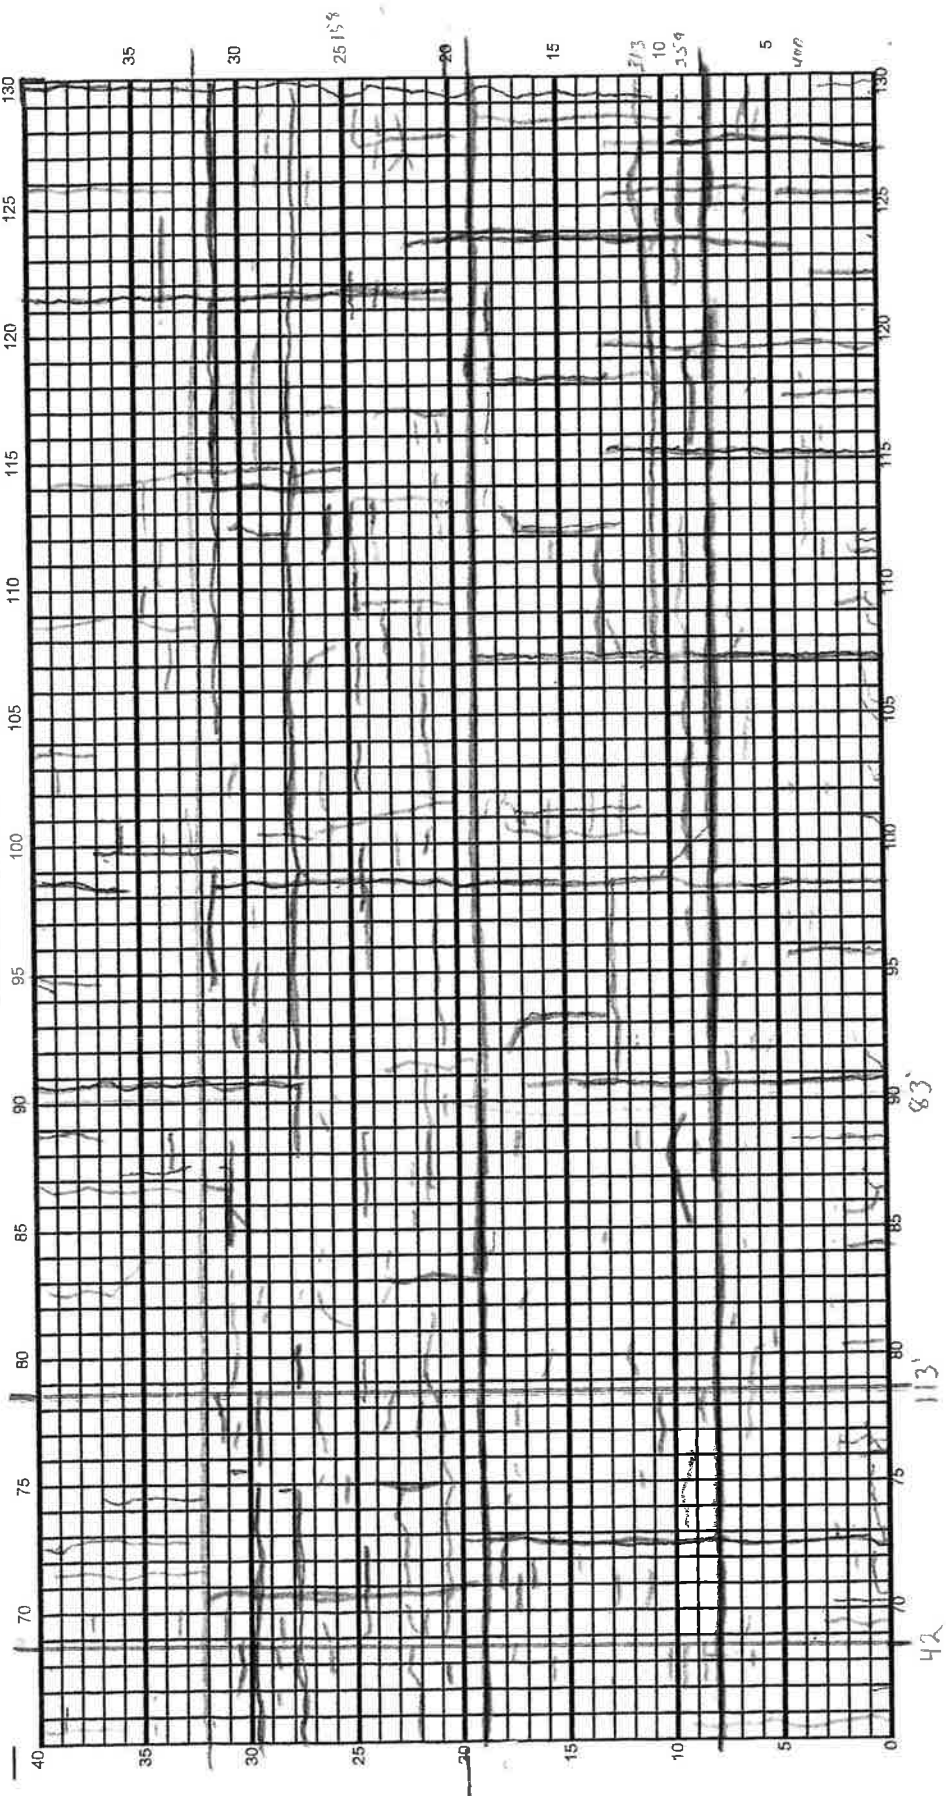
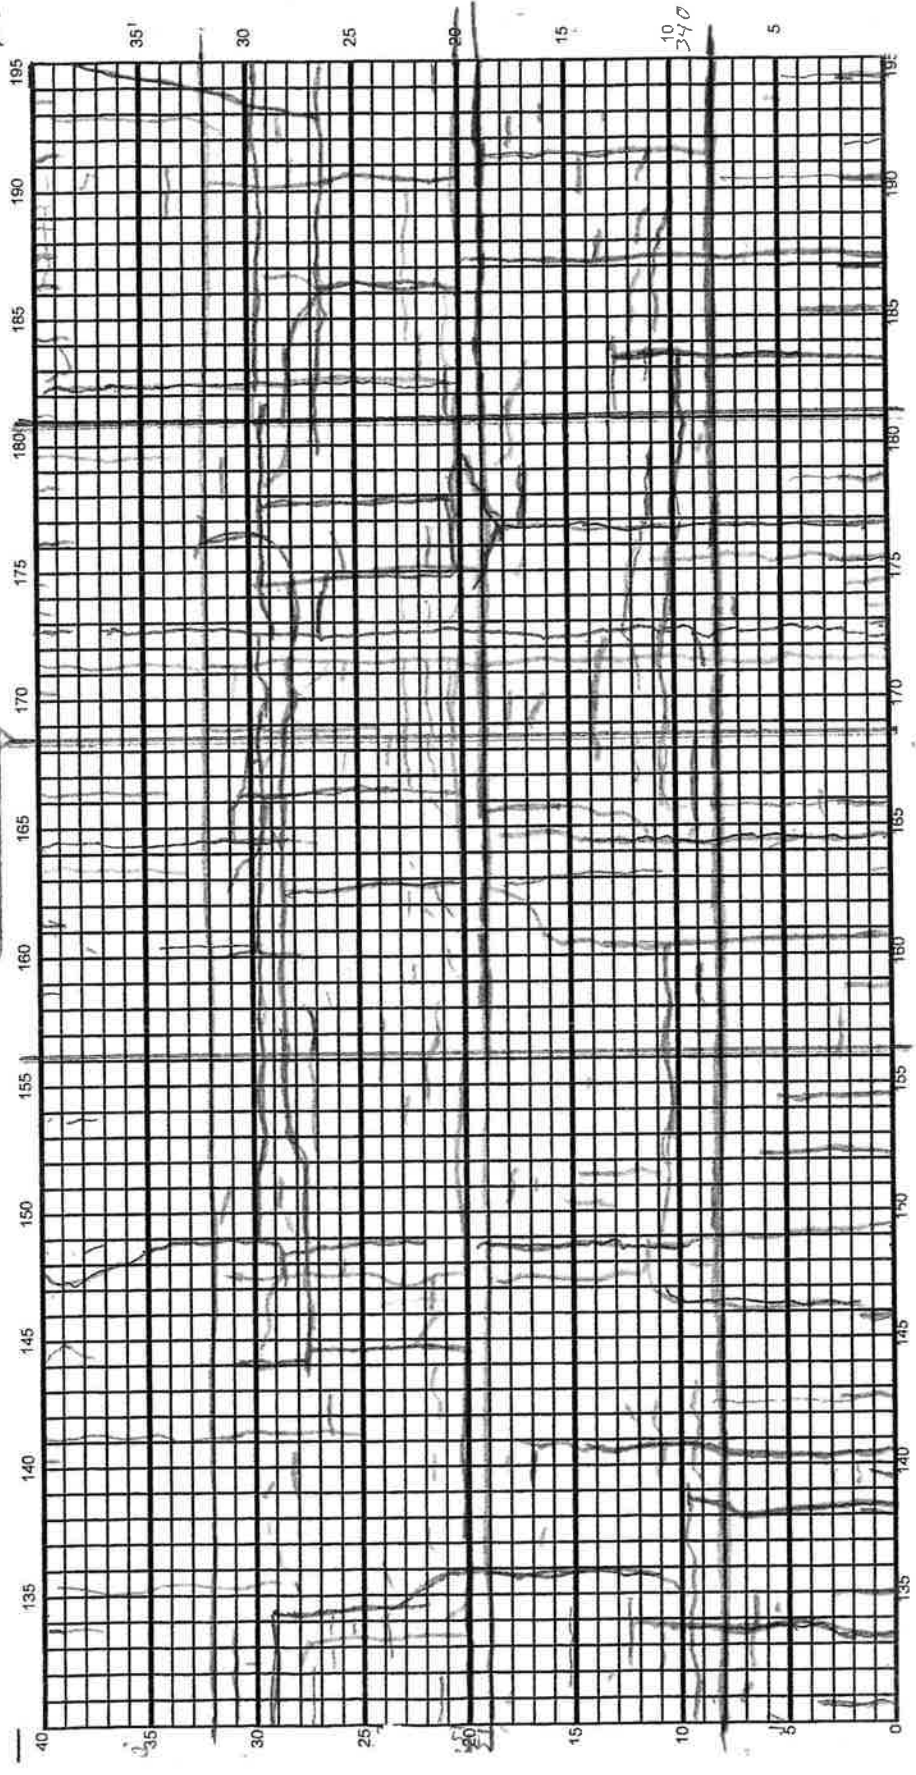
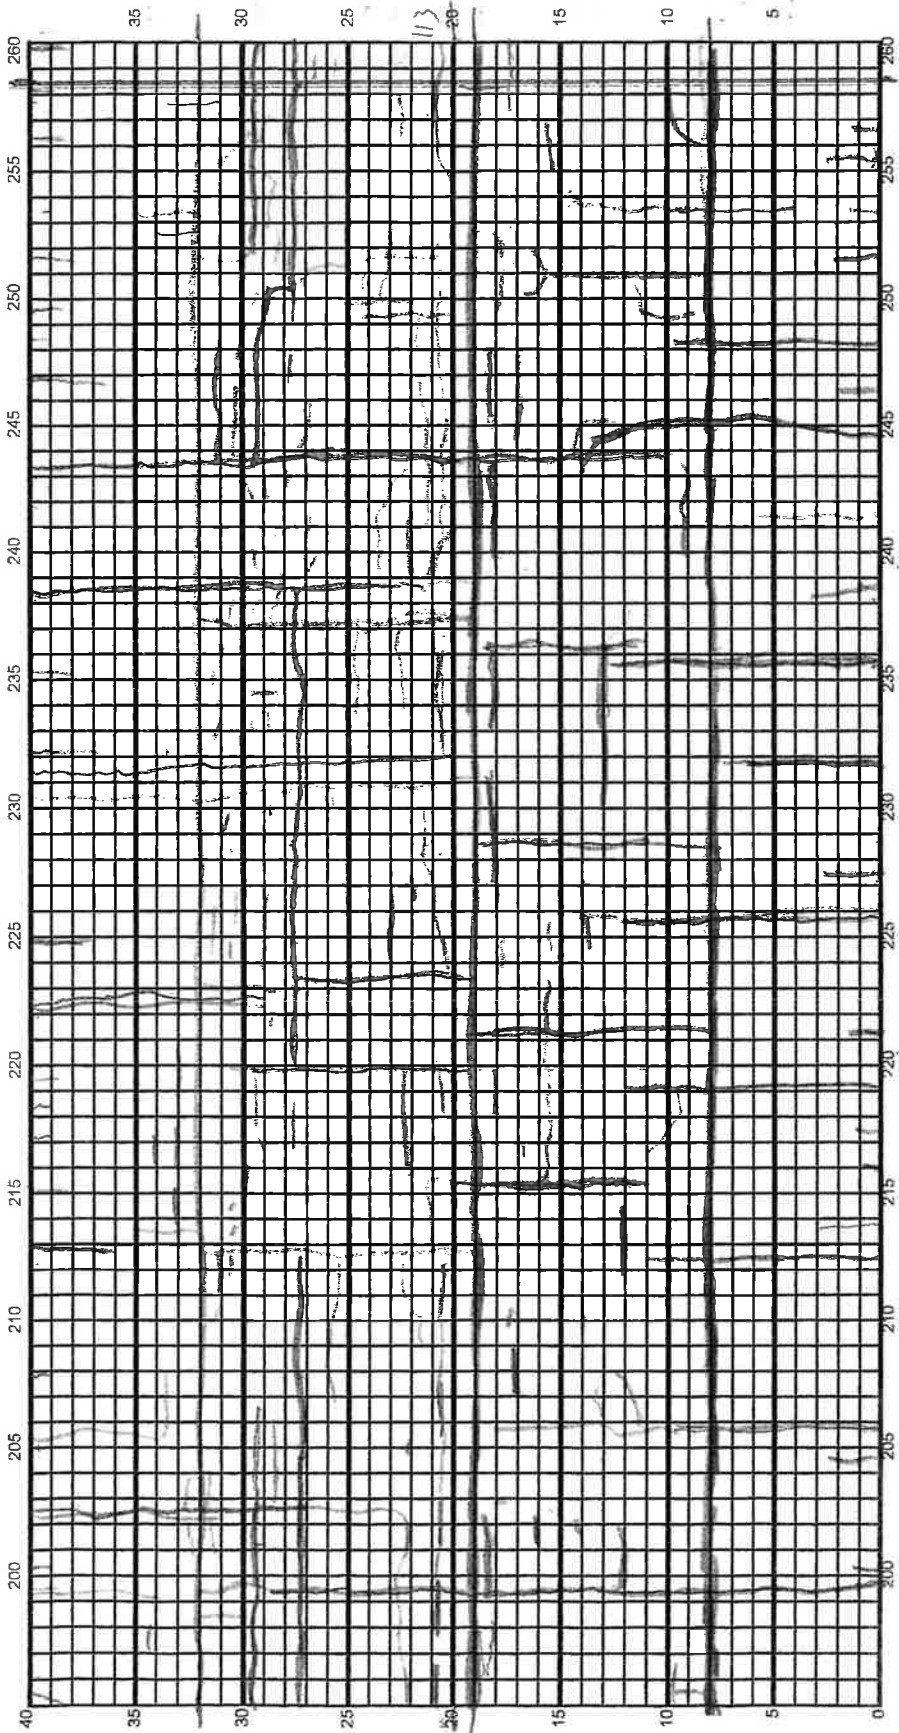
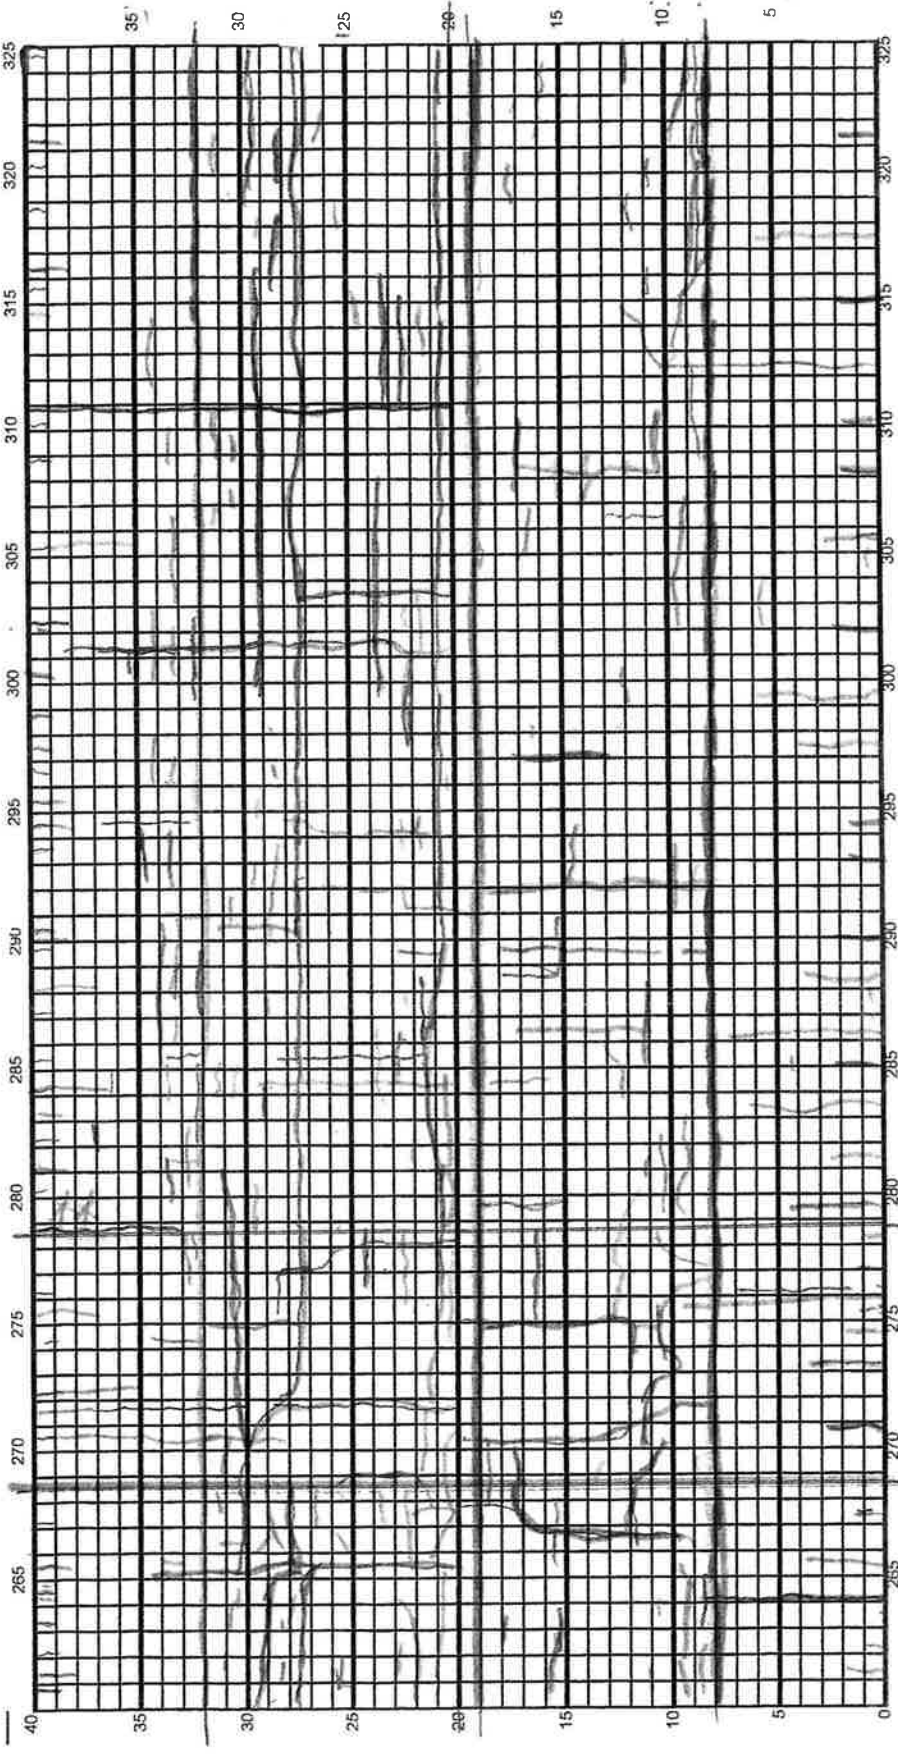
Project No. 03032Z  
Route 371, Sect. 5

The final bridge in the project was Job Number 030322 near Prescott, Arkansas. The bridge deck was placed on August 19, 2010 and the first distress survey was completed on October 20, 2010. There were 265 linear feet of cracking on the HPCC section of the deck and 327 linear feet of cracking on the control section. The HPCC section had a reduction in cracking of approximately 19% when compared to the control section at the time of the survey. The second distress survey was completed on March 24, 2011. The total crack length on the HPCC section was 906 linear feet and was 1,137 linear feet on the control section. This showed a reduction in cracking on the HPCC section of approximately 20% when compared to the control section. The third and final distress survey was completed on March 6, 2012. The control section had 1,978 linear feet of cracking where the HPCC section had 1,709 linear feet of cracking. The amount of cracking on the HPCC section of the bridge deck was reduced by approximately 14% when compared with the control half of the bridge deck.
