Guidelines for Selections of Pipe Culverts

**DURABILITY STUDY OF
VARIOUS CULVERT MATERIALS**

April 1999

1. Report No. FHWA/AR-98-007		2. Government Accession No.		3. Recipient's Catalog No.	
4. Title and Subtitle GUIDELINES FOR SELECTION OF PIPE CULVERTS				5. Report Date April 1999

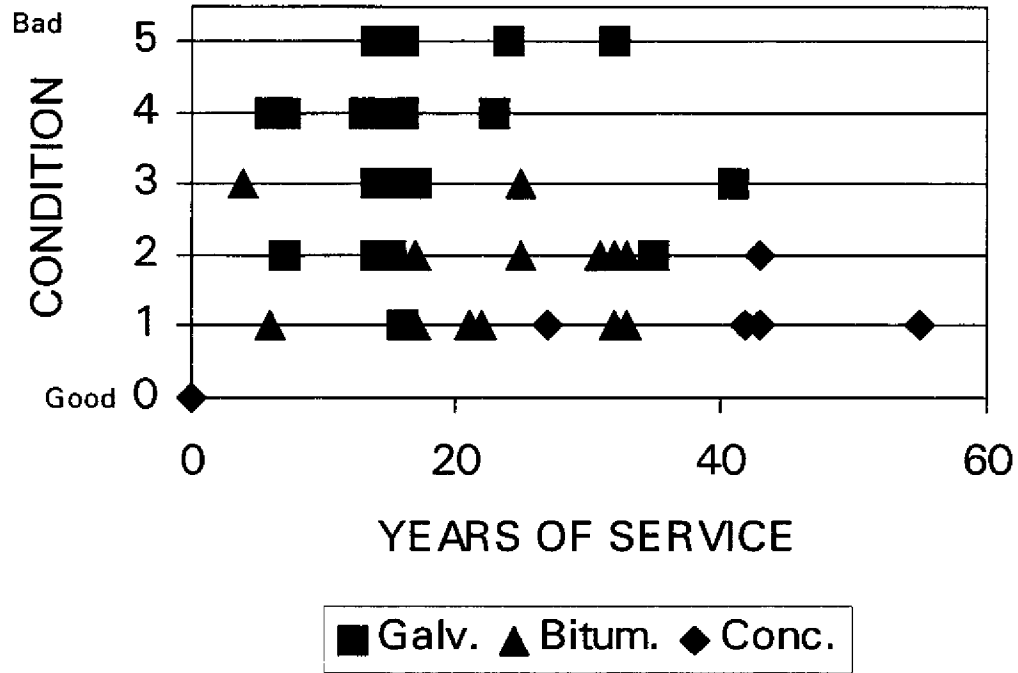
Figure 5 compares the condition rating given to culverts of these three types after observing them in the field. This figure suggests that the concrete pipe has a long service when installed in the site conditions studied, while galvanized pipe without any other coatings has a much shorter service life. Asphalt or bituminous-coated pipe also seemed to be durable, but it did not perform as well the concrete pipe.

Figure 5. Comparison of Condition Ratings

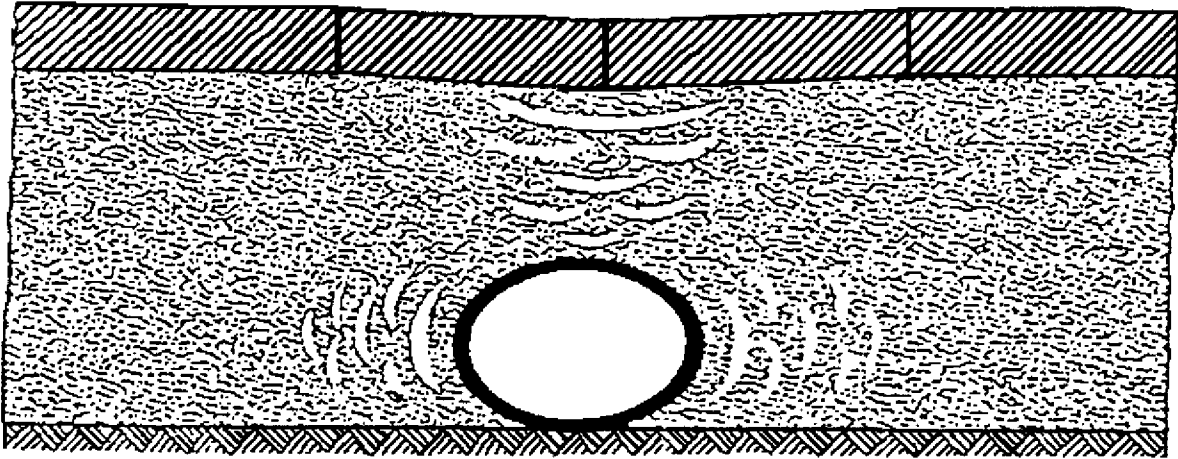
Rigid pavements (concrete) bridge over minor subsurface voids while flexible pavements (asphalt) have little bridging capability. Settlement of material beneath the pavement can lead to cracking in rigid and irregular settlement in flexible pavements as explained in Fig. 1.

Figure 16. Pavement failure due to inadequate compaction or material quality adjacent to flexible pipe. [Source: *Effects of Loads on Storm Drains and Culverts*, U.S. Army Corps of Engineers]

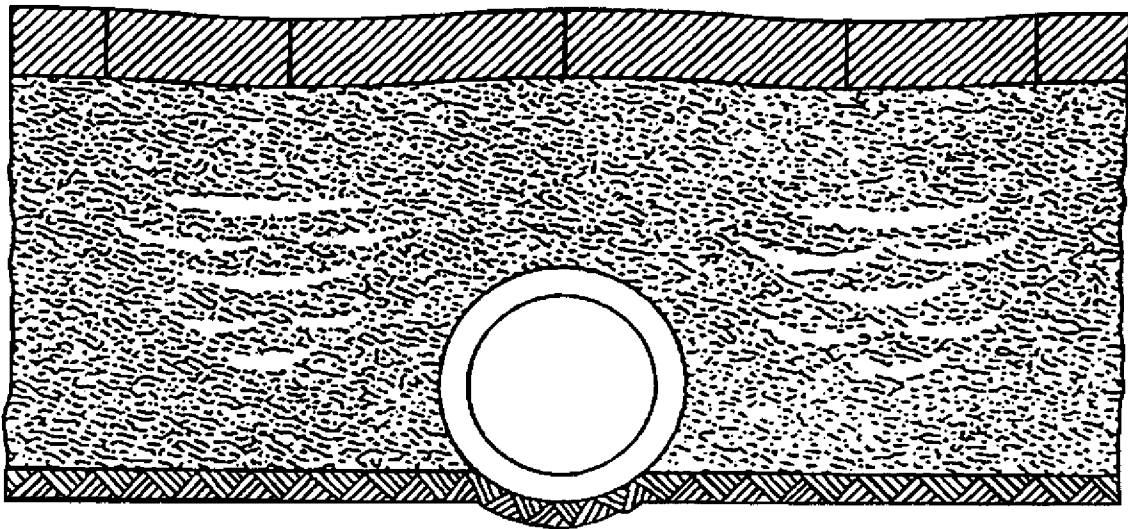
Flexible culverts will deflect if adequate lateral support is not provided by the surrounding soil. This may result in loss of support for the approach pavement and usually results in settlement over the culvert. Inadequate compaction of backfill for rigid culverts usually results in settlement beside the culvert as shown in Fig. 2.

Figure 17. Pavement failure due to inadequate compaction or material quality adjacent to rigid pipe. [Source: *Effects of Loads on Storm Drains and Culverts*, U.S. Army Corps of Engineers]

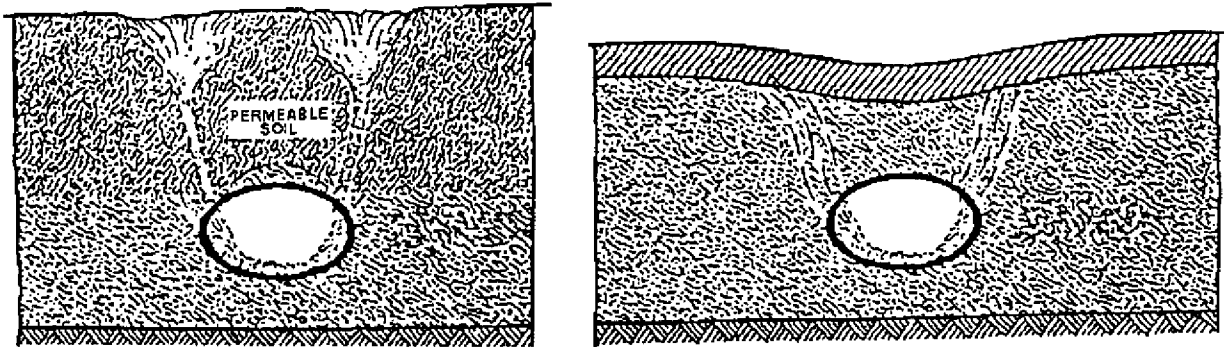
2. Vertical and horizontal misalignment of the pipes during construction may affect structural or hydraulic performance.
3. Joint defects of the pipes may lead to backfill infiltration and water exfiltration. Excessive seepage through an open joint can cause soil infiltration or erosion of the surrounding backfill material reducing lateral support. The defects in joints can affect the surrounding as shown in Fig. 3.

Figure 18. Surface indications of infiltration. Left: Effect on unpaved areas. Right: Effect on pavement.

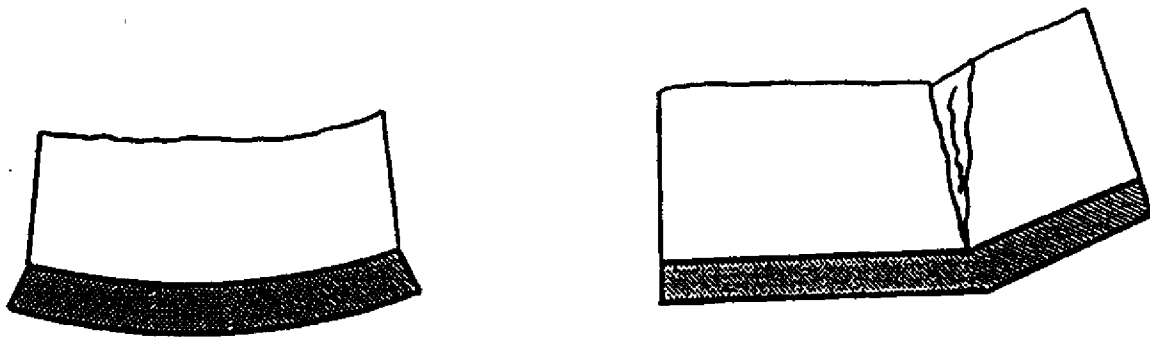
4. Defects in concrete footing may lead to failure of the pipe. The possible structural defect is differential settlement as shown in Fig. 4.
5. Defects in concrete inverts may lead to erosion as shown in Fig. 5.

Figure 19. Differential footing settlement. Left: No distress in arch. Right: Distress in arch.

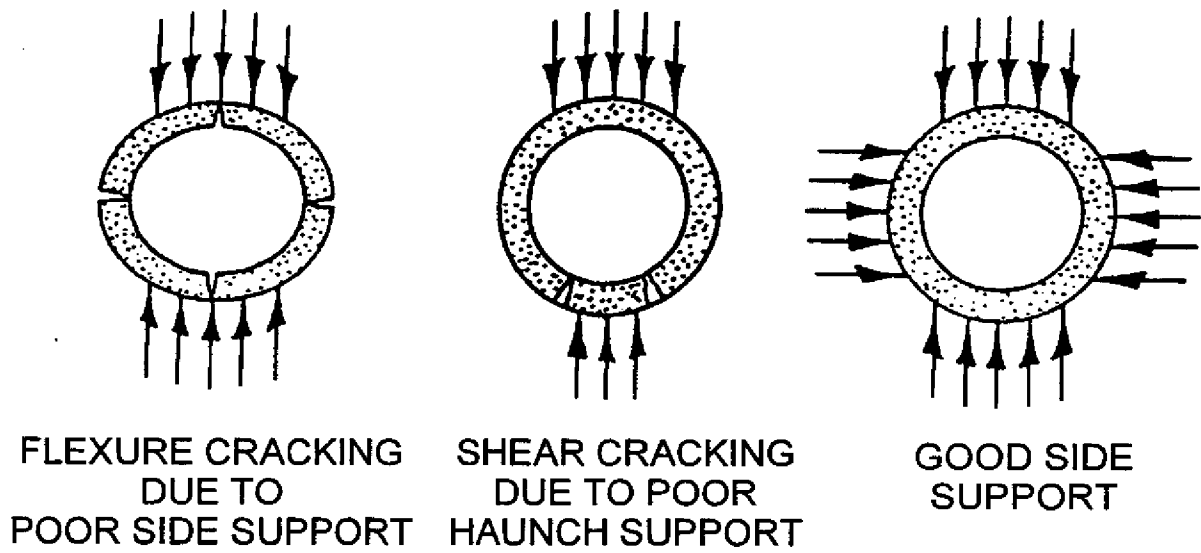
5. Longitudinal cracks: Longitudinal cracking in excess of 0.1 inch in width may indicate overloading or poor bedding. If the pipe is placed on hard material and backfill is not adequately compacted around the pipe or under the pipe, loads will be concentrated along the bottom of the pipe and may result in flexure or shear cracking as illustrated in Fig. 6.

Figure 21. Results of poor and good side support, rigid pipe.

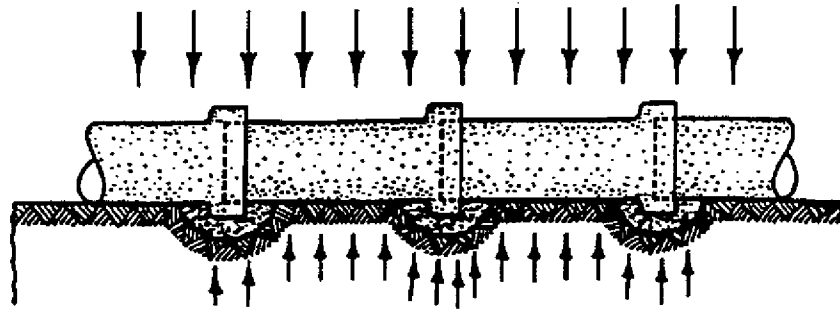
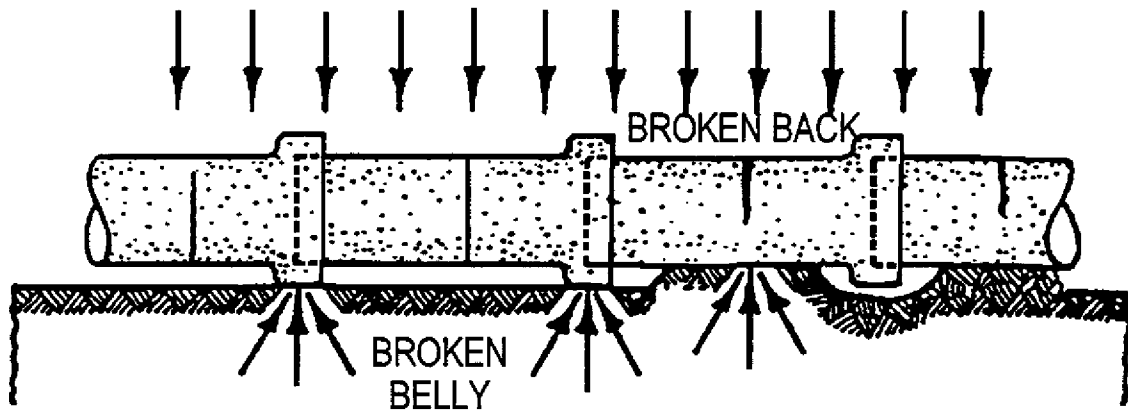
6. Transverse Cracks: Transverse or circumferential cracks may be caused by poor bedding. Cracks can occur at the bottom of the pipe when the pipe is supported only at the ends of each section. This is generally the result of poor construction practices. Cracks may occur at the top of the pipe when settlement occurs and rocks or other areas of hard foundation material near the midpoint of a pipe section are not adequately covered with suitable bedding material. Transverse cracking is illustrated in Fig. 7.

PROPERLY PREPARED BEDDING EVENLY DISTRIBUTES LOADS.
PROPERLY PREPARED BEDDING MAY RESULT IN STRESS CONCENTRATION

IMPROPERLY PREPARED BEDDING

Figure 22. Transverse or circumferential cracks.
