INVESTIGATION OF THE EFFECTIVENESS
OF BRIDGE BEARING ANCHOR DEVICES
AND BRIDGE JOINT COMPRESSION SEALS

FINAL REPORT

HIGHWAY RESEARCH PROJECT 56

AUGUST, 1979

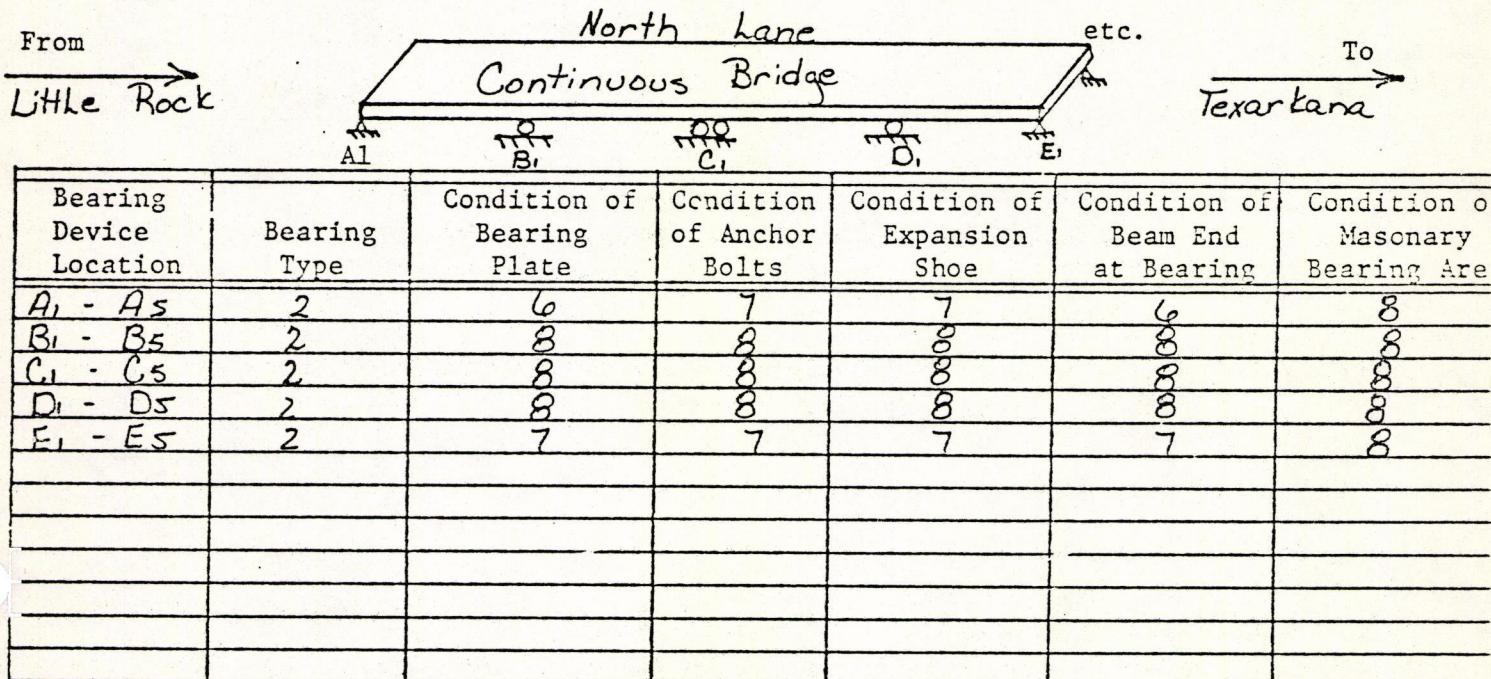
1. STATE Arkansas 2. DIST. 3 3. COUNTY 46 Miller
4. ROUTE U.S. 71 5. SEC. 3 6. LOG 2.90 7. BR. NO. 5142 A
8. FEATURE INTERSECTED Over I-30
9. BRIDGE ON HIGHWAY State Line Road (Arkansas Side)
10. YEAR BUILT 1964 11. MAIN SPAN (TYPE) I-Beam

Comments No Bridge No Headwall Cracked

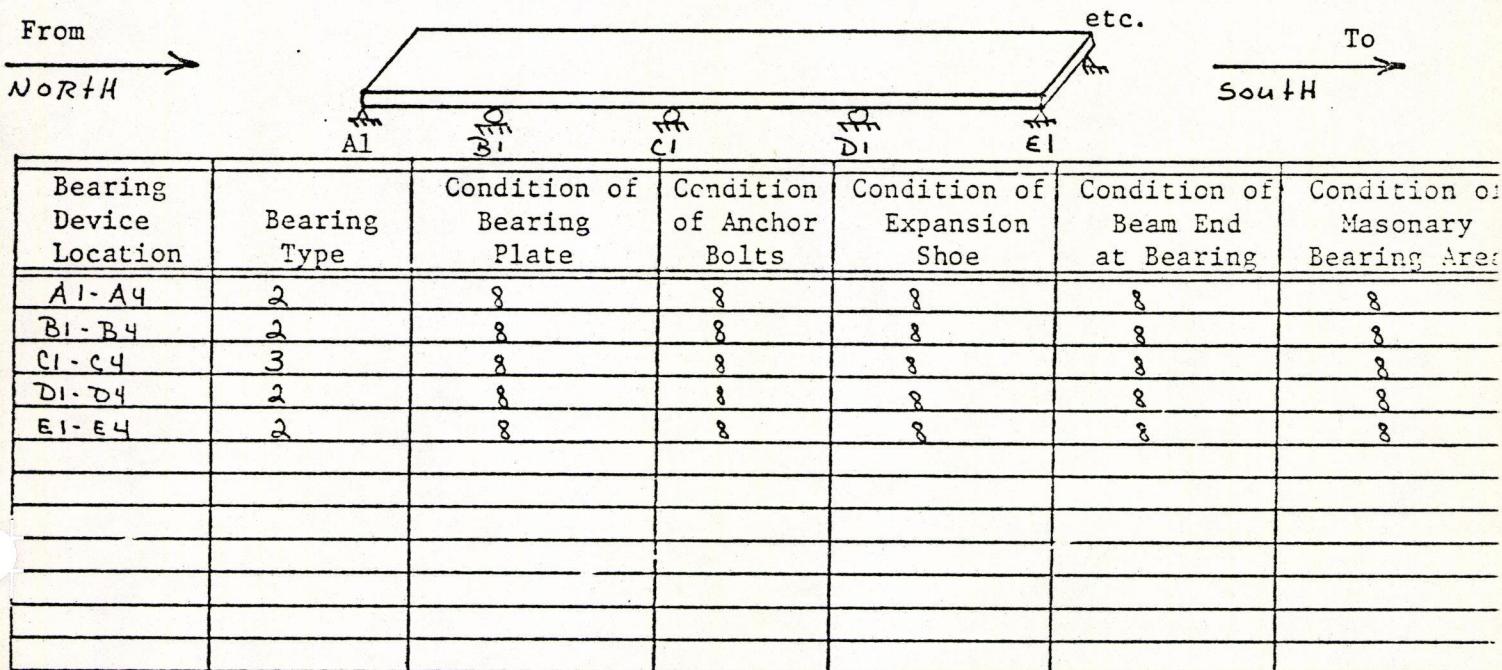
1. STATE Arkansas 2. DIST. 4 3. COUNTY 24 FRANKLIN
4. ROUTE Cry. Rd. 5. SEC. 12 6. LOG 29.34 7. BR. NO. 5112
8. FEATURE INTERSECTED OVER I-40
9. BRIDGE ON HIGHWAY TONEY Rd.
10. YEAR BUILT 1971 11. MAIN SPAN (TYPE) I-Beam

Comments Photo of Neoprene Joint #35

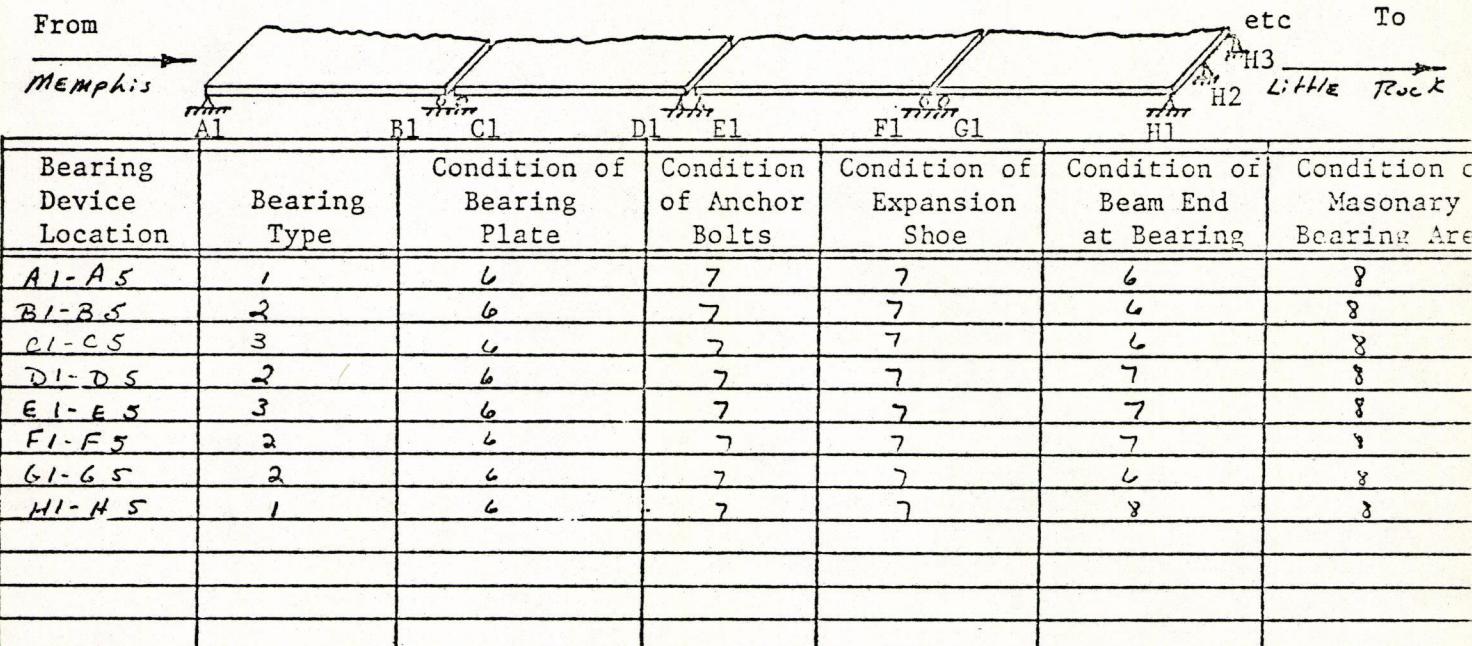
1. STATE Arkansas 2. DIST. 6 3. COUNTY Prairie (59)
4. ROUTE I-40 5. SEC. 42 6. LOG 19718 7. BR. NO. A 3711
8. FEATURE INTERSECTED CRT & PRR RAILROAD
9. BRIDGE ON HIGHWAY I-40
10. YEAR BUILT 1965 11. MAIN SPAN (TYPE) I-Beam

Comments COVER R's ALL HAD EXPANSION ROOM
(PHOTO OF ABUTMENT WASHOUT)

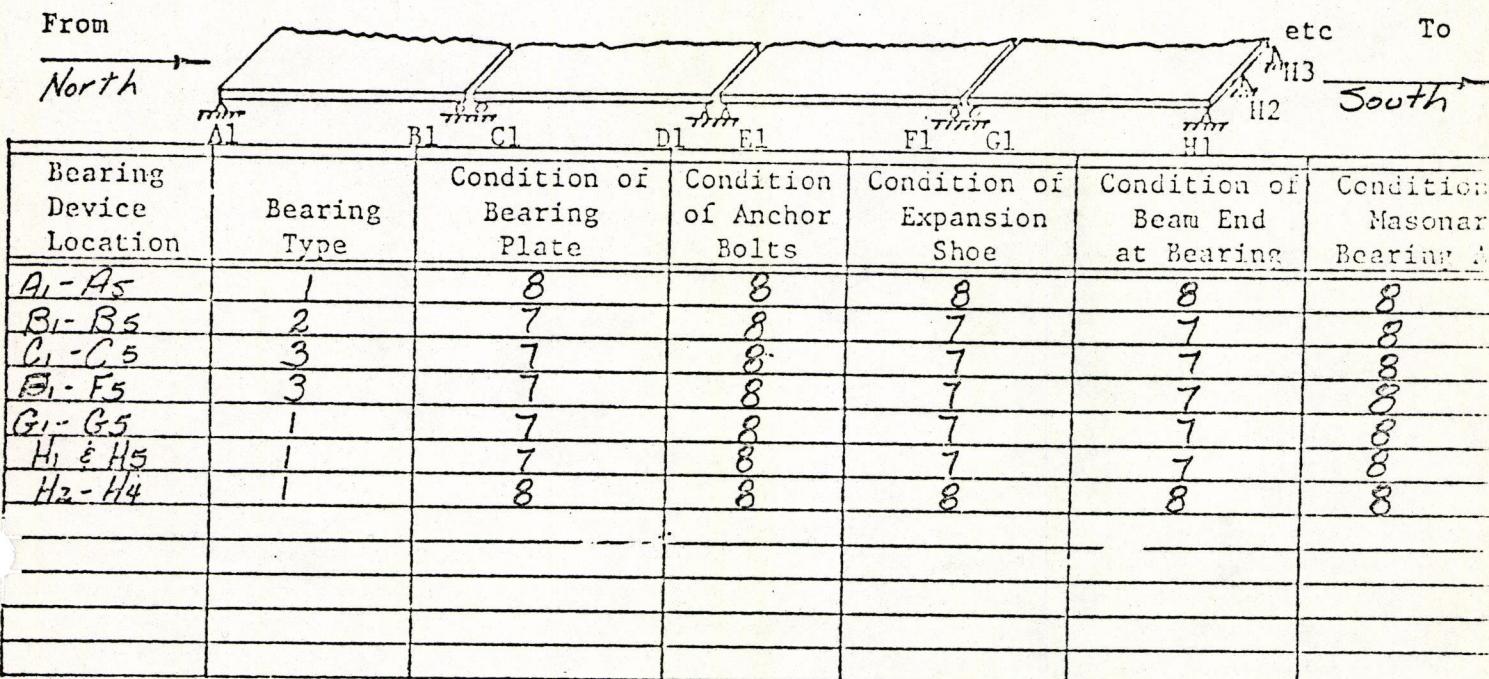
1. STATE Arkansas 2. DIST. 9 3. COUNTY 8 Carroll
4. ROUTE S.H. - 103 5. SEC. 4 6. LOG 6.81 7. BR. NO. 5082
8. FEATURE INTERSECTED over Osage Creek
9. BRIDGE ON HIGHWAY S.H. - 103
10. YEAR BUILT 1967 11. MAIN SPAN (TYPE) I-Beam

Expansion Joint Location	Type	Condition of Joint Device	Width of Joint Measured Under Bridge			Width of Joint Measured on Top of Bridge		
			Near Side	Center	Far Side	Near Side	Center	Far Side
A	3	✓				1.210"	1.300"	1.370"
BC	3	Failed				1.105"	1.272"	1.403"
DE	3	✓				2.382"	2.464"	2.052"
FG	3	Failed				1.316"	1.539"	1.267"
H	3	✓				1.210"	1.422"	1.455"

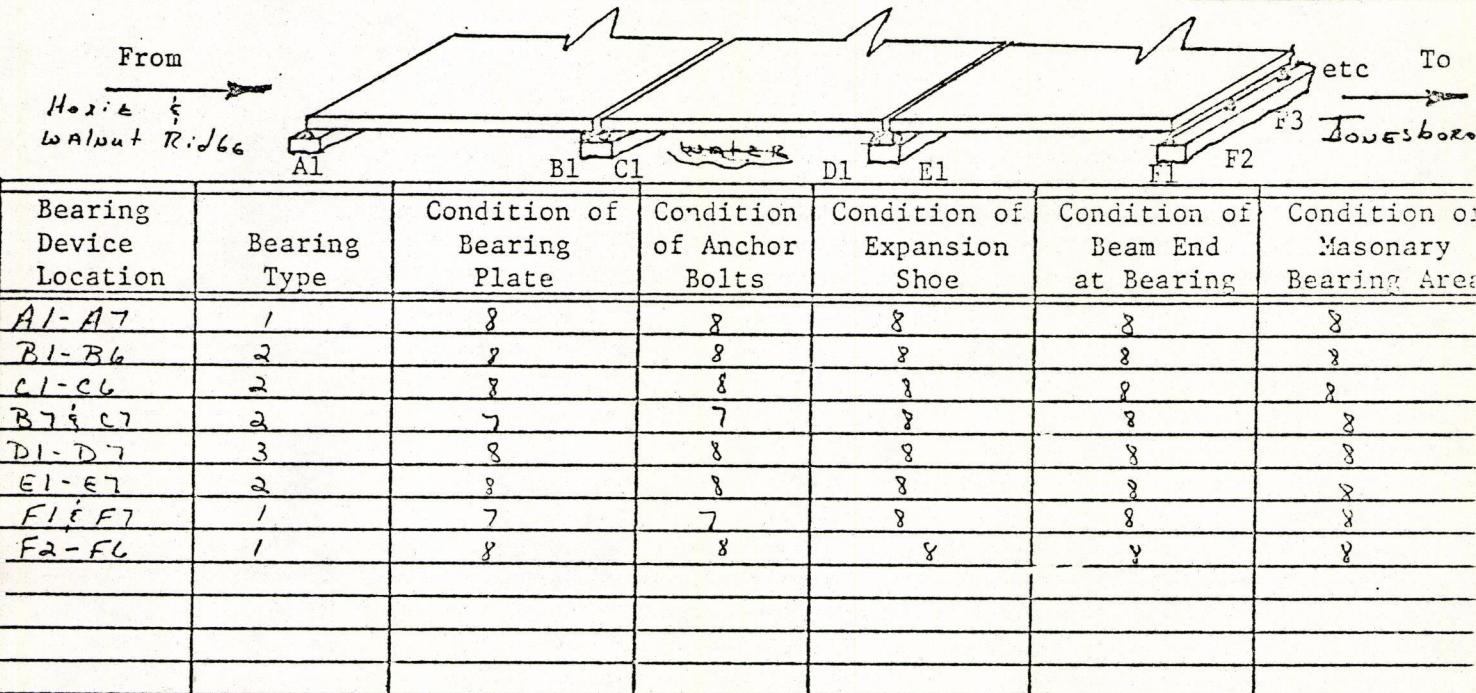
Expansion Joint Location	Type	Condition of Joint Device	Width of Joint Measured Under Bridge			Width of Joint Measured on Top of Bridge		
			Near Side	Center	Far Side	Near Side	Center	Far Side
A	3	O.K.	MAT'L. MOVING IN SLOP	1.400"	1.429"	1.326"		
B	3	O.K.	2.750"	2.858"	3.006"	2.951"	2.999"	2.999"
C	3	O.K.				1.962"	1.734"	2.025"
D	3	O.K.					1.400"	1.429"
E	3	O.K.						1.326"
F	3	O.K.

Comments Some Dirt Build-up on A-piers but base P's
ARE IN SURPRISINGLY Good Condition.

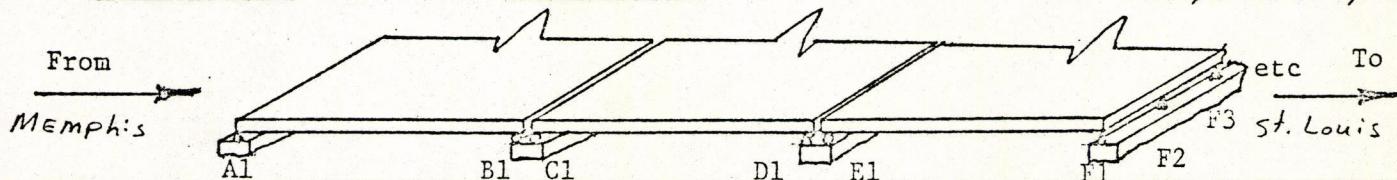
Bearing Device Location	Bearing Type	Condition of Bearing Plate	Condition of Anchor Bolts	Condition of Expansion Shoe	Condition of Beam End at Bearing	Condition of Masonary Bearing Area
A1-A5	1	6	7	7	8	8
B1-B5	3	7	7	7	7	8
C1-C5	2	7	7	7	7	8
D1-D5	3	7	7	7	8	8
E1-E5	3	7	7	7	7	8
F1-F5	1	6	7	7	8	8

Expansion Joint Location	Type	Condition of Joint Device	Width of Joint Measured Under Bridge			Width of Joint Measured on Top of Bridge		
			Near Side	Center	Far Side	Near Side	Center	Far Side
B-C	2	OK		.525"				
D-E	2	OK		2.060"	FIXED	Both BEAM ENDS

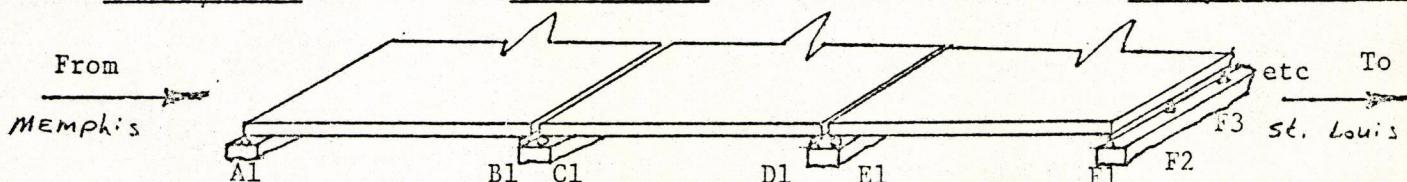
Bearing Device Location	Bearing Type	Condition of Bearing Plate	Condition of Anchor Bolts	Condition of Expansion Shoe	Condition of Beam End at Bearing	Condition of Masonry Bearing Are
A1 - A5	1	6	7	7	8	8
B1 - B5	3	7	7	7	7	8
C1 - C5	2	7	7	7	6	8
D1 - D5	3	7	7	7	7	8
E1 & E5	3	7	7	7	7	8
F2 - F4	3	7	7	7	6	8
F1 - F3 & F5	1	6	6	7	8	8
F4	1	6	6	7	7	8

Expansion Joint Location	Type	Condition of Joint Device	Width of Joint Measured Under Bridge			Width of Joint Measured on Top of Bridge		
			Near Side	Center	Far Side	Near Side	Center	Far Side
B C	2	OK		0.634"				
D E	2	OK		2.084"

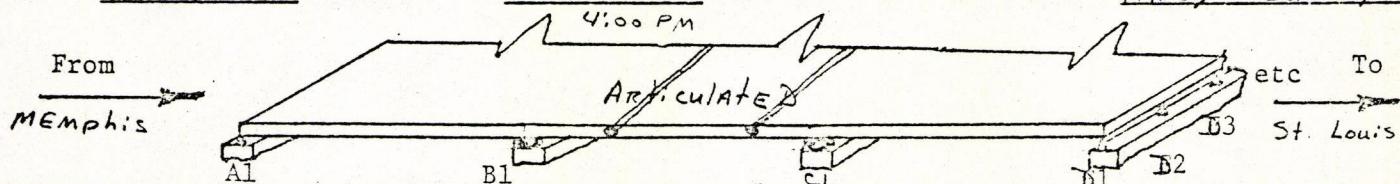
Bearing Device Location	Bearing Type	Condition of Bearing Plate	Condition of Anchor Bolts	Condition of Expansion Shoe	Condition of Beam End at Bearing	Condition of Masonary Bearing Area
A1-A5	1	6	7	7	3	8
B1-B5	3	7	8	8	8*	8
C1-C5	3	7	7	8	8*	8
D1-D5	1	7	7	8	8	7

*Beam ends evaluated at joint rather than at bearing since for this design, they do not occur at the same location.

Joint EXPANSION SPACE ON top of Bridge by COVER IT's LOOKED MARGINAL for a REAL "hot" DAY. Joint R would RIDE UP on CONCRETE Some SPALLING indicated THIS May BE HAPPENING.
