TRC9207

Performance of Pavement Drainage Systems

Final Report

**Planning & Research Division
Arkansas State Highway and Transportation Department**

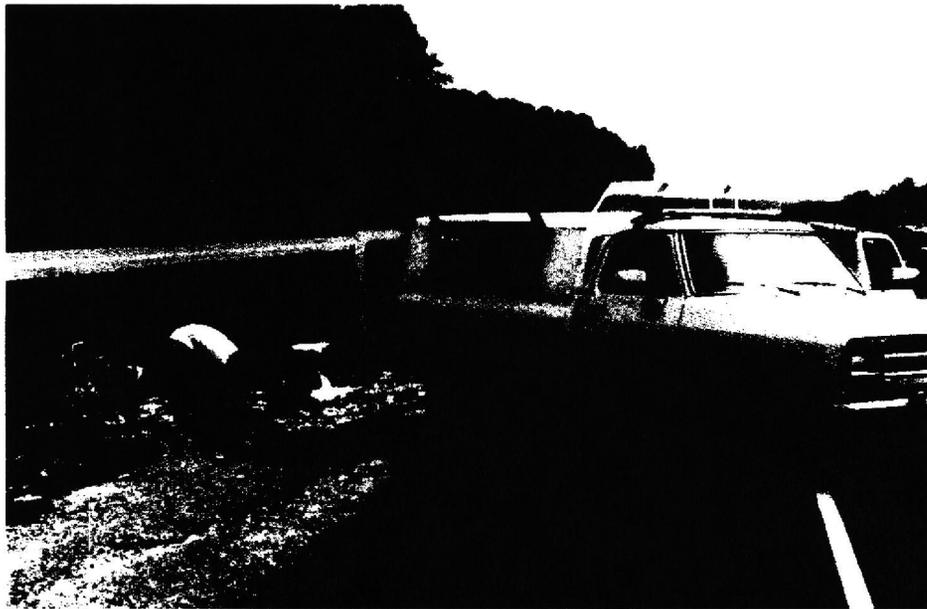
Picture 22. Camera Control Unit and Generator for Video Inspection System Operated from Pickup Truck

In 1996, the Department purchased, under Job #60592, a waterproof video camera system capable of inspecting 4" diameter edge drains pipes. See Picture 22 in Appendix A. This video inspection system enabled District personnel to further investigate existing edge drain pipes being repaired on I-540 in Crawford County and edge drains under construction with Jobs R20138, I-530, Section 4 and 5 (see Picture 23 in Appendix A) and 070061, I-30, Section 14. The inspection showed that in new construction many of the edge drains were being damaged during or slightly after installation by trucks and heavy equipment during the construction phase. These drains were installed along the highway equipped with a pavement over an open graded base. Trucks hauling roadbed material from quarries located along the right of way crushed many of the edge drain laterals installed on the project. Many of the edge drains replaced after the hauling was complete, were subsequently crushed a second time by heavy equipment working along the shoulders. The flexible pipe or light wall PVC pipe used to construct these laterals provided inadequate strength at shallow depths along the shoulder to withstand heavy loads. If the installation of the laterals had been delayed until the road bed construction was completed and heavier rigid pipe had been used for the
