**ARKANSAS STATE HIGHWAY AND TRANSPORTATION DEPARTMENT
EQUIPMENT AND PROCUREMENT DIVISION
BID INVITATION**

Bid Number: M-13-063P

1. Asbestos Abatement and Demolition located at Hwy. 13 Extension (Searcy), White County; as per attached work list for Tracts 3X, 22X & 82X - Job 050189.

**PROPERTY MANAGEMENT
ASBESTOS ABATEMENT & DEMOLITION CONTRACT**

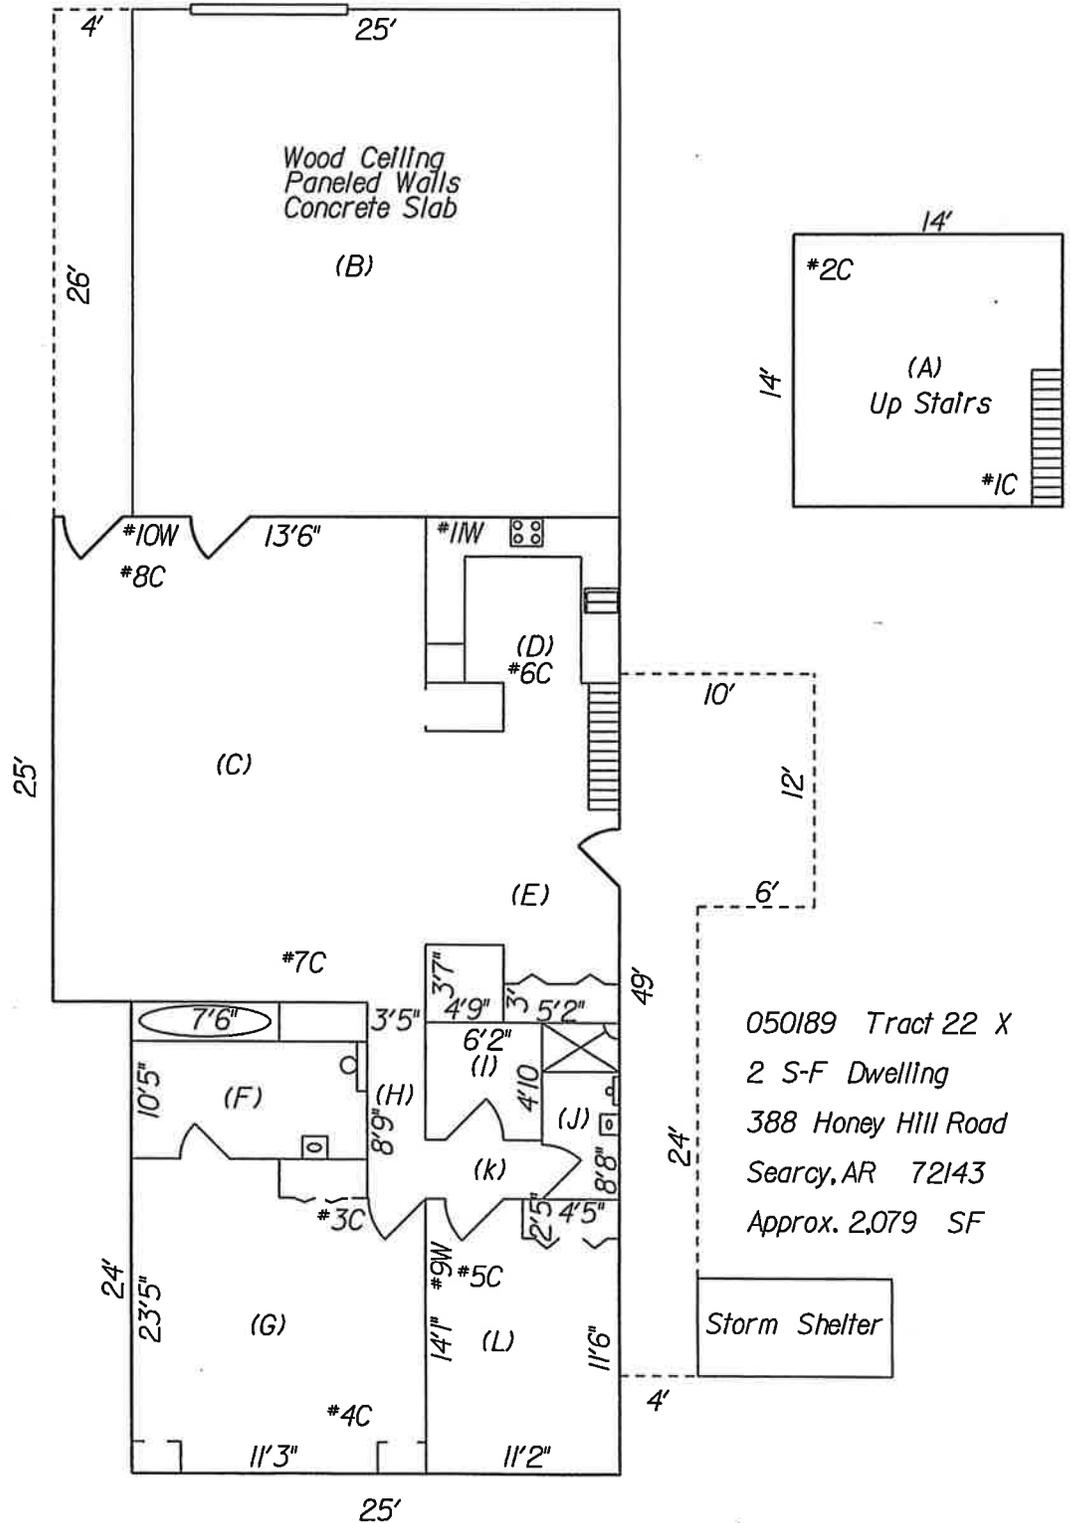
Sample Number	Description/ Location	Sample Number	Description/ Location
#1	A) Ceiling	#11	D) Wall
#2	A) Ceiling	#12	
#3	G) Ceiling	#13	
#4	G) Ceiling	#14	
#5	L) Ceiling	#15	
#6	D) Ceiling	#16	
#7	C) Ceiling	#17	
#8	C) Ceiling	#18	
#9	L) Wall	#19	
#10	C) Wall	#20

Homogenous Areas:	
Roofing	Composition Shingle
Siding	Vinyl/Wood; Rock
Ceilings AFG-Textured SR;	BDEHIJK -- Sheet Rock
Walls B -- Wood Paneling;	B -- Wood Joist
Floors DGHIKL --Pergo/Wood	AC-L Sheet Rock
	DEFJ -- Ceramic Tile;
	A -- Carpet/Wood

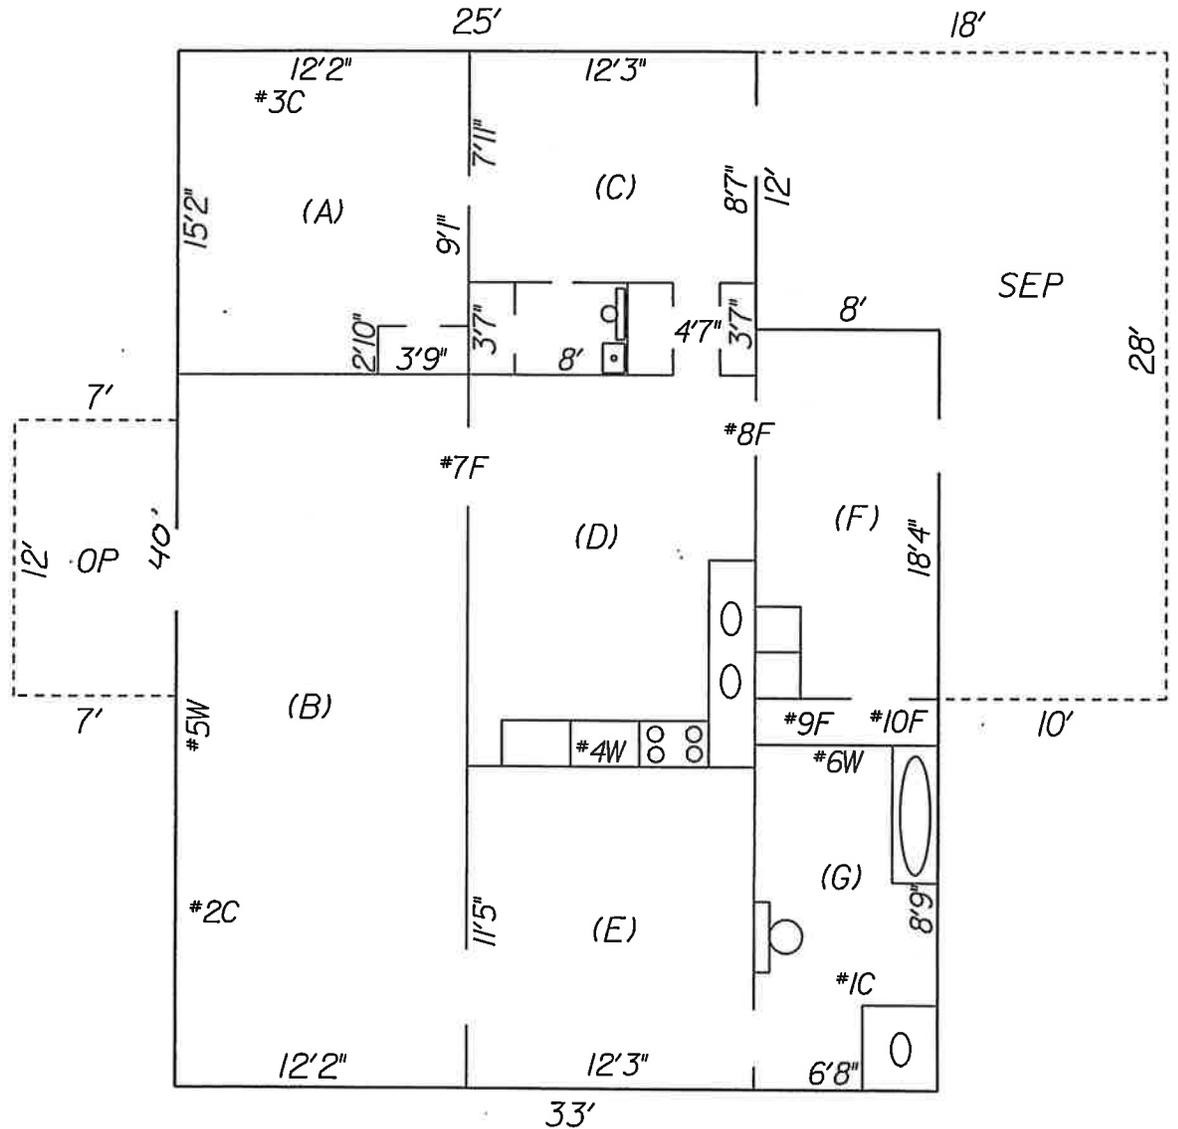
050189 Tract 82 X
 1-S-F Office Building
 3239 Hwy.36
 (Bebee Capps)
 Searcy, AR 72143
 Approx. 1,849 SF

Sample Number	Description/Location	Sample Number	Description/Location
#1	G) CEILING	#11	
#2	B) CEILING	#12	
#3	A) CEILING	#13	
#4	D) WALL	#14	
#5	B) WALL	#15	
#6	G) WALL	#16	
#7	D) FLOOR	#17	
#8	D) FLOOR	#18	
#9	F) FLOOR	#19	
#10	F) FLOOR	#20

Homogenous Areas:	
Roofing	Composition Shingle
Siding	Aluminum; Wood
Ceilings	All Sheet Rock
Walls (A & C) Paneling	(BDEFG) Sheet Rock
Floors (ABC) Carpet/Wood	(C-Bath) Rubber Matt/Wood (DEFG) Hardwood

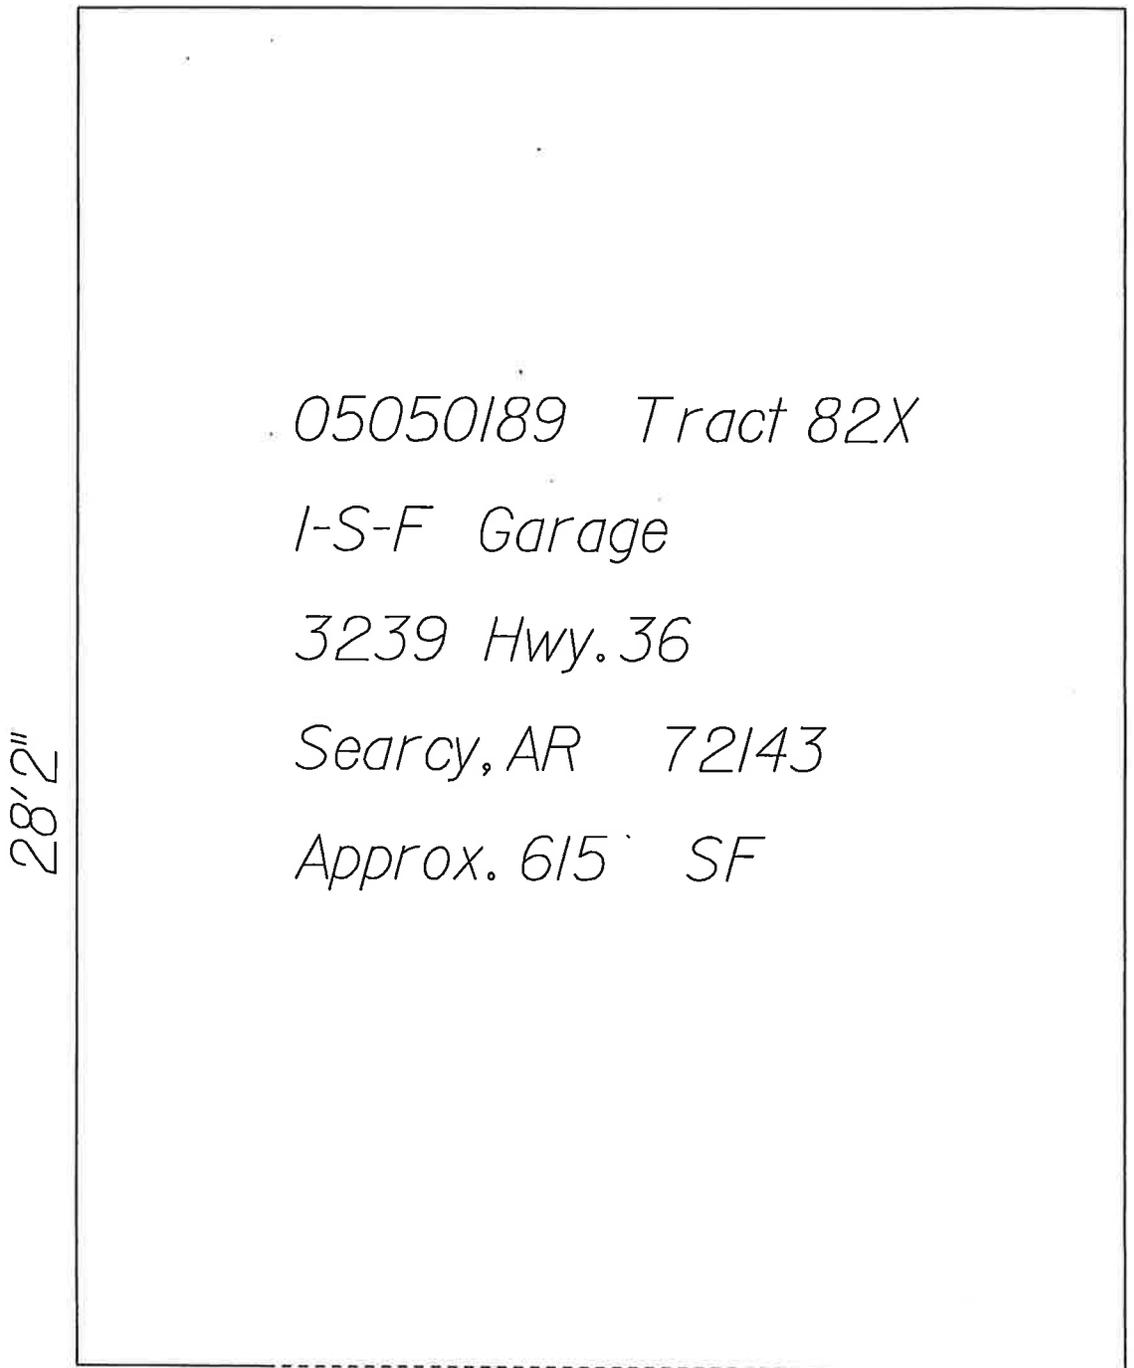
INSPECTION FLOOR PLAN

JOB: 050189 PROPERTY LOCATION 1-S-F Garage Building .INSPECTED BY Joel Clark (011518)
TRACT: 82 X DATE: 2/28/2013 3239 Hwy. 36 (Beebe Capps)
Searcy, AR 72143

Homogenous Areas:	
Roofing	Composition Shingle
Siding	Wood
Ceilings	Wood
Walls	Wood
Floors	Concrete Slab

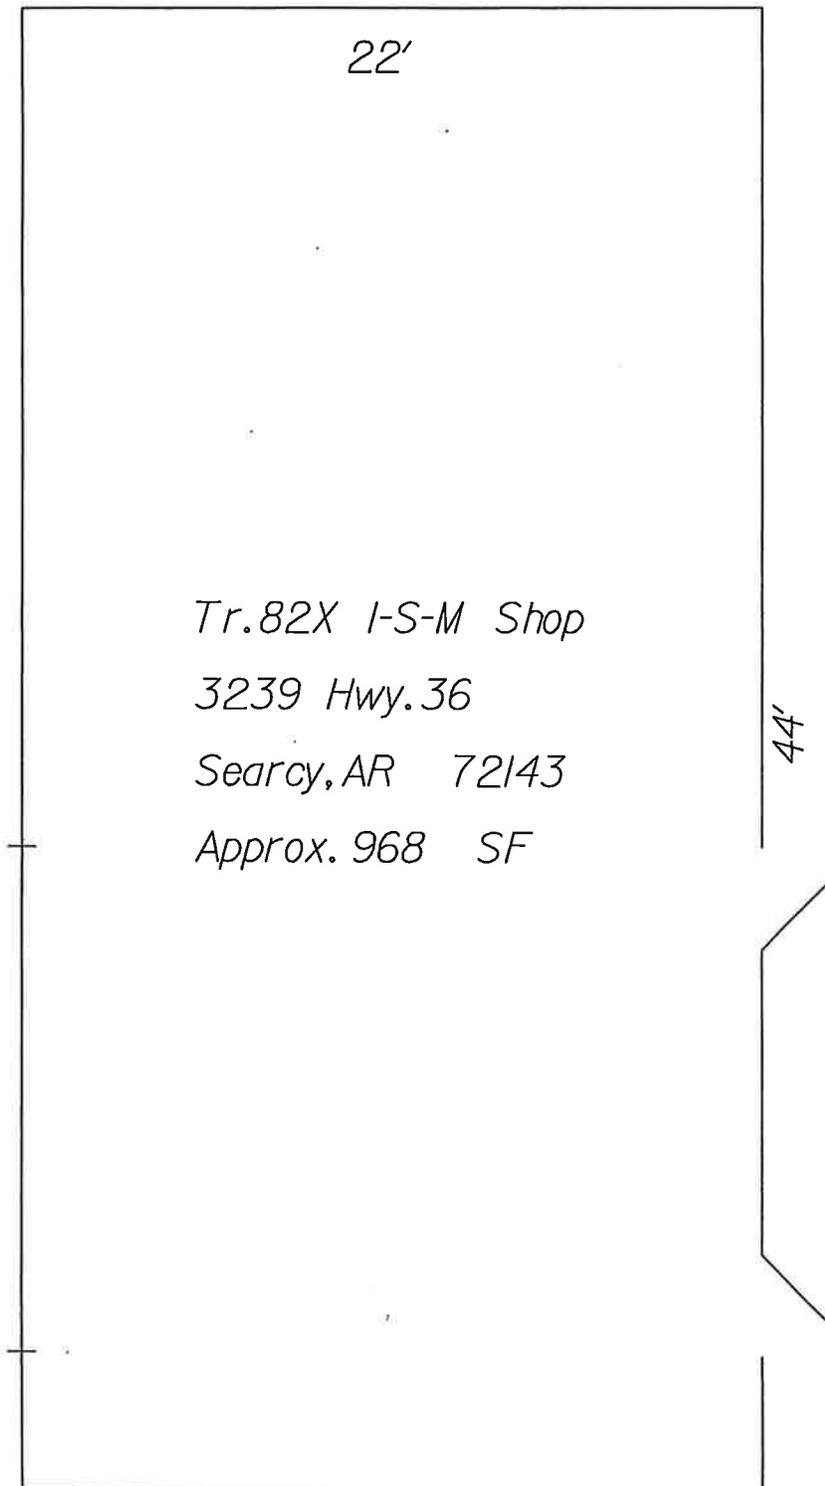
INSPECTION FLOOR PLAN

JOB: 050189
 TRACT: 82 X
 DATE: 2/28/2013

Homogenous Areas:	
Roofing	Metal
Siding	Metal
Ceilings	Metal
Walls	Some Unfinished Sheet Rock & Metal
Floors	Concrete Slab
